Phase I Environmental Site Assessment

Residential Properties
3817, 3819, 3835 and 3843 Innes Road
Ottawa, Ontario

May 8, 2015

Report: PE3532-1

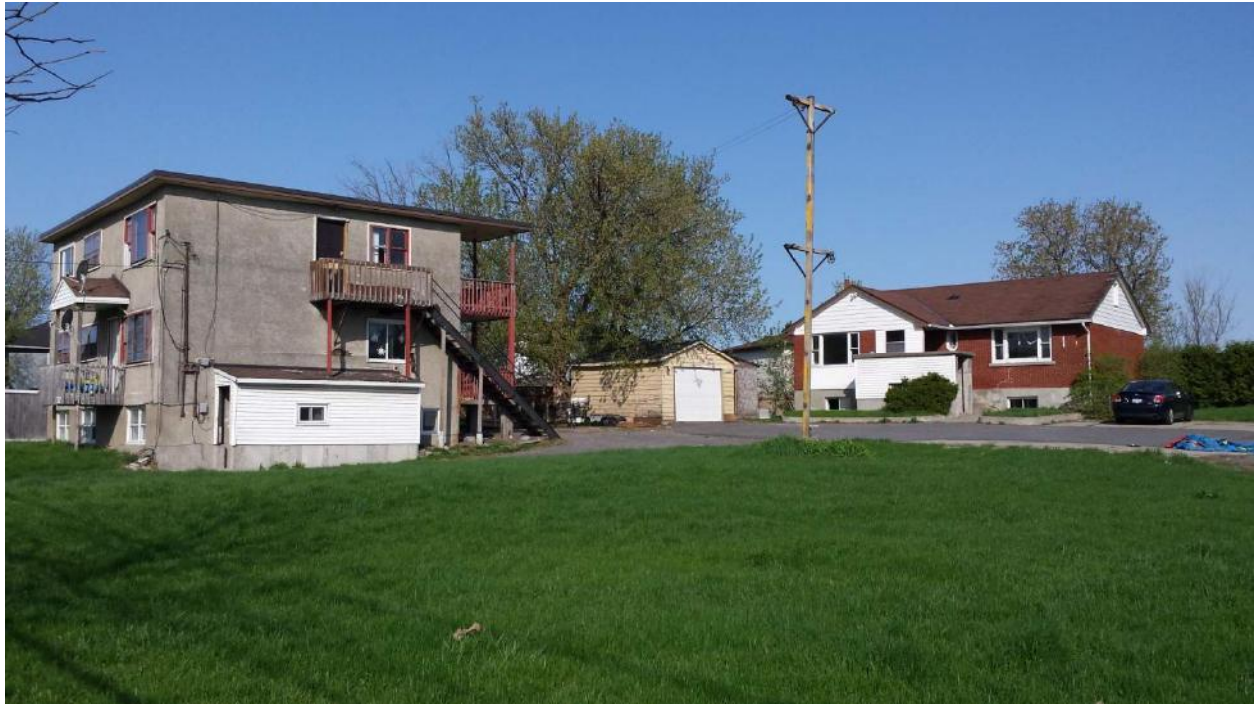
Photograph 1: View from the driveway of the subject site at 3817 (left) and 3819 Innes Road, looking west.

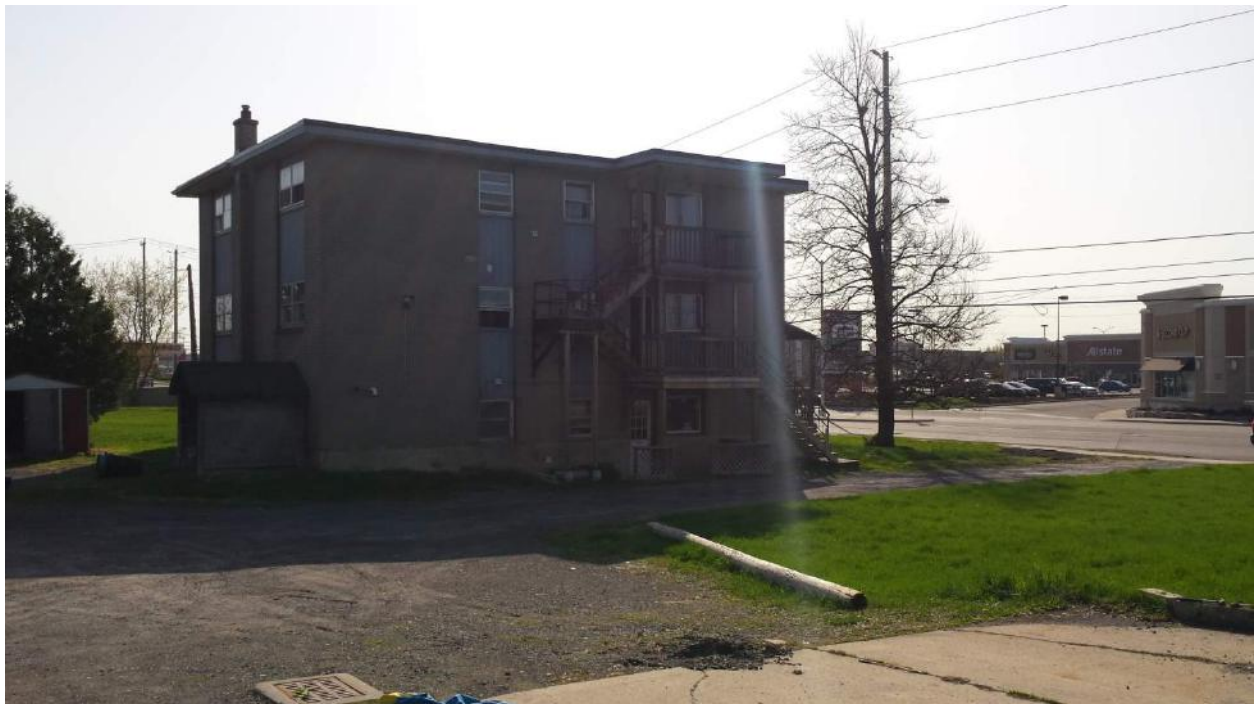
Each unit of the apartment building at 3835 Innes Road occupies one level of the building. The building has a concrete foundation and the exterior is finished with brick. The second and third floor units each have a wooden balcony facing west. Each unit contains ceramic tile, vinyl tile and laminate flooring, and drywall on the walls and ceiling. Incandescent lighting was observed throughout the building. The mechanical room located in the basement level contains a forced air, natural gas fired furnace. No unusual odours or visual observations were made at the time of the site visit.

Photograph 2: View of 3835 Innes Road, looking south. Innes Road and commercial development behind.

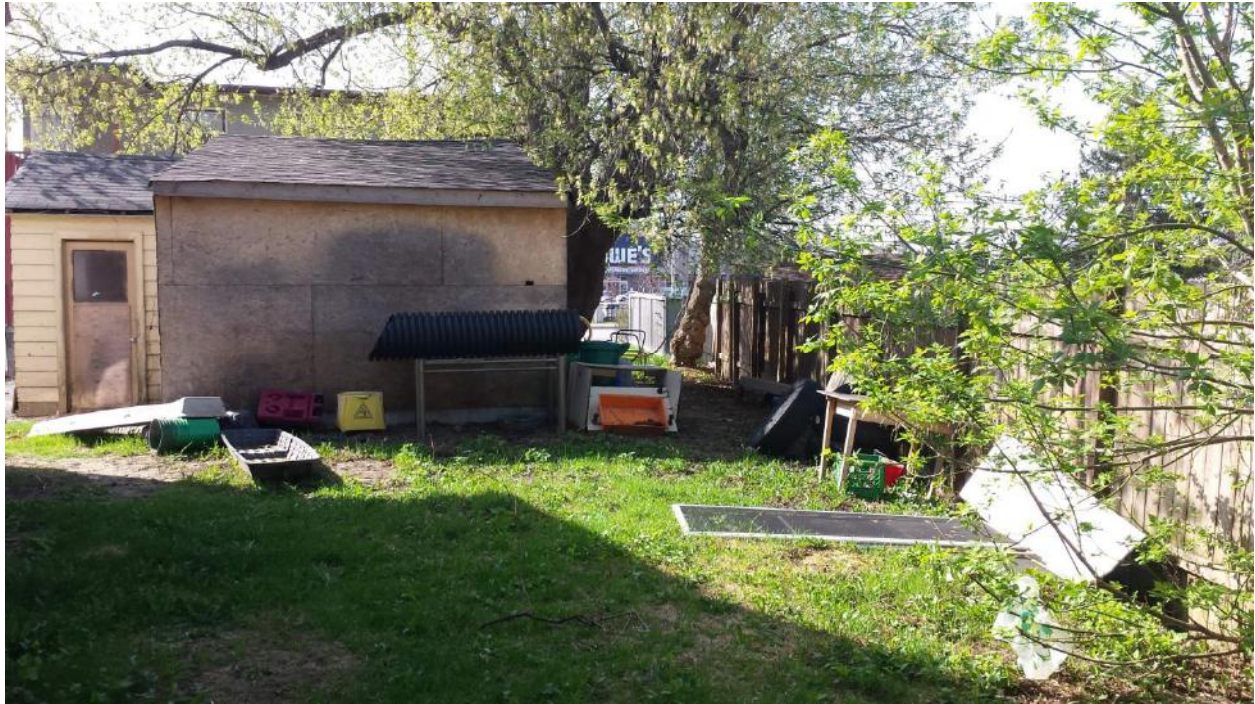
Two (2) small shed structures are present between the two buildings at 3817 and 3819 Innes Road. These structures contained a filing cabinet and broken furniture and construction debris. Some of this material was also scattered around the exterior of the sheds at the time of the site visit.

Photograph 3: View of yard with sheds beside house at 3819 Innes Road, looking south.

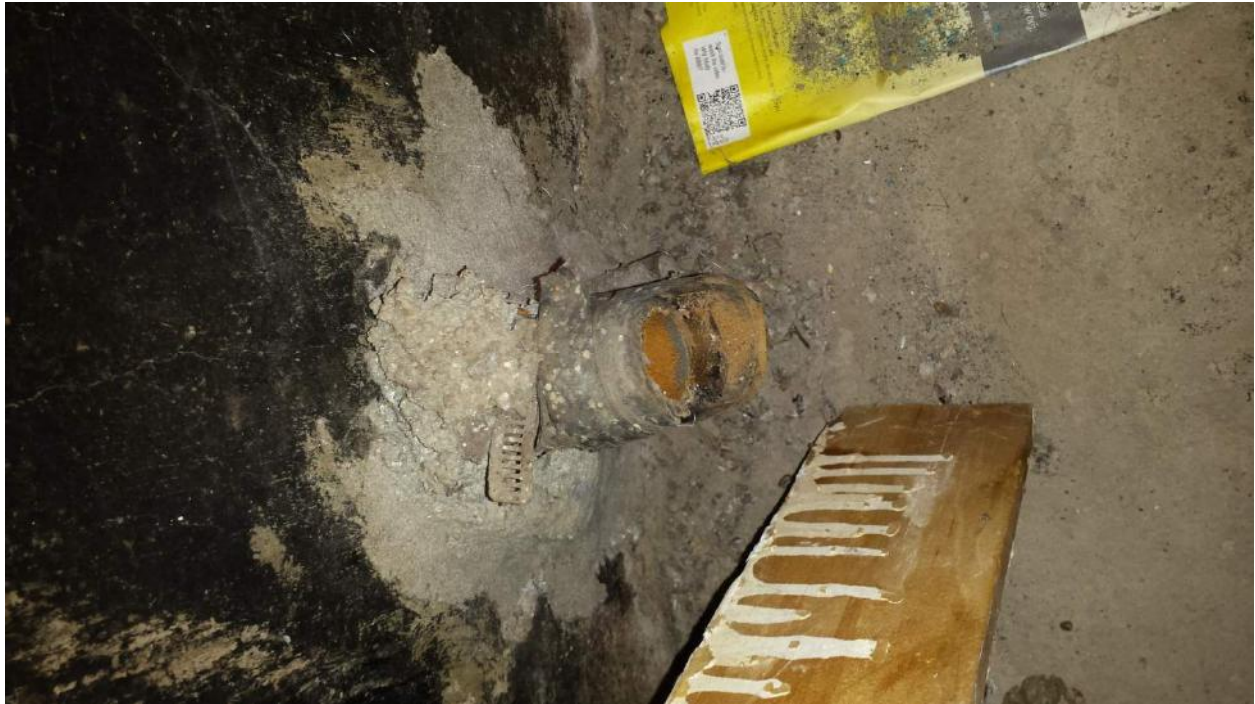
Photograph 5: Exposed pipe and possible asbestos-containing material in the basement level of 3835 Innes Road.

Based on the construction dates of the buildings, asbestos-containing materials and lead-based paints are potentially present. It is recommended that a designated substances survey (DSS) be completed on the subject buildings prior to their demolition.

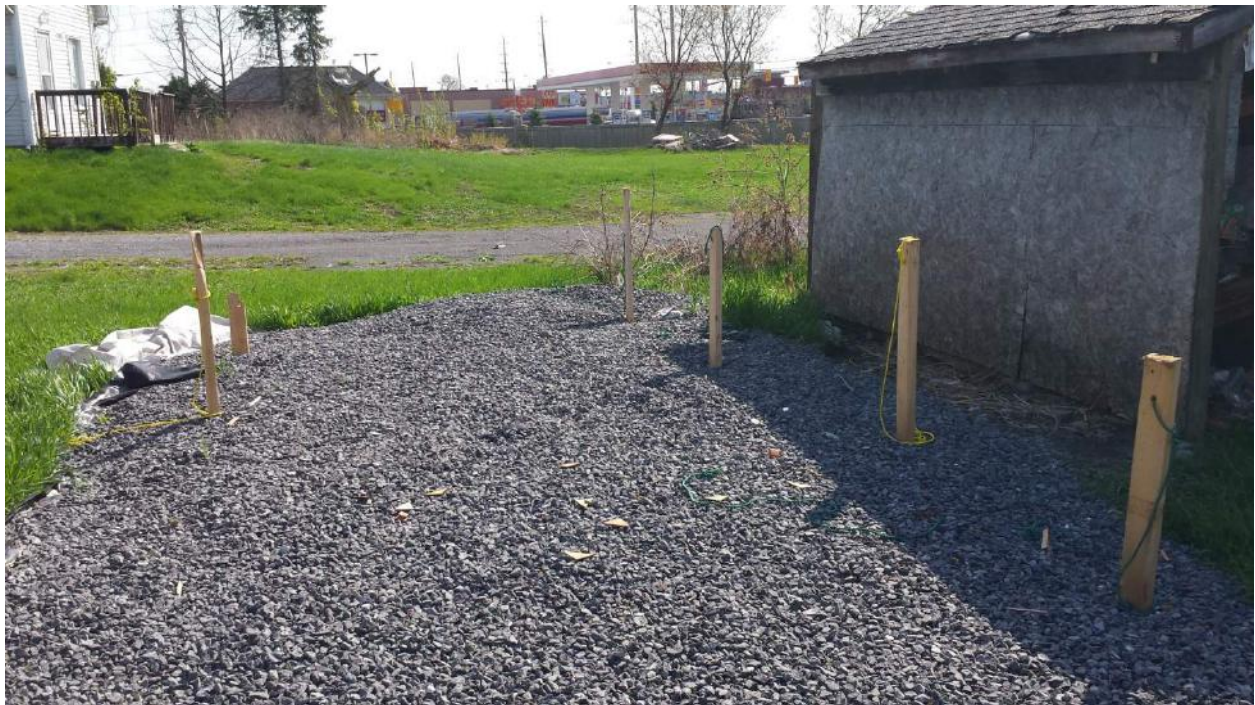
Three (3) shed structures are present at the back of the building at 3835 Innes Road. The first shed, closest to the building, contains plywood scraps, a propane tank, pieces of brick, wood, and broken furniture. The second shed contains furniture and yard debris. The third shed contains logs and yard debris. A gravel pad is present between the second and third sheds, and appears to have been constructed for the installation of another shed.

Areas of Potential Environmental Concern (APECs) were identified on site as a result of the retail fuel outlet adjacent to the subject site at 3869 Innes Road, and at the apparent leak from the AST at 3843 Innes Road.

Photograph 6: Gravel pad and shed at 3835 Innes Road, looking east. The building at 3843 is visible at top left, and the adjacent retail fuel outlet at 3869 Innes Road is visible at the top.

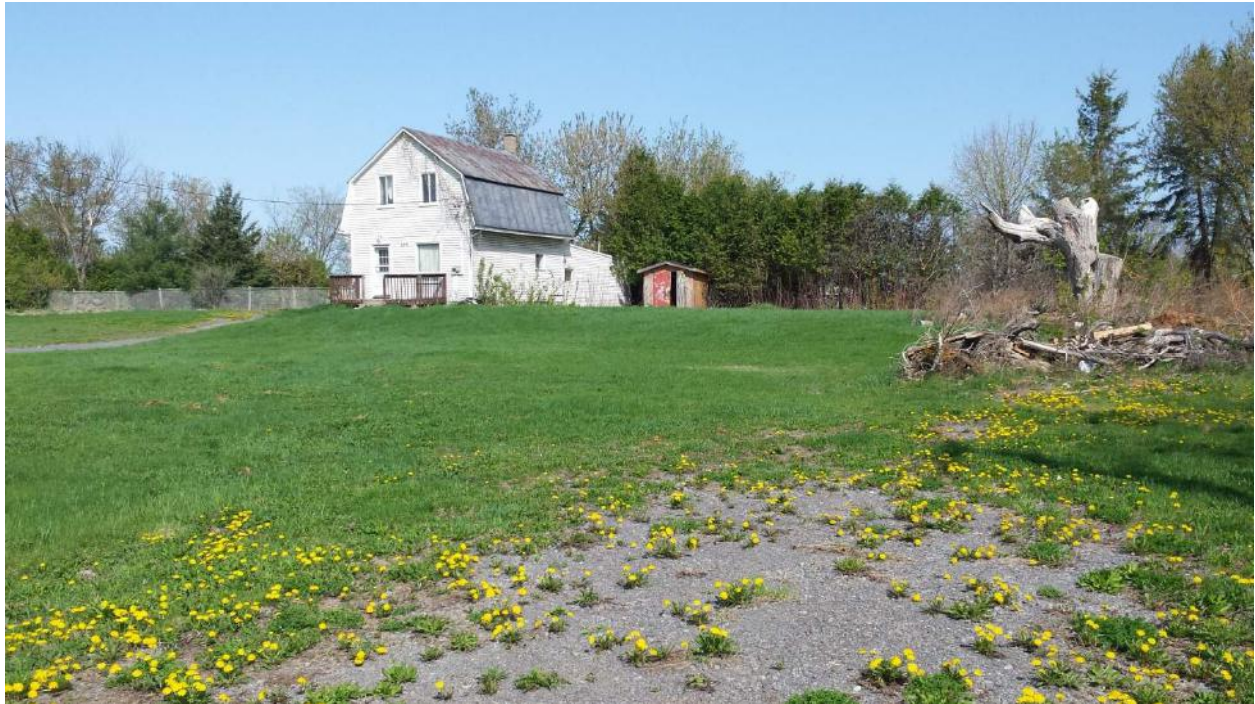
The residential dwelling at 3843 Innes Road is located in the northwest corner of the property, and the ground is raised above the surrounding land on the property. The structure is two storeys, and has a sloped sheet metal roof, vinyl siding, and concrete foundation. The building has linoleum, carpet, laminate, and vinyl tile flooring, tile and drywall walls, stucco ceilings, and fluorescent and incandescent lighting. The building is not currently heated, but was heated with electric baseboard heaters when it was occupied. The gravelled basement crawlspace contains an aboveground fuel oil storage tank (AST) and furnace, which would have been used to heat the building prior to its conversion to electric heating. Some suspected fuel oil staining was visible on the gravel around the AST and furnace. An empty methanol barrel was also present at the site, located along the west wall of the building. The barrel appeared to not have been used to store methanol at the site, and was not considered to pose a concern.

Photograph 7: View of 3843 Innes Road, looking north.

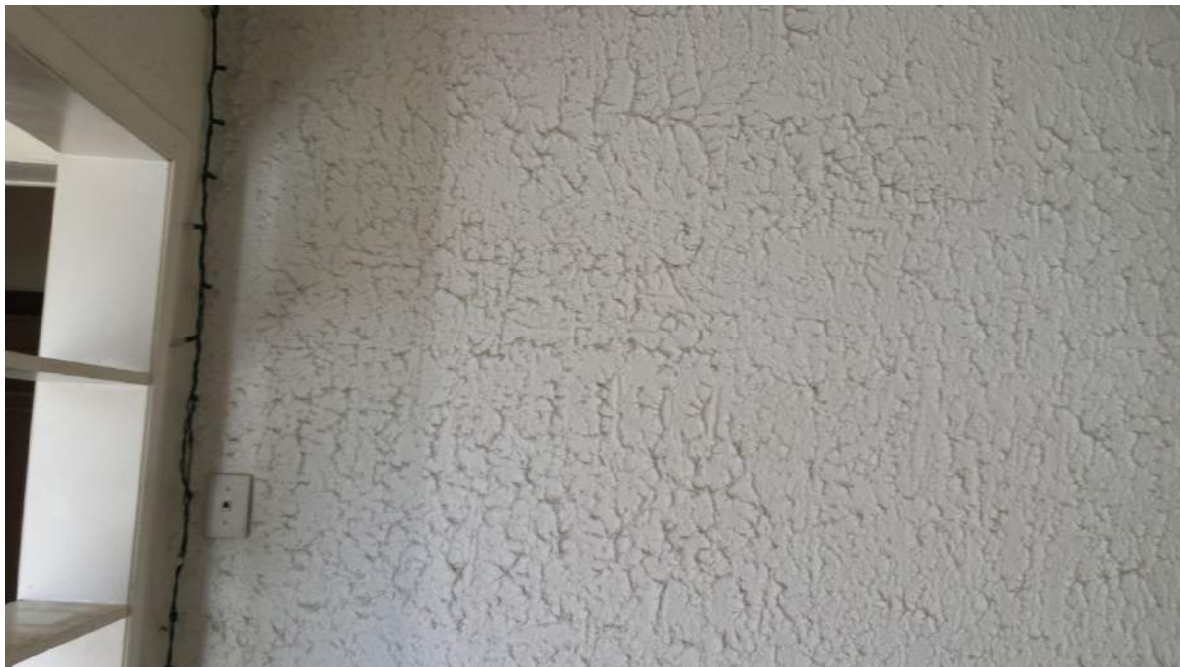
Photograph 8: Interior wall at 3843 Innes Road, finished with a potential asbestos-containing plaster material.

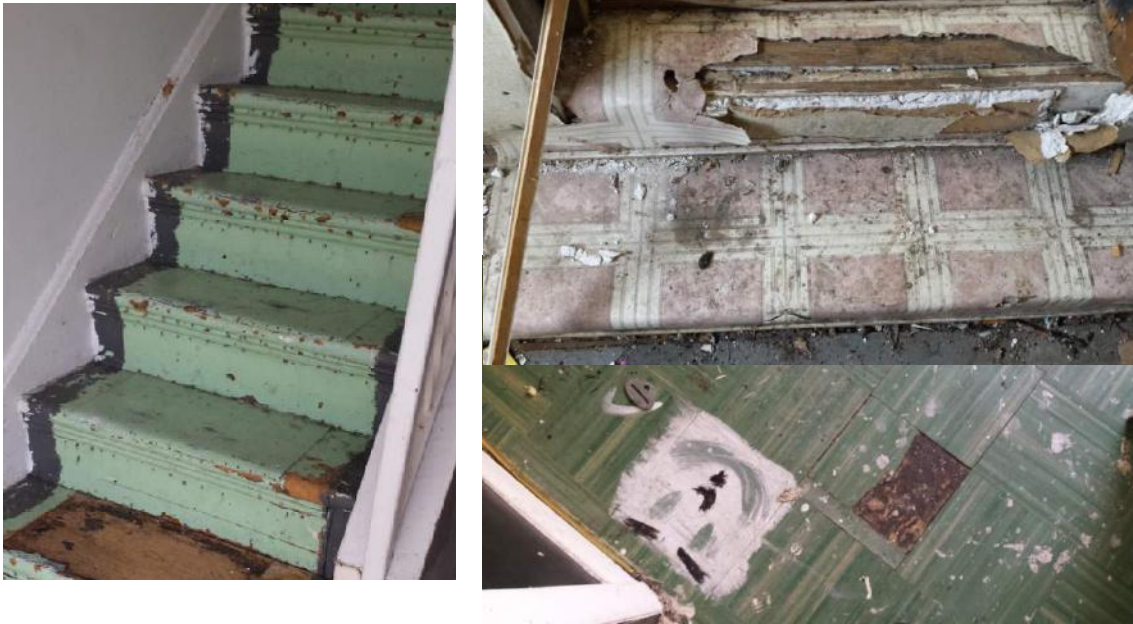
Photograph 9, 10 and 11: Possible asbestos-containing flooring materials at 3843 Innes Road, in poor condition.

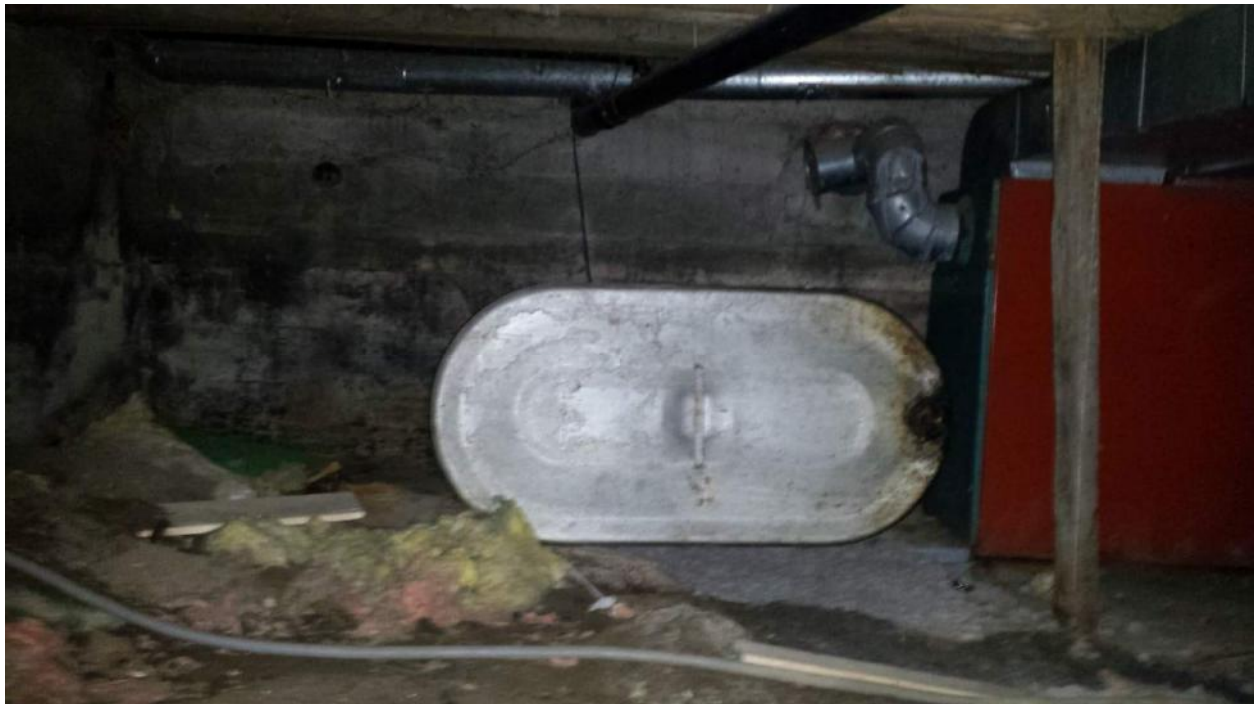
Potentially Contaminating Activities (PCAs) were identified within the Phase I study area. These include the retail fuel outlet at 3869 Innes Road, immediately adjacent to the site, and suspected furnace oil leak from the aboveground storage tank (AST) in the basement of the building at 3843 Innes Road.

Photograph 12: Aboveground storage tank and furnace (at right) in the basement at 3843 Innes Road.

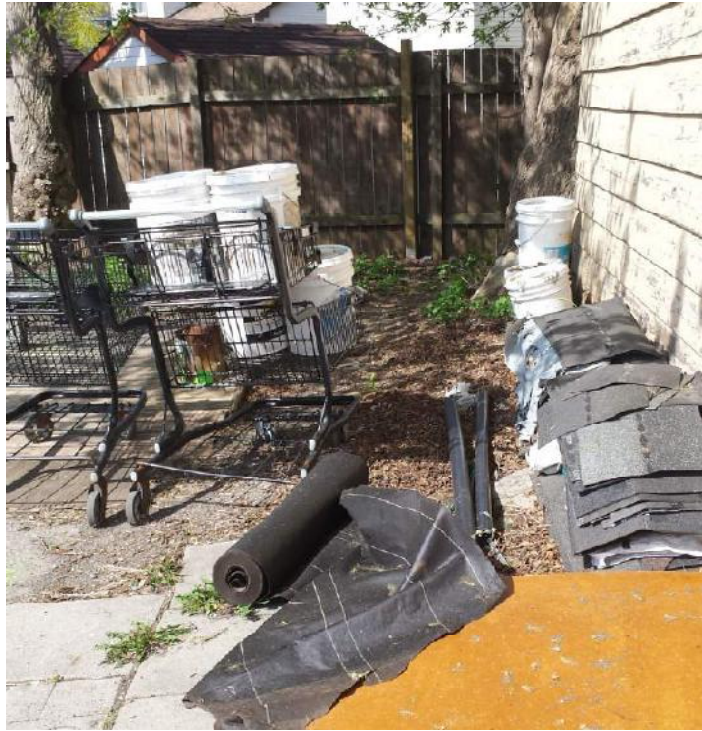
Photograph 13: Yard space behind 3817 Innes Road, between the shed to the right and the access ramp (unseen to the left), looking west. Buckets are labeled as containing paint and petroleum oil.
