Client:  
 Project:  
**MARITIME-ONTARIO**  
**OTTAWA**  
**8800 CAMPEAU DRIVE**  
 Drawing Title:  
**LANDSCAPE PLAN**

Project: **MARITIME-ONTARIO OTTAWA**  
**8800 CAMPEAU DRIVE**

Drawing Title: **LANDSCAPE DETAILS**

**RE: TREE CONSERVATION REPORT FOR 8800 CAMPEAU DRIVE, OTTAWA**

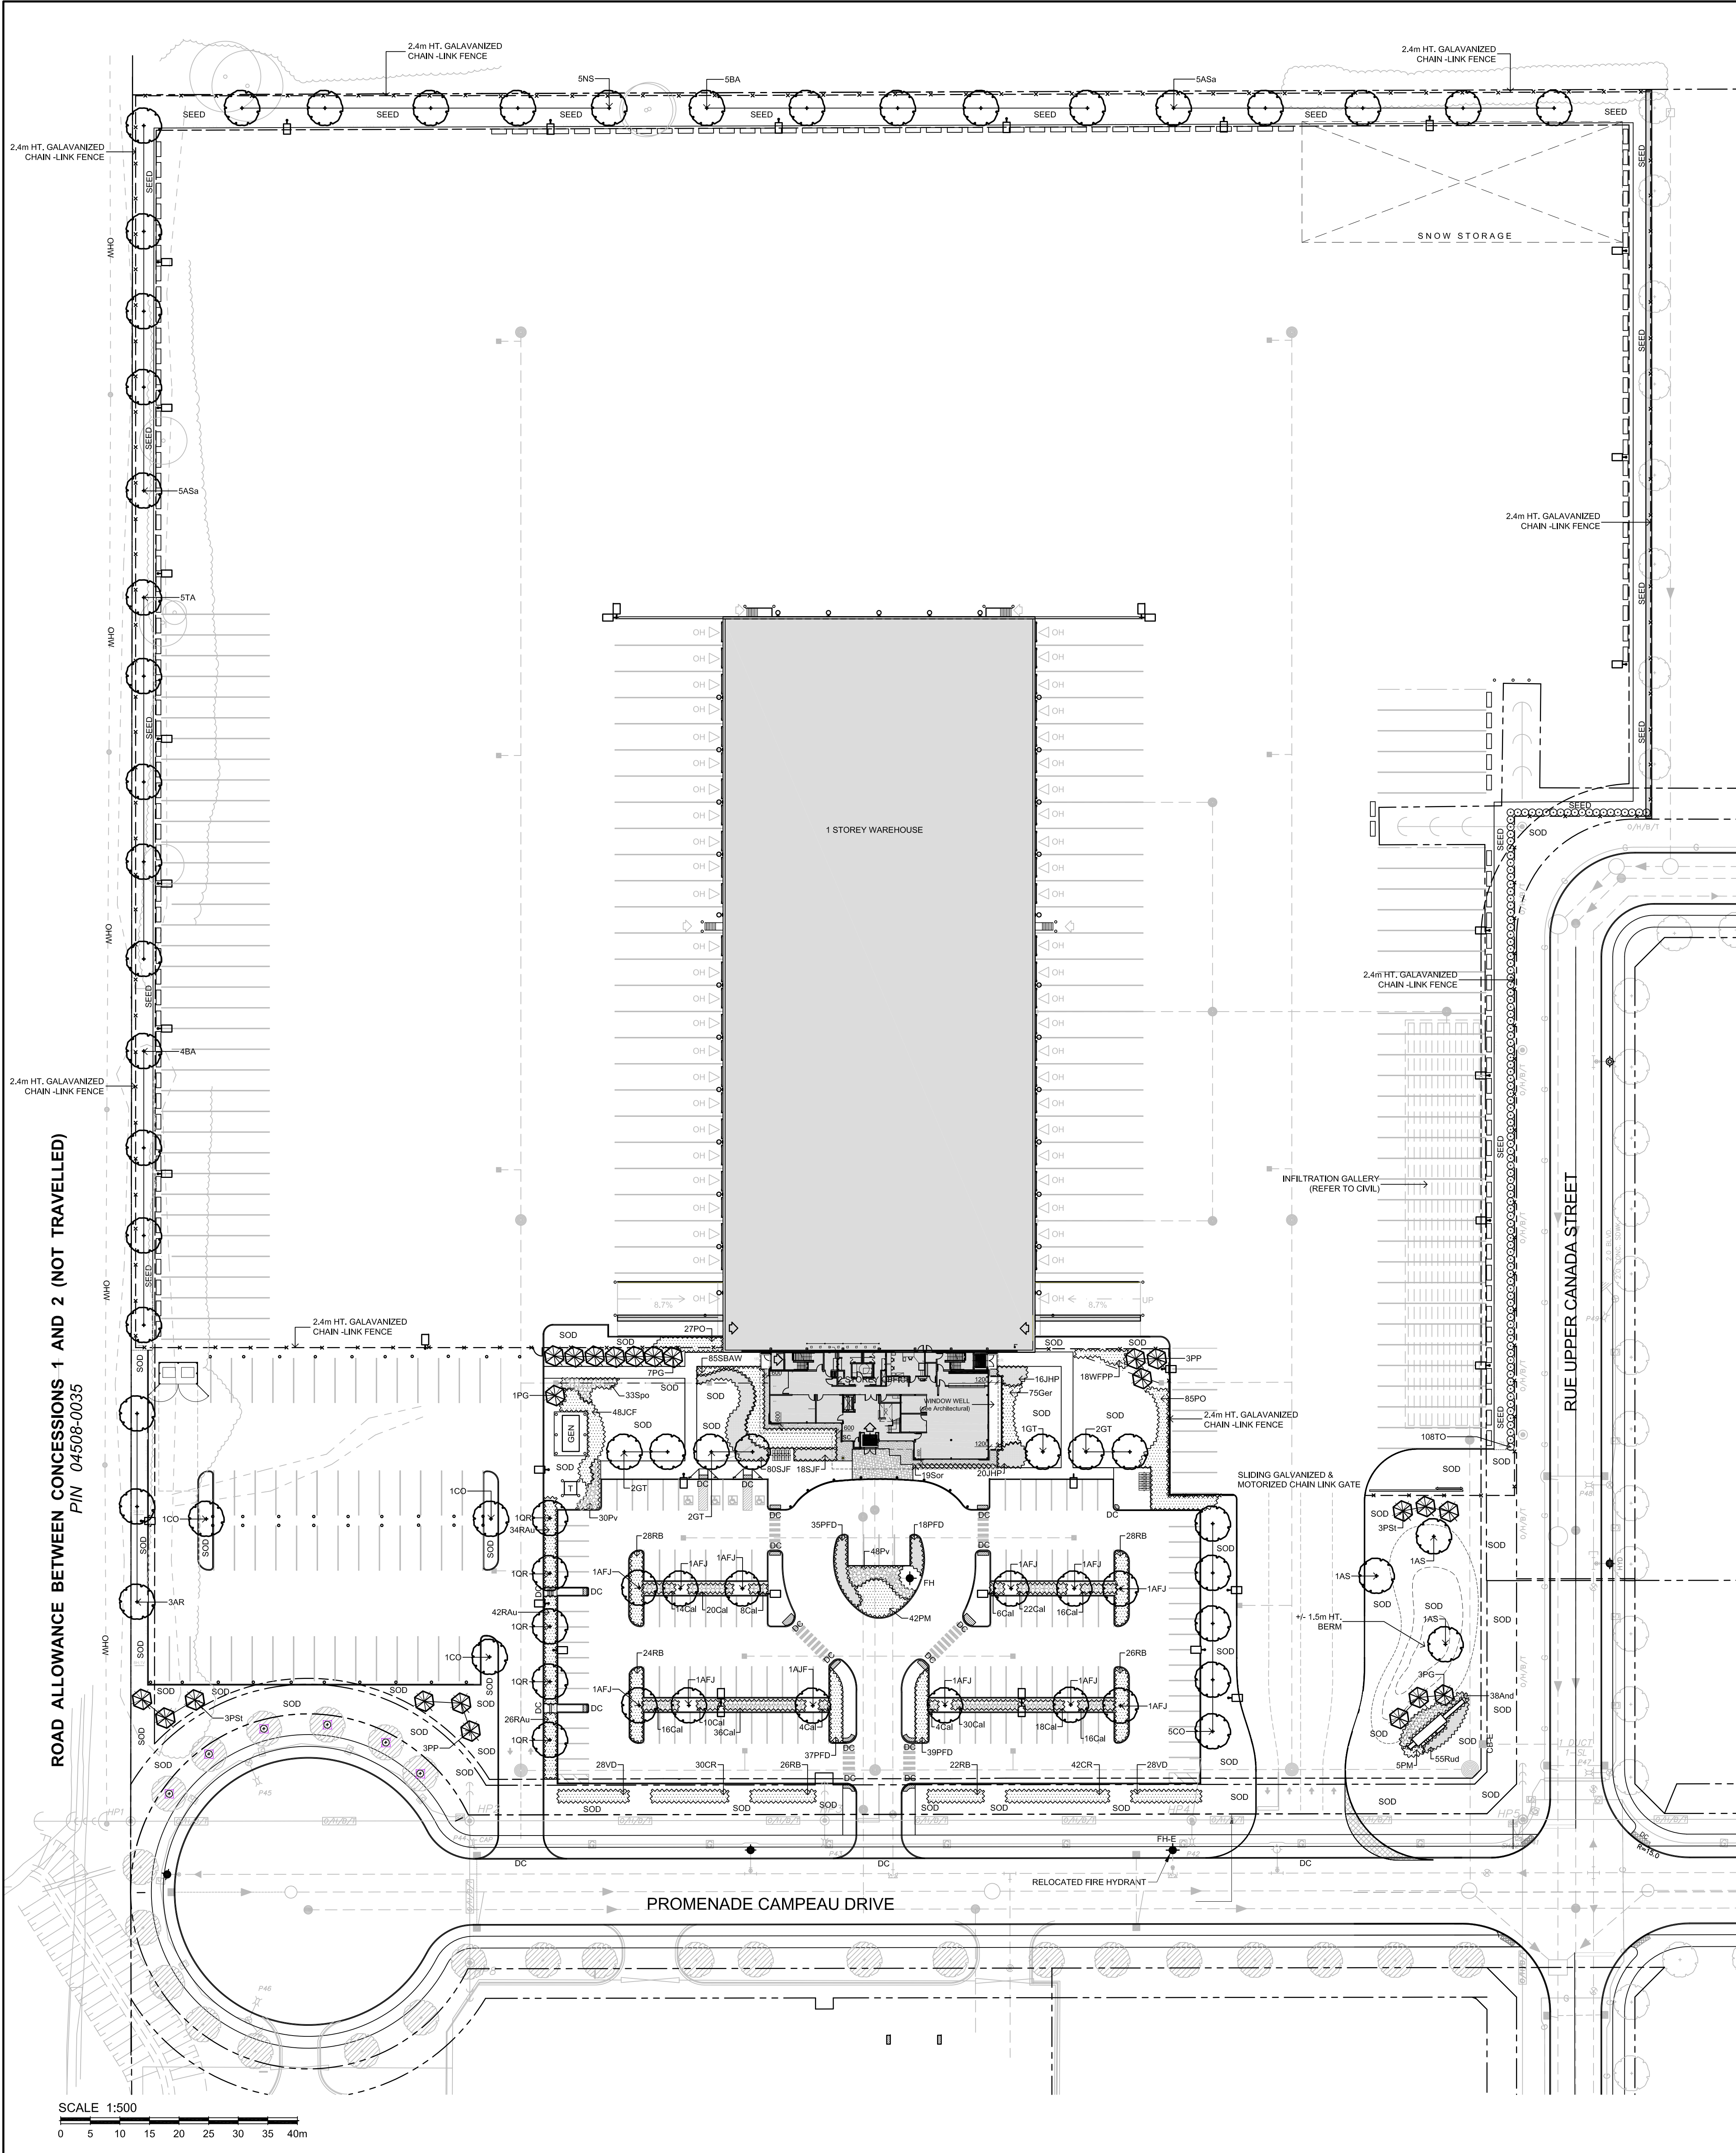
- Shrubs shall be planted in a continuous prepared bed of 450mm depth planting soil mix covered over with a woven polypropylene weed control fabric (LANDSCAPE FABRIC-Green-Line by Thrace-LINQ) and 75mm depth composted pine mulch to finish grade, as specified.

- Perennials and Ornamental Grasses shall be planted in a continuous prepared bed of 450mm depth planting soil mix covered over with 75mm depth composted pine mulch to finish grade. (NO WEED CONTROL FABRIC), as specified.

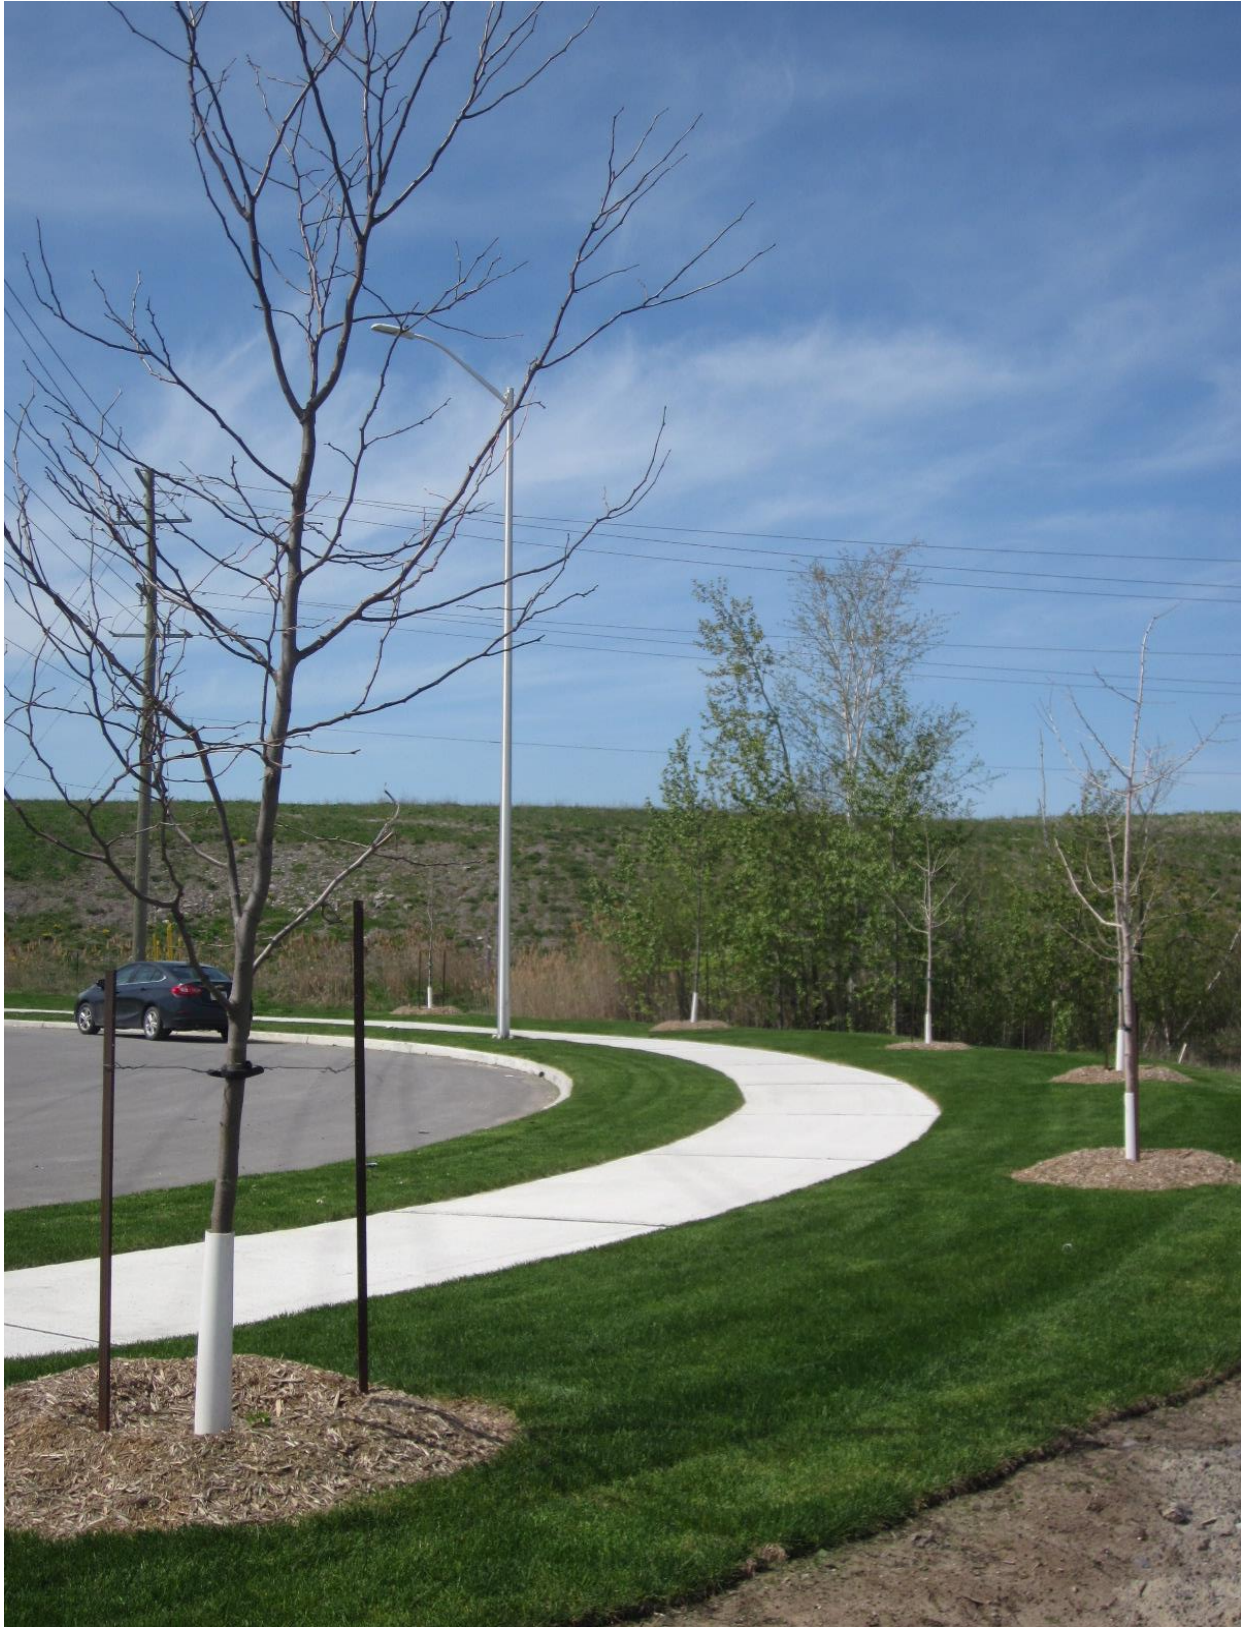
spp.), white spruce (*Picea glauca*) and white cedar (*Thuja occidentalis*) are present as well, but are typically less than 10cm in diameter. A mature double-stemmed ash tree (#4 on the TCR plan) is located on the subject property near this tree line. Six recently planted juvenile trees were found adjacent to the subject property on city land along Campeau Drive: three ginkgo (*Ginkgo biloba*), two little-leaf lindens (*Tilia cordata*) and one honey-locust (*Gleditsia triacanthos*). All are in good condition except one ginkgo which is missing its leader and several lateral branches. The field work for this report was completed in April 2021.

Picture 1. Recently planted trees along Campeau Drive adjacent to subject property

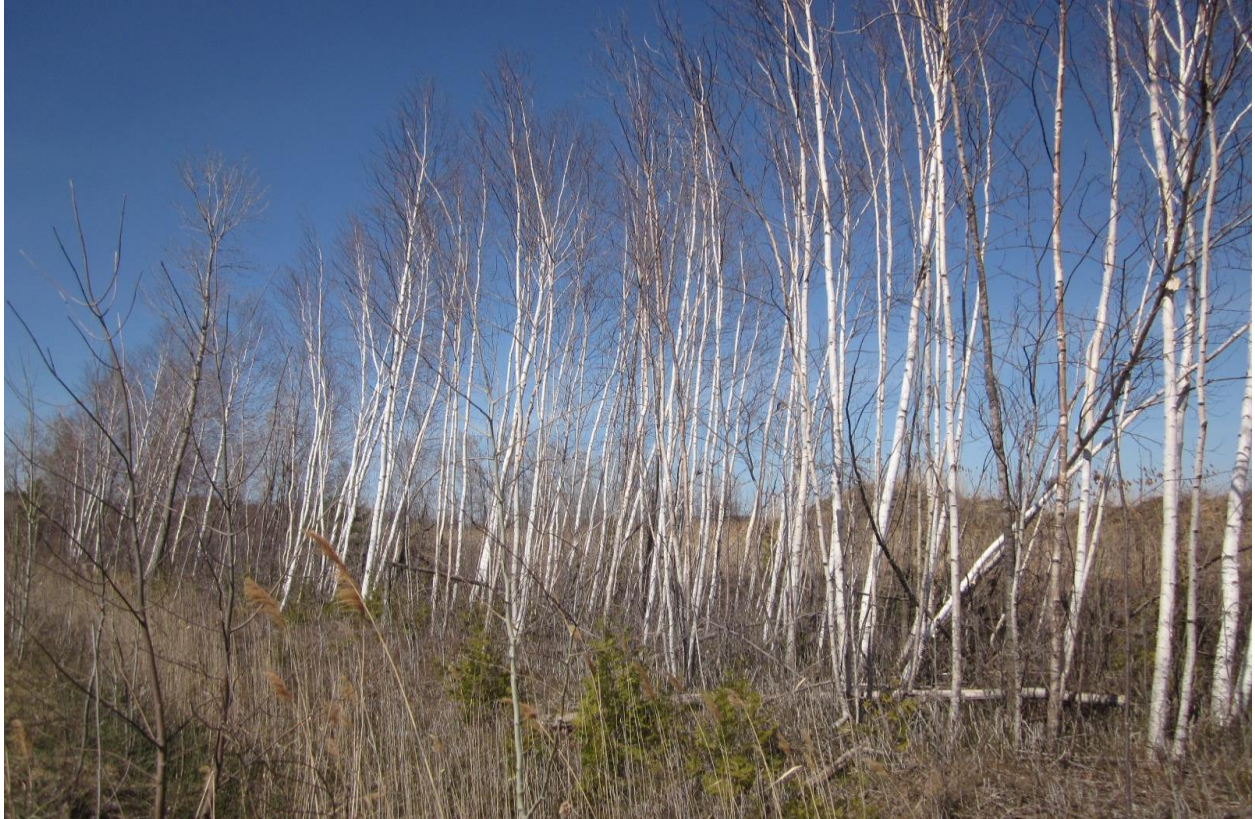
Picture 2. Tree line #1 located on 8800 Campeau Drive (looking northward)

Although this tree line was left untouched during the clearing/stripping operation it is now slated for removal under the current development proposal – leaving no trees remaining on the subject property. However, trees on neighbouring private and City of Ottawa property will be preserved and protected during construction.

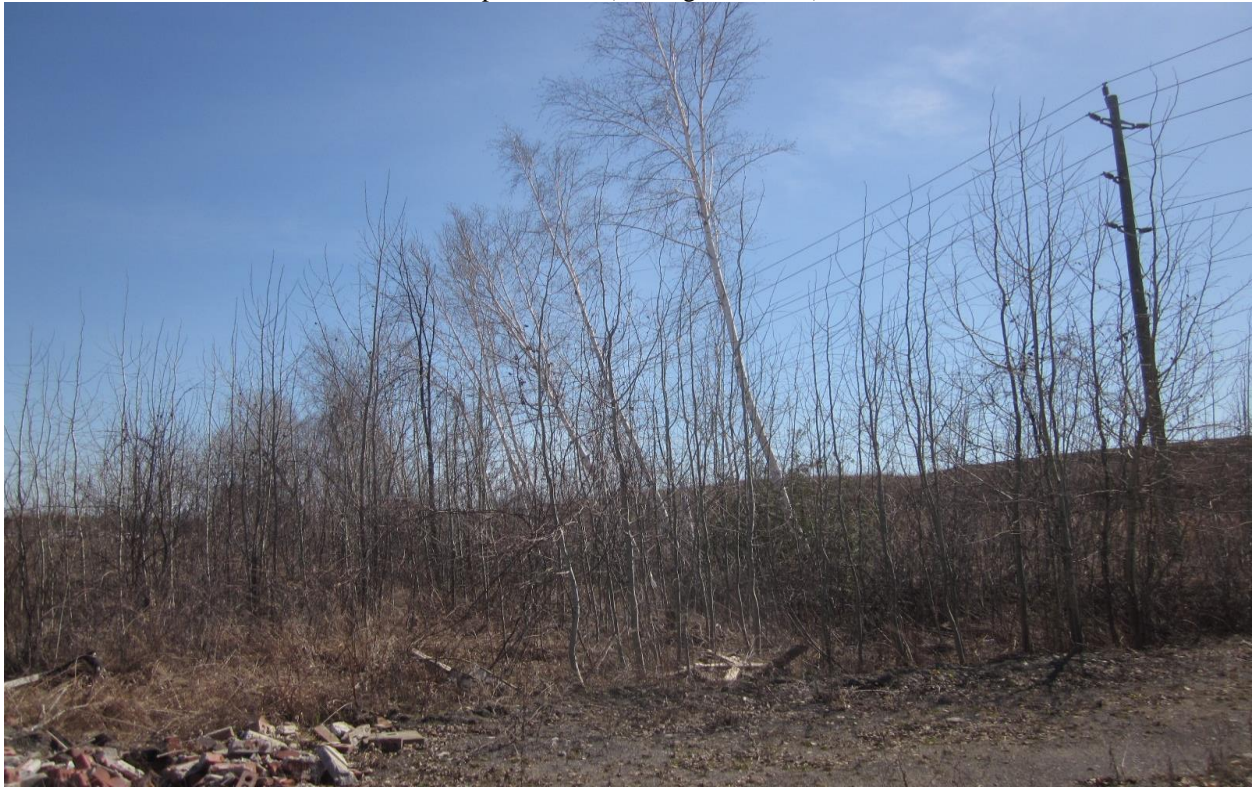
Picture 3. Tree line #1 located on 8800 Campeau Drive (looking southward)

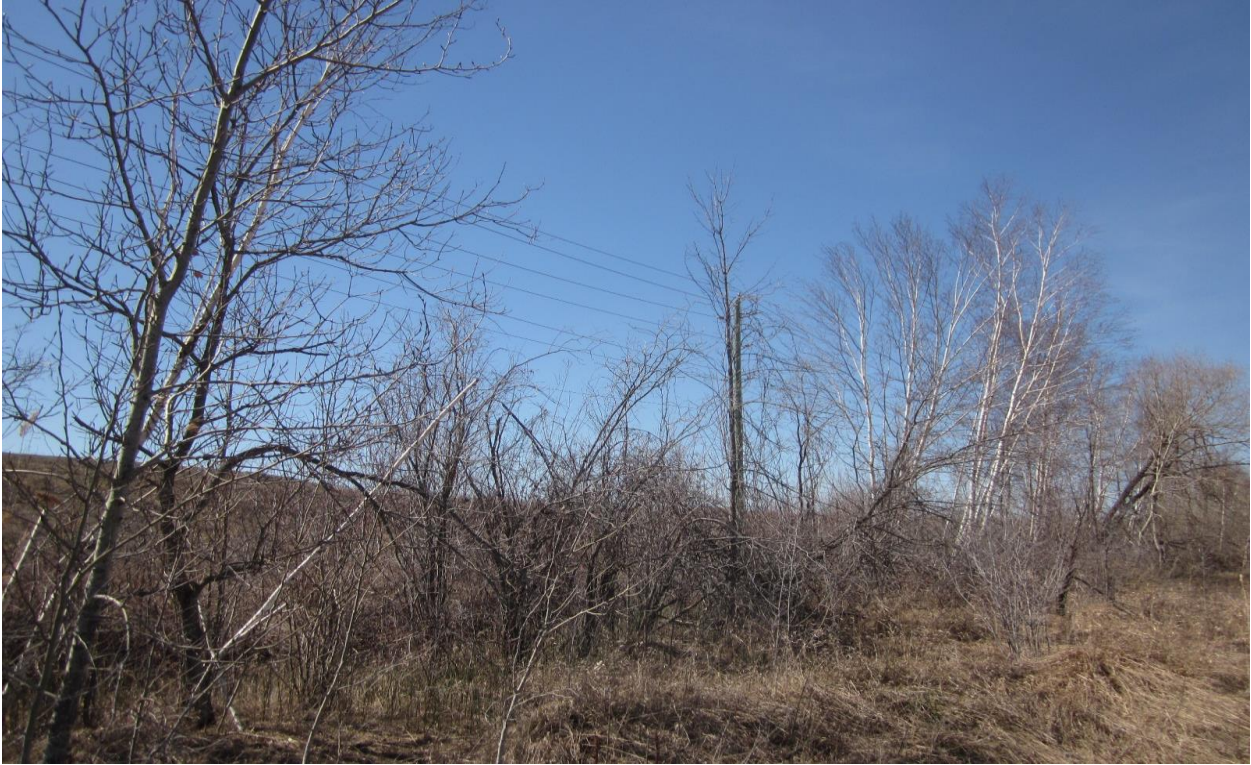
Picture 4. Tree line #2 located on 8800 Campeau Drive (looking westward)

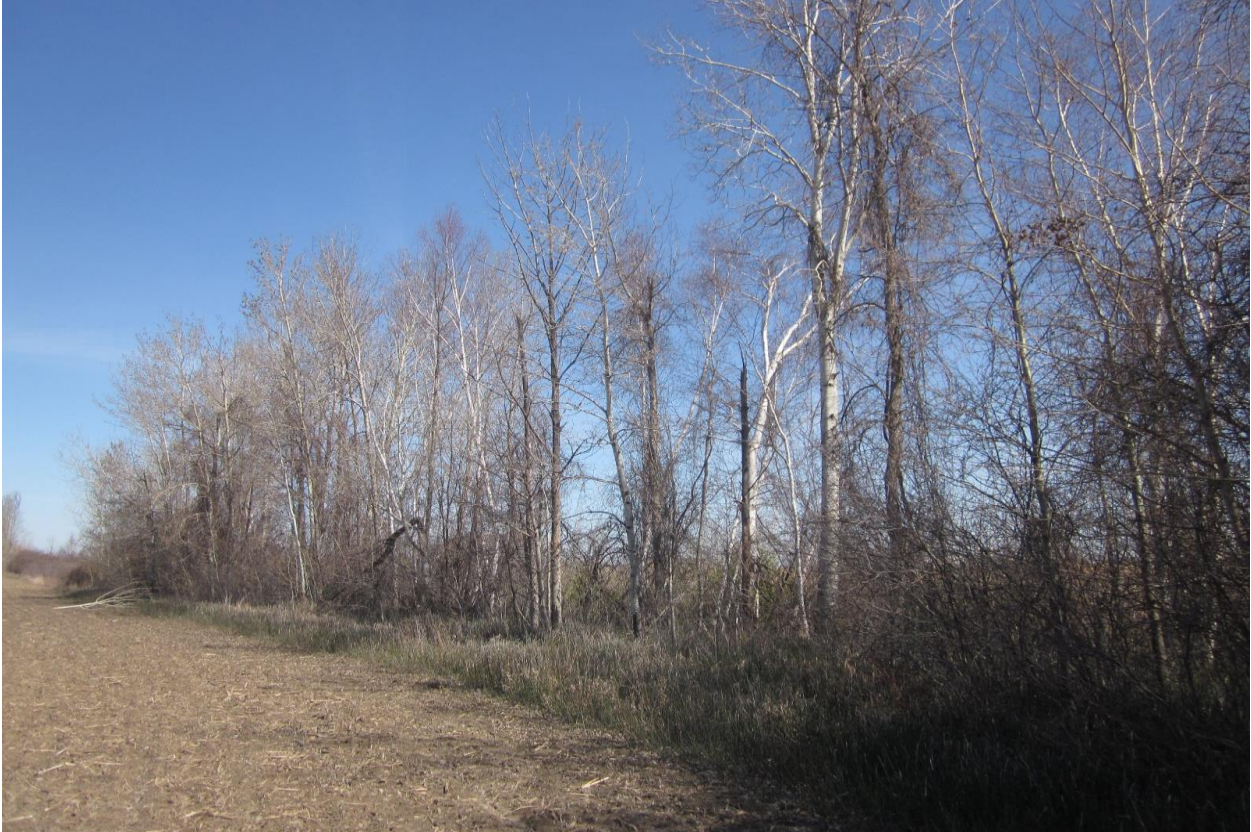
A second tree line is located to the north, on a neighbouring property. It is identified as #3 on the TCR plan. This line is dominated by mature ash (*Fraxinus* spp.) and trembling aspen (*Populus tremuloides*). Lesser amounts of cherry (*Prunus* spp.), apple (*Malus* spp.), buckthorn (*Rhamnus*

Picture 5. Mature tree line #3 on property adjacent to 8800 Campeau Drive

Preservation and protection measures intended to mitigate damage during construction will be applied for the trees to be retained adjacent to the subject property. The following measures are the minimum required by the City of Ottawa to ensure tree survival during and following construction:

1. Erect a fence at the critical root zone (CRZ<sup>1</sup>) of trees;
2. Do not place any material or equipment within the CRZ of the tree;

3. Do not attach any signs, notices or posters to any tree;
4. Do not raise or lower the existing grade within the CRZ without approval;
5. Tunnel or bore when digging within the CRZ of a tree;
6. Do not damage the root system, trunk or branches of any tree;
7. Ensure that exhaust fumes from all equipment are NOT directed towards any tree's canopy.

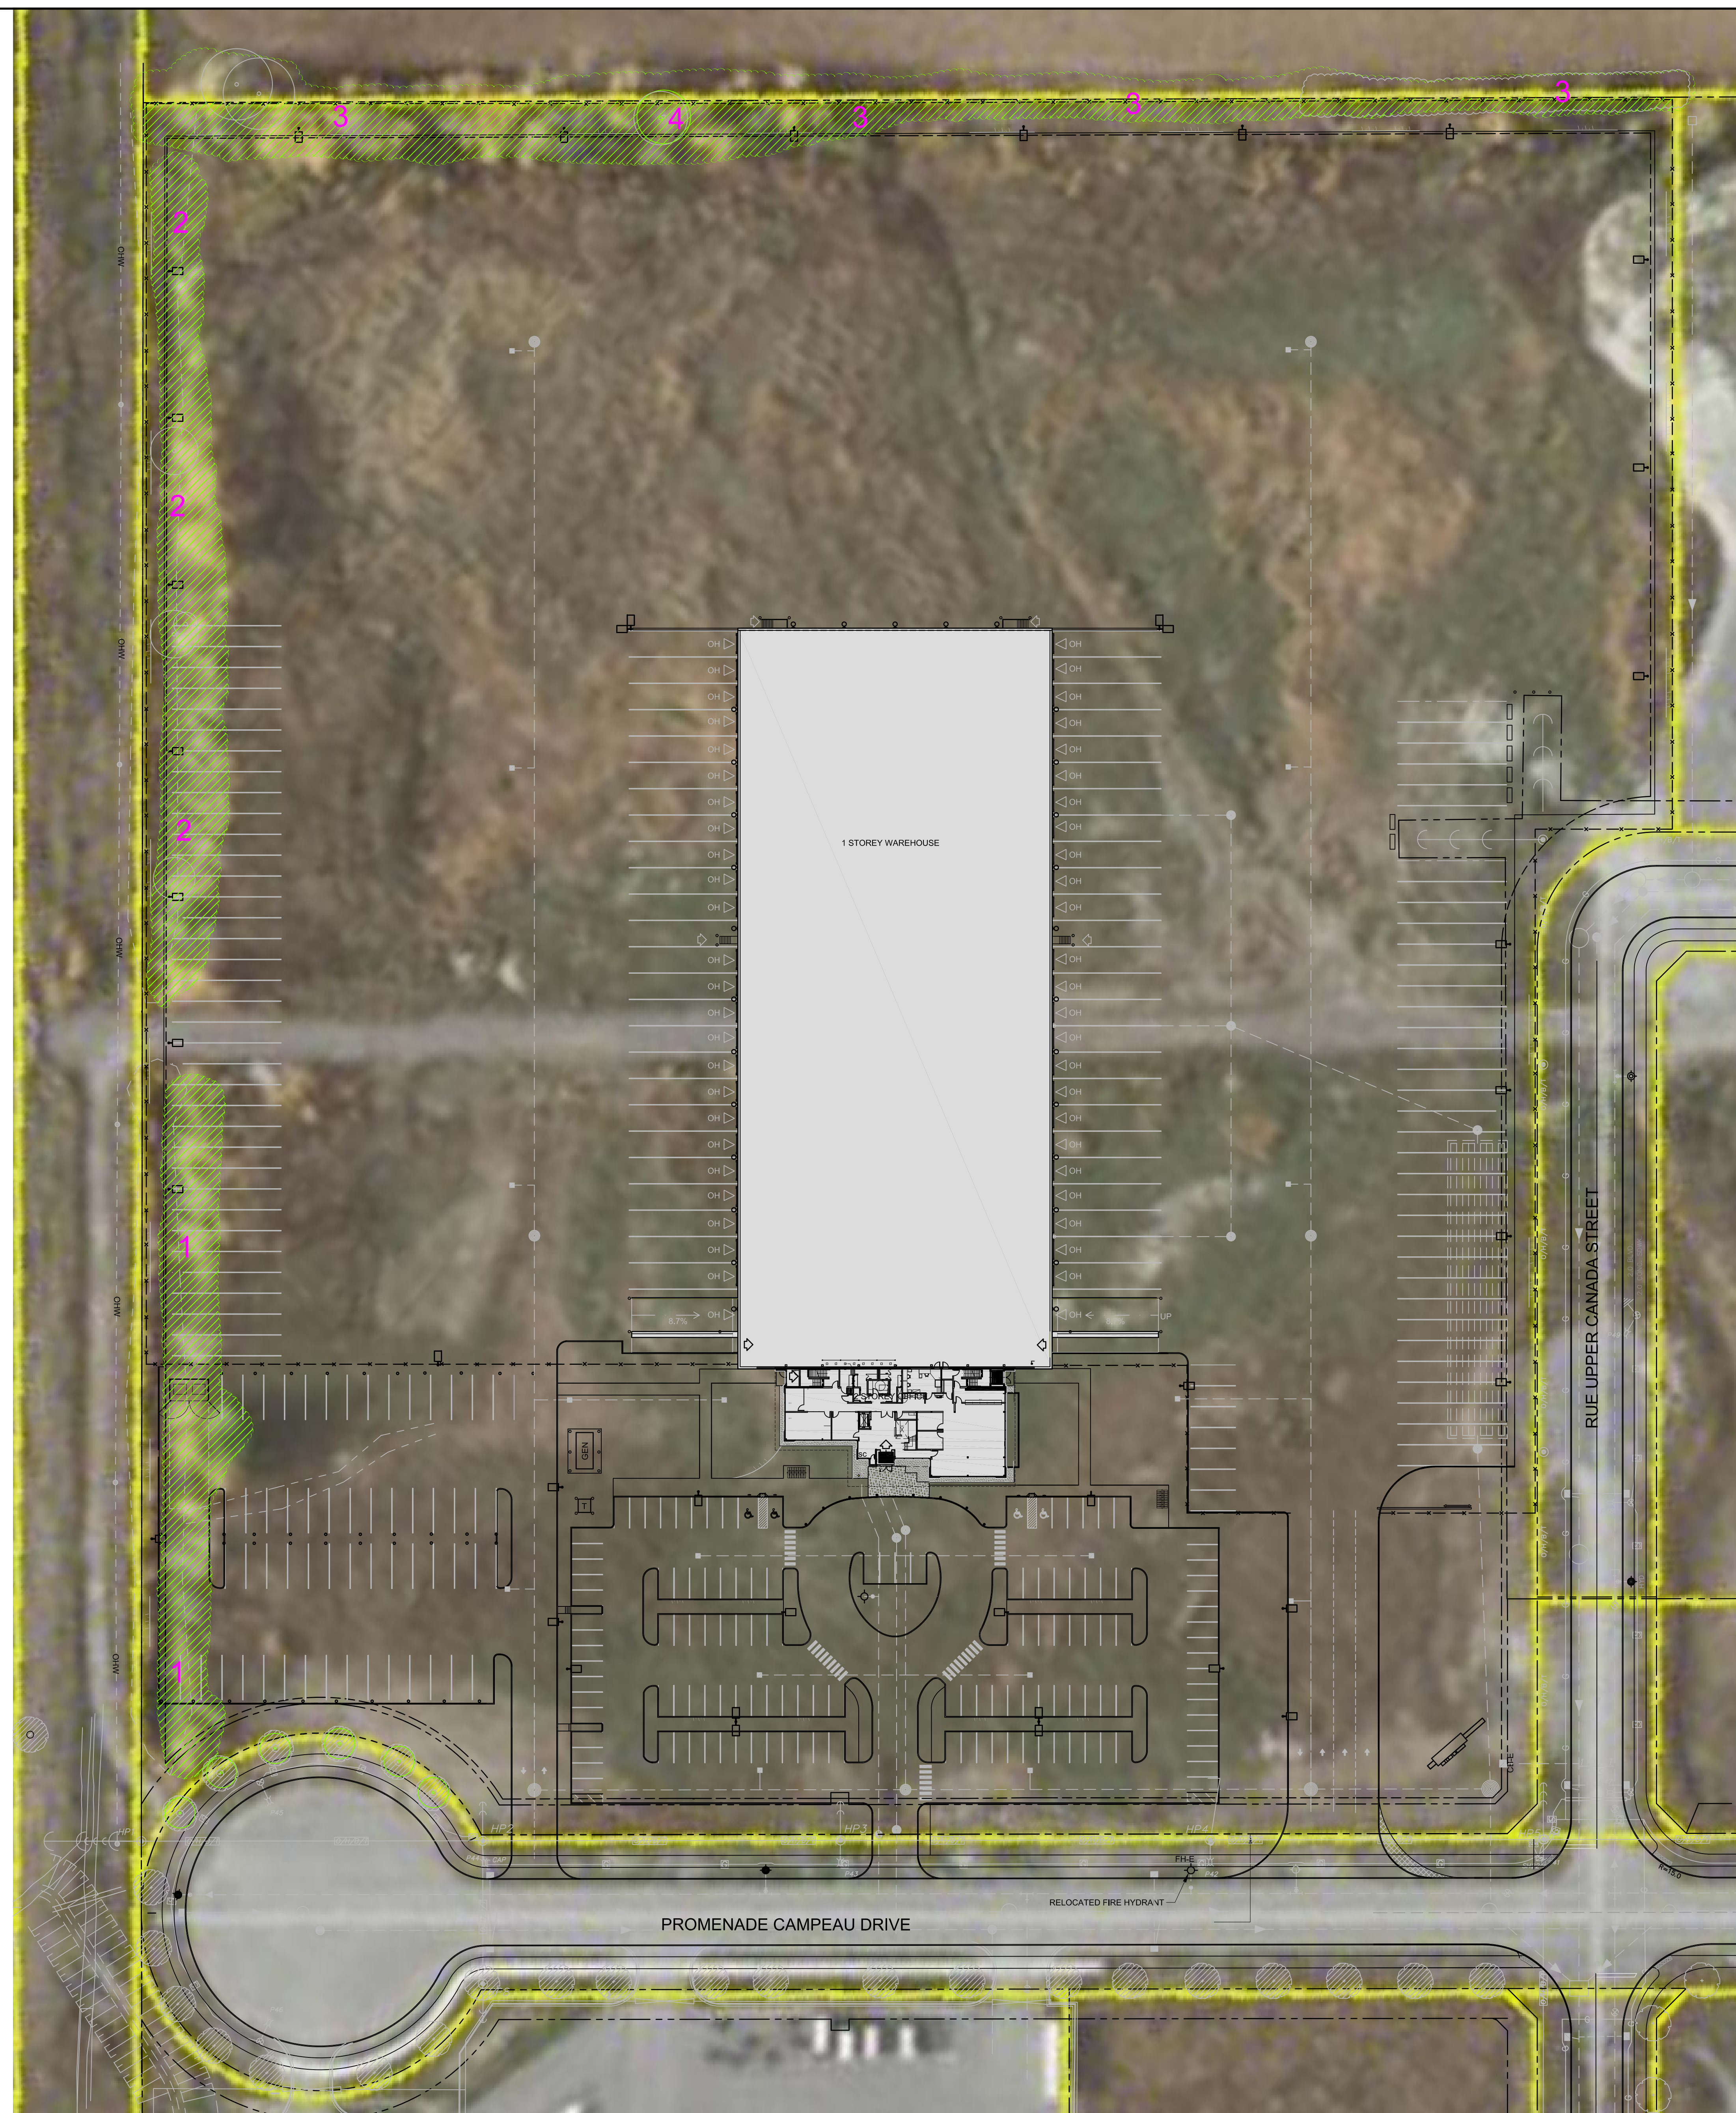
Drawing Title  
**TREE CONSERVATION PLAN**

EX. DECIDUOUS TREE TO BE RETAINED AND PRESERVED
-

EX. VEGETATION TO BE RETAINED AND PRESERVED
-

EX. VEGETATION TO BE REMOVED
