## Phase One Environmental Site Assessment 229-231, 241-247 Beechwood Avenue, Ottawa, Ontario

Phase One Environmental Site Assessment

OTT-002238207-C0

2022-03-18

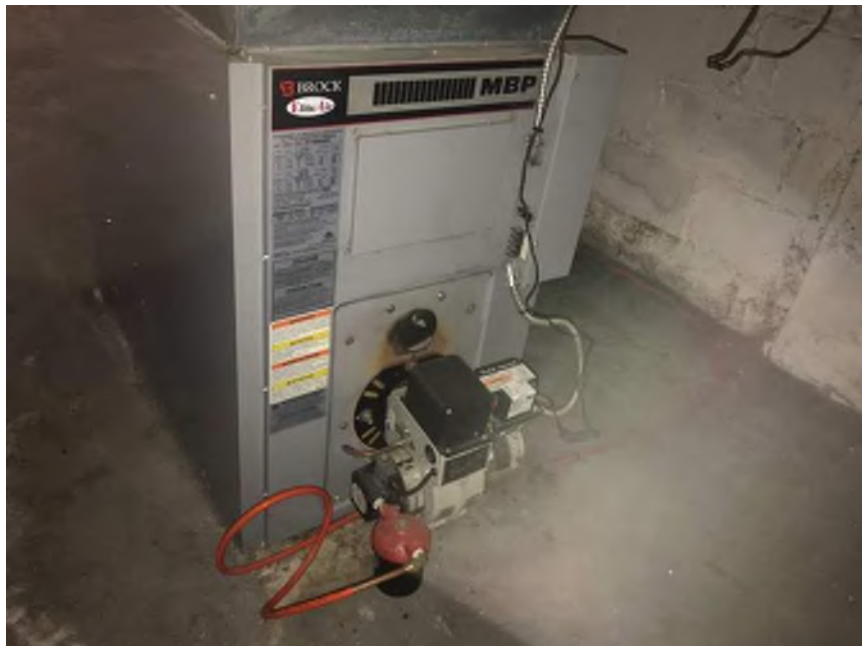
**Photograph No. 2**

View of the unfinished section of the basement at 229 Beechwood Avenue with heating oil fueled furnace.

The heating system is fuelled by heating oil at 229 Beechwood Avenue A 910-litre single-walled aboveground storage tank manufactured in 2009 is present to the west (rear) of the dwelling. Forced air natural gas was observed at 231 Beechwood Ave. Natural gas heating is not anticipated to be original to this building.

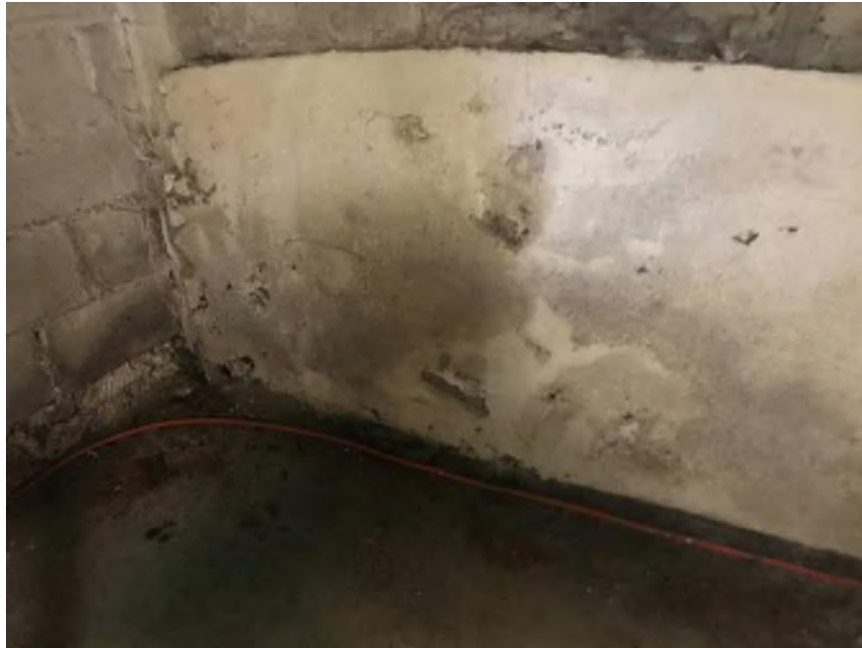
**Photograph No. 3**

View of black mould on concrete wall.

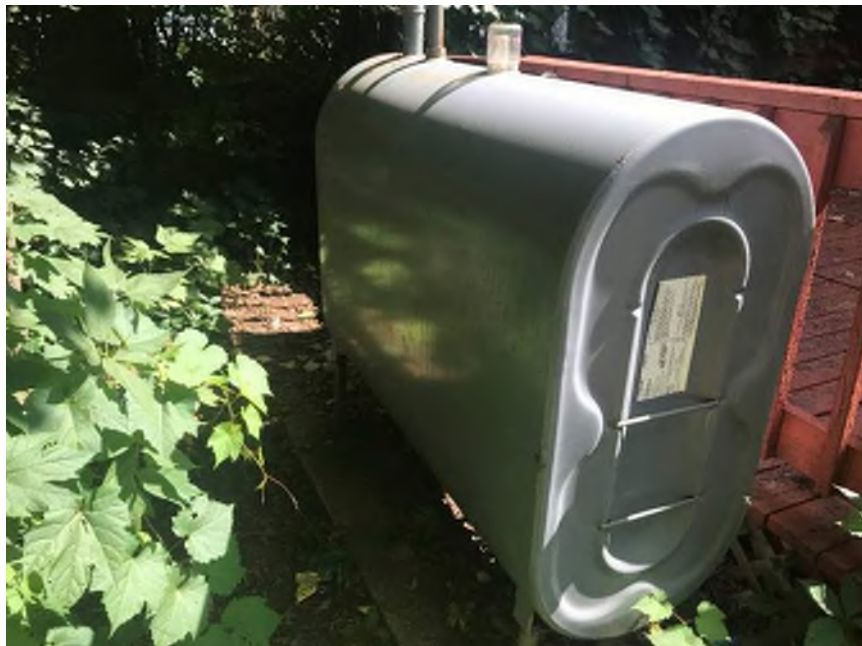
**Photograph No. 4**

View of the heating oil AST located at the rear (west) of the residence at 229 Beechwood Avenue on a concrete pad.

Exp observed A 910-litre single-walled aboveground storage tank (AST) manufactured in 2009 the west (rear) of the dwelling located at 229 Beechwood Avenue. The tank was in good condition at the time of the investigation. There was evidence of former vent/fill pipes located in the basement of the building indicating that a fuel oil tank was previously located in the basement. However, there was no evidence of spills or staining present on the concrete pad beneath the tank or in the basement. Therefore, this tank does not represent an APEC.

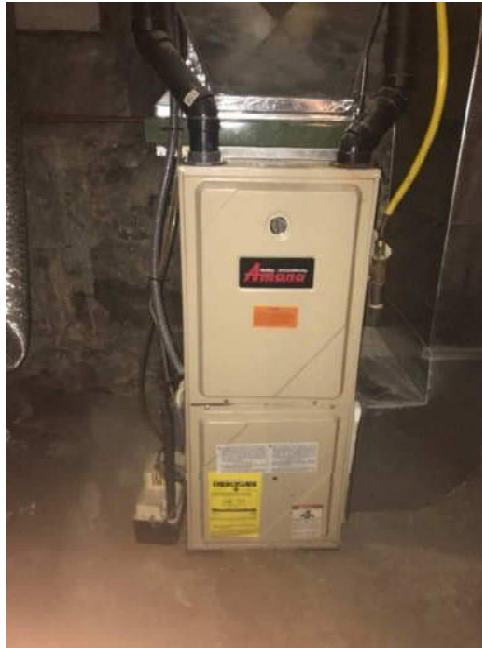
**Photograph No. 7**

View of the unfinished basement and natural gas furnace at 231 Beechwood Avenue.

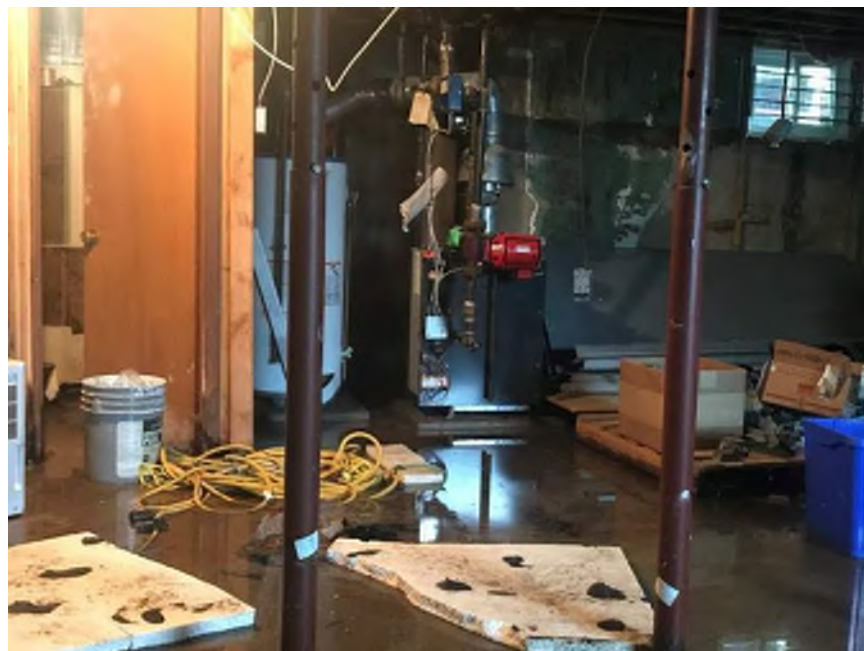
**Photograph No. 12**

View of hot water boiler furnace in the basement of the 245 Beechwood Avenue residence, approximately 3" of water on the floor

The heating system was observed to be forced air natural gas at 245 Beechwood Ave and hot-water boiler heating at 241 and 247 Beechwood Avenue Natural gas/hot water heating is not anticipated to be original to these buildings.

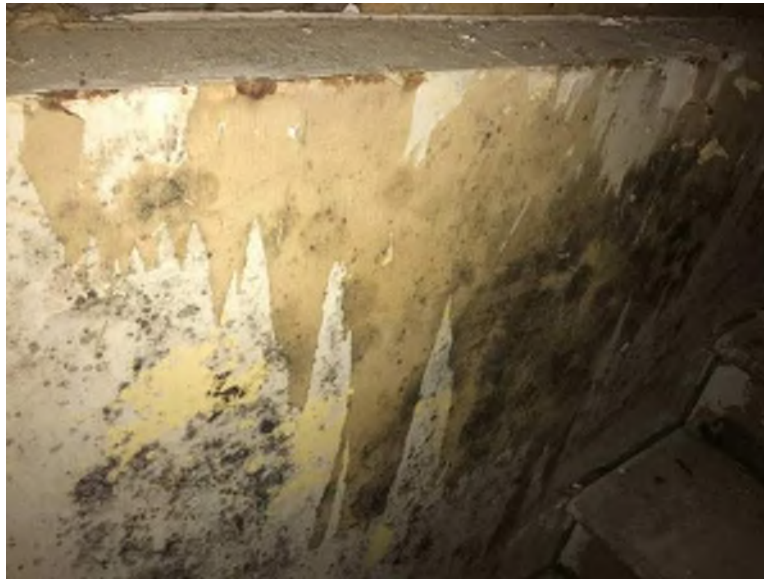
**Photograph No. 13**

View of black mould on the basement walls.
