**Headwater Drainage Feature Assessment**  
**2822 Carp Road**  
**Ottawa, Ontario**

**Headwater Drainage Feature Assessment**  
**2822 Carp Road**  
Ottawa, Ontario

May 14, 2020  
Project: 61730.65

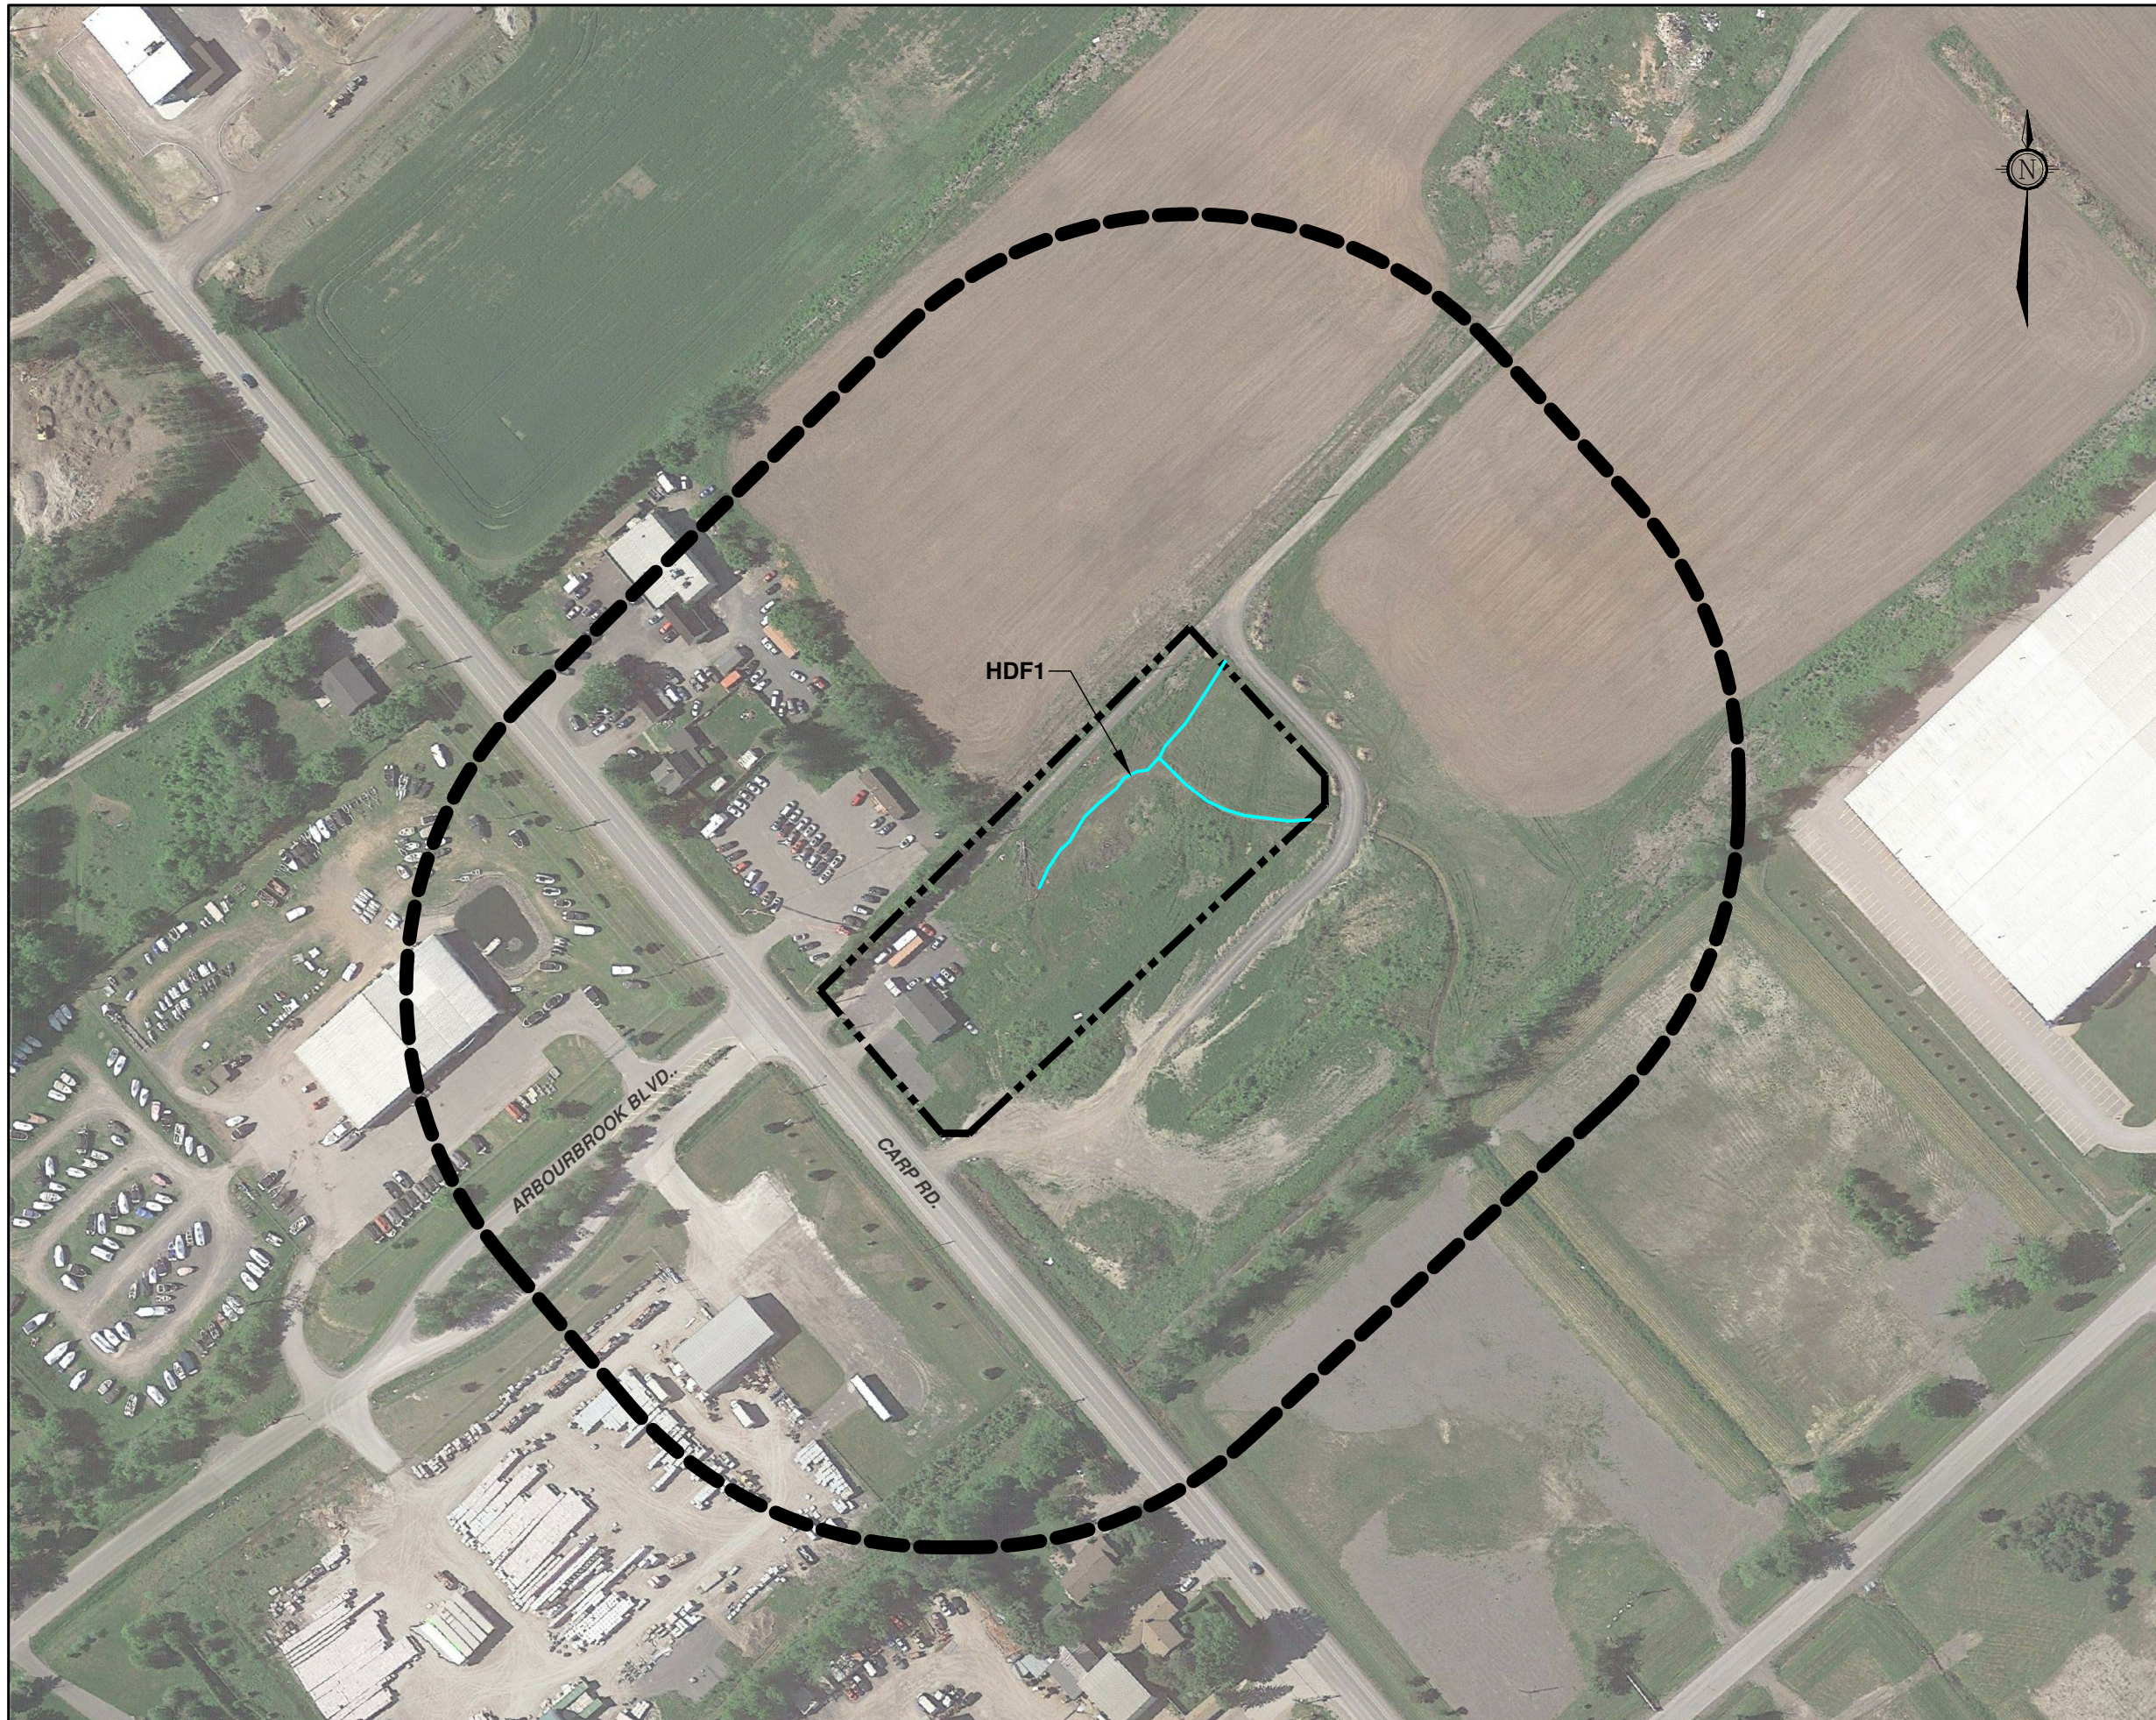
Date MAY 2020	Rev. 0	<b>FIGURE A.2</b>
------------------	-----------	-------------------

Based on the desktop review and the site investigations, a single headwater drainage feature (HDF) occurs on-site and is identified as HDF1. HDF1 is illustrated on Figure A.2 in Appendix A.

HDF1 originates on-site and flows in a southeastern direction onto the neighbouring property addressed as 2826 Carp Road, before turning west and flowing into roadside ditches along Carp Road. The on-site portion of HDF1 is approximately 100 m in length. The watercourse is mapped as originating on neighbouring farm fields and flowing onto 2822 Carp Road, however based on observations during site investigations, the on-site portion of the watercourse is not connected to any upstream watercourses.

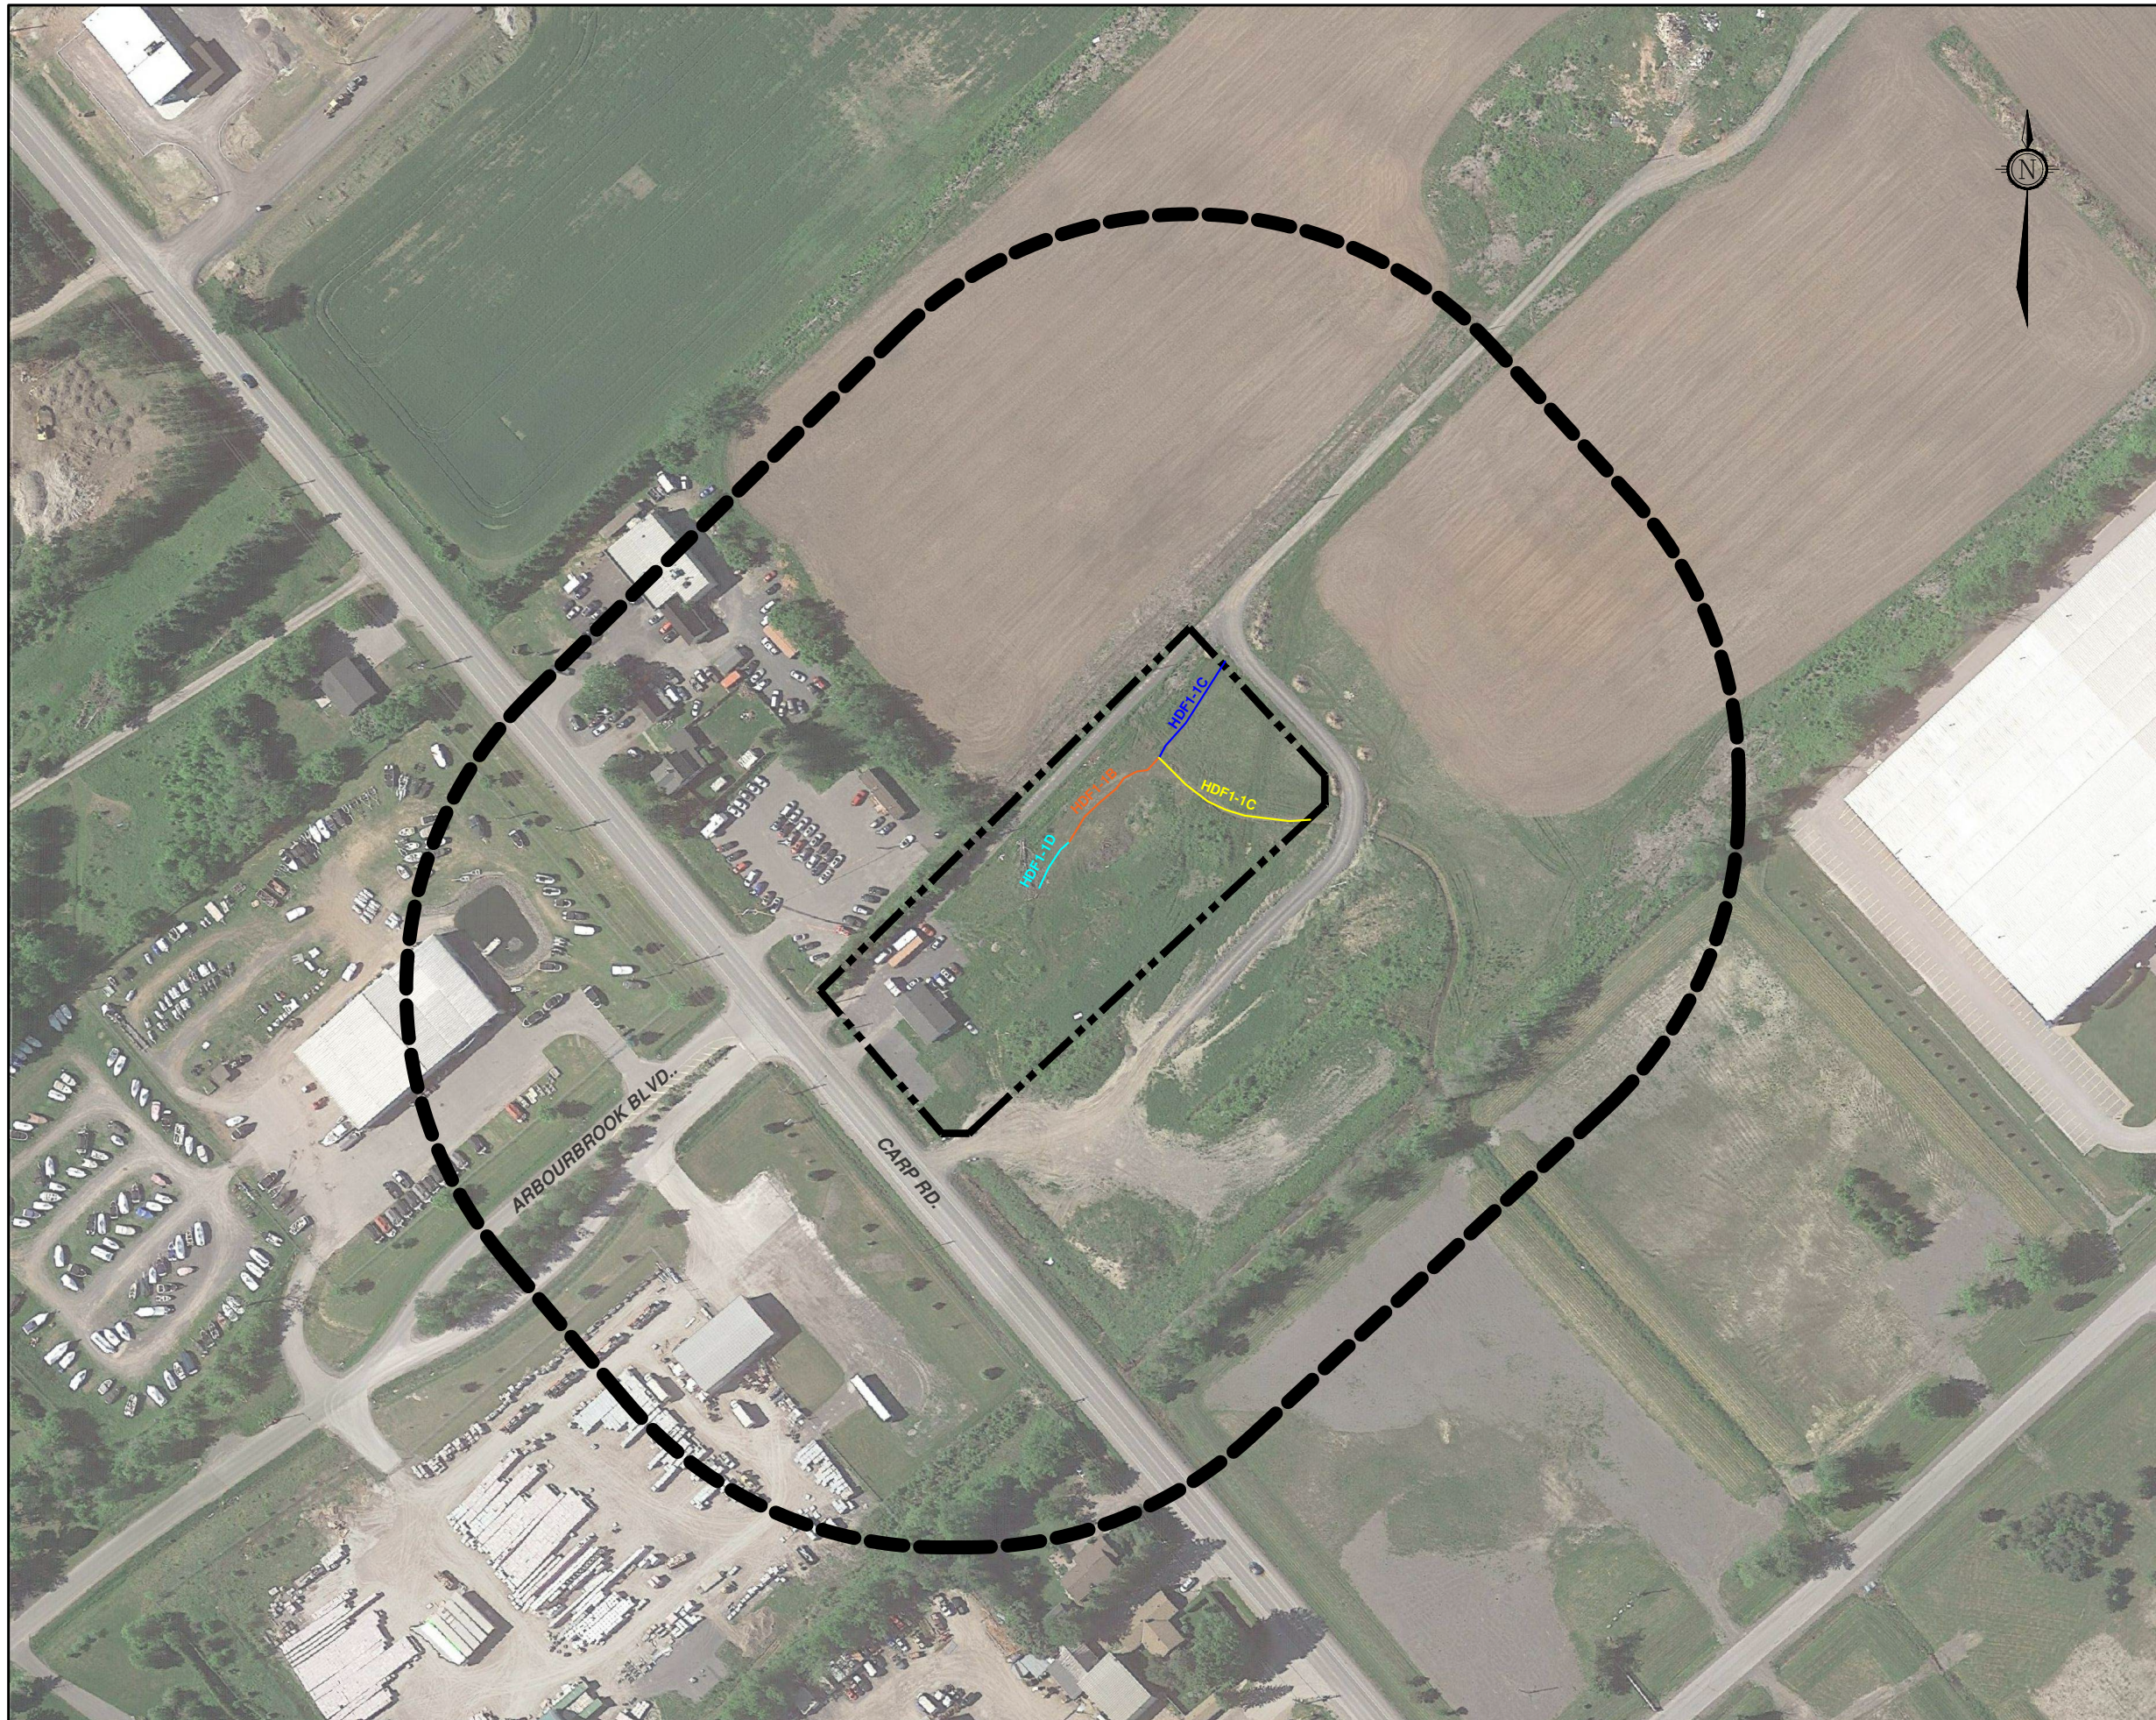
During the site investigation HDF1 was assessed in four segments, based on site break triggers, the segments are illustrated on Figure A.3 in Appendix A.

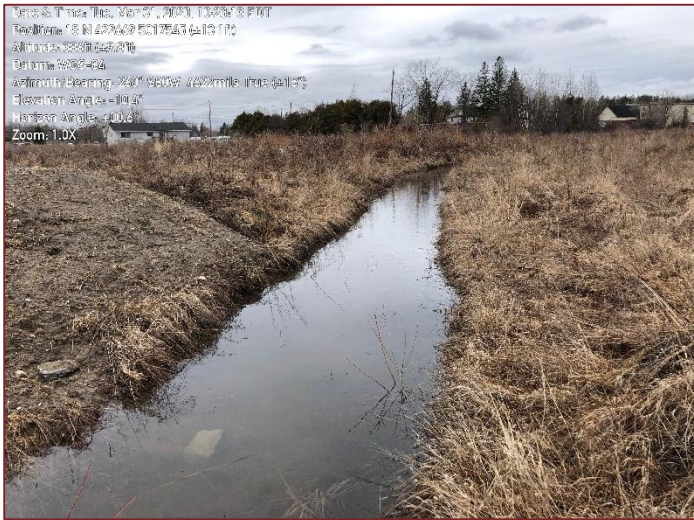
HDF1-1A is described as channelized, and had interstitial flow during the initial spring and was document as stagnant during late spring site investigation.

Site Photograph 1 – HDF1-1A looking downstream (March 31, 2020)

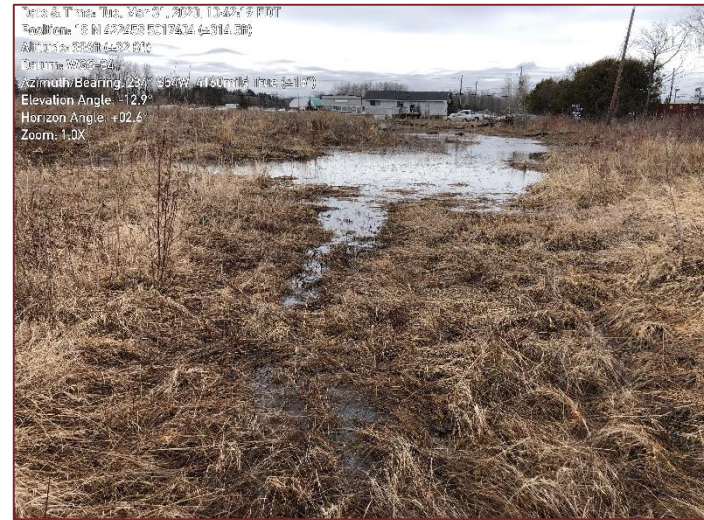
Segment HDF1-1B is described as no-defined feature and had a mix of interstitial flow and standing water during the initial spring investigation and standing water and dry conditions during the late spring visit.

Site Photograph 2 – HDF1-1B looking upstream (March 31, 2020)

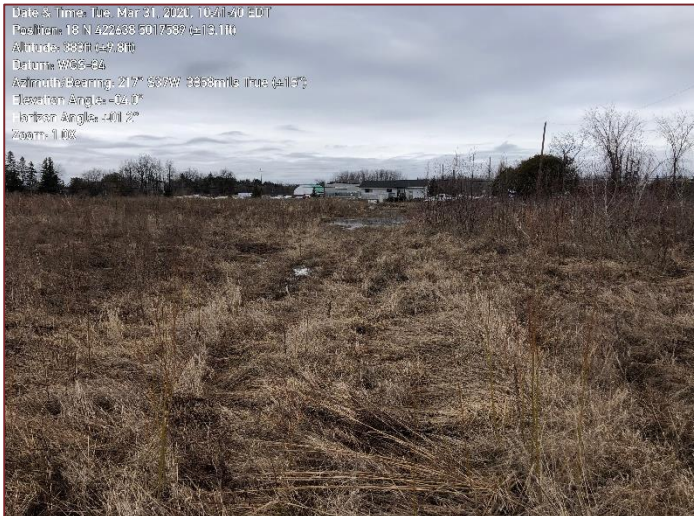
Segment HDF1-1C is described as no-defined feature and had standing water conditions during the initial spring investigation and completely dry conditions during the second site investigation.

Site Photograph 3 – HDF1-1C looking downstream (March 31, 2020)

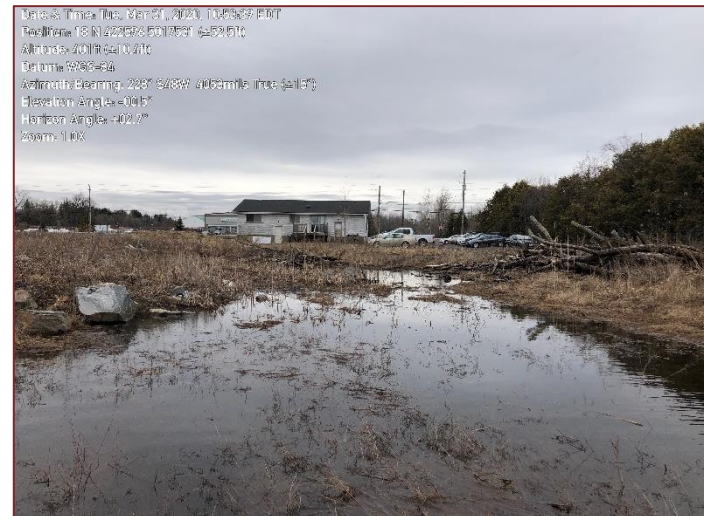
Segment HDF1-1D is described as no-defined feature with a mix of interstitial flow and standing water during the first investigation and standing water and dry conditions during the second investigation.

Site Photograph 4 – HDF1-1D looking upstream (March 31, 2020)

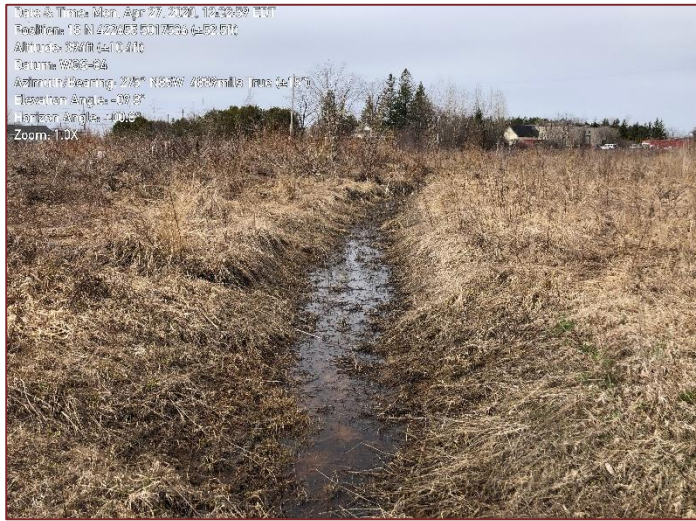
Site Photograph 5 – HDF1-1A looking downstream (April 27, 2020)

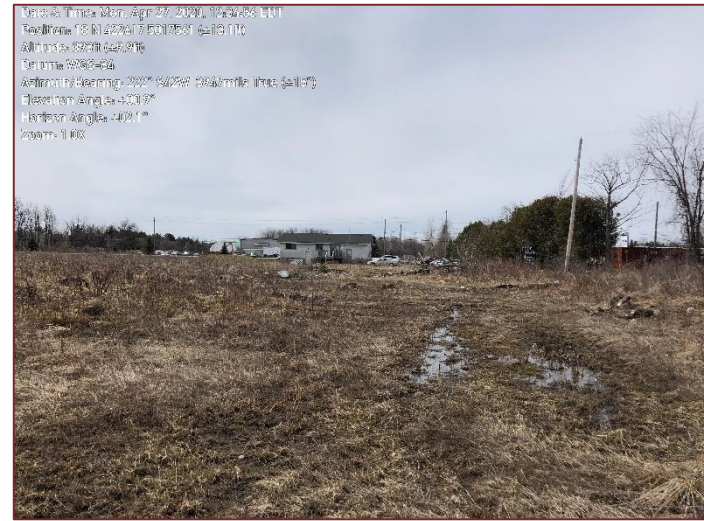
Site Photograph 6 – HDF1-1B looking upstream (April 27, 2020)

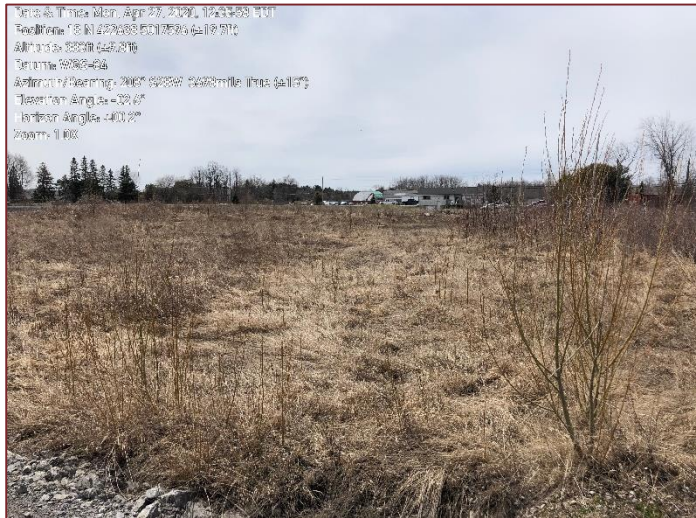
Site Photograph 7 – HDF1-1C looking downstream (April 27, 2020)

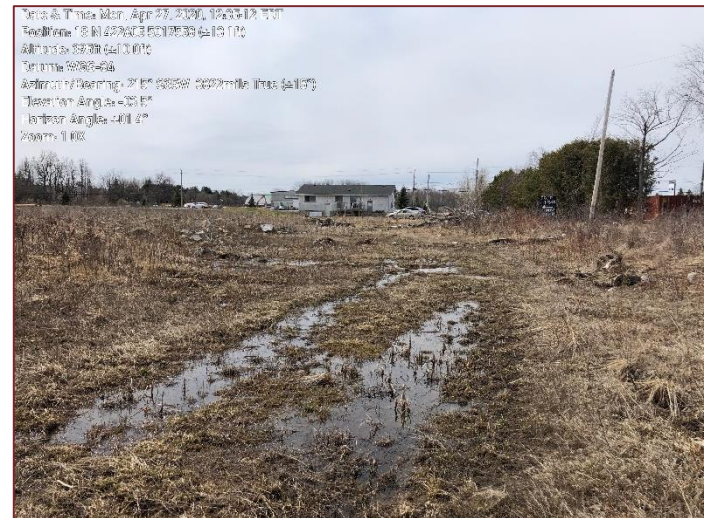
Site Photograph 8 – HDF1-1D looking upstream (April 27, 2020)
