Muncaster  
Environmental  
Planning Inc.

November 25, 2022

**RE: 5497 Manotick Main Street Retail Development**  
**Environmental Impact Statement and Tree Conservation Report - Updated**

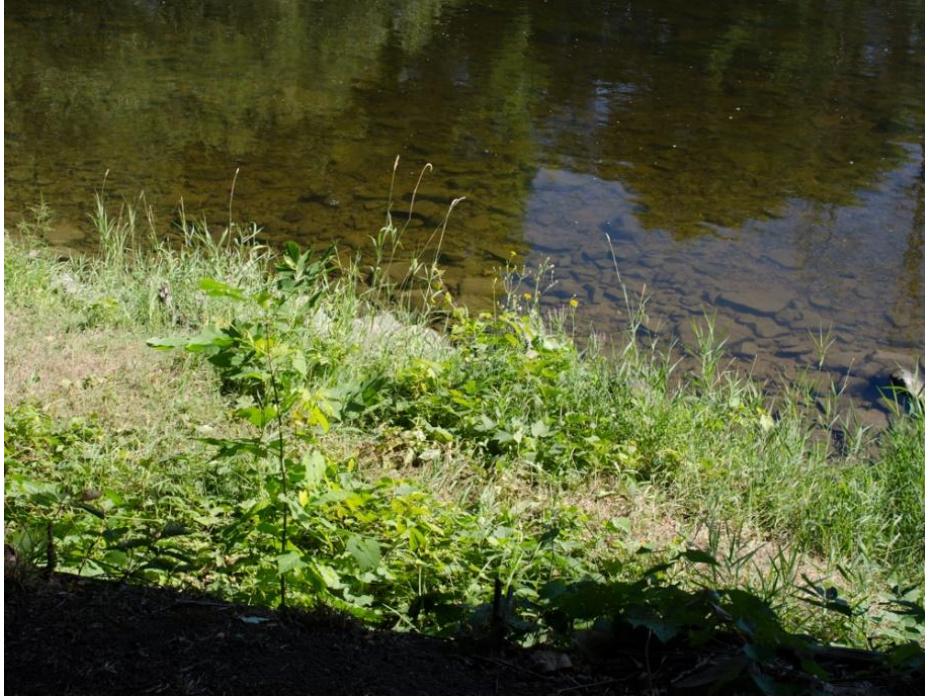
*Photo 1 – Typical littoral zone and shoreline along the Rideau River with short transition to upland habitat. View looking east*

Specifically, along the west shore of the west channel of the Rideau River immediately to the east of the site, the exposed substrate includes a combination of boulders, cobble, gravel and fines providing a diversity of available aquatic habitat (Photo 1). Submergent, floating and emergent aquatic vegetation such as large-fruited bur-reed, Canada waterweed, eel grass, and sedges add to the aquatic habitat structure. Rock protection is common along the shoreline. The water was clear. There is a clear rise in elevation west of the shoreline and the natural riparian vegetation extended for a maximum of half a metre west of the water's edge on July 31<sup>st</sup>, before mowed areas. The vegetation in this 0.5 metre wide area is a mixture of wetland and upland vegetation including reed canary grass, joe-pye-weed, blue vervain, boneset, common burdock, wild grape, heal-all, yellow sweet-clover, field sow-thistle, ground ivy, and evening primrose (Photos 1 and 2).

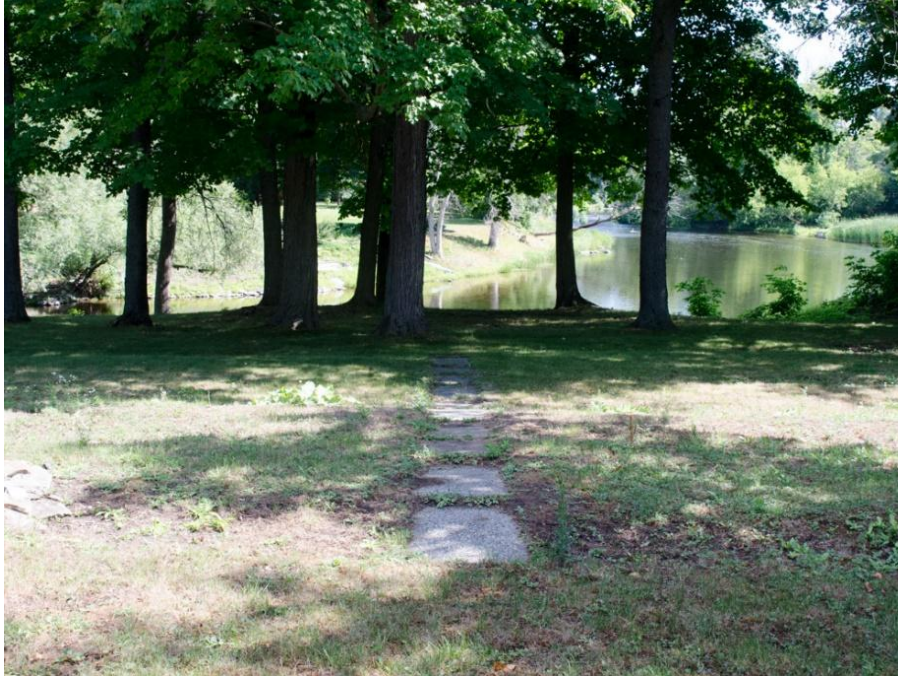
*Photo 3 – West of the Rideau River the site is dominated by an occupied residence and large mowed area, with several deciduous trees in the mowed area approaching the river. View looking east from east of the residence.*

The topography of the site includes a gentle slope to the east towards the river (Photo 3). A wooden retaining wall is approximately five metres west of the Rideau River shoreline. The top-of-slope is approximately another five metres west of the retaining wall, so about ten metres west of the shoreline (Photo 4), and in the general location of the floodplain limit. The native soils on the site are primarily a combination of thick deposits of sandy silt and silty clay (St. Lawrence, 2020).

Several mature deciduous trees are among the east mowed area within the Rideau River setback (Photos 3 and 4). Due to the canopy cover this area is shown on Figure 1 as a cultural woodland. The largest trees are silver maples up to 60 cm diameter at breast height (dbh), with sugar maple and black cheery in the 45cm to 50cm dbh range. Most of these trees appear to be in good condition, with reduced leaf-out noted on some of the black cherry.
