**Re: Slope Stability Assessment
Proposed Retaining Wall
5497 Manotick Main Street
Manotick (Ottawa), Ontario**

This letter presents the results of a global stability assessment carried out for the construction of a proposed retaining wall at 5497 Manotick Main Street in Manotick (Ottawa), Ontario.

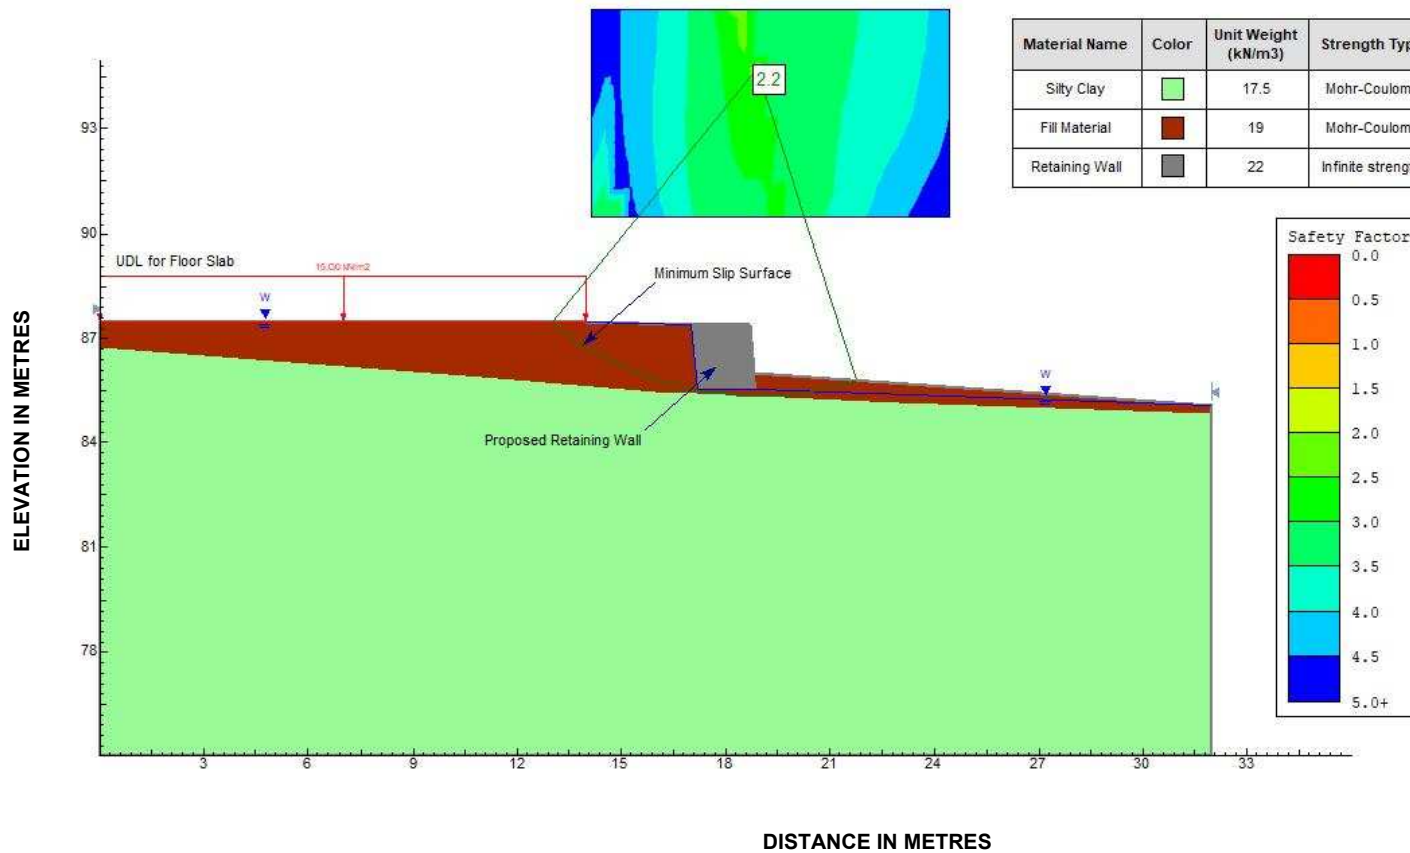
- The slope stability analyses show that the proposed retaining wall at Section B-B', under the current configuration, has a minimum factor of safety of 2.2 for the static condition i.e. greater than the minimum required value of 1.5, indicating adequate long term stability (refer to Figure A1 in Attachment A).
- The results indicate that the proposed retaining wall at Section B-B' has a minimum factor of safety of 1.4, i.e. greater than minimum required value of 1.1 for the pseudo-static (seismic) condition, which is considered acceptable (refer to Figure A2 in Attachment A).

The slope stability analyses of the proposed retaining wall were performed using SLIDE, a two-dimensional limit equilibrium slope stability commercial program by RocScience. The retaining wall and slope were modeled using the information above. The global stability was analyzed by considering our assessment of the worst case scenario (based on the available information):

- The tallest wall section (Section 2 in the Retaining Wall Design Report) was applied in the model. Since Section B-B' perpendicularly intersects the Section 2, the stability analyses was carried out at Section B-B'.
- The surcharge loading of the building is 15 kPa.
- The slope is fully saturated with the groundwater level at (or near) to the ground surface.
- The retaining wall system, including stone panels, Geogrid Reinforcement, reinforcement fill, embedment fill, engineered fill, etc., was modeled as an entire unit with a weight of 22 kN/m³.
- The cross-section accounts for the future grade raise filling at the site by inclusion of earth fill to the proposed levels shown on the available plans.

The Bishop Simplified Method was used for the stability analyses.

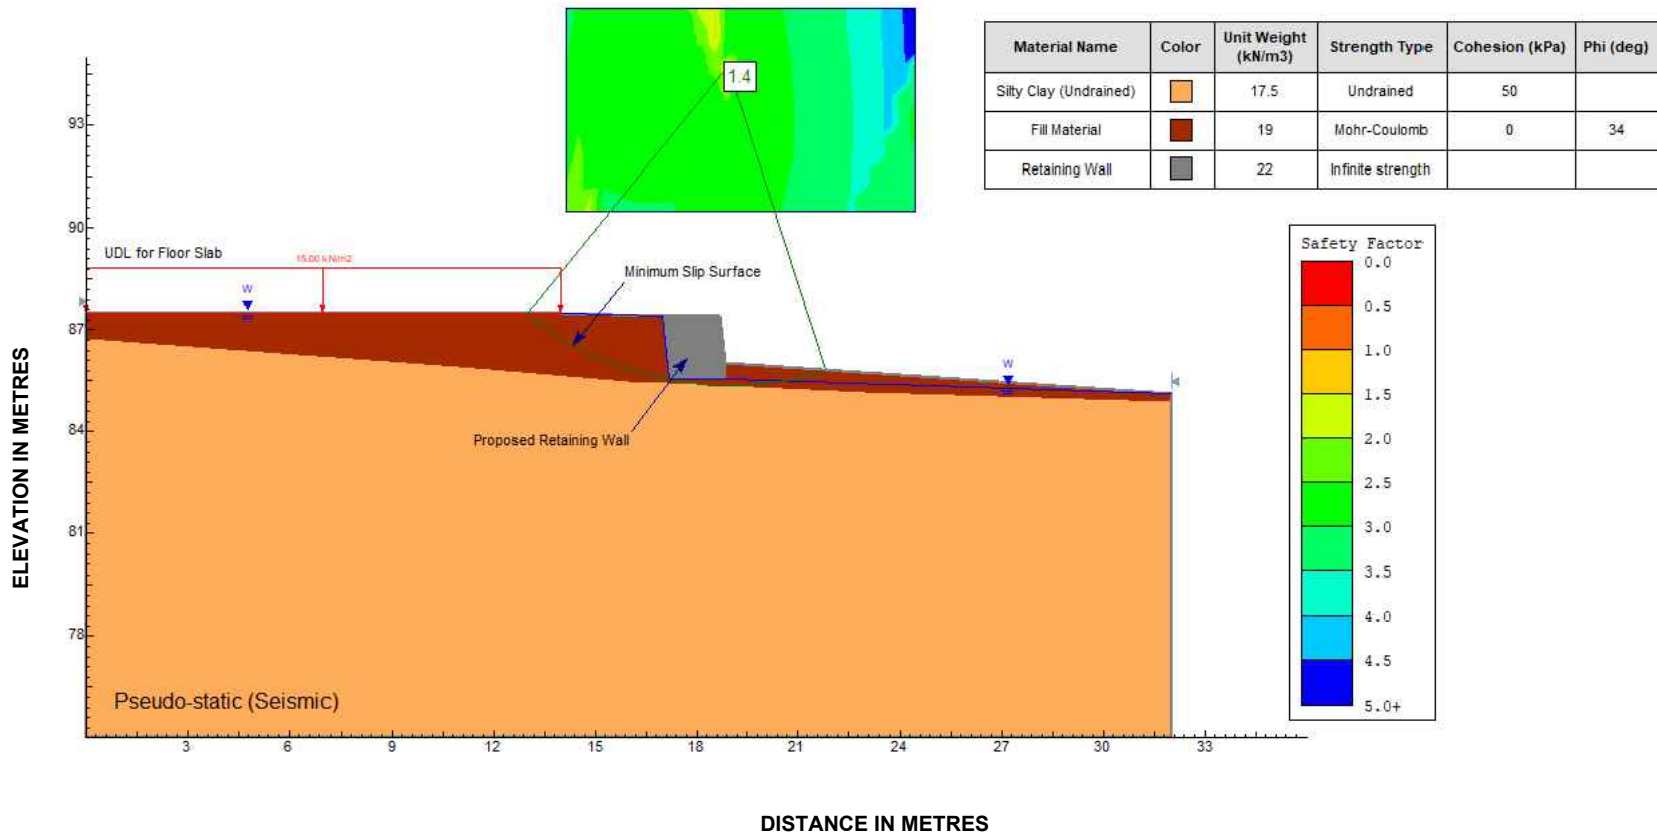
Both static and pseudo-static conditions were considered. For the pseudo-static (seismic) condition, a horizontal seismic coefficient (k_h) of 0.14 was used, which is half of the Peak Ground Acceleration (PGA) for Ottawa according to the Ontario Building Code 2015.
