Muncaster
Environmental
Planning Inc.

September 18, 2021

RE: 5497 Manotick Main Street Retail Development
Environmental Impact Statement and Tree Conservation Report

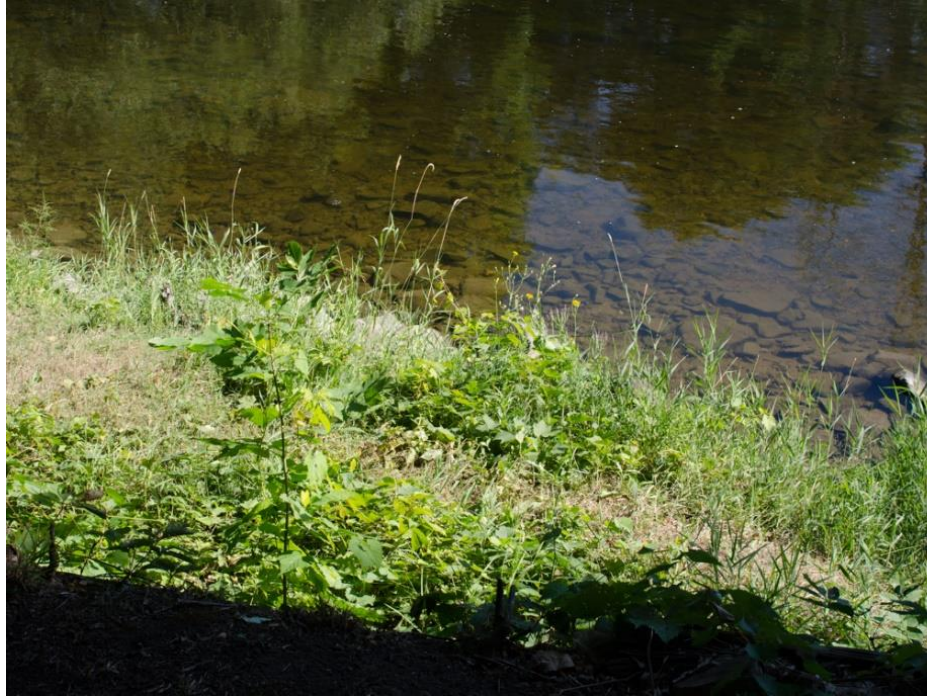
Specifically, along the west shore of the west channel of the Rideau River immediately to the east of the site, the exposed substrate includes a combination of boulders, cobble, gravel and fines providing a diversity of available aquatic habitat (Photo 1). Submergent, floating and emergent aquatic vegetation such as large-fruited bur-reed, Canada waterweed, eel grass, and sedges add to the aquatic habitat structure. Rock protection is common along the shoreline. The water was clear. There is a clear rise in elevation west of the shoreline and the natural riparian vegetation extended for a maximum of half a metre west of the water's edge on July 31st, before mowed areas. The vegetation in this 0.5 metre wide area is a mixture of wetland and upland vegetation including reed canary grass, joe-pye-weed, blue vervain, boneset, common burdock, wild grape, heal-all, yellow sweet-clover, field sow-thistle, ground ivy, and evening primrose (Photos 1 and 2).

Photo 1 – Typical littoral zone and shoreline along the Rideau River with short transition to upland habitat. View looking east

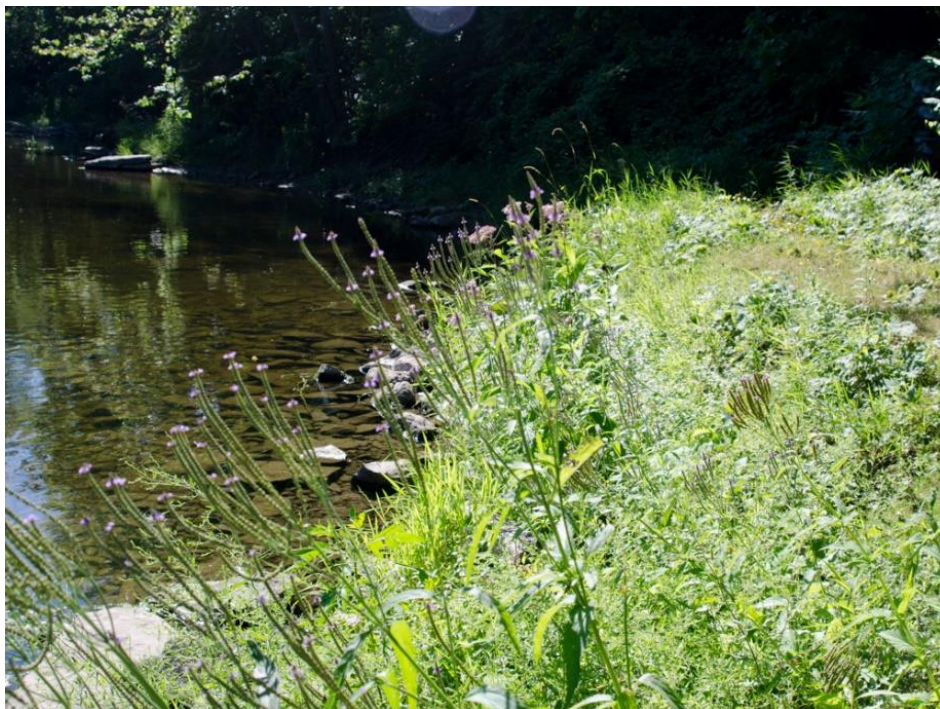
Photo 2 – Another view, this one south, of the littoral zone, shoreline and transition to upland habitat

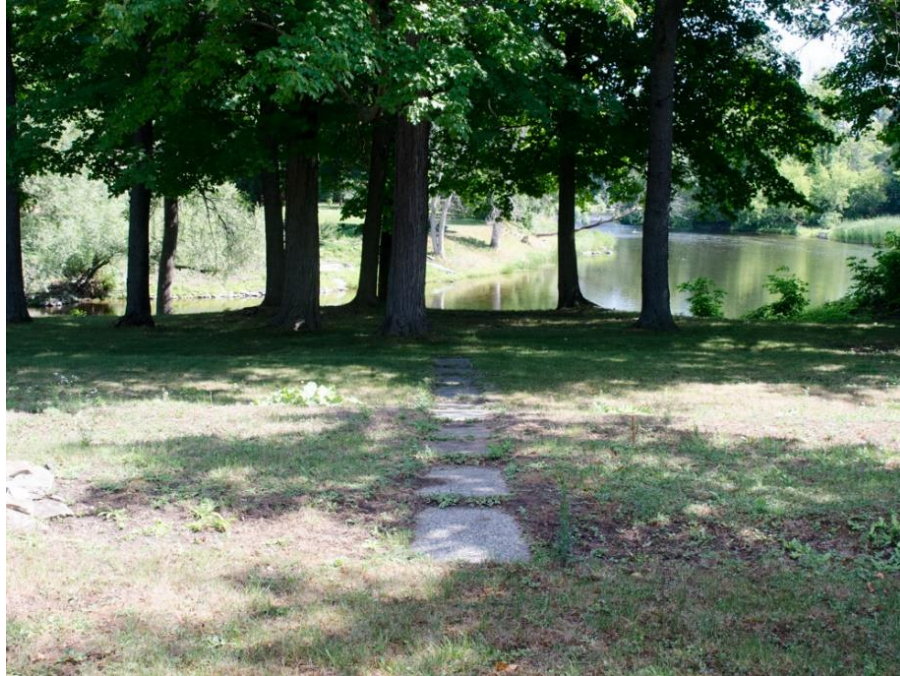
The topography of the site includes a gentle slope to the east towards the river (Photo 3). A wooden retaining wall is approximately five metres west of the Rideau River shoreline. The top-of-slope is approximately another five metres west of the retaining wall, so about ten metres west of the shoreline (Photo 4), and in the general location of the floodplain limit. The native soils on the site are primarily a combination of thick deposits of sandy silt and silty clay (St. Lawrence, 2020).

Several mature deciduous trees are among the east mowed area within the Rideau River setback (Photos 3 and 4). Due to the canopy cover this area is shown on Figure 1 as a cultural woodland. The largest trees are silver maples up to 60 cm diameter at breast height (dbh), with sugar maple and black cheery in the 45cm to 50cm dbh range. Most of these trees appear to be in good condition, with reduced leaf-out noted on some of the black cherry.

Photo 3 – West of the Rideau River the site is dominated by an occupied residence and large mowed area, with several deciduous trees in the mowed area approaching the river. View looking east from east of the residence. Proposed amenity area will be in the foreground
