# TREE CONSERVATION REPORT

2046-2050 Scott Street

Tree Conservation Report submitted as Partial  
Requirements for a Site Plan Control Application

# Preliminary Tree Conservation Report

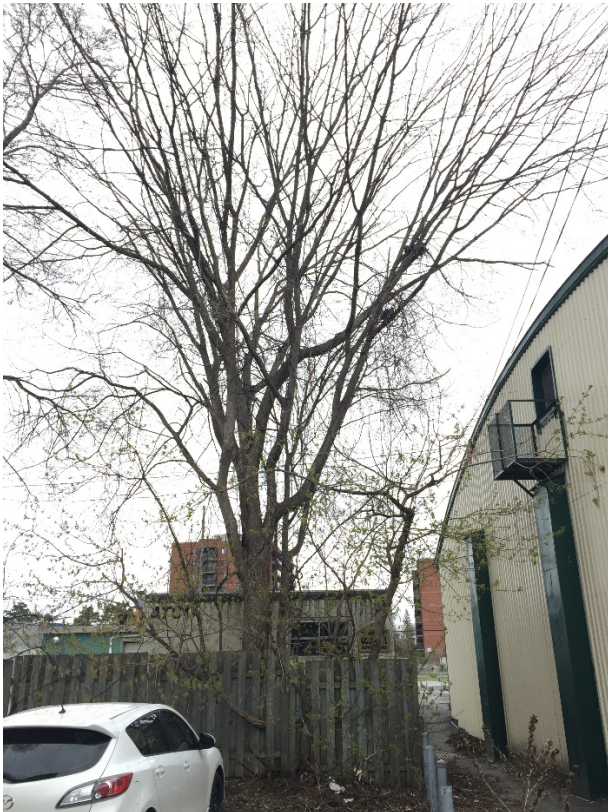
Figure 1: Trees no. 1-3: American elms and Manitoba maple to be removed

The trees along the existing fence in the rear of 2046 Scott and 295 Ashton are all privately-owned and are in the footprint of the proposed 30-storey building. All of these trees have seeded naturally, and several are considered non-native, invasive species. However, these species can withstand harsh urban environments and provide shade and other benefits where other native species may not survive. Because their location is not compatible with the new building, removal is recommended.

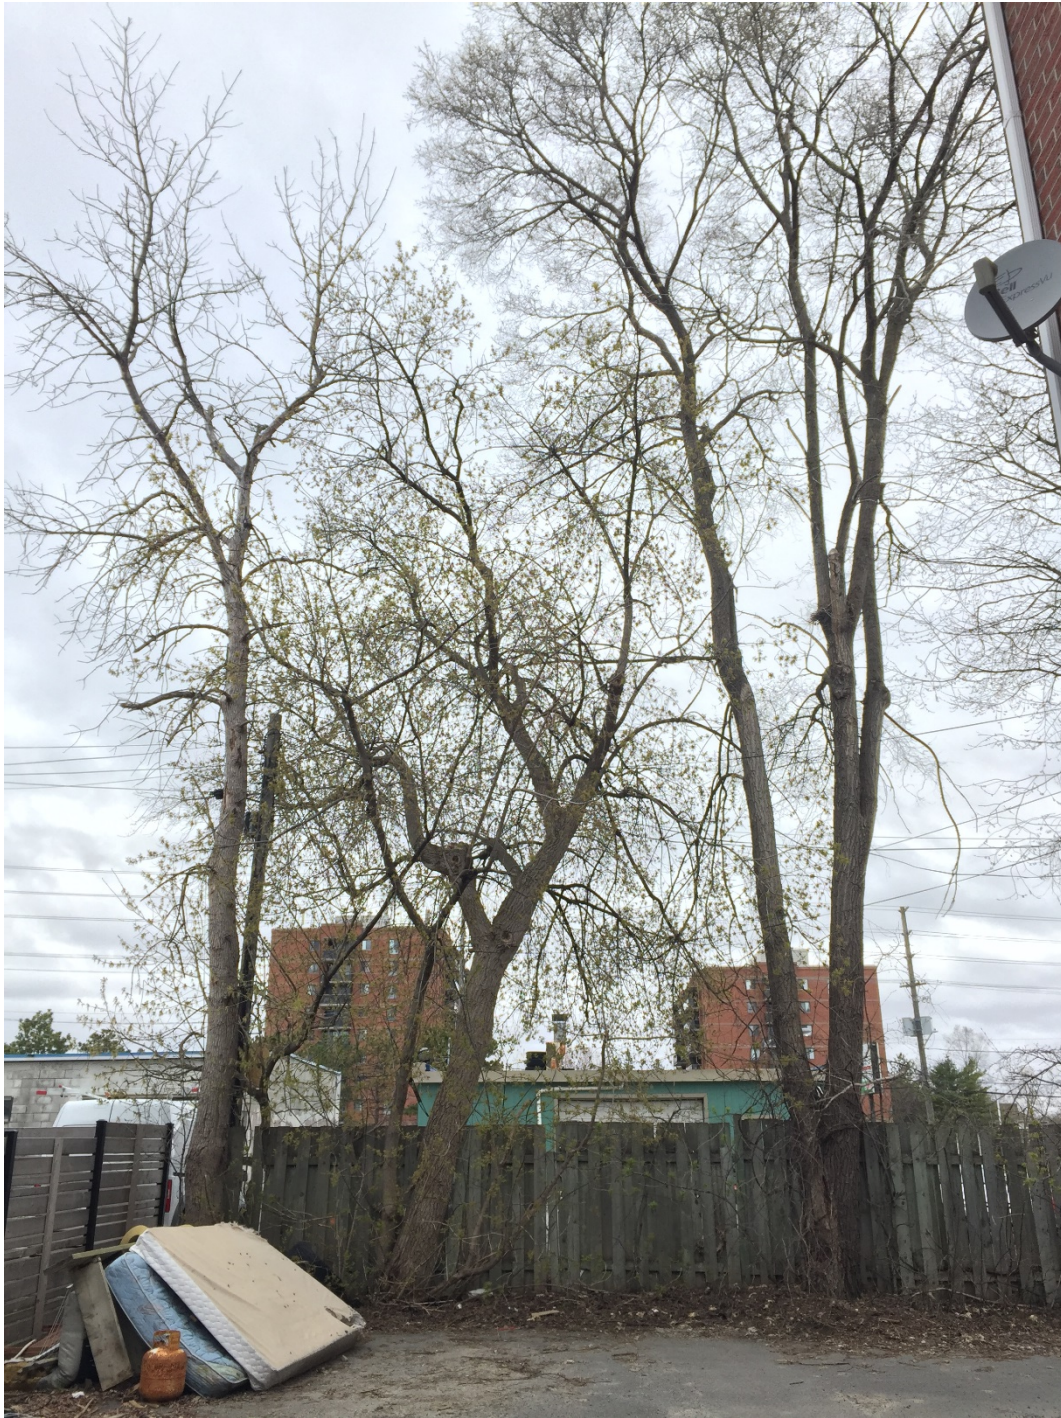
Figure 2: Trees 4 to 7: Siberian elm, Manitoba maple and ash (dead) to be removed

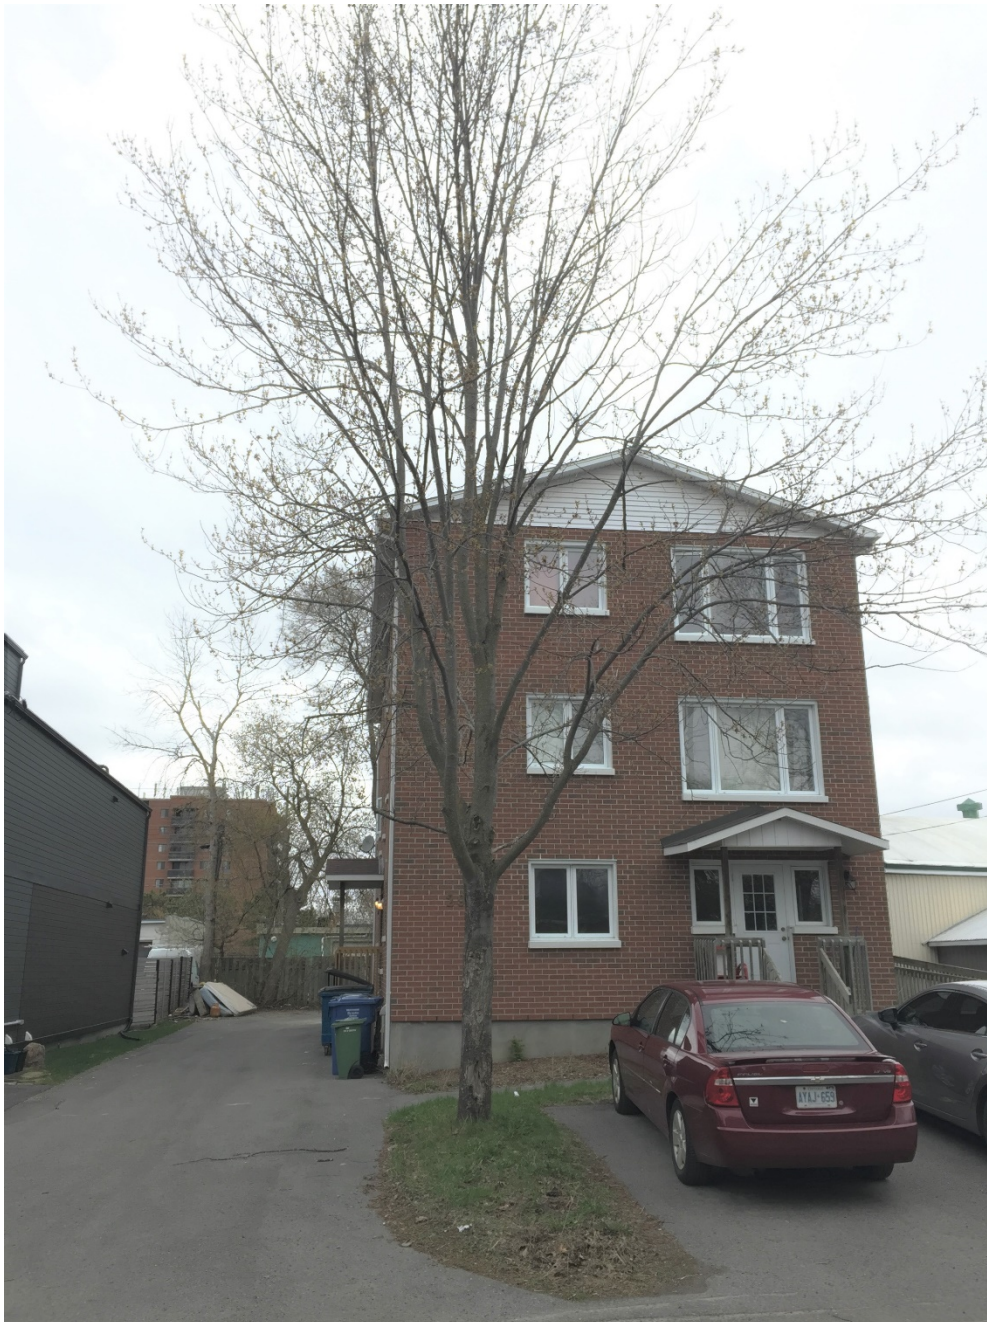
Tree no. 8 is a Freeman maple that is in fair condition. The main stem has several cankers, some of which have sealed over. There is also some crown dieback, possibly caused by root damage when the adjacent soft surface was converted to asphalt about 5 years ago (see Google Street view for reference). Given the poor health of this tree, it is not recommended that it be incorporated into the new development.

Figure 3: Tree no. 8 - City-owned Freeman maple to be removed
