Phase I-Environmental Site Assessment

2046 and 2050 Scott Street
295, 297, 299 and 301 Ashton Avenue
Ottawa, Ontario

Scott Street Developments Inc.

Report: PE4892-1R

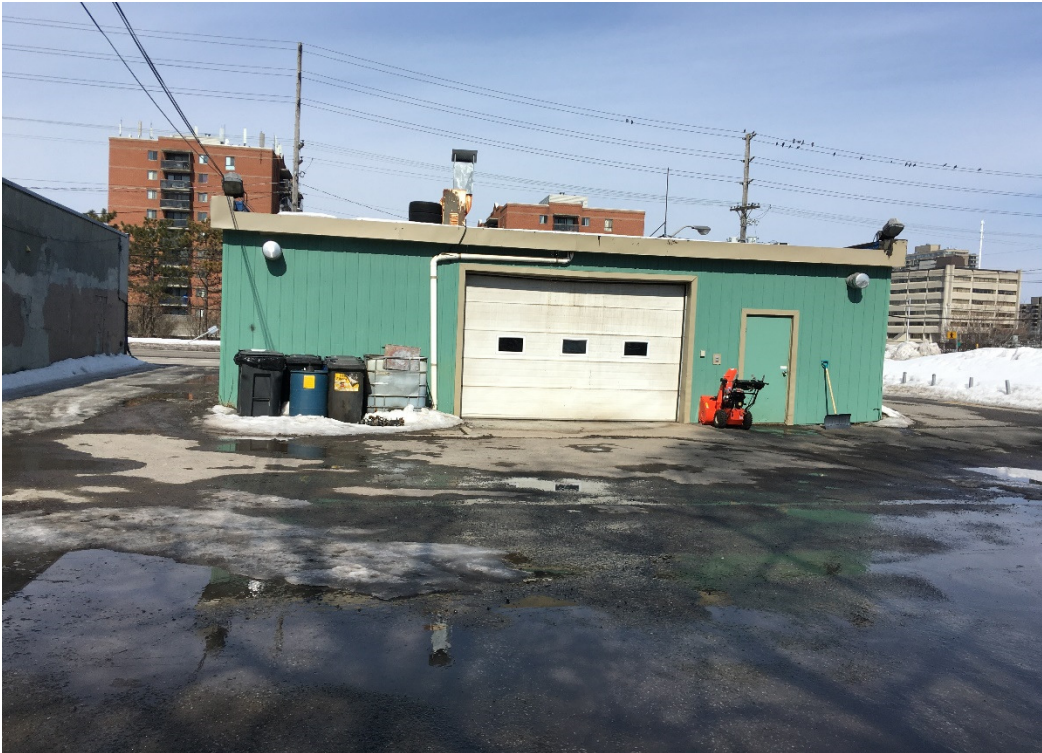
Photograph 7: View of northeastern portion of the Phase I Property, facing north. Photograph illustrates the south face of 2046 Scott Street and the exterior storage of waste oil and filters.

A 200L drum and 950L tote containing waste motor oil were observed on the exterior of this property, situated on a concrete slab. No obvious signs of staining were observed on the exterior of the property around the waste oil storage area; it should be noted that this portion of the property was partially covered with snow and ice at the time of the site visit. The waste oil is reportedly collected and disposed off-site by a licenced contractor as needed.

Tires, waste oil drum/tote and filters stored at 2046 Scott Street are collected and disposed off-site by contractors licenced for these works, on an as-needed basis. It should be noted that the waste oil drum/tote and filter containers are situated on a concrete slab.

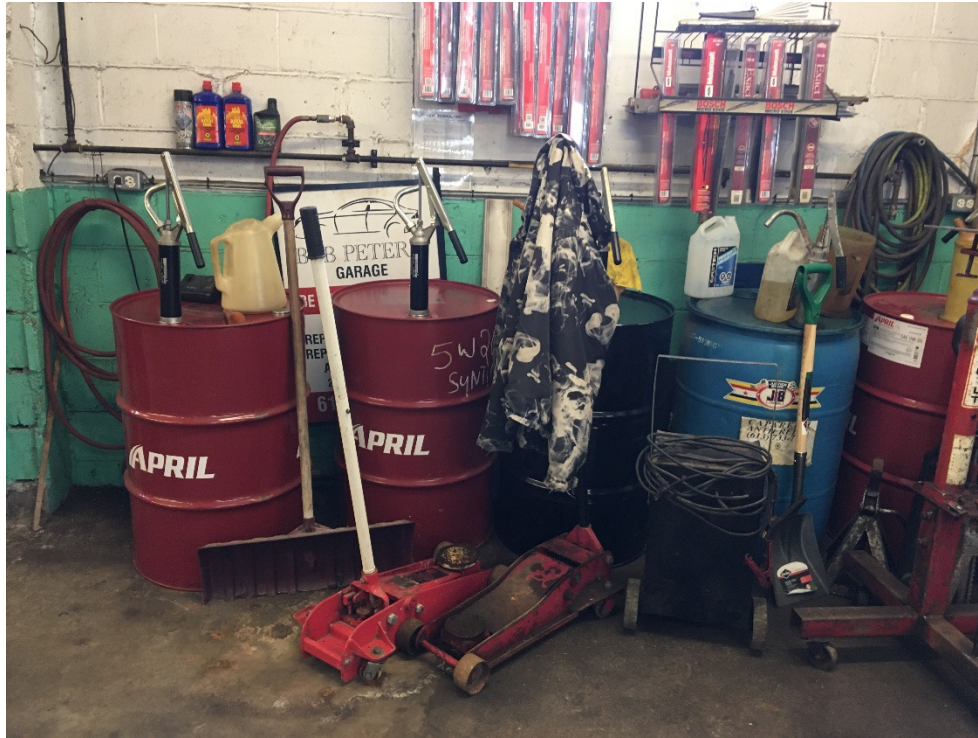
Photograph 9: View of interior of automotive service garage at 2046 Scott Street, facing west. Photograph illustrates storage of new oil and waste oil.

As previously noted, five (5) 200L drums of new or waste oil were observed on the interior of the automotive service garage at 2046 Scott Street, in addition to multiple containers (less than 10L in volume) of various motor oils, washer fluid, brake fluid and transmission oil. Areas of staining were noted on the concrete floor throughout the garage at the time of the site visit. The concrete floor was observed to be in fair condition, with some cracks and pitting noted at the time of the site visit.

A 200L drum containing waste oil was observed on the interior of the property. Staining as observed on the concrete floor in the vicinity of the waste oil and new oil storage area. A 200L drum and 950L tote containing waste motor oil were observed on the exterior of this property, situated on a concrete slab. No obvious signs of staining were observed on the exterior of the property around the waste oil storage area; it should be noted that this portion of the property was partially covered with snow and ice at the time of the site visit. The waste oil is reportedly collected and disposed off-site by a licenced contractor as needed.

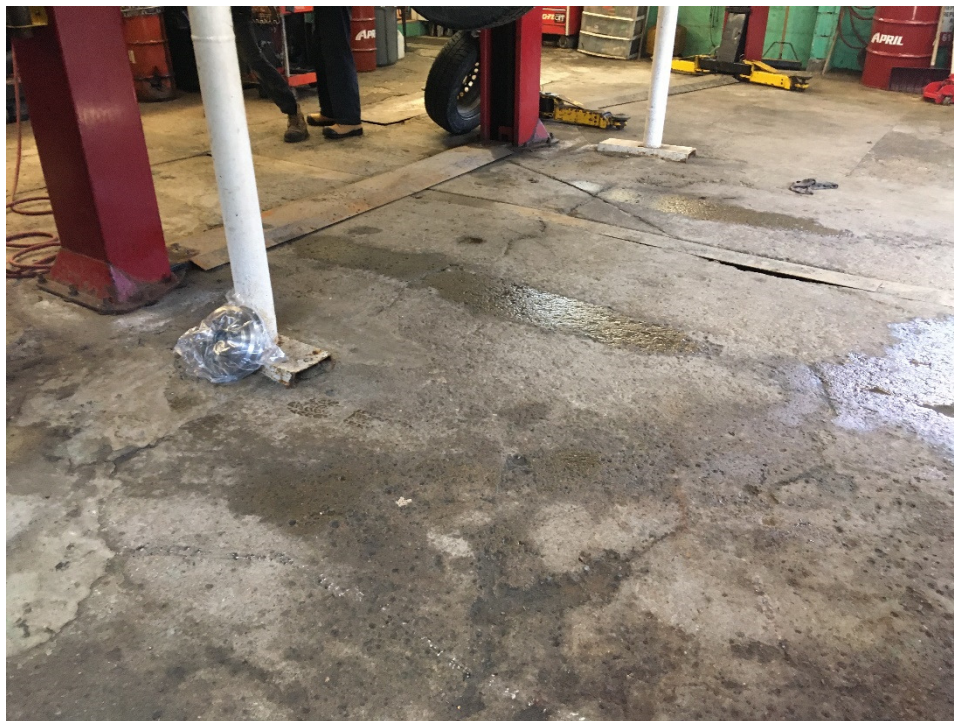
Photograph 10: View electric hoist and floor drains on the interior of 2046 Scott Street.

The garage consists of two (2) bays, both equipped with electrical hoists. Two (2) floor drains leading to an oil-water separator were observed in the garage. The drains were observed to be dry at the time of the site visit. As previously noted, Mr. Park indicated that automotive service repairs carried out on-site are limited to oil changes, transmission and brake flushes, tire replacement and wheel alignments.
