**Phase One Environmental Site Assessment**

**951 Gladstone Avenue & 145 Loretta Avenue North  
Ottawa, Ontario**

**Prepared for:  
Trinity Development Group Inc.**

**August 2017**

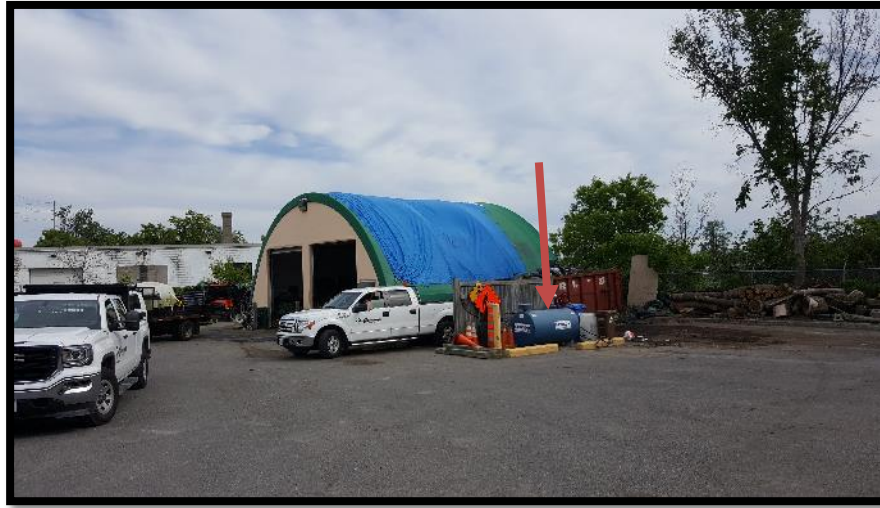
Photograph 7 – View of the gasoline AST (see arrow) on the northeast portion of the Site.

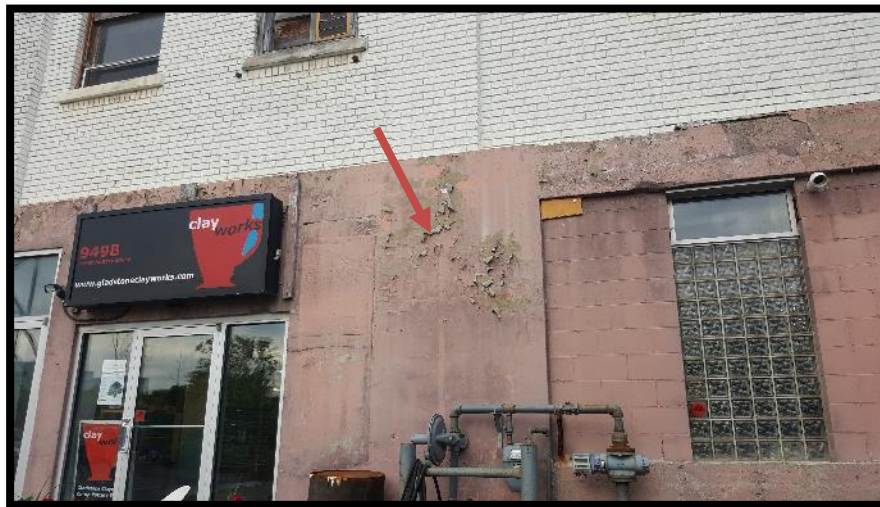
Photograph 8 – View of peeling paint (see arrow) on the exterior of the Site building associated with 951 Gladstone Avenue.

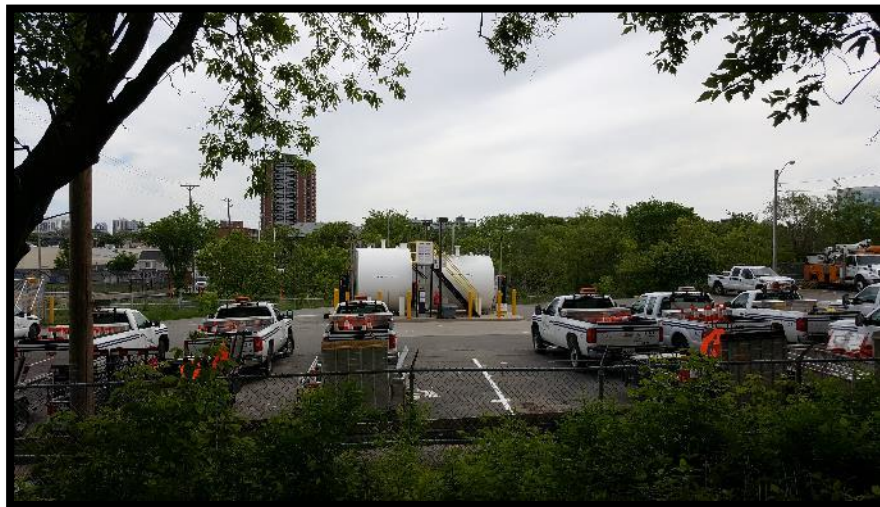
Photograph 10 – View of the private fuel outlet associated with 175 Loretta Avenue North, located approximately 30 m south of the Site.

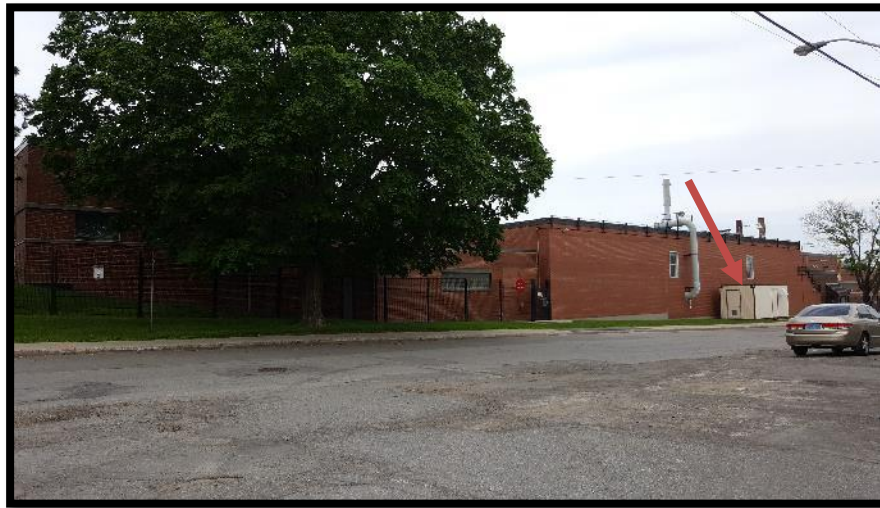
Photograph 6 – View of a portion of the neighbouring printing facility and the inferred soil-vapour extraction shed (see arrow) to the west of the Phase One Property.
