**Re: Phase One Environmental Site Assessment Update**  
949, 949A, 949B, 951, 951A, 953, 955A, 955B, 957A, 957C and 971 Gladstone Avenue  
and 145 and 155 Loretta Avenue North, Ottawa, Ontario  
Pinchin File: 285722

**Phase One Environmental Site Assessment Update**

949, 949A, 949B, 951, 951A, 953, 955A, 955B, 957A, 957C and 971 Gladstone Avenue and 145 and 155 Loretta Avenue North, Ottawa, Ontario

TIP Gladstone Limited Partnership by its General Partner TIP Gladstone GP Inc. c/o CLV Group Developments Inc.

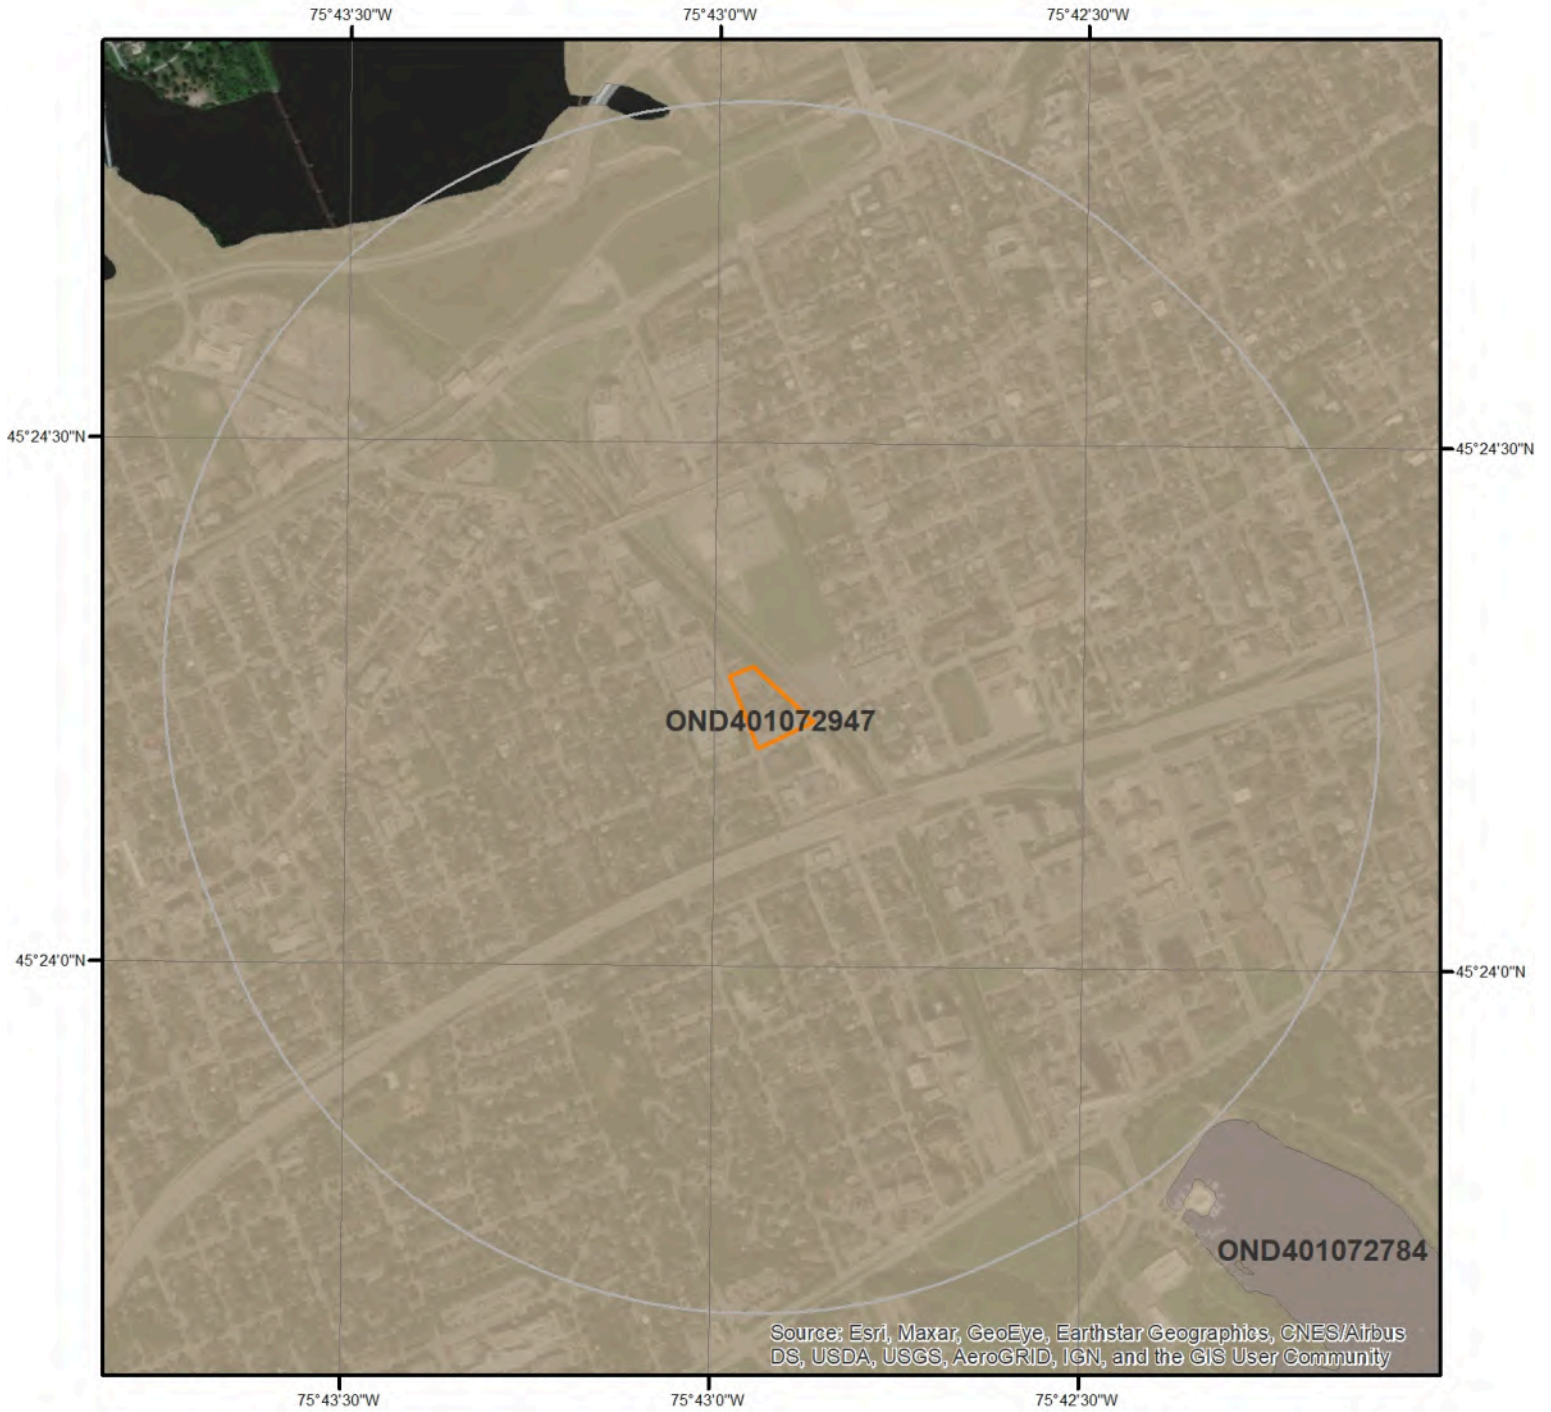
## Soil Map

| Material Description: | Sandy and silty compact diamicton, grey at depth but brown where oxidized; calcareous where derived from sedimentary rocks and not leached; consists dominantly of lodgment till. In areas that lie below marine limit (198 m a.s.l.) it is overlain by a discontinuous lag consisting of gravel, sand and boulders |
