Re: Phase One Environmental Site Assessment Update
951 Gladstone Avenue and 145 Loretta Avenue North, Ottawa, Ontario
Pinchin File: 285722.002

Phase One Environmental Site Assessment Update

951 Gladstone Avenue and 145 Loretta Avenue North, Ottawa, Ontario
TIP Gladstone Limited Partnership by its General Partner TIP Gladstone GP Inc. c/o CLV Group Developments Inc.

October 19, 2022
Pinchin File: 285722.002

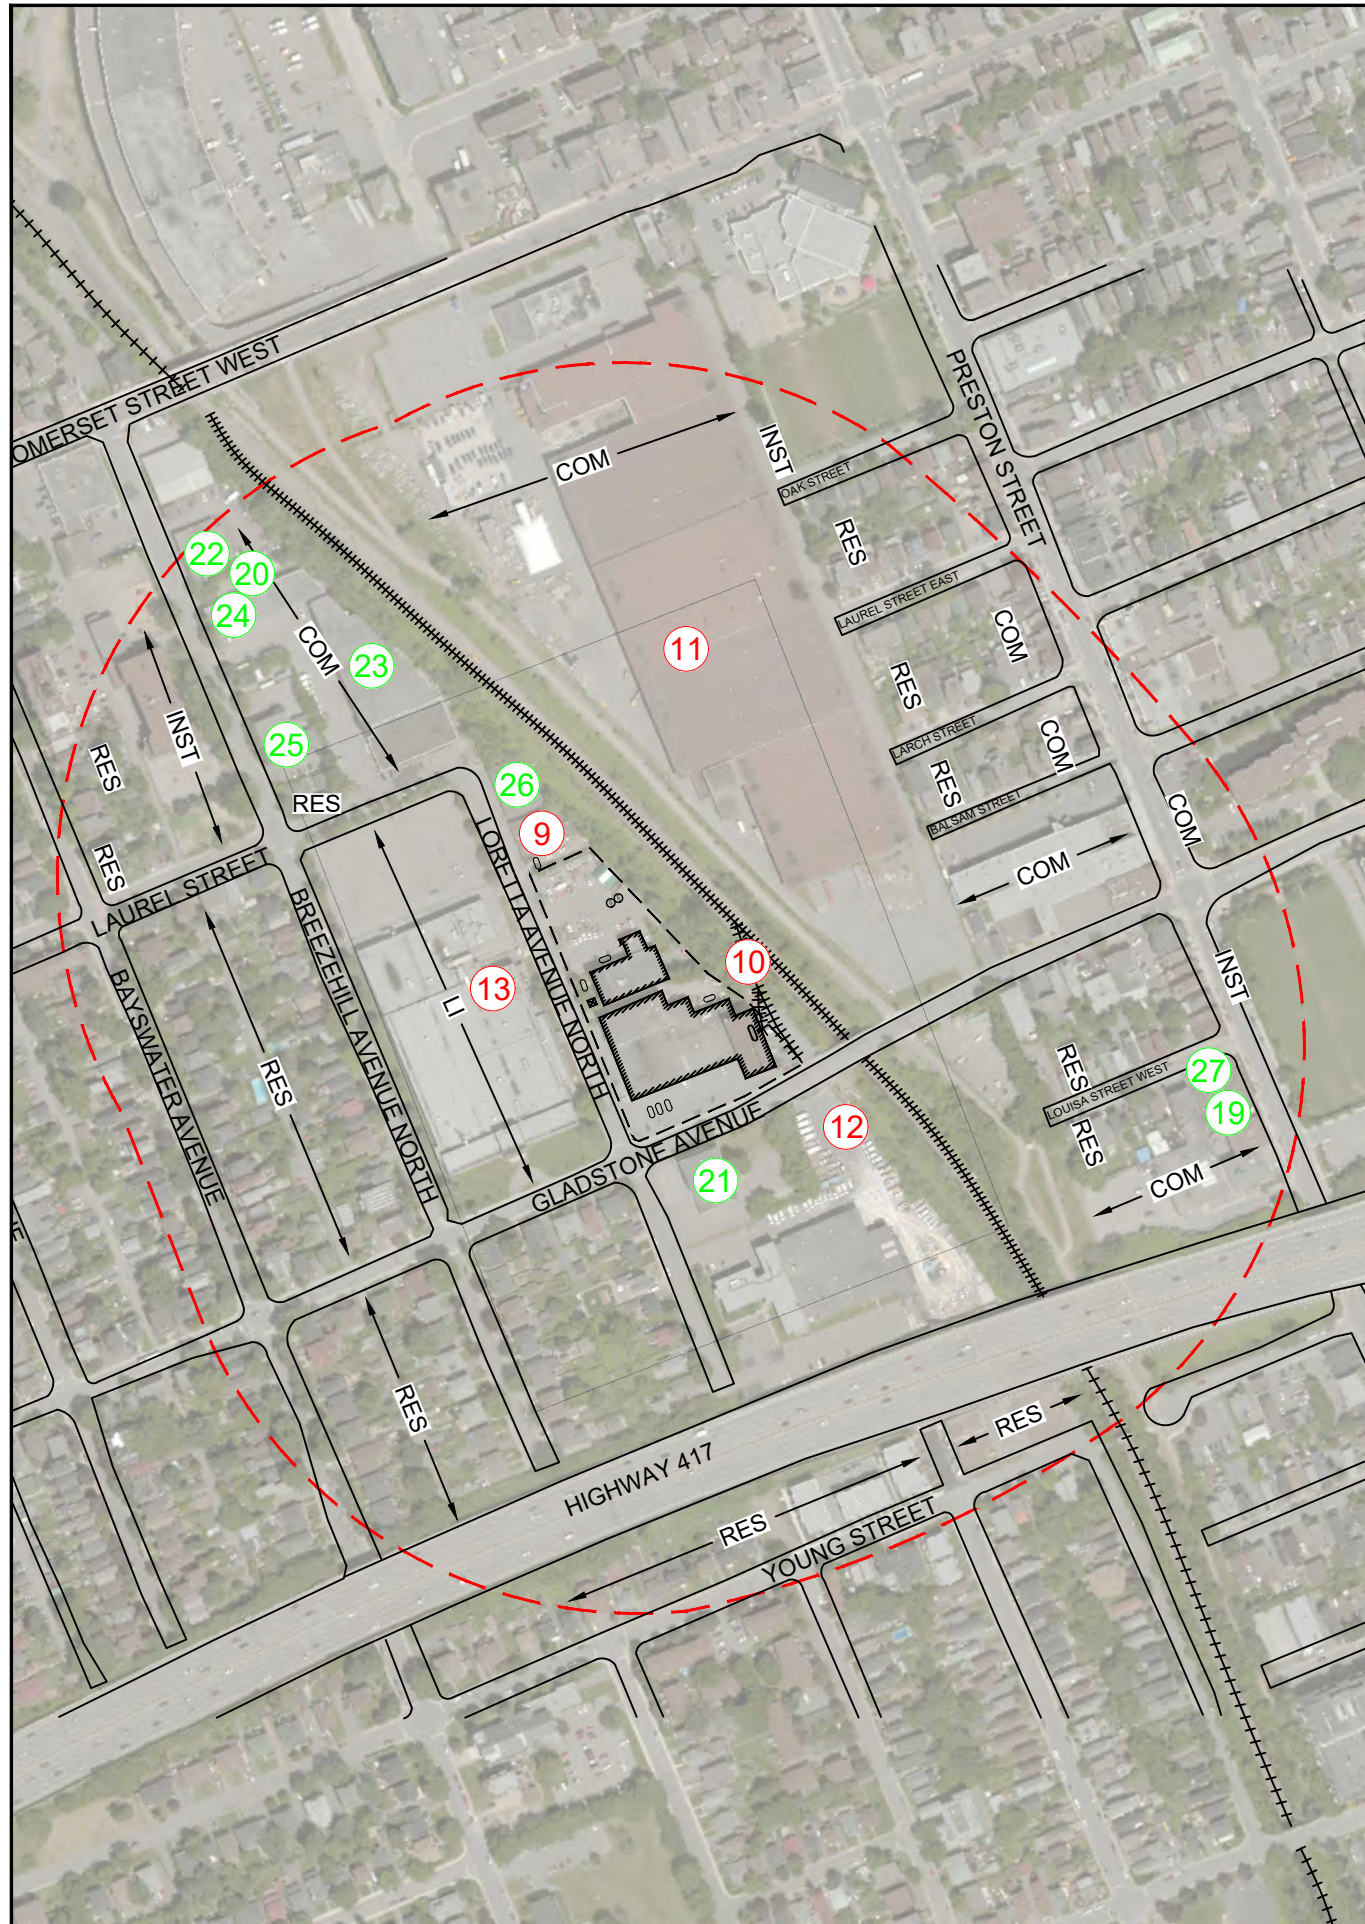
PROJECT NUMBER: 285722.002	SCALE: AS SHOWN
DRAWN BY: DM	REVIEWED BY: MA
DATE: OCTOBER 2022	FIGURE NUMBER: 5

PCA Designation	Location of Potentially Contaminating Activity	Potentially Contaminating Activity	Location of PCA (On-Site or Off-Site)	Media Potentially Impacted (Ground Water, Soil and/or Sediment)
PCA-9	One former UST associated with Hall Fuel Ltd., located on the north adjacent property, 131 Loretta Avenue North	Item 28 - Gasoline and Associated Products Storage in Fixed Tanks	Off-Site	Groundwater
PCA-10	Former railway tracks located on the east adjacent property (no civic address)	Item 46 - Rail Yards, Tracks and Spurs	Off-Site	Groundwater
PCA-11	No. 26 Central Ordnance Depot historically located 50 m east of the Phase One Property (no civic address)	Item 38 - Ordnance Use	Off-Site	Groundwater
PCA-12	Off-site PFO associated with the City of Ottawa's Traffic Operations, located at 175 Loretta Avenue North	Item 28 - Gasoline and Associated Products Storage in Fixed Tanks	Off-Site	Groundwater

PCA-13	Off-Site printing facility located at 975 Gladstone Avenue	Item 31 - Ink Manufacturing, Processing and Bulk Storage	Off-Site	Groundwater
PCA-19	Former RFO located at 284 Preston Street	Item 28 - Gasoline and Associated Products Storage in Fixed Tanks	Off-Site	Not Applicable
PCA-20	Various historical automotive repair facilities located at 55 Breezehill Avenue North	Item 27 - Garages and Maintenance and Repair of Railcars, Marine Vehicles and Aviation Vehicles	On-Site	Not Applicable
PCA-21	Renters News, an inferred publisher/printing facility, was formerly located at 950 Gladstone Avenue	Item 31 - Ink Manufacturing, Processing and Bulk Storage	Off-Site	Not Applicable
PCA-22	Barrie Coal & Wood Yard was located at 53 Breezehill Avenue North	Item 59 - Wood Treating and Preservative Facility and Bulk Storage of Treated and Preserved Wood Products	Off-Site	Not Applicable
PCA-23	Various metal sign manufacturers were historically located at 35 Laurel Street	Item 34 - Metal Fabrication	Off-Site	Not Applicable

PCA-24	Grant Trading Coal & Wood was located at 75 Breezehill Avenue North	Item 59 - Wood Treating and Preservative Facility and Bulk Storage of Treated and Preserved Wood Products	Off-Site	Not Applicable
PCA-25	An automotive repair facility, Grandtech Auto, was historically located at 111 Breezehill Avenue North	Item 27 - Garages and Maintenance and Repair of Railcars, Marine Vehicles and Aviation Vehicles	Off-Site	Not Applicable
PCA-26	Buchanan Lighting, an inferred light bulb manufacturer and retailer, was historically located at 127 Loretta Avenue	Item 29 - Glass Manufacturing	Off-Site	Not Applicable
PCA-27	Mario's Dry Cleaning, an inferred dry-cleaning facility, was historically located at 280 Preston Street	Item 37 - Operation of Dry Cleaning Equipment (where chemicals are used)	Off-Site	Not Applicable
