CIRCLE K STORES INC.
R&R No. 52287

1545 WOODROFFE AVENUE
NEPEAN, ON, CANADA
K2G 1W2

TREE PRESERVATION AND PROTECTION EXISTING CONDITIONS PLAN

L1.0

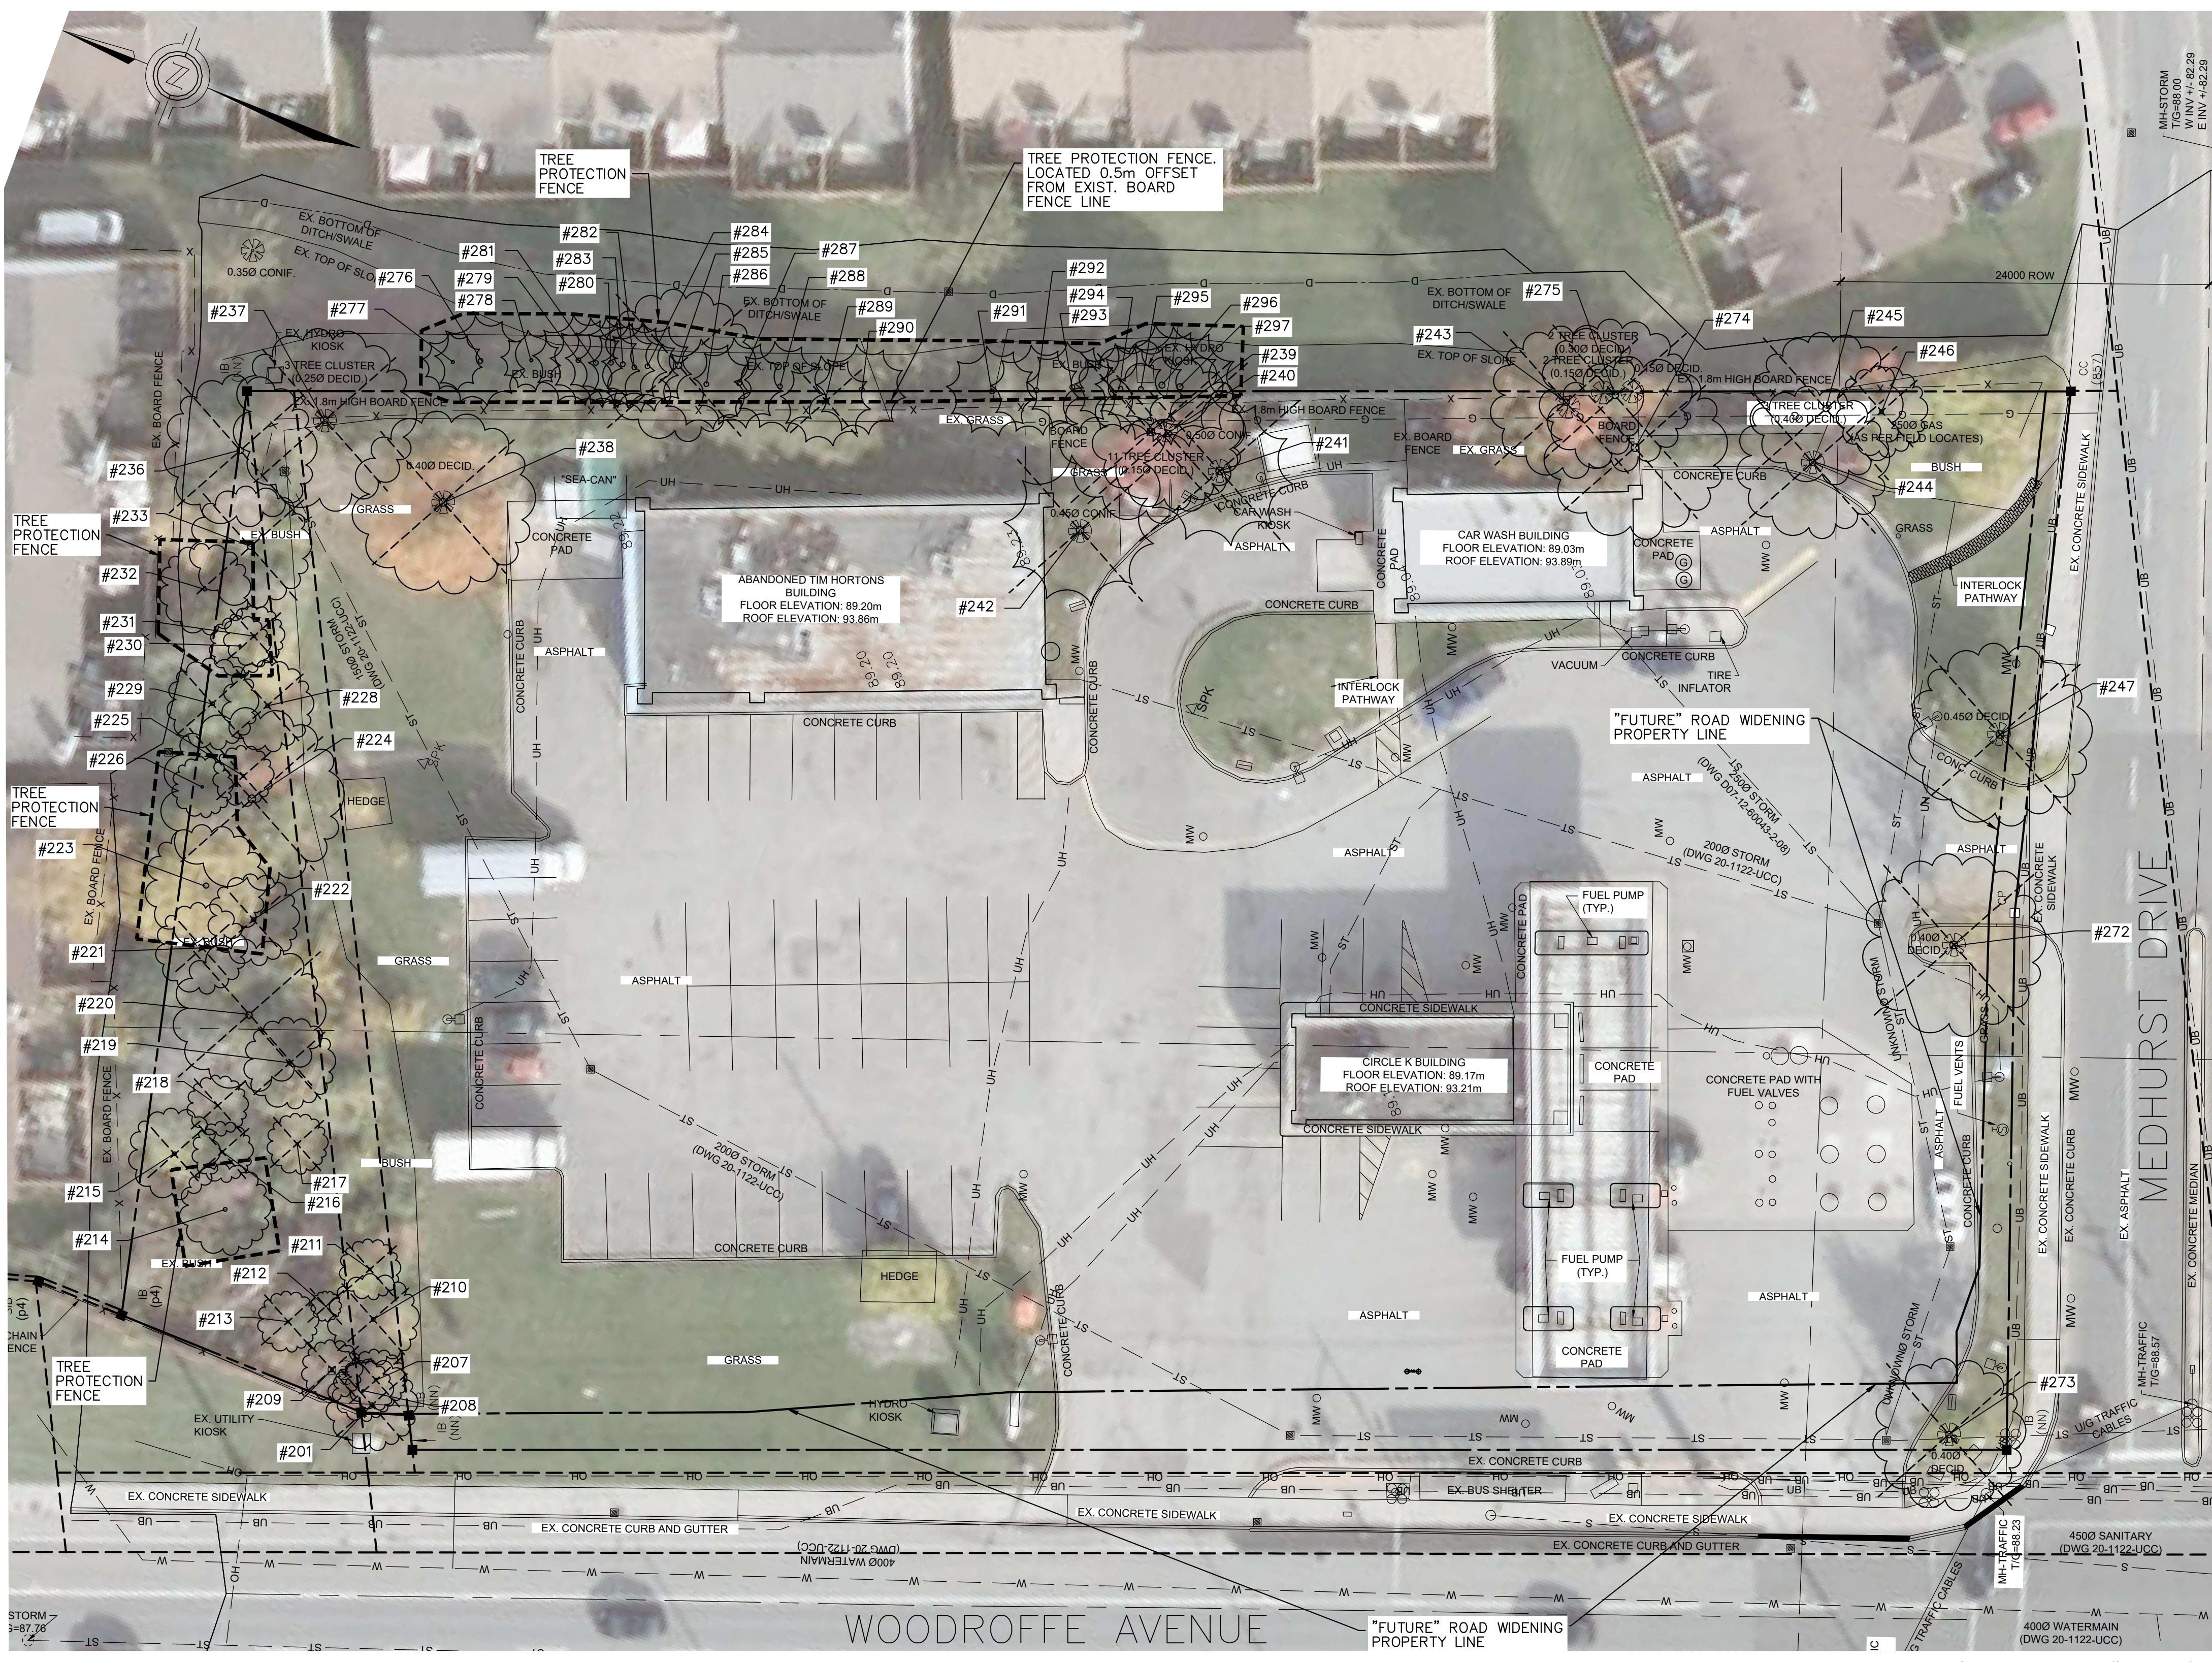
- DENOTES SURVEYED LOCATION OF EXISTING TREES, & # SPECIES / CALIPER / CONDITIONS / REMARKS ARE AS NOTED IN ARBORIST REPORT & TREE INVENTORY LIST
- TREE PRESERVATION FENCE, PER OTTAWA TREE PROTECTION SPECIFICATION DETAIL
- DENOTES EXISTING TREES TO BE REMOVED FOR DEVELOPMENT, AS NOTED, SEE ARBORIST REPORT
