New Civic Development for The Ottawa Hospital

Environmental Impact Statement and Tree Conservation Report - Master Site Plan

September 2021

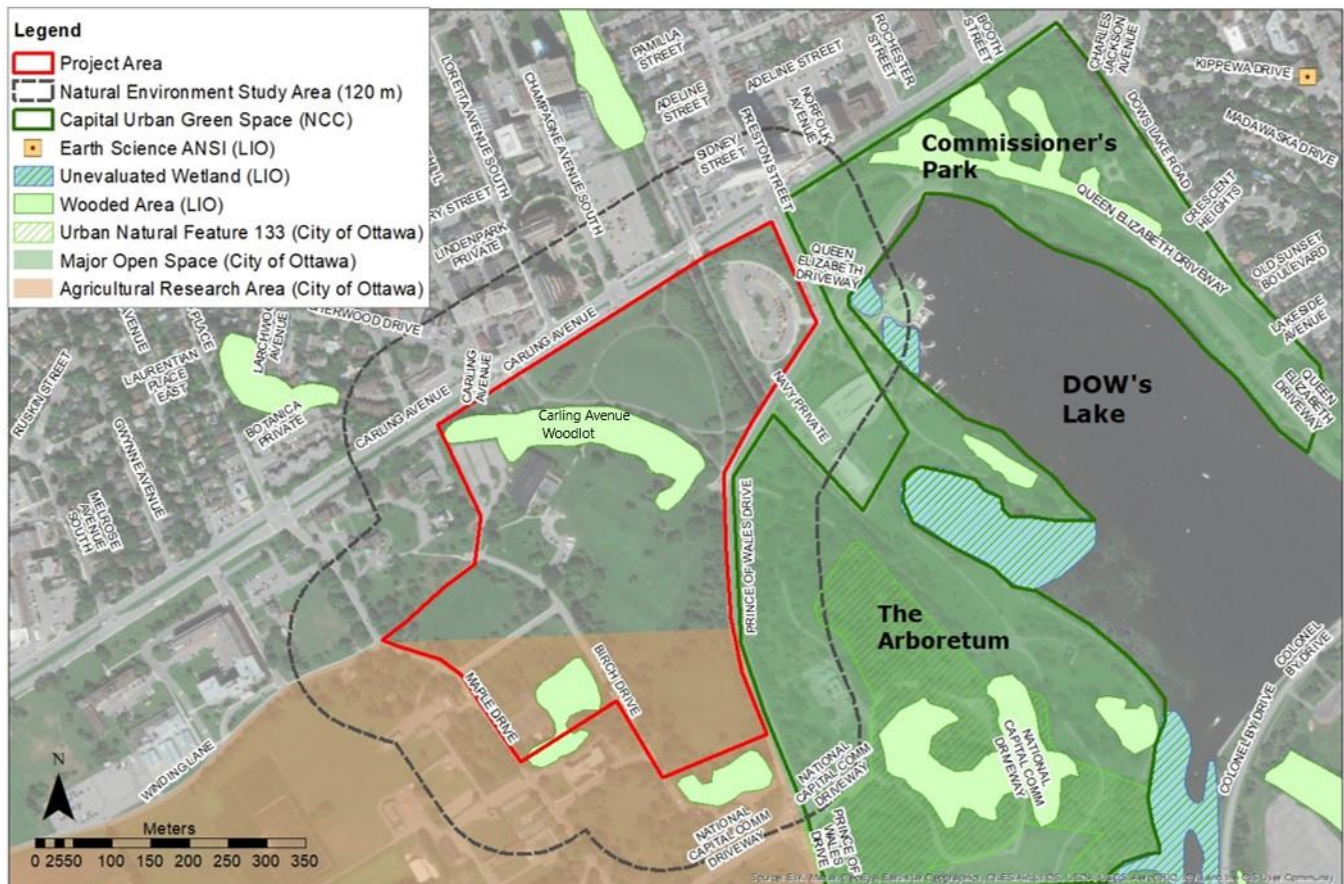
Figure 3: Natural Heritage Features

Natural Heritage Features were identified for the study area and surrounding lands (Figure 3).

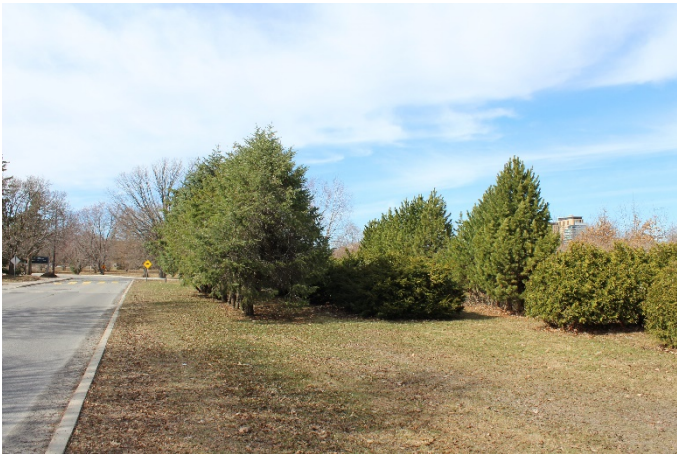
Photo 3: Old Hedge Collection, looking northwest along Maple Drive.

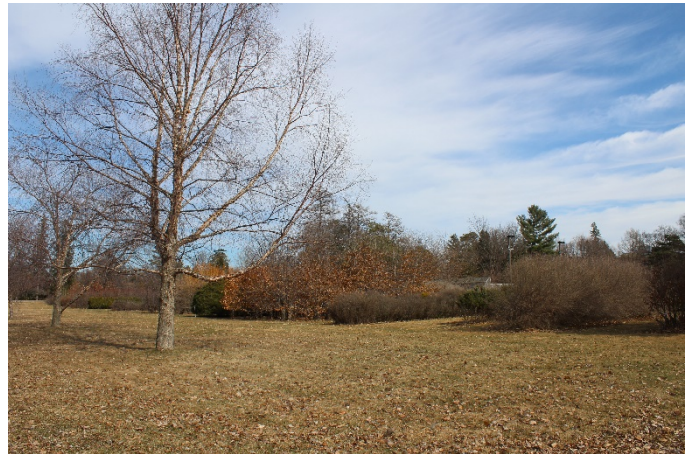
Photo 4: Old Hedge Collection, looking east, travelling from Maple Drive to Birch Drive.

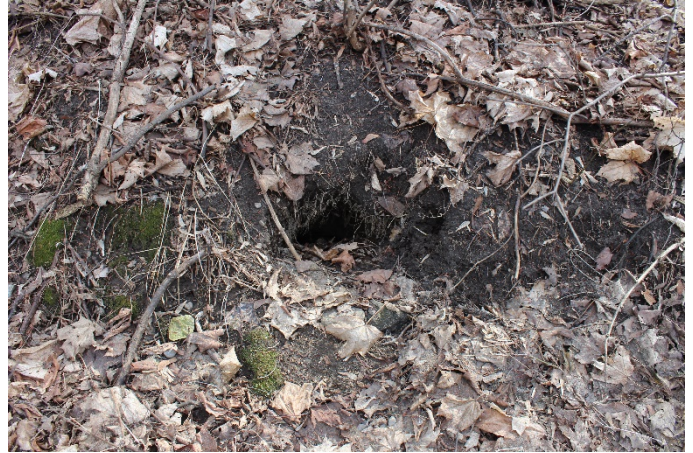
Photo 8: Mammal den in Carling Avenue Woodlot.

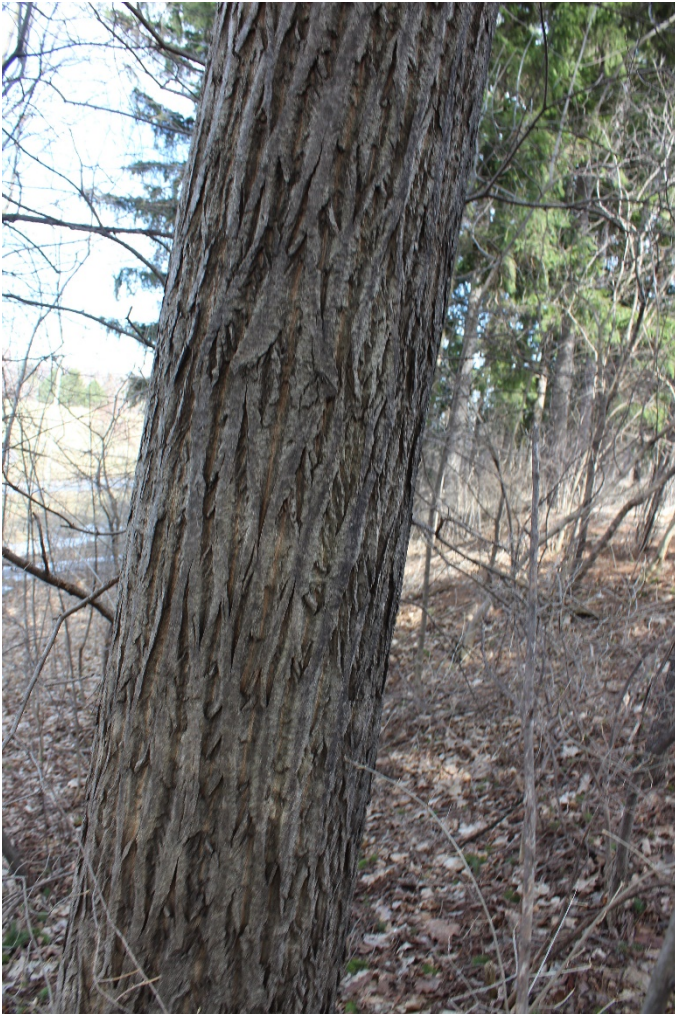
Photo 9: Mature butternut (*Juglans cinerea*) tree in Carling Avenue Woodlot, showing distinctive grey bark with diamond-shaped fissures.

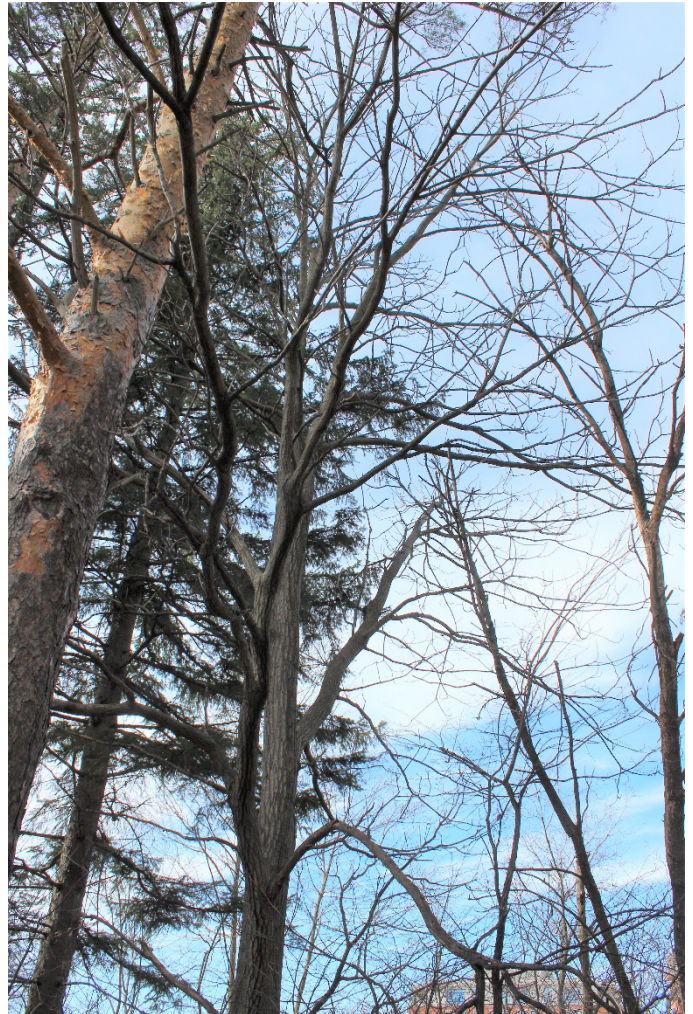
Photo 10: Mature butternut (*Juglans cinerea*) tree in Carling Avenue Woodlot, showing minor canopy damage.

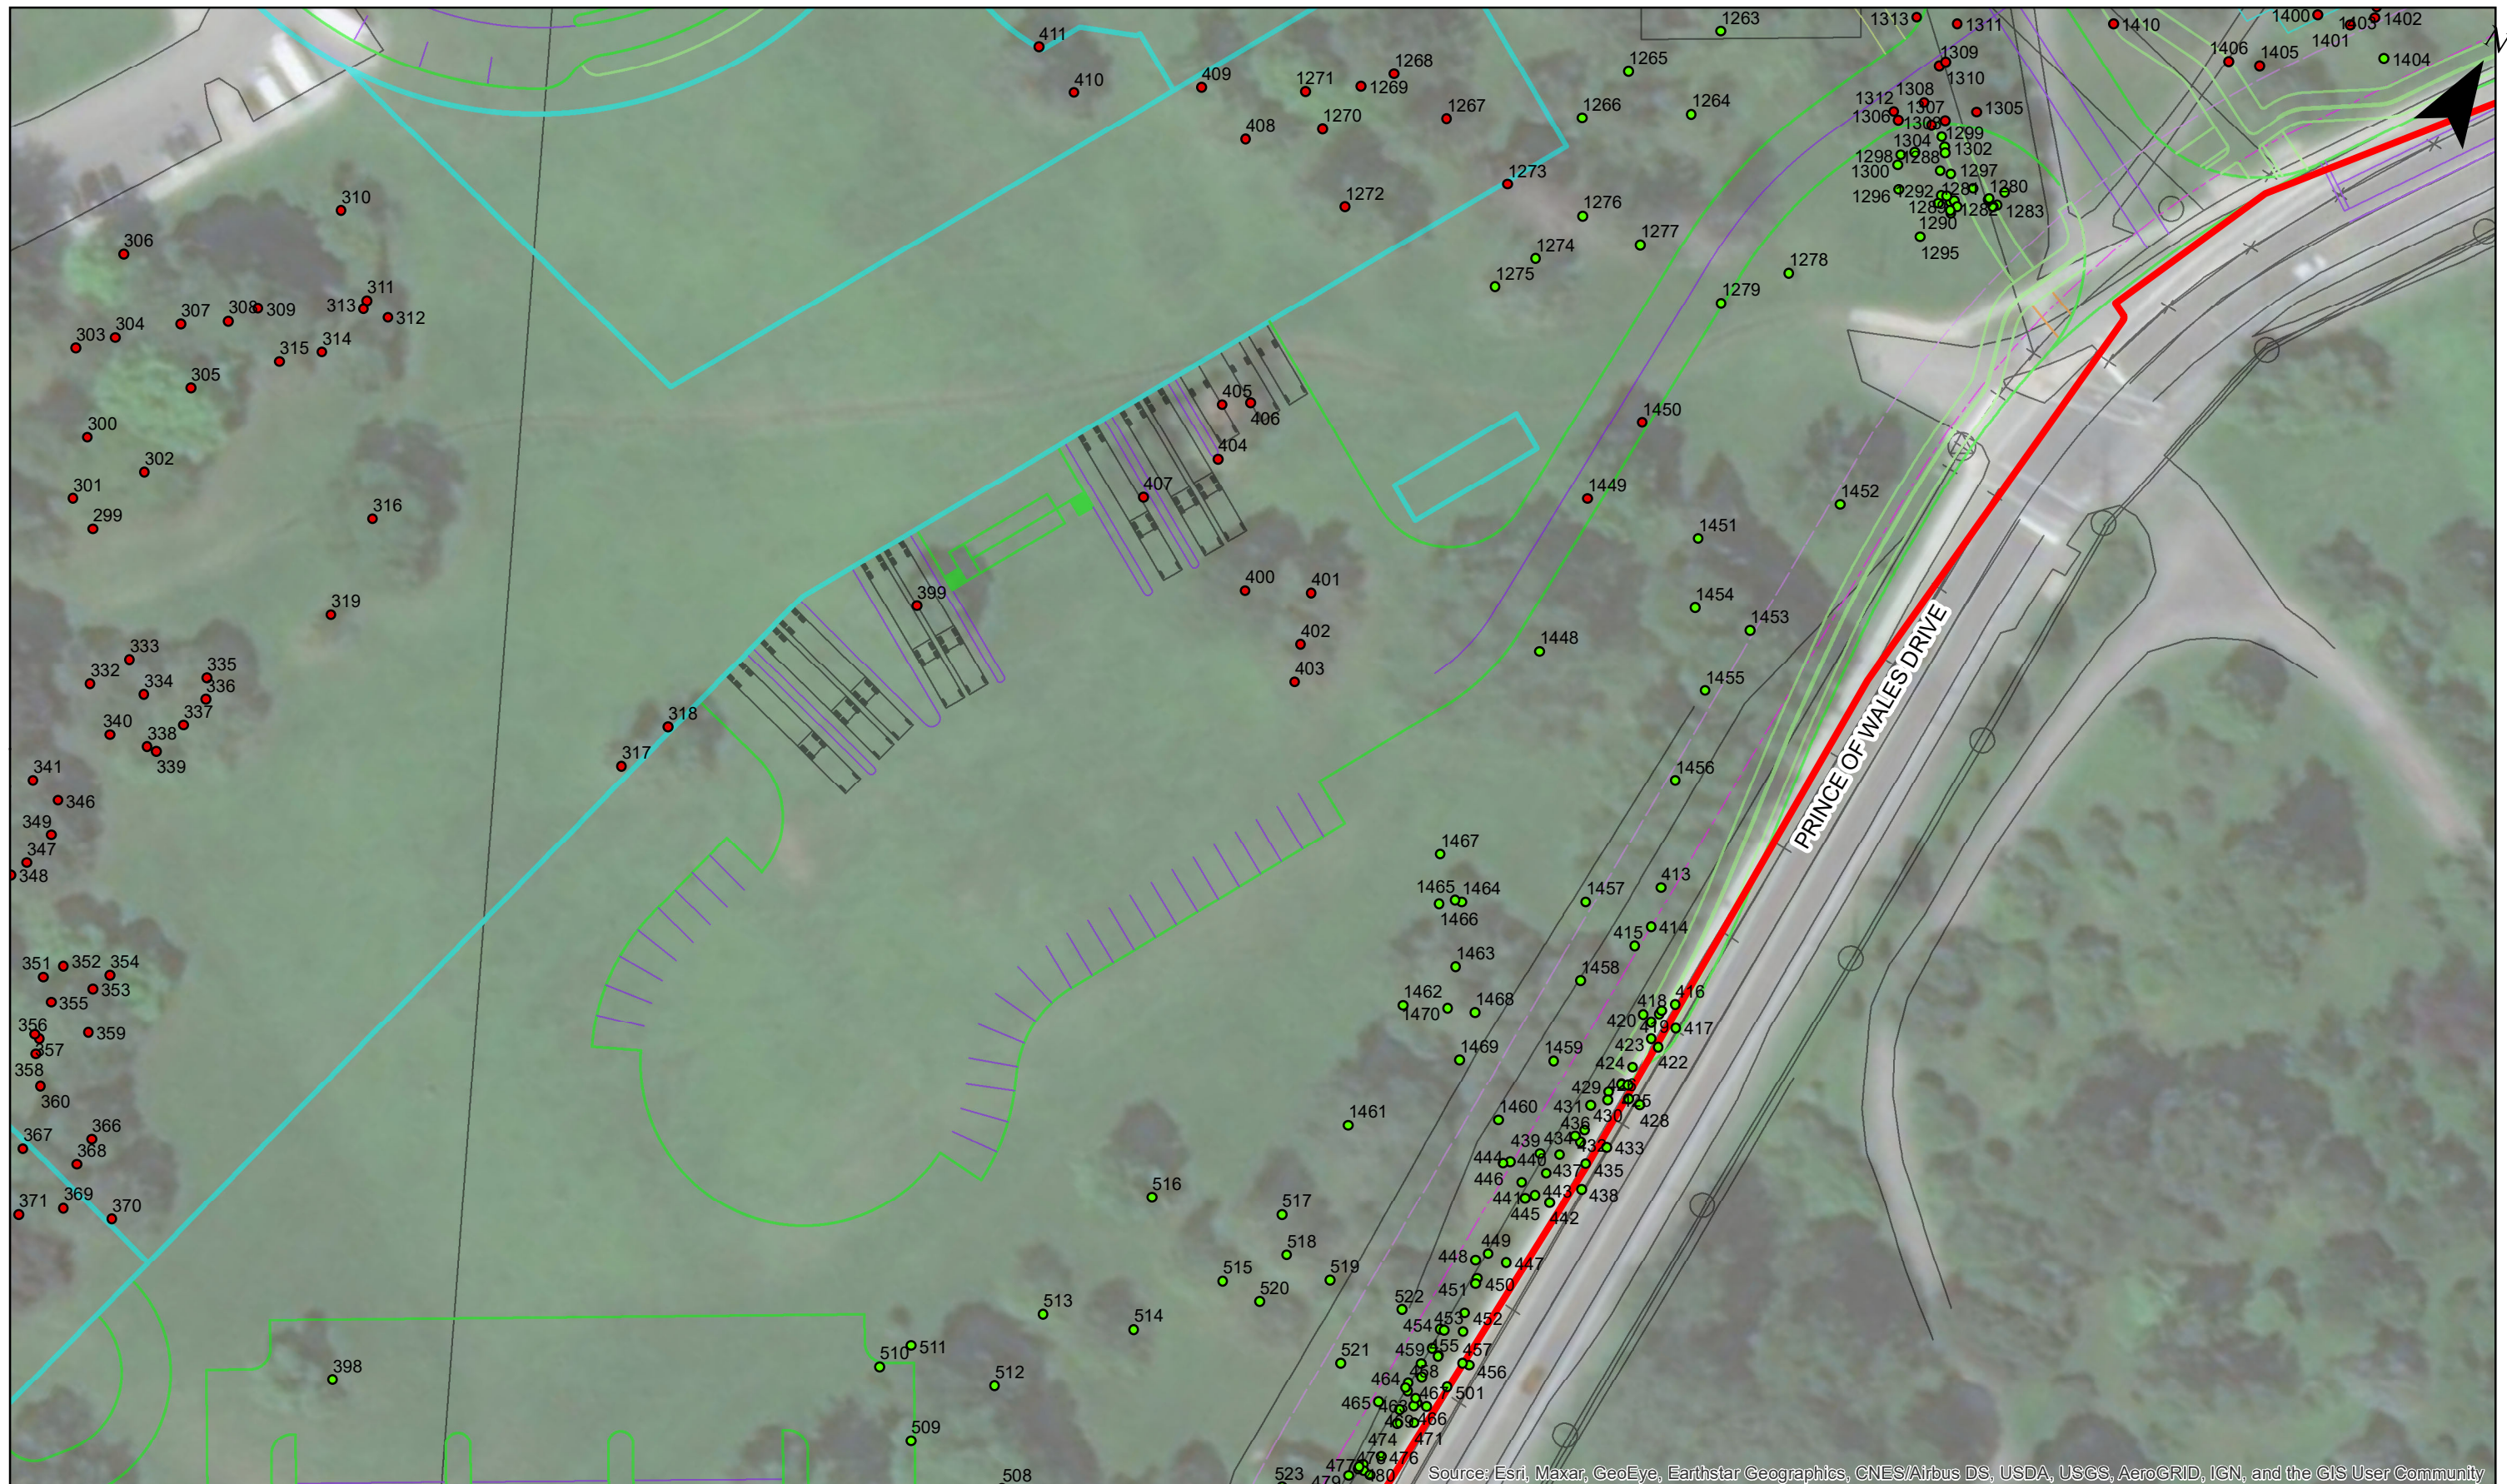
Appendix C, Figure 2H: Tree Inventory Results

- Retain (142)
- Retain - Offsite (0)
- LRT Corridor (0)
- Remove (91)
- × Previously Removed (0)
- ★ Butternut
- Project Area
