FINAL REPORT

Phase One Environmental Site Assessment

The Ottawa Hospital- New Civic Campus

19127064

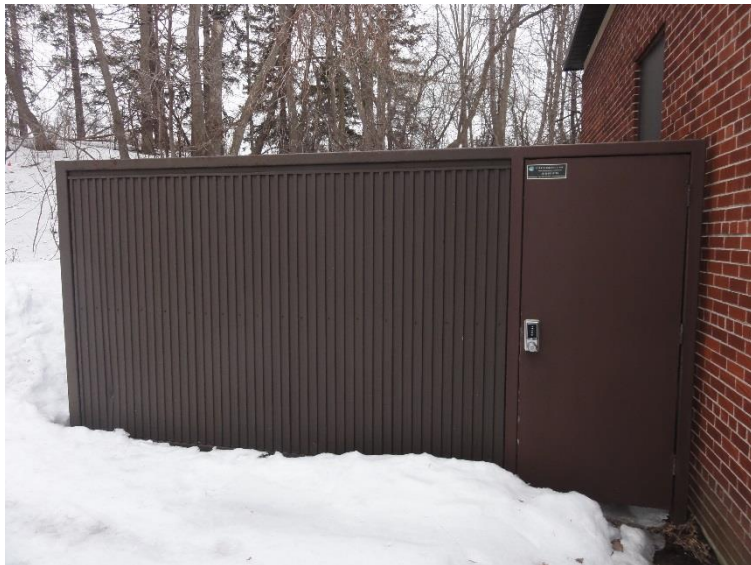
Photo 6 – View of storage area located south of Building 61.

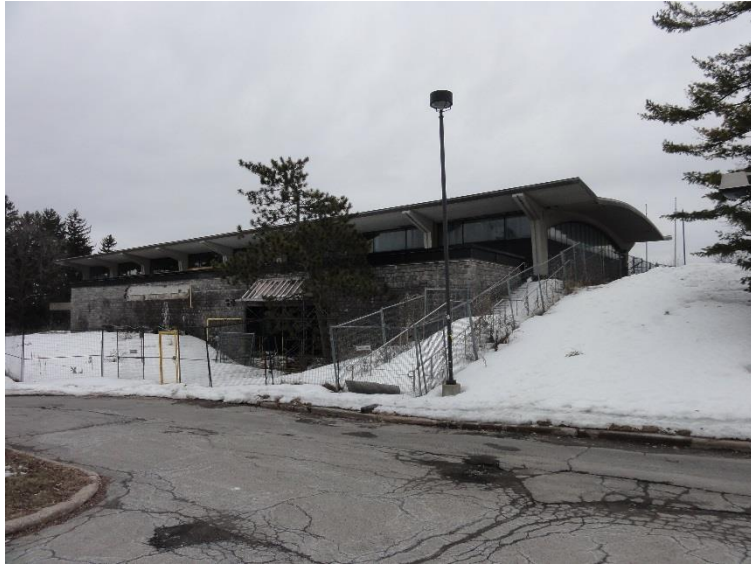
Photo 7 – View of West Annex (under demolition) on the northern portion of Parcel C, looking east.

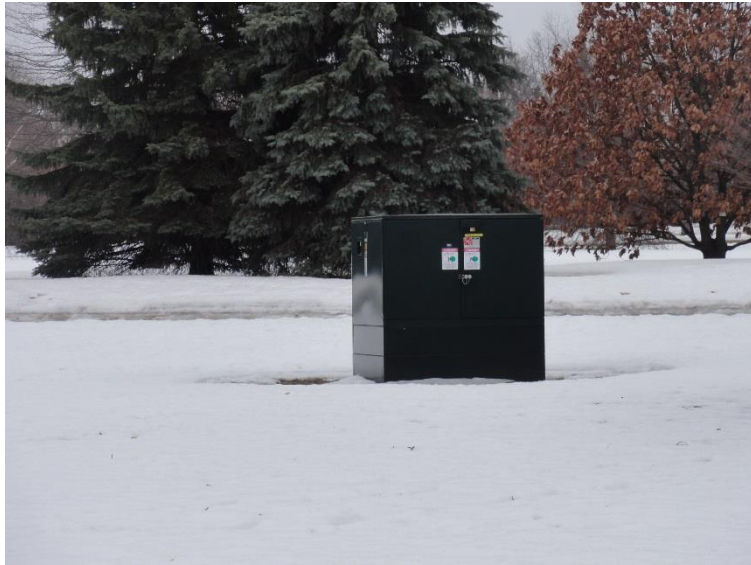
Photo 11 – View of a typical concrete pad-mounted transformer located west of West Annex Building; however, snow cover restricted inspection of ground conditions in the vicinity of this PCA.

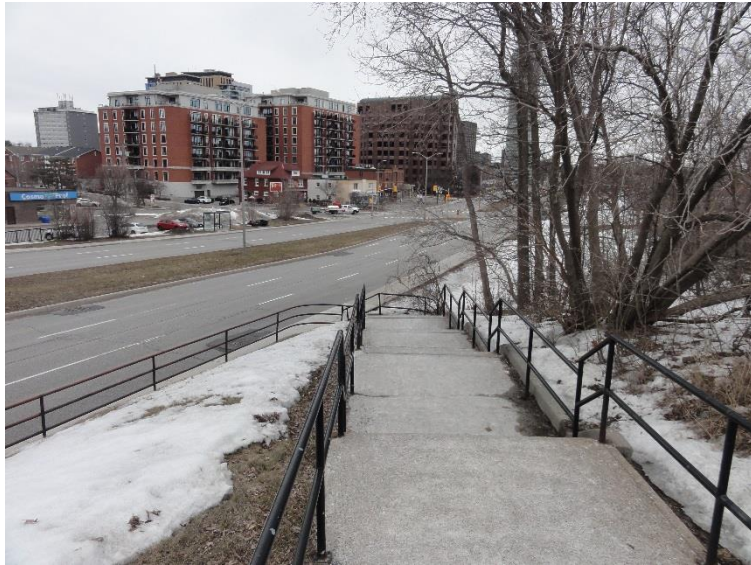
Photo 15 – View of walkway on the northern portion Parcel C leading towards Carling Avenue, indicating steep drop in elevation.
