McKINLEY
ENVIRONMENTAL
SOLUTIONS

Combined Environmental Impact Statement &
Tree Conservation Report
400 Hunt Club Road, Ottawa, Ontario

May 2021

Prepared for Novatech Engineers, Planners, and Landscape Architects

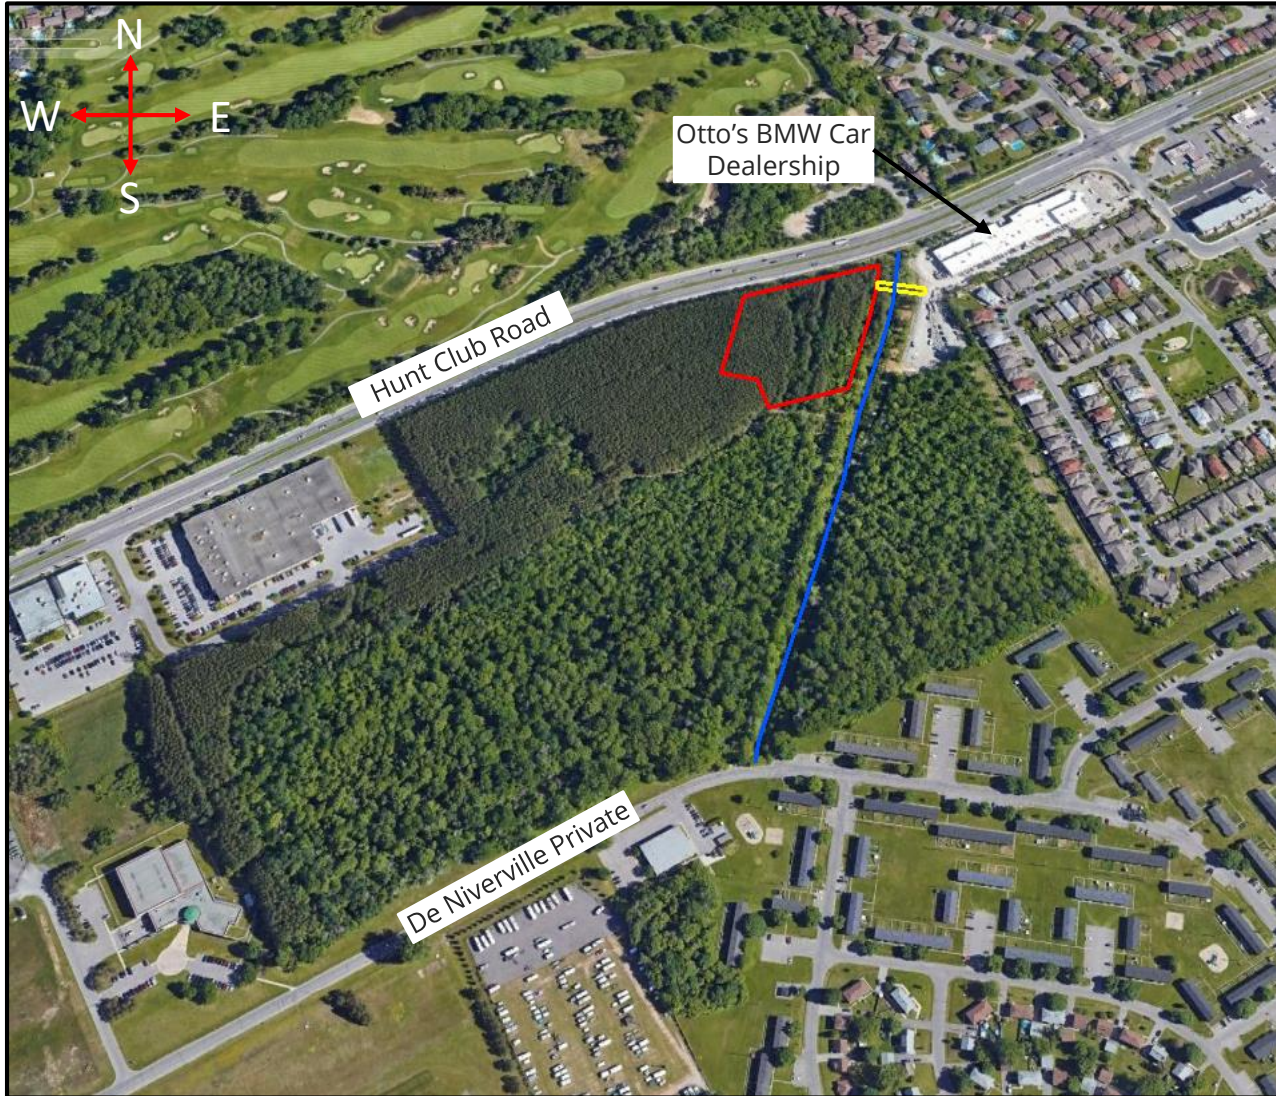
FIGURE 1: SITE OVERVIEW

The Site is located at 400 Hunt Club Road, Ottawa (Part of Lot 6, Concession 2 from Rideau River, Geographic Township of Gloucester) (Refer to Figure 1). The Site is approximately 1.25 ha (3.1 acres) in size and predominantly consists of a Red Pine Plantation, which is part of a larger woodlot. The Red Pine Plantation extends to the west beyond the Site, whereas the area to the south of the Site includes a regrowth deciduous forest. Hunt Club Creek is located east of the Site, beyond which is the Otto's BMW Car Dealership. Hunt Club Road is located north of the Site. As described below in Section 3.5, the Site falls within the City of Ottawa's Natural Heritage System Overlay (City of Ottawa 2014). The regrowth deciduous forest found to the south of the Site is shown to be part of the Greenbelt (City of Ottawa 2020).

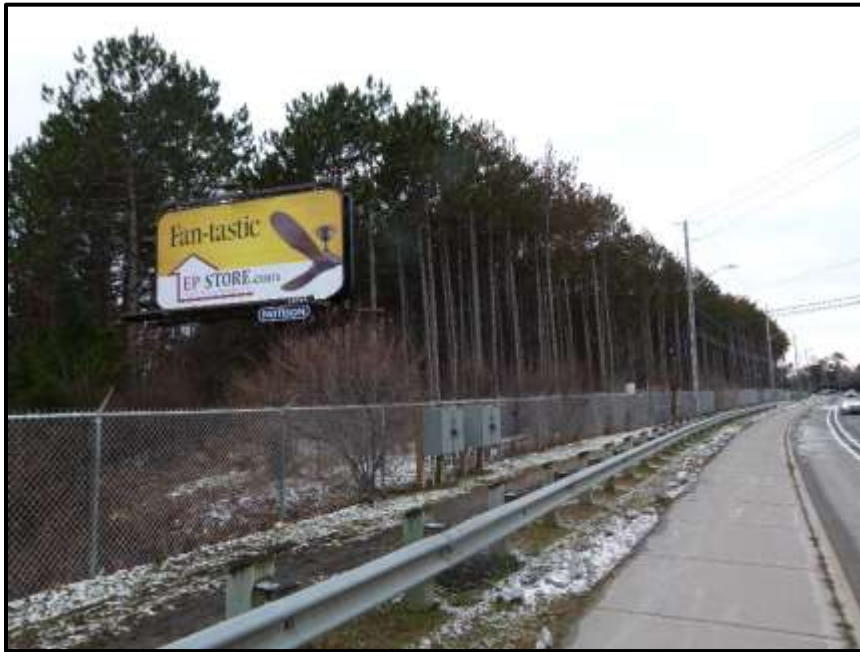
Photograph 1: Looking southwest along Hunt Club Road at the edge of the Site. The Red Pine Plantation is shown (December 3rd, 2020).

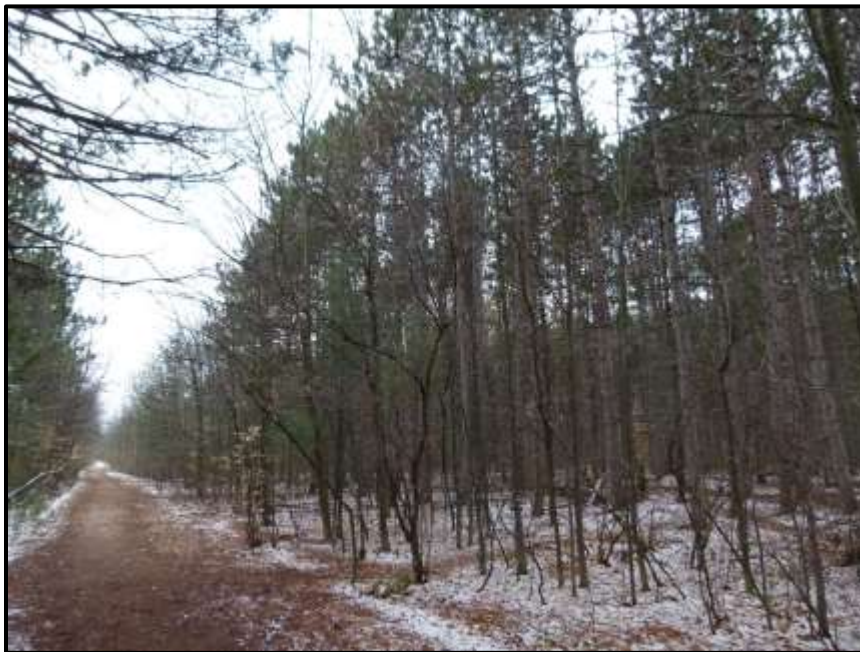
Photograph 2: Looking south at the deciduous stems growing along the edges of the trail at the eastern side of the Red Pine Plantation (December 3rd, 2020).

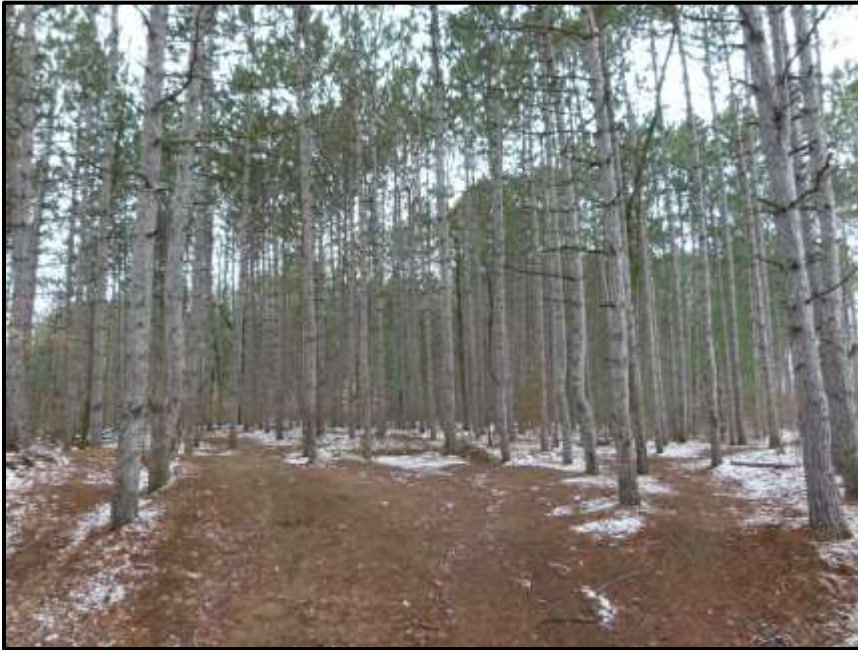
Photograph 3: Interior of the Red Pine Plantation in the eastern part of the Site. Note the absence of shrubs and groundcover plants (December 3rd, 2020).

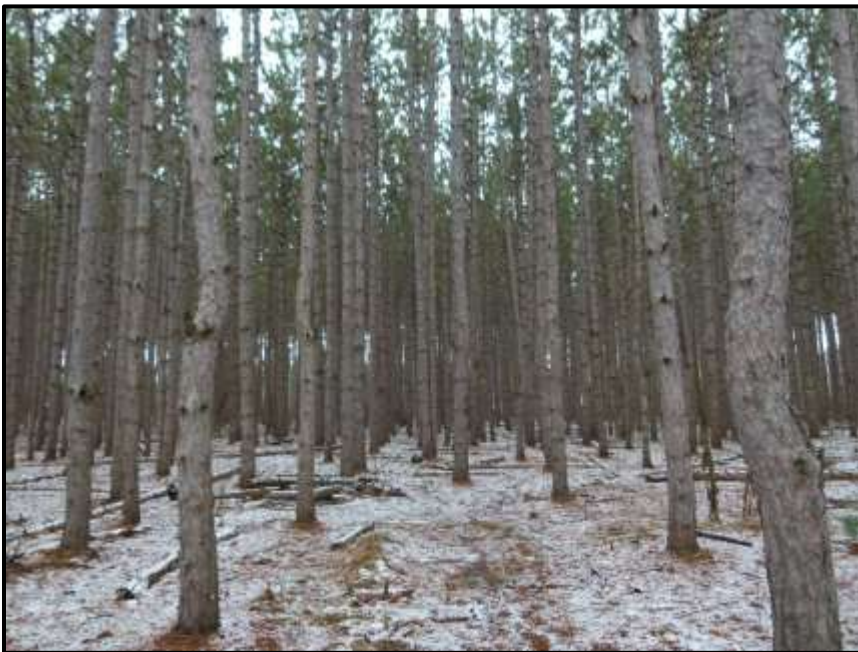
Photograph 4: Interior of the Red Pine Plantation in the western part of the Site. Note the absence of shrubs and groundcover plants (December 3rd, 2020).

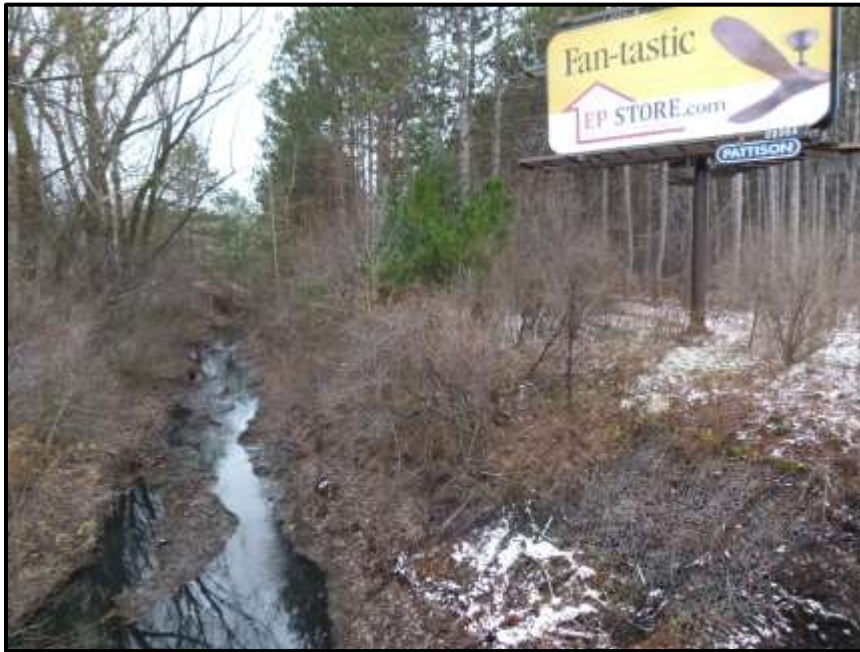
Photograph 5: Looking south along Hunt Club Creek from Hunt Club Road. The Red Pine Plantation at the eastern edge of the Site is visible at the right (December 3rd, 2020).

A segment of Hunt Club Creek is located to the east of the Site. The watercourse flows in a south to north direction and is channelized adjacent to the Site. As shown in Figure 1, Hunt Club Creek is entombed in underground piping to the north and south of the Site. The piping of Hunt Club Creek is such that the segment of the creek that occurs east of the Site does not directly connect to adjacent natural watercourses. The Rideau Valley Conservation Authority (RVCA) conducts monitoring of Hunt Club Creek as part of their City Stream Watch Program. The RVCA identifies the catchment of Hunt Club Creek as being predominantly urbanized, with only 16.7% of the catchment forested (RVCA 2019). No wetlands are shown to exist within the Hunt Club Creek catchment. The watercourse is highly degraded and channelized throughout the majority of its length, including the segment of the watercourse which occurs east of the Site. No Species at Risk (SAR) were noted by the RVCA within the creek, and the RVCA describes the watercourse as being comparatively polluted and impacted by garbage and siltation (RVCA 2019). Only three (3) fish species have been documented within Hunt Club Creek by the RVCA monitoring program between 2007 and 2019. These include Brook Stickleback, Pumpkinseed, and Bluegill. Each of these species is common throughout the Ottawa area, and each is highly tolerant of disturbed environments. As described below in Section 4.2.1, a 15 m wide setback from Hunt Club Creek will be maintained during the development of the Site. This matches the 15 m wide setback which was approved for the opposing bank of the watercourse in 2016. Refer to Section 4.2.1 for additional detail.
