Muncaster  
Environmental  
Planning Inc.

**RE: Leikin Lands, South Merivale Business Park, Nepean  
Tree Conservation Report and Environmental Impact Statement**

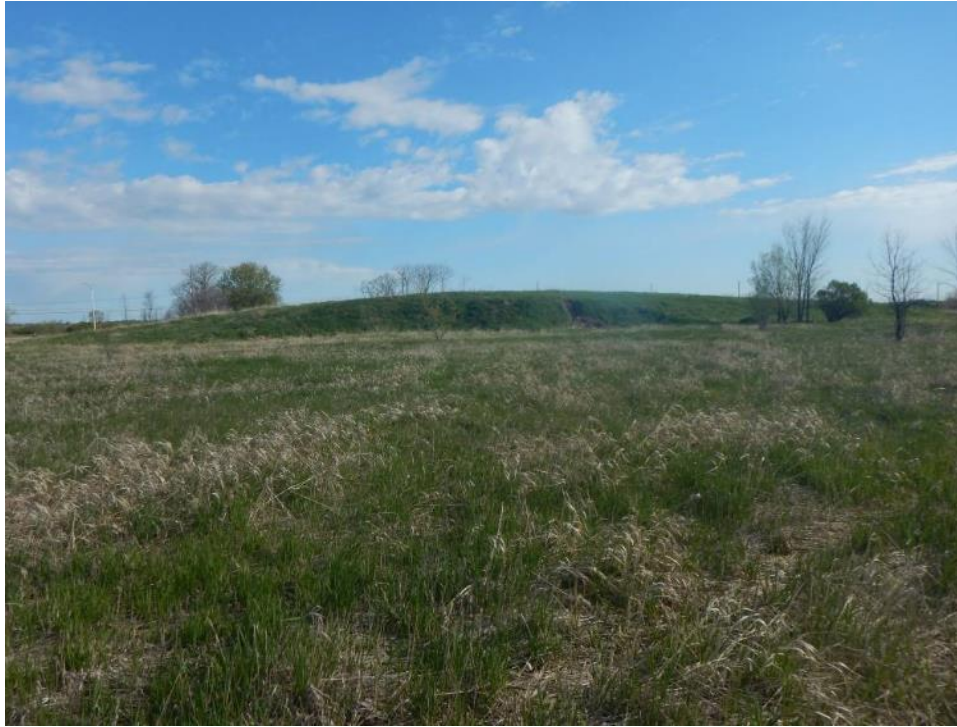
The terrain is relatively flat with the exception of what appears to be large, now grassed, spoil piles in the cultural meadow habitat in the southwest portion. The majority of this cultural meadow is dominated by grasses, such as June meadow grass, reed canary grass, orchard grass, timothy, poverty oat grass, and common manna grass, with more broad-leaved plants such as wild carrot, wild parsnip, Canada thistle, bull thistle, wild carrot, field mustard, common ragweed, bird's-foot trefoil, common burdock, chicory, common milkweed, tufted vetch, wild parsnip, common dandelion, curled dock, red clover, and Canada and early goldenrod, appearing in the eastern portion (Photo 1). Regenerating white elm, Manitoba maple, and white ash, along

*Photo 1 – Cultural meadow habitat dominates the south portion of the site. View looking west*

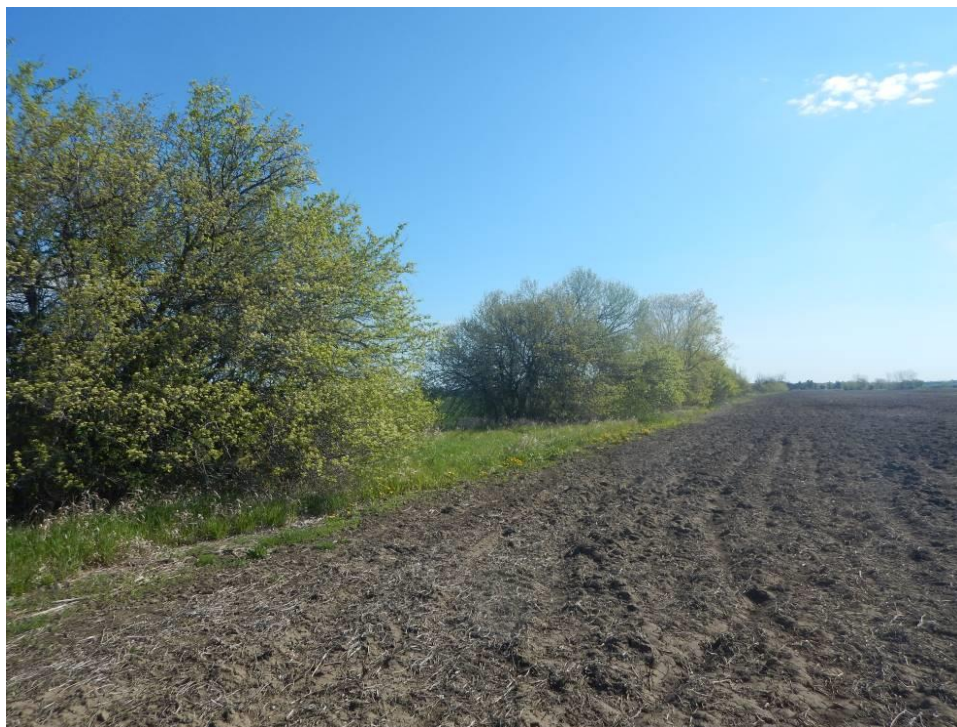
A few white ash and Manitoba maple, as large as 30cm diameter at breast height (dbh) but most much smaller, are scattered along the north site edge. Many of the ash appeared dead. Common buckthorn, hawthorn, and willow shrubs are also in this intermittent hedgerow, noted as 'Windrow 2' on Map 1 (Photo 2). Bur oak and basswood are in the west-central portion of the site, labelled as 'Windrow 4' on Map 1 (Photo 3). The larger bur oaks are between 55cm and 80cm dbh. Smaller basswood stems and nannyberry, Japanese barberry, chokecherry, and common buckthorn shrubs are also present. A small cultural thicket inclusion composed of common buckthorn, and slender and pussy willow shrubs, is to the south of 'Windrow 4' (Photo 4). Regenerating white ash stems are also present.

*Photo 2 – Scattered shrubs and small trees along the north site edge.  
View looking east*

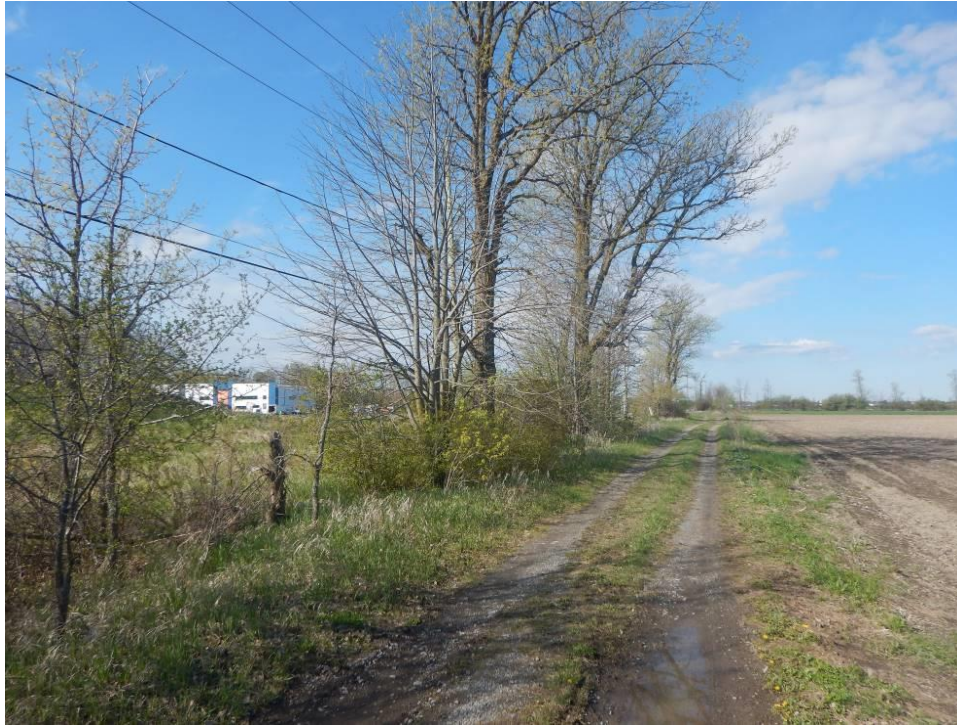
*Photo 3 – ‘Windrow’ 4 in the west-central portion of the site. View looking west*

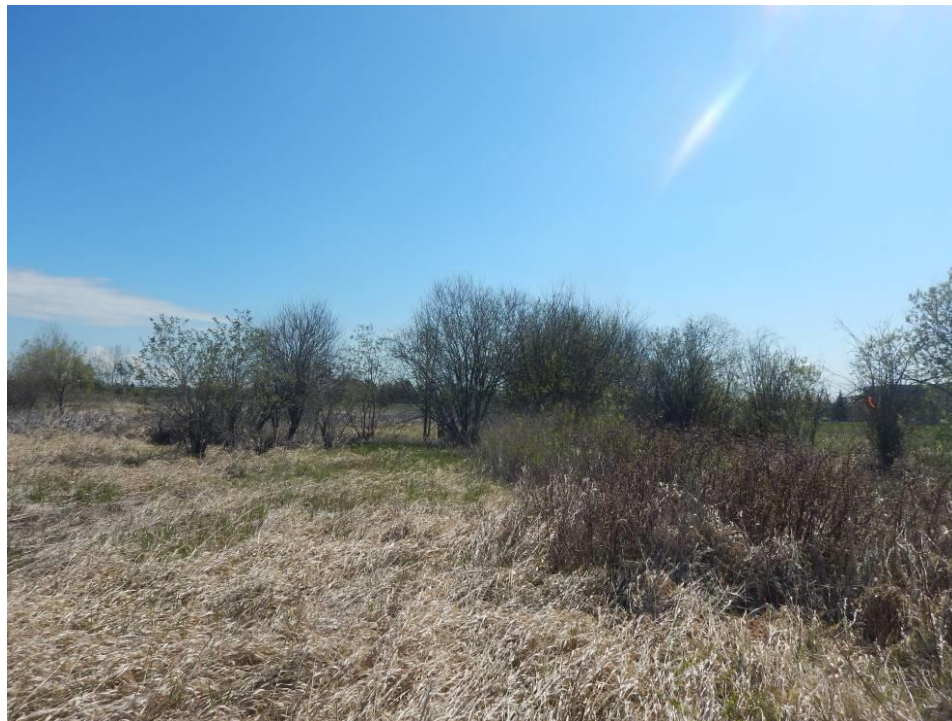
*Photo 4 - Small area of cultural thicket in the west-central portion of the site south of ‘Windrow 4’. View looking north*

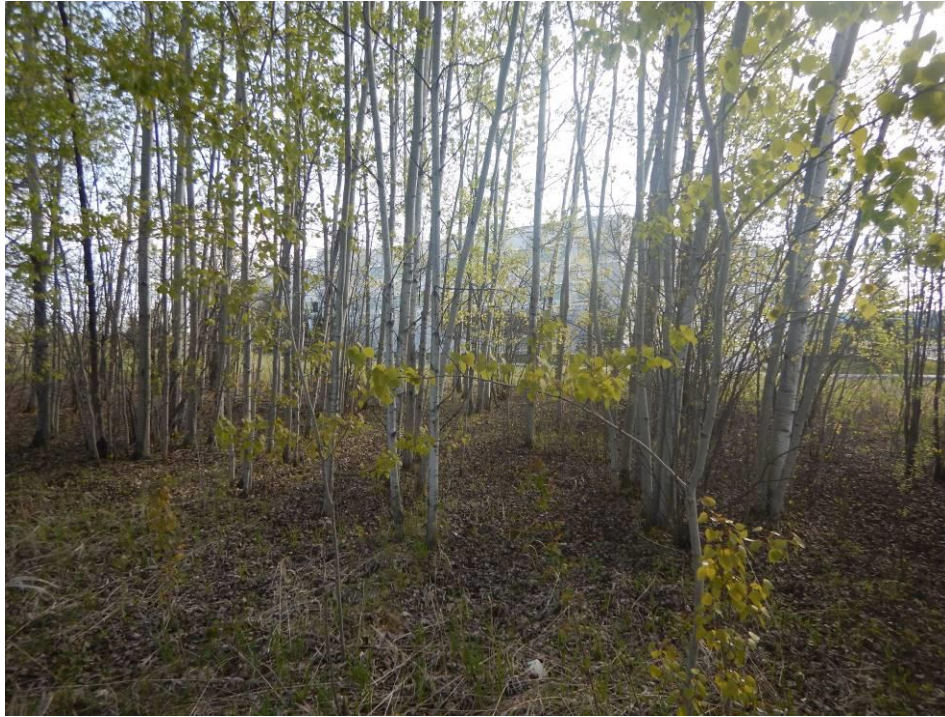
A small corpse dominated by trembling aspen with bur oak common is in the southwest corner of the site. This area is shown as a bur oak/trembling aspen inclusion on Map 1. Most trees are in the 10cm – 20cm dbh range (Photo 5), with a few larger trees present including a 37cm dbh white ash with potential wildlife cavities. The ash is in poor condition due to emerald ash borer. Three larger bur oaks are between 50cm and 66cm dbh and appear to be in better condition. Smaller basswood and white elm are also present, along with willow, tartarian honeysuckle, and red raspberry shrubs. Ground cover includes June meadow grass, Canada goldenrod, and common strawberry.

*Photo 5 – Trembling aspen and bur oak inclusion in the southwest corner of the site.  
View looking west*

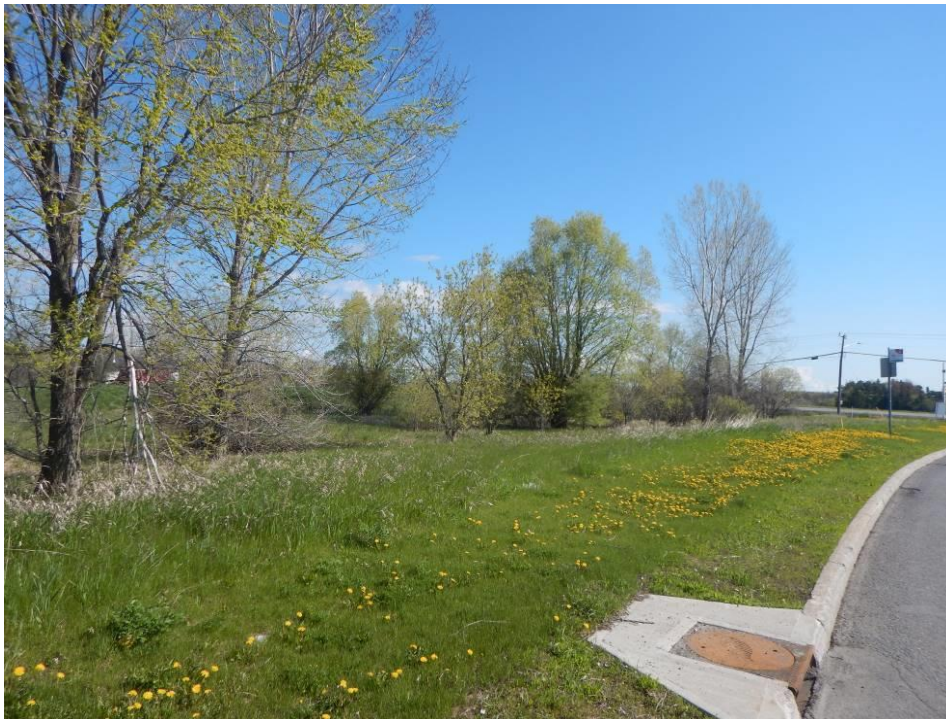
Trembling aspen, white elm, white spruce, and Manitoba maple, between 10 and 30cm dbh, are in other small treed areas in the south portion of the site (Photo 6). Slender willow shrubs are also present.

*Photo 6 - Small treed area along the east site edge. View looking north*

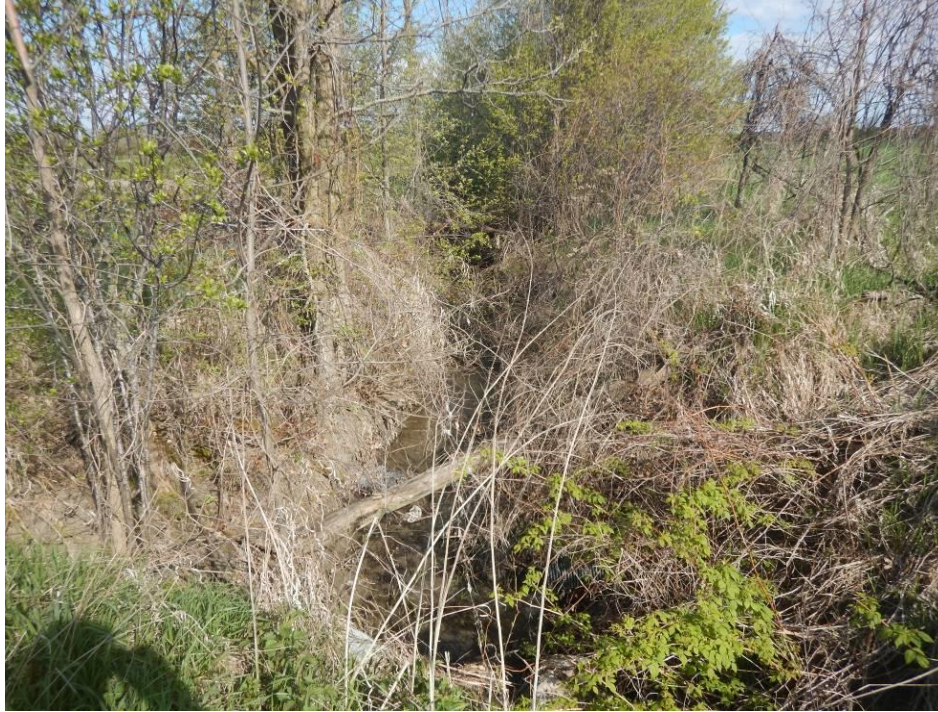
*Photo 7 – Watercourse to the west of the site. View looking north*

No significant natural heritage features, as defined in the Provincial Policy Statement, were observed on the site. The channel approximately 60 metres to the west of the site leads to the Clarke Bellingier Environmental (Stormwater Management) Facility and likely supports direct fish habitat. The maximum required setback distance from the channel would be 30 metres, with the site a greater distance to the east.

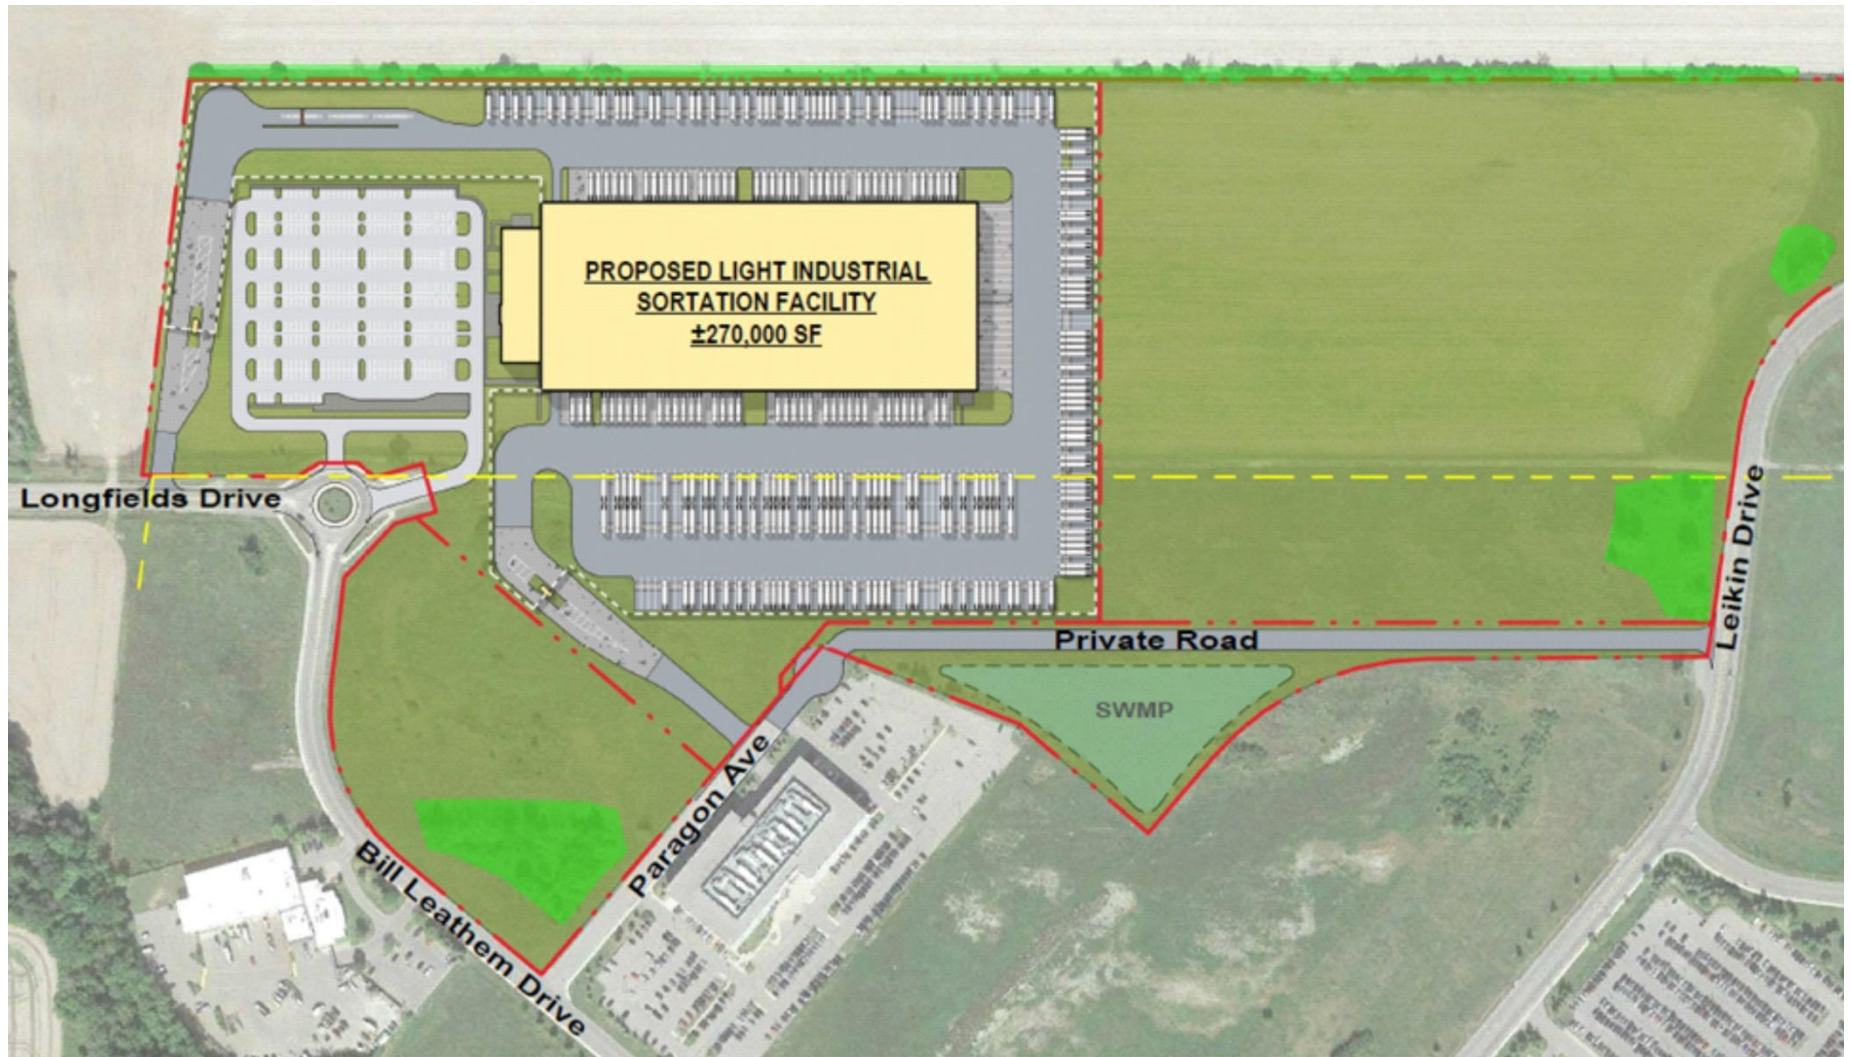
MAP 2 – SITE PLAN and INITIAL POTENTIAL TREE RETENTION

As shown on the Site Plan (Map 2), the proposed development consists of a light industrial use, and associated surface parking for trucks and employee vehicles. Access to the new facility will be off of the Longfields Dive and Bill Leatham Drive intersection, north from Paragon Avenue, and east through a proposed private road connecting to Leikin Drive. A stormwater management facility (detention only – dry pond) in the south-central portion of the site will control surface water.

Due to the adjacent roads and fields there are no adjacent trees with critical root zones that would extend onto the site. Where possible tree retention should be considered for healthy trees of desirable species such as bur oak and basswood along and adjacent to the site perimeter and Map 2 shows trees that will be retained at this time. Some of these trees may be removed in the future if additional development occurs on the site.

Potential Tree Retention  
(at this time)

1. Trees to be retained are to be protected with sturdy temporary fencing at least 1.3 metres in height installed from the tree trunk a minimum distance of ten times the retained tree diameter (the critical root zone). Signs, notices or posters are not to be attached to any tree. No grading, heavy machinery traffic, stockpiling of material, machinery maintenance and refueling or other activities that may cause soil compaction to occur within five metres of the critical root zone of the trees to be retained and protected. The root system, trunk or branches of the trees to be retained are to be protected and not damaged. If any roots of trees to be retained are exposed during site alterations, the roots shall be immediately reburied with soil or covered with filter cloth, burlap or woodchips and kept moist until the roots can be buried permanently. A covering of plastic should be used to retain moisture during an extended period when watering may not be possible. Any roots that must be cut are to be cut cleanly to facilitate healing and as far from the tree as possible. Exhaust fumes from all equipment during construction will not be directed towards the canopy of retained trees.
