### **Geotechnical Investigation**

**Proposed Sortation Facility** Leikin Drive and Merivale Road Intersection Nepean, Ontario

Medusa LP

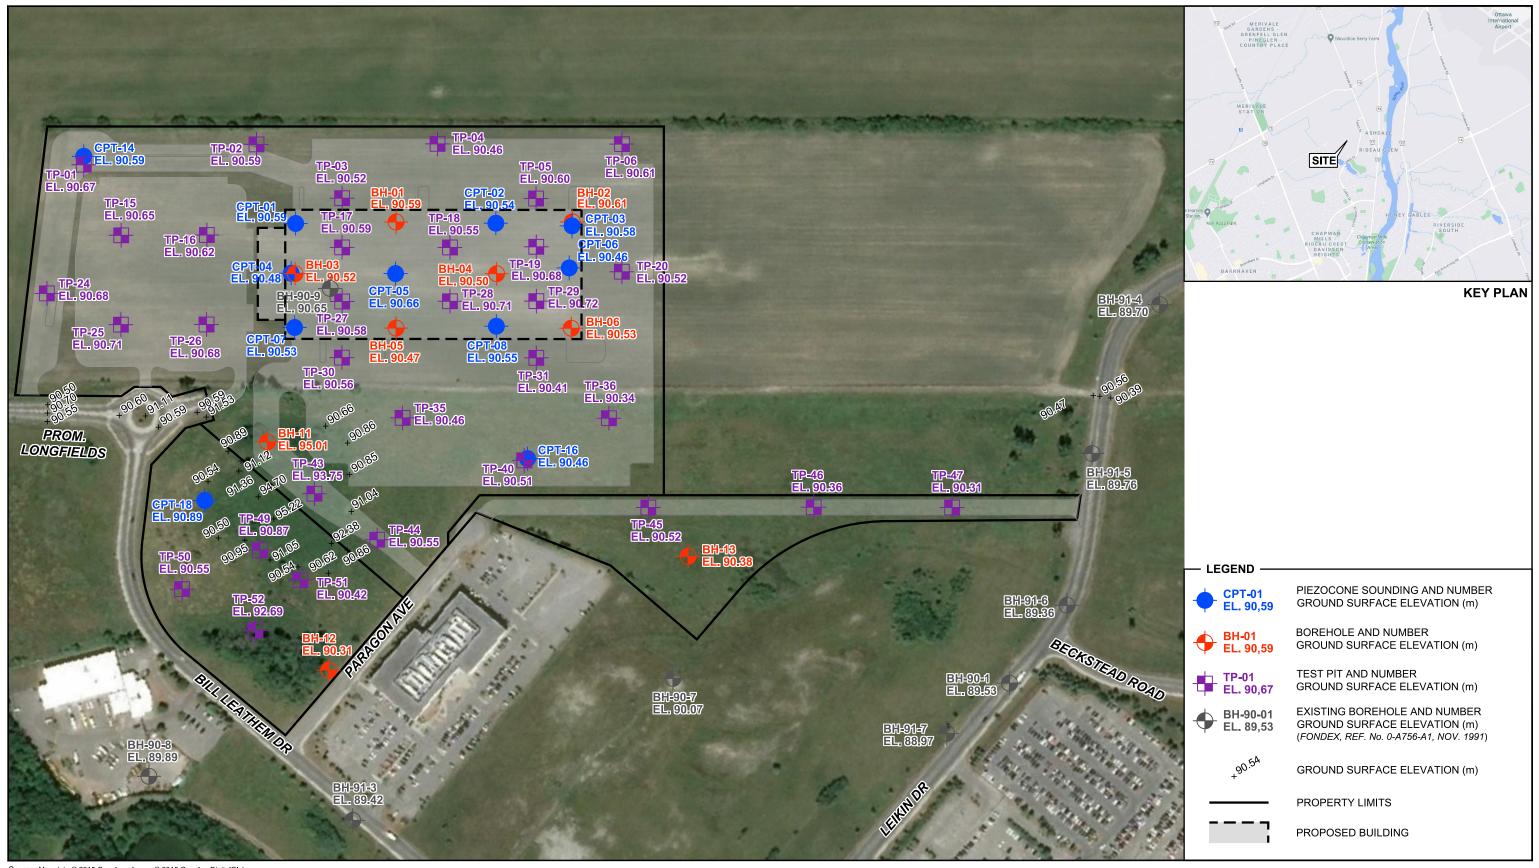
# Appendix A Site Location Plan (Drawing No. 11227097-A1-1)

SCALE = 1:3000       0     30     60     90m       BENCHMARK:       RTCM-REF 3696 (GPS Antenna)       EL. 98.527m (Geodetic)	DRAWN BY: T. NGUYEN / I. CARON CHECKED BY: MA. RICHARD	GHD	MEDUSA LP LEIKIN DRIVE AND MERIVALE ROAD I PROPOSED SORTATION FACILITY GEOTECHNICAL INVESTIGAT SOUNDING LOCATIONS
--	---	-----	---

The drawing N<sup>o.</sup> 11227097-A1-1A, presented in the Appendix A of this report, illustrates current site conditions, proposed building and exterior asphaltic and concrete structure configurations as well as the location of the various investigative soundings completed by GHD.

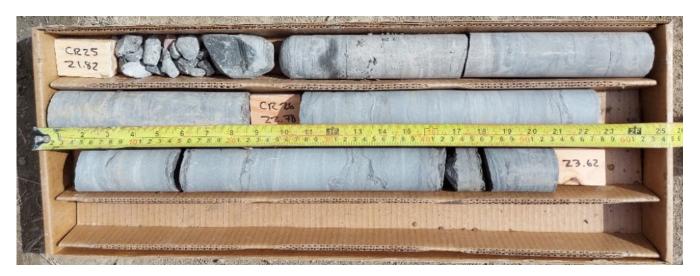
Photo 1 : BH-02 Core box – Dry rock

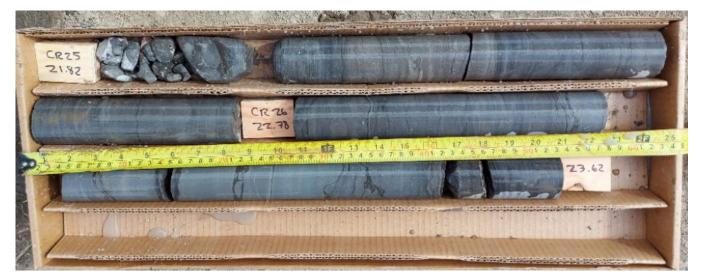
Photo 2 : BH-02 Core box – Wet rock

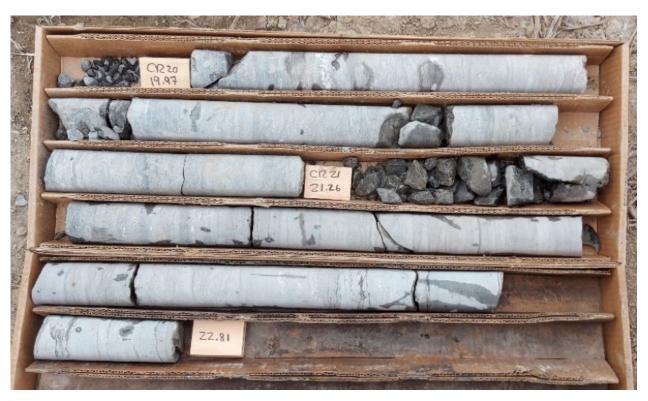
Photo 3 : BH-03 Core box – Dry rock

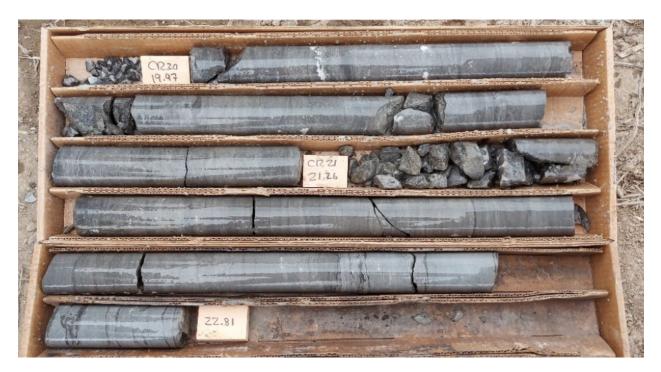
Photo 4 : BH-03 Core box – Wet rock
