Site Servicing and Stormwater
Management Brief – Mooney's Bay -
729 Ridgewood Avenue, Ottawa, ON

File: 160410536/83

June 9, 2021

Stantec Consulting Ltd.

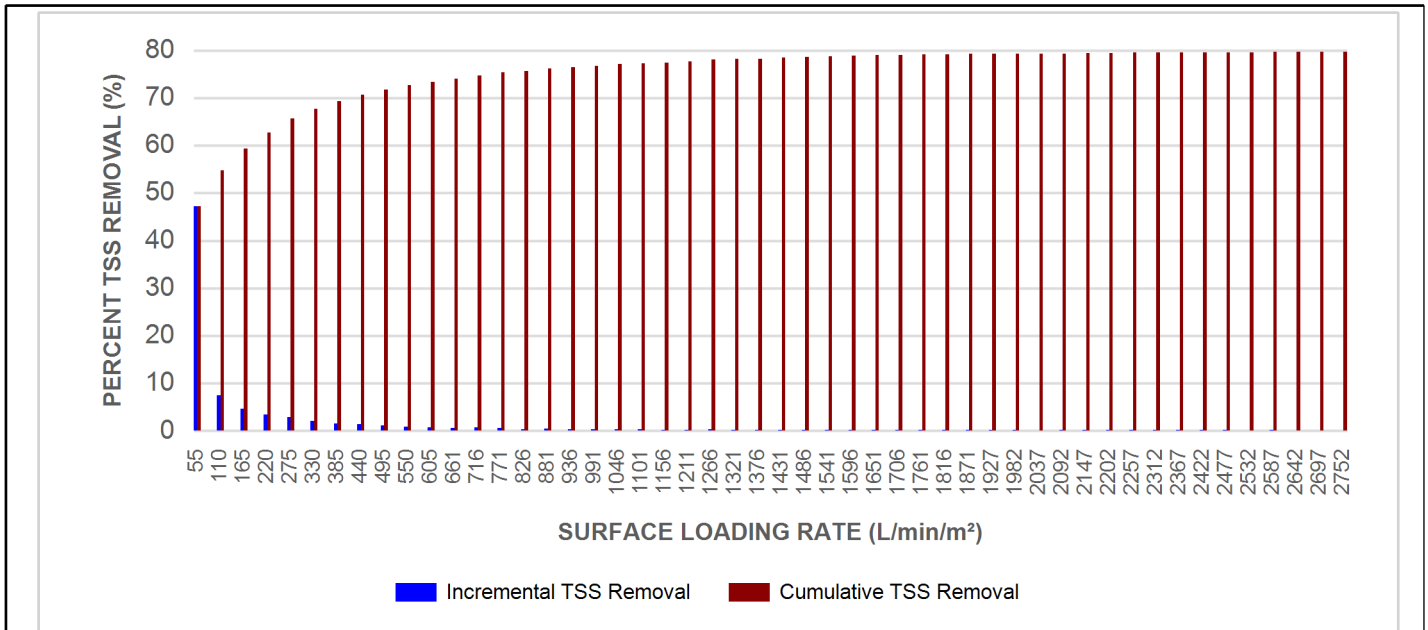
INCREMENTAL AND CUMULATIVE TSS REMOVAL FOR THE RECOMMENDED STORMCEPTOR® MODEL

The online software available for Stormceptor sizing was used to size a unit capable of providing the required TSS removal. A drainage area of 0.72 ha (i.e., surface parking and access areas) with an imperviousness of 50% resulted in a Stormceptor EF4 which can provide 80% TSS removal. It should be noted that the Stormceptor Unit has been provided as an example and that an approved equivalent unit can be used during construction subject to approval. Stormceptor sizing information has been provided in **Appendix D**.
