Phase One Environmental Site Assessment

729 Ridgewood
Avenue
Ottawa, Ontario

Prepared for:
11684663 Canada Inc.

July 27, 2020

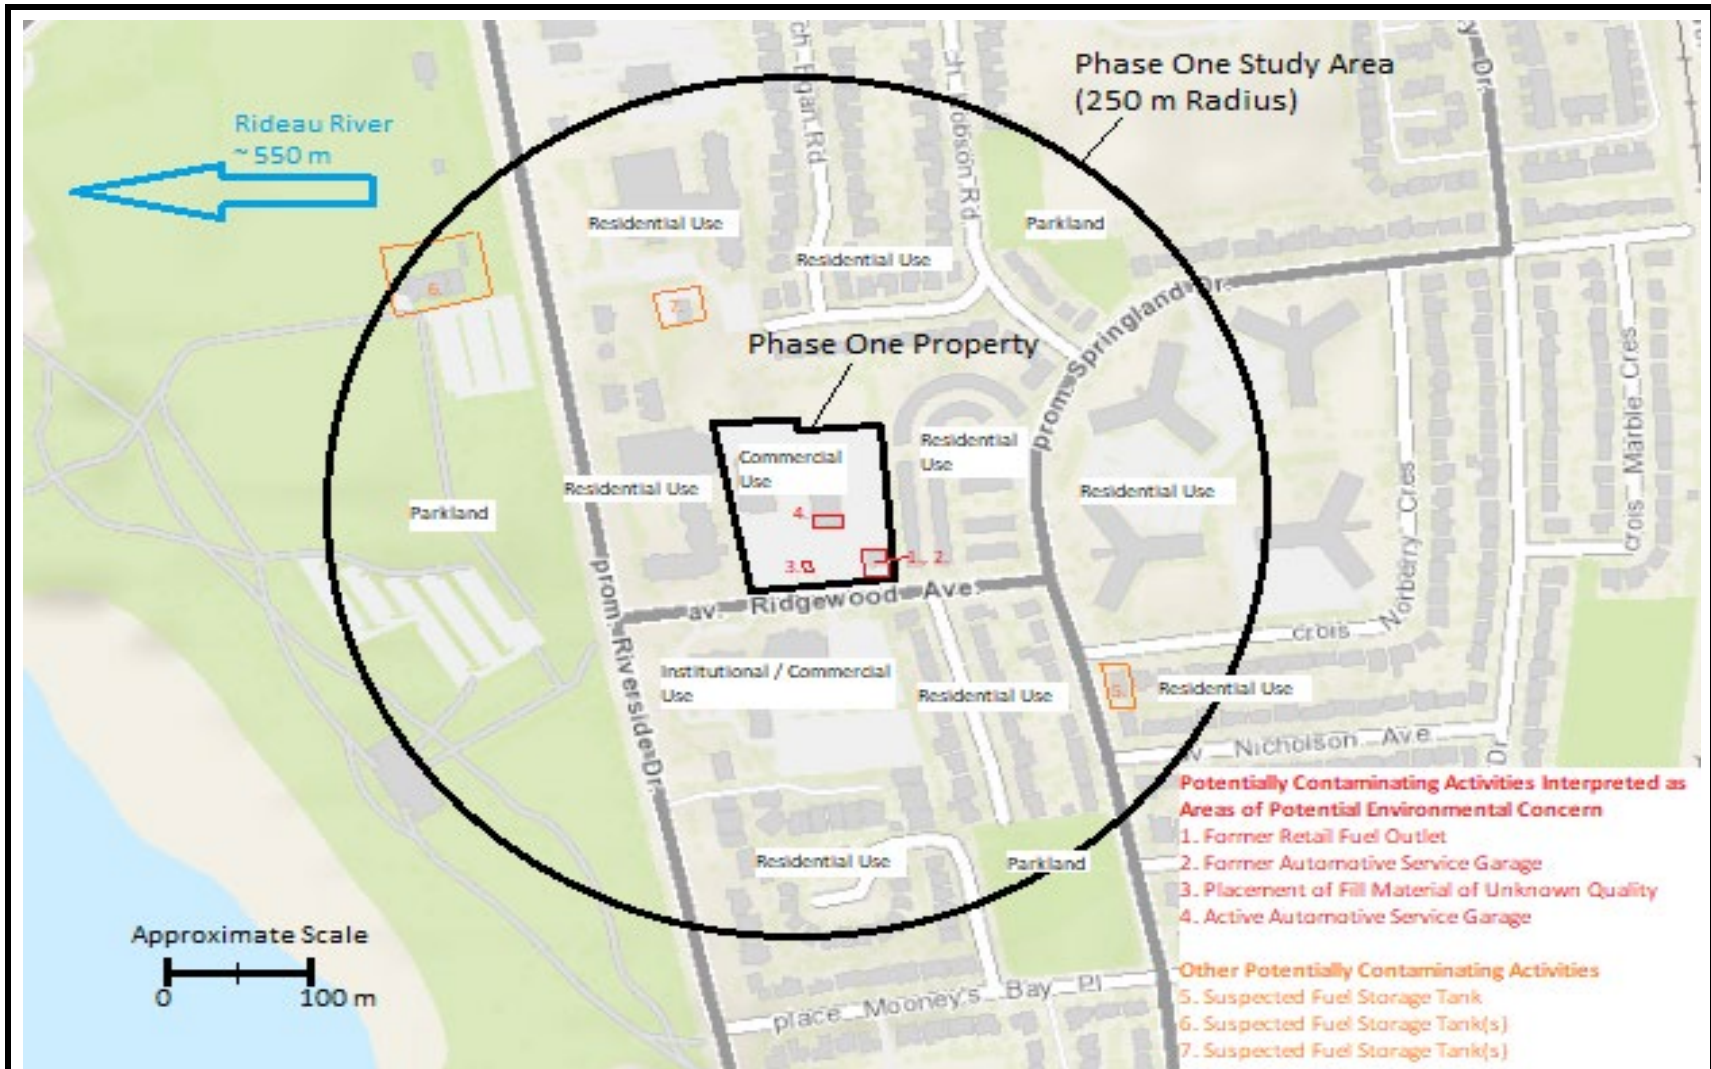
Figure 3: Surrounding Land Use
Phase One Environmental Site Assessment
729 Ridgewood Avenue, Ottawa, Ontario
11684663 Canada Inc.

Neighbouring land uses are shown on Figure 3: Surrounding Land Use. No indications of PCAs were observed during the review of land use in the Phase One Study Area. The current uses of the neighbouring properties are not considered to represent any APECs for the Phase One Property.

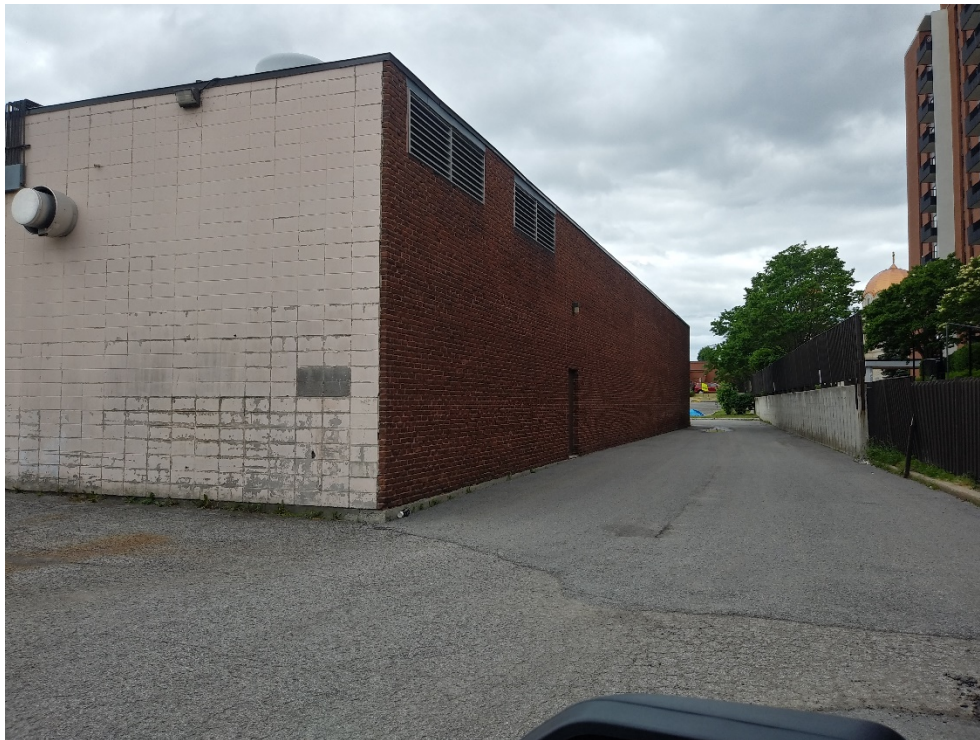
Photograph 4: View of the west side of the Phase One Property looking south. View shows the west side of the north commercial building.

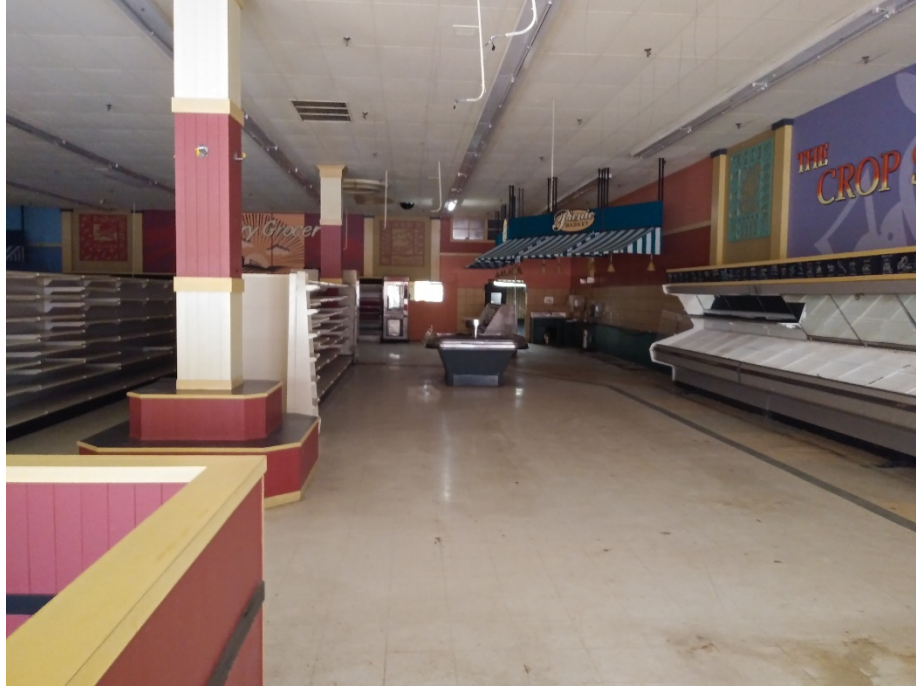
Photograph 11: View of interior of the former grocery store in the northwest portion of the north commercial plaza building.

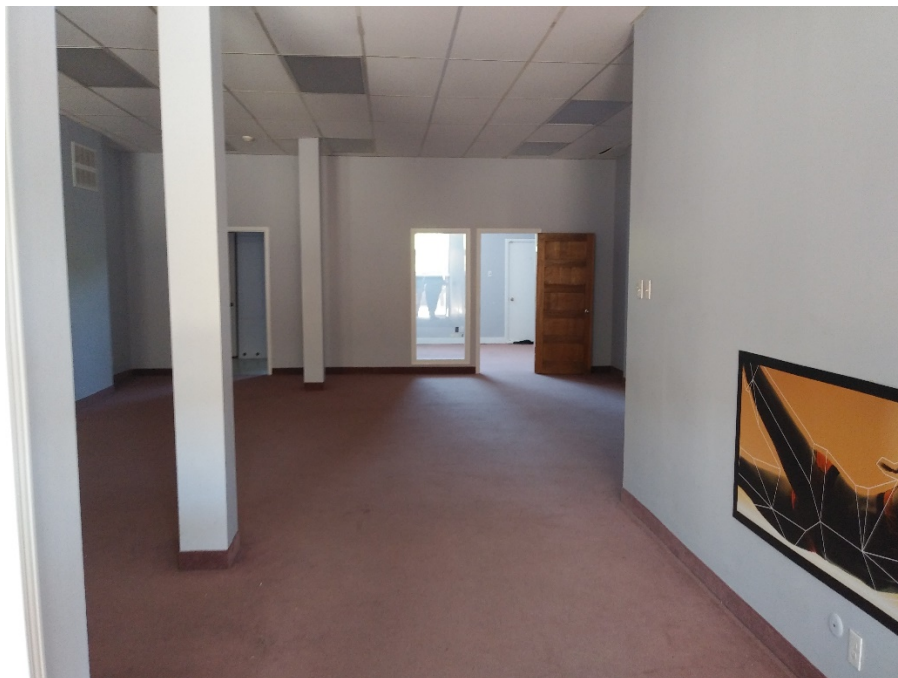
Photograph 12: View of the interior (typical) of one of the commercial units in the north commercial plaza building.
