Phase I Environmental Site Assessment

1354 and 1376 Carling Avenue
Ottawa, Ontario

Holloway Lodging Corporation

Report: PE3896-1

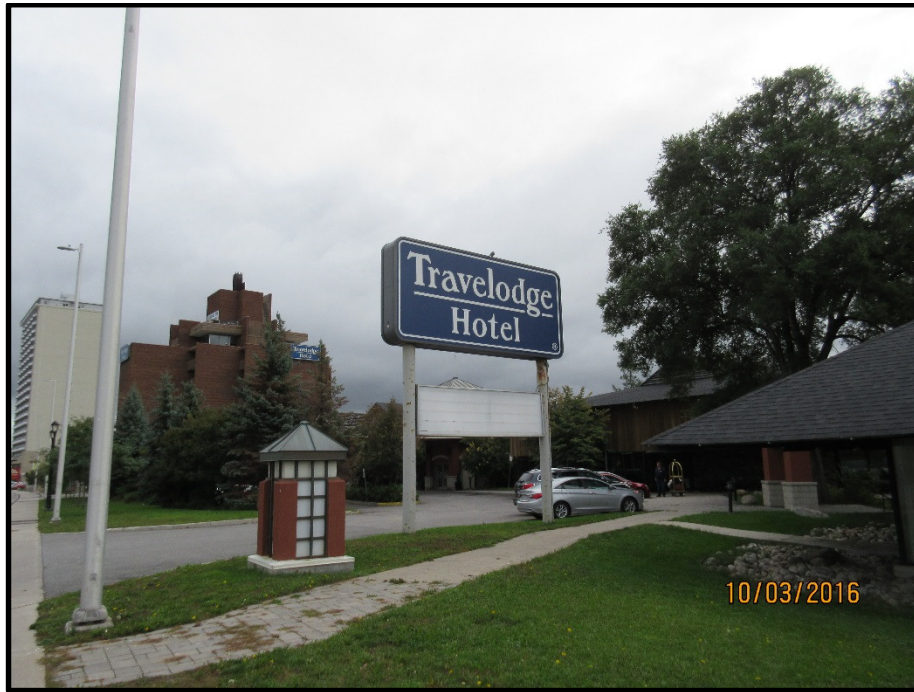
Photograph 1: View of northwest portion of Phase I Property, facing east-southeast.

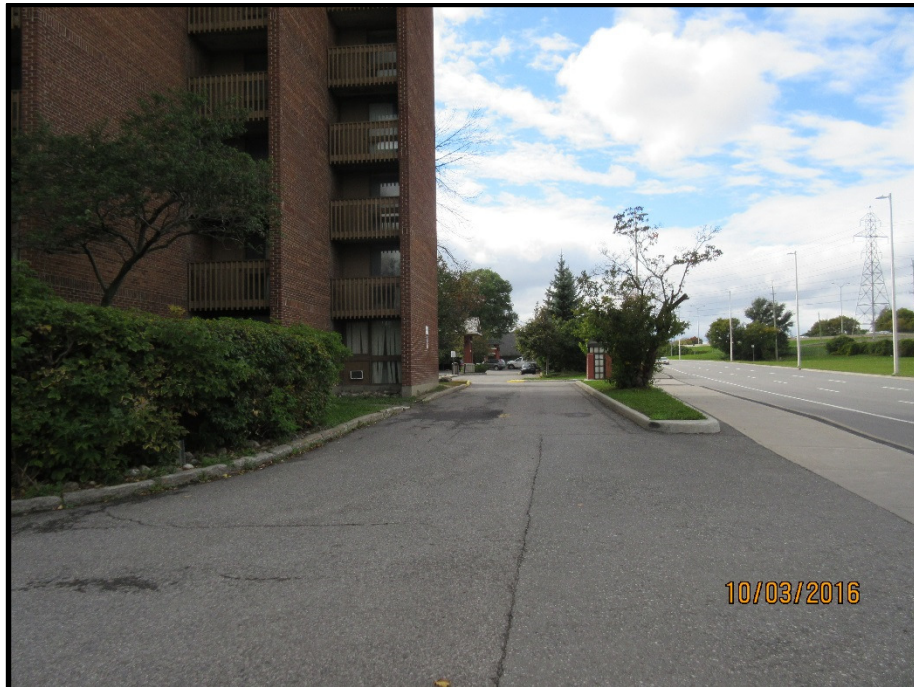
Photograph 2: Photograph shows condemned tower on northeast portion of Phase I Property, facing west.

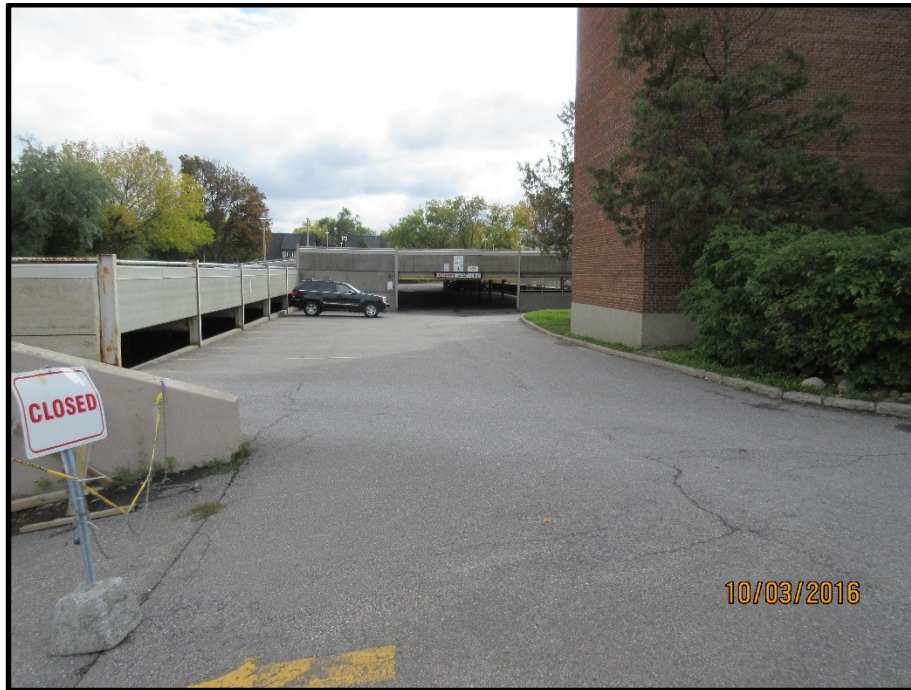
Photograph 3: Photo illustrates the eastern portion of the tower and the parking structure on the northeast corner of the Phase I Property, facing south.

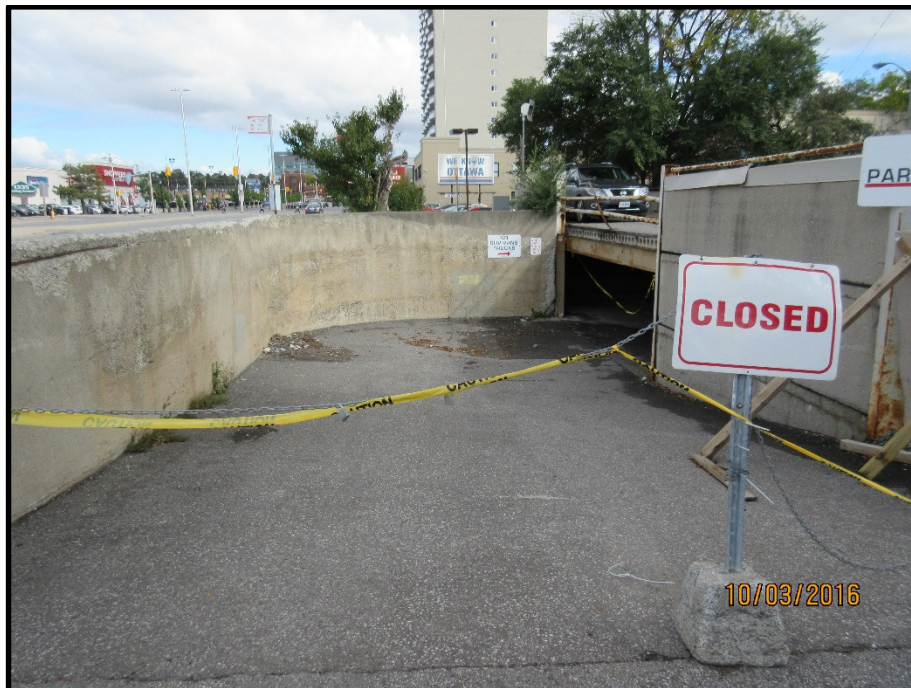
Photograph 4: Photo illustrates the entrance to the parking structure as well as the commercial properties to the east and northeast of the Phase I Property, looking east.

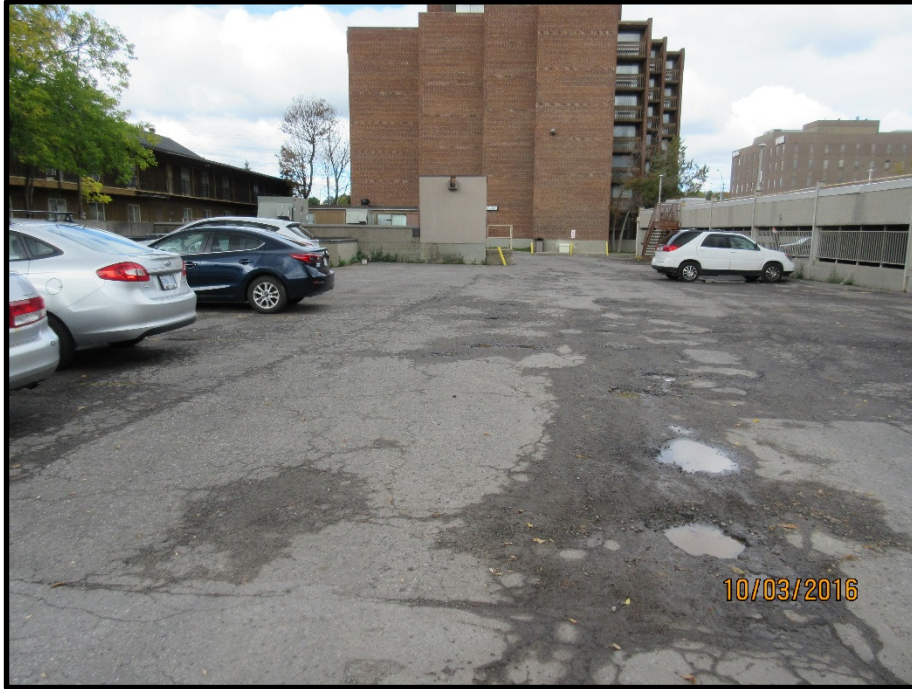
Photograph 5: Photo illustrates the southeastern portion of the Phase I Property. Photograph illustrates the south face of the tower, the above-grade portion of the former Centennial Ballroom, and the east-face of the guest rooms in the original portion of the hotel complex, facing north.

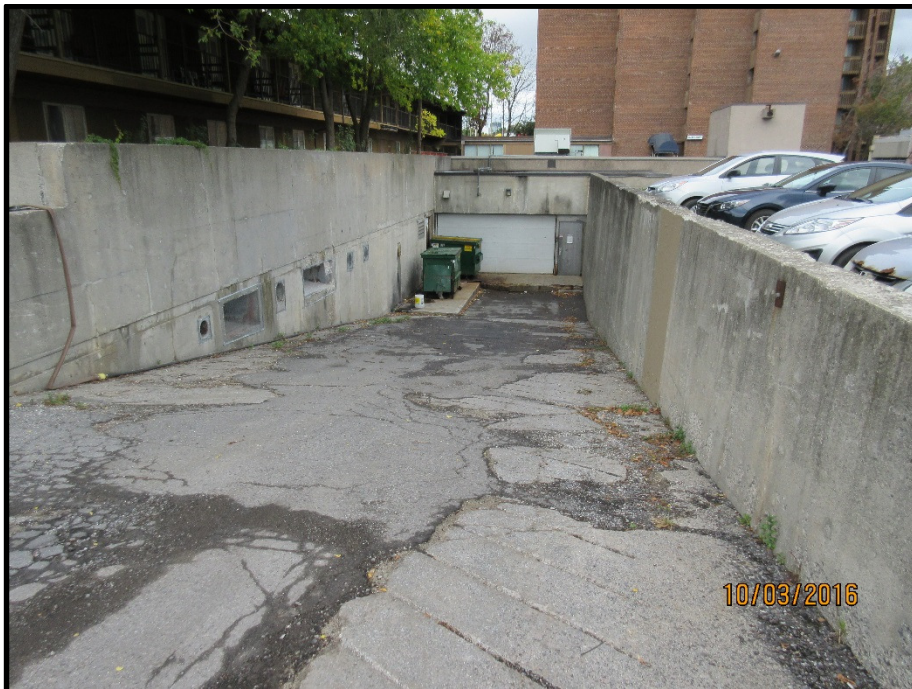
Photograph 6: Photo illustrates the access ramp to the shipping and receiving area, south of the former Centennial Ballroom, facing north.

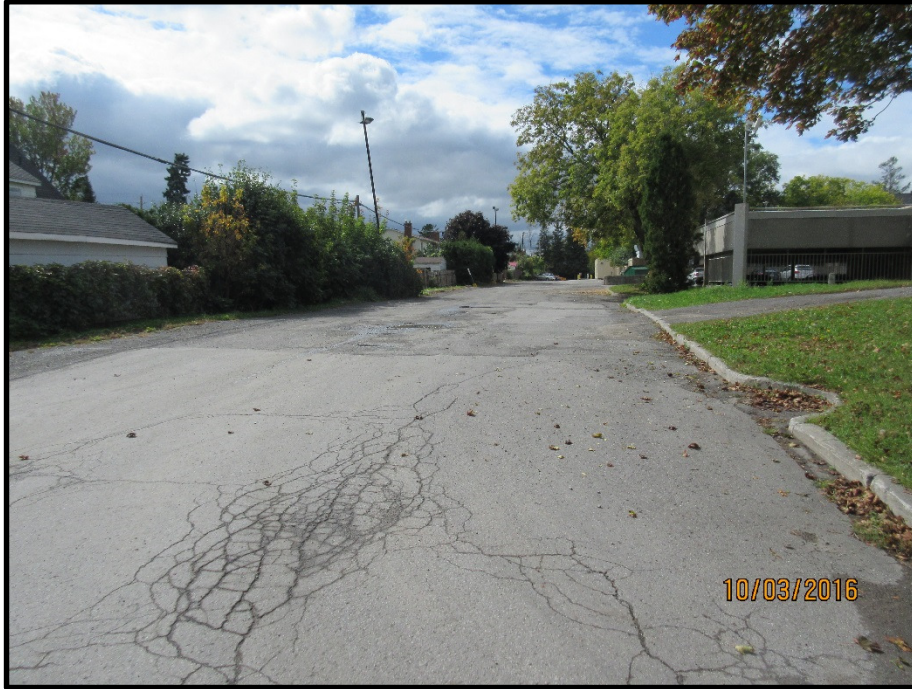
Photograph 7: Photo illustrates the access laneway on the southernmost portion of the Phase I Property, as well as the residential properties to the south, facing west.

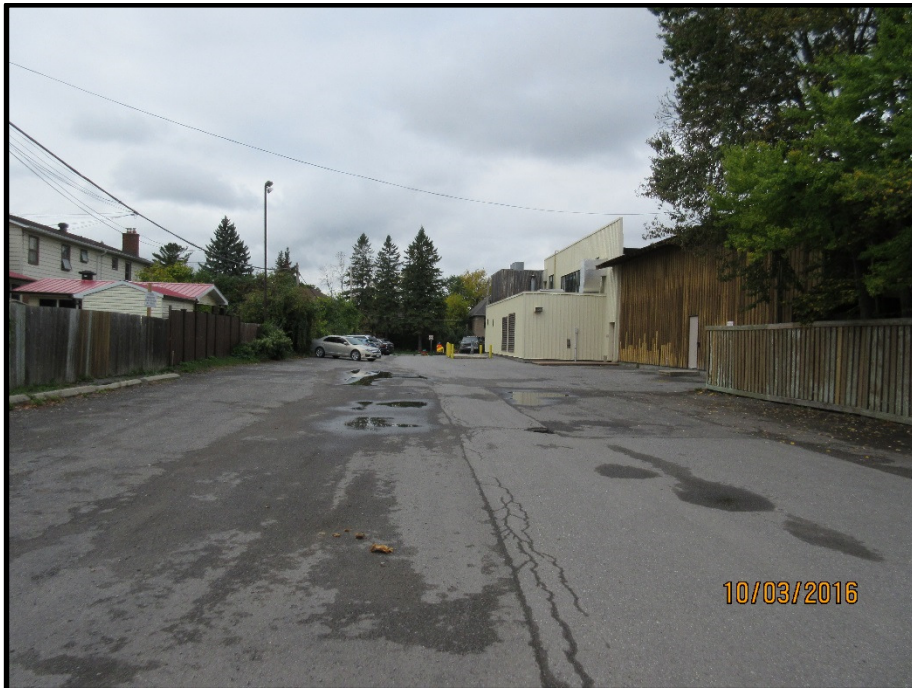
Photograph 8: Photo illustrates the access laneway on the southernmost portion of the Phase I Property, further west of Photograph 7. The location of the interior waterpark and storm water tank (concrete pad surrounded by bollards) can be seen.

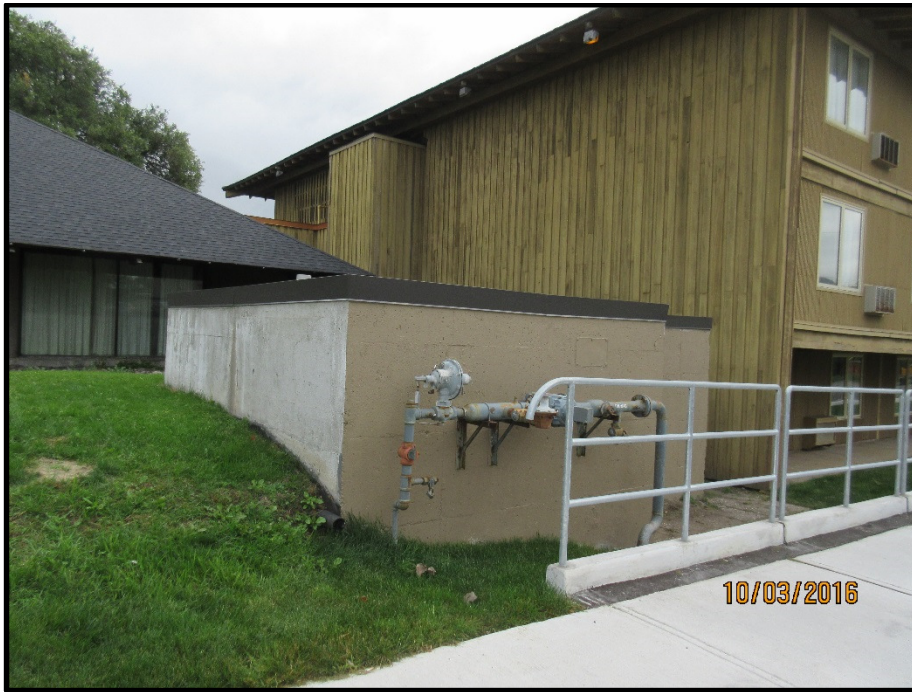
Photograph 9: Photograph illustrates southernmost access to the basement level, situated along Meath Street, facing east-southeast.

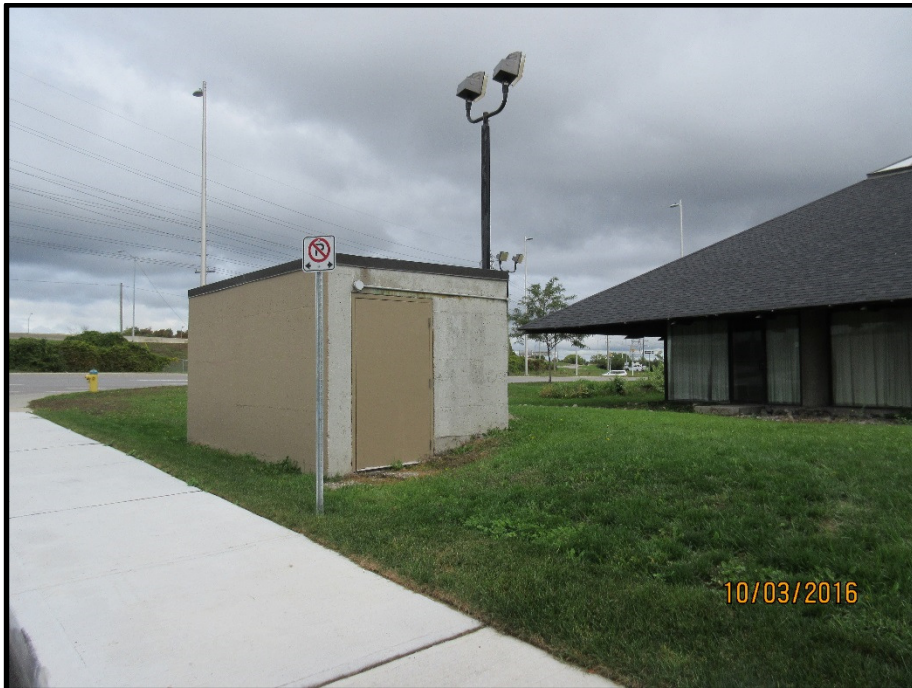
Photograph 10: Photograph illustrates northwest corner of Phase I Property and exterior access to basement of the Beachcomber (former nightclub), facing northeast.

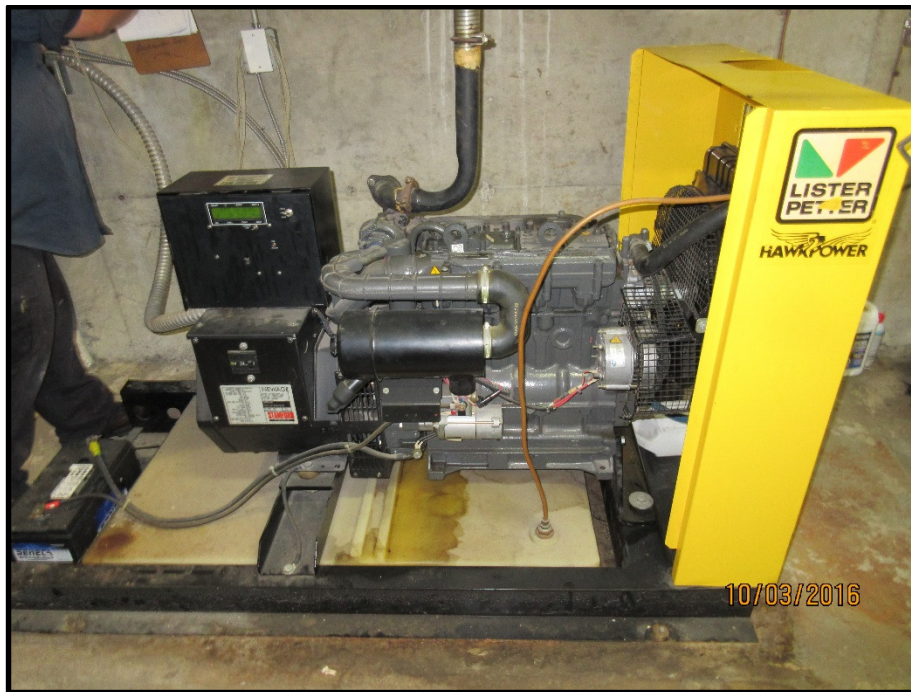
As mentioned above, a small diesel generator with a sub-base diesel tank, was present in the mechanical room of the Beachcomber. Minor staining was observed on the concrete floor in the vicinity of the generator; the floor slab was in good condition with no potential migratory pathways.

Photograph 11: Photograph illustrates diesel generator in the Beachcomber mechanical room.

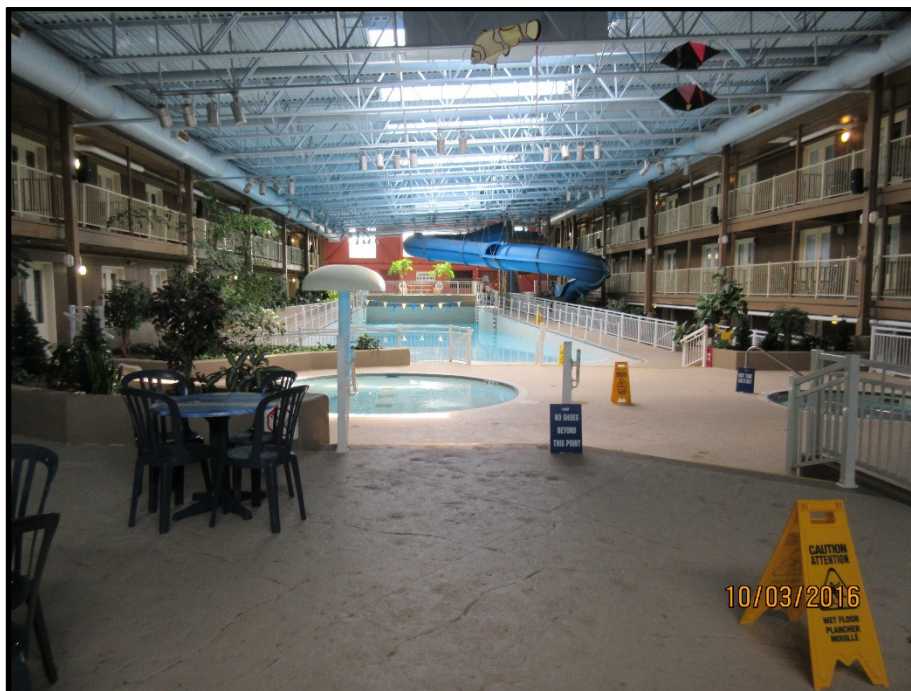
Photograph 12: Photograph illustrates former exterior in-ground pool area which has been retrofitted as an interior water park.

Other than the aforementioned underground utilities, catch basins and storm water storage tank associated with the private sewer system, there was no evidence of belowground structures observed on the exterior of the Phase I Property at the time of the site visit. Drawings reviewed in conjunction with the site visit indicate that the storm water storage tank is situated approximately 2.1 m below grade and has a volume of 30.2 m³ or 30,200 L. Tank construction details were not available for review. As noted above, a former in-ground pool within the existing garden area, has been in-filled.
