PHASE TWO ENVIRONMENTAL SITE ASSESSMENT

University of Ottawa
Eastern Portion of 200 Lees Avenue,
Ottawa, Ontario

FINAL REPORT

Project No. 1329-1102
December 9, 2011

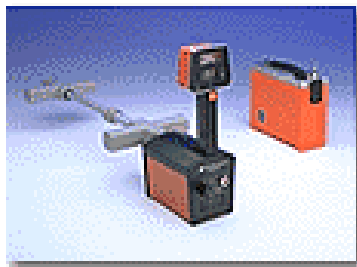
- An electromagnetic (EM) survey using an EM locator device, commonly referred to as a pipe and cable locator, is an industry standard. This device may be used either in an active or passive mode. Several companies make EM locators, as the technology is in common practice. The EM locator is fairly simple to use and should be available in most regions. A typical pipe and cable locator is shown below (receiver on the left and transmitter on the right).

- In active mode a transmitter induces an EM signal directly into a line which radiates and can be traced with a receiver unit. If the utility line is accessible, the needed signal may be created through a physical connection to the utility or it may be created by induction through a clamp or coil on the line (see below). Active mode is used for accessible, known lines, since some type of attachment is needed. “Tracer wires” are sometimes buried with utilities. As part of this protocol, the PM and locator service should always confirm if they exist through evaluation of site maps and direct questioning of the site operator. If so, a direct hookup can be made and a more accurate locate performed. When looking for lines that are unknown, an alternative “passive” method is needed.

- Passive mode operates in a similar fashion, except that it detects the 50 Hz or 60 Hz typical of AC power lines. A direct connection to the line is not made; this mode is useful in detecting unknown electrical lines where current is flowing. Where practical, all lines at the site should be energized (e.g. turn lights on, etc.) when performing this method. If energized, this approach may be useful for locating electrical lines below concrete with rebar.

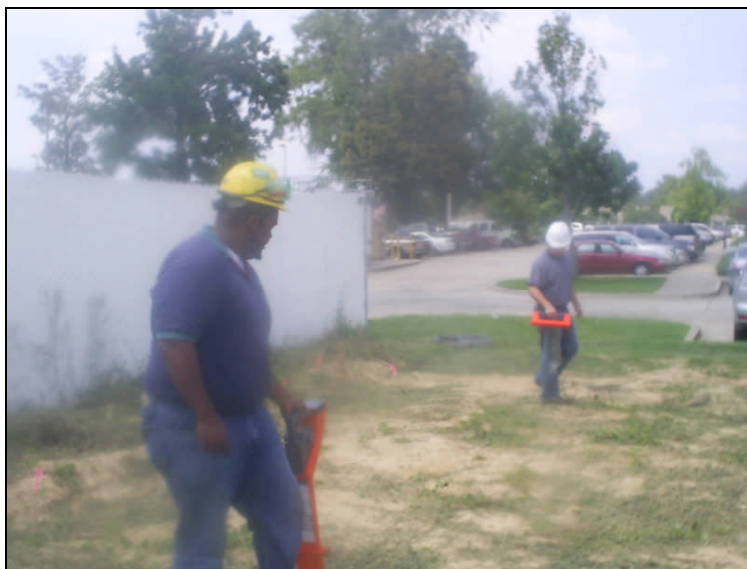
- For electrical lines that are not energized or for other conductive utilities, a transmitter can be carried in parallel to the detector (e.g. 15 feet/ 5 m apart) in a grid pattern to search for unknown utilities as shown in the picture below. This is sometimes referred to as “blind locating”. Although not as accurate as direct locates, this method should be deployed for purposes of identifying unknown utilities at all sites. Conductive materials such as rebar will interfere with this method. Also, note that the locators in the picture below are not wearing high visibility clothing as this is not an ExxonMobil job site. For clarification, high visibility clothing is required when performing locating procedures on ExxonMobil projects.

- Generally, for a point area, i.e. drilling location, an area 20-30 feet/ 6-9 m should be surveyed around the proposed location. Surveying a larger area allows the equipment to cross potential utilities multiple times and thereby increases the probability of detection. Usually a grid with 2-3 survey lines/paths is performed. For large area surveys, a similar methodology is deployed, with the survey extending out 20-30 feet/ 6-9 m beyond the area of excavation.

- The use of EM inductive locators usually allows for very accurate horizontal locations, but less reliable depths. Other limitations of this method include the fact that the utility must be conductive and, for active tracing, the utility must be accessible at some point for either direct or inductive coupling. In passive mode, the detector cannot locate electrical lines where current is not flowing. However, the blind locate method may detect the electrical line even without current.

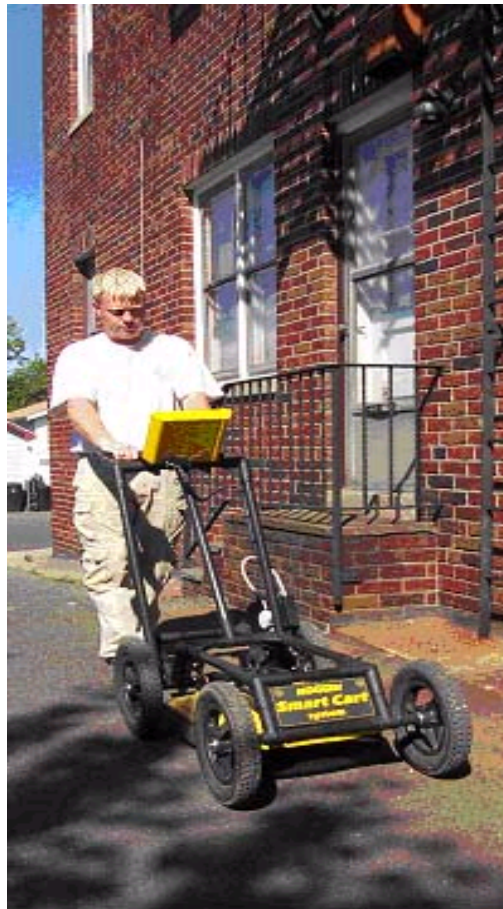
- GPR should be used in conjunction with a pipe and cable locator as an additional line of knowledge. GPR operates by transmitting an electromagnetic wave into the ground and detecting energy reflected back from objects with different electrical properties compared to the surrounding soil. GPR can detect both conductive and nonconductive utilities. Under appropriate operating conditions, GPR can provide a very accurate and rapid measurement of utility location and depth. GPR complements pipe and cable locator technology, especially where utilities are unknown (“blind” surveys). A typical deployment is shown below. Again, note that in the picture below the locator is not wearing high visibility clothing since this is not an ExxonMobil site. For clarification, high visibility clothing is always required when performing a survey at all ExxonMobil sites.

- Certain conditions can limit the usefulness of GPR data. The more conductive the ground, the less the GPR signal can penetrate before it is distorted to the point where no return signal can be detected. Void spaces, such as ground separation beneath concrete, can cause the loss of the GPR signal and rebar can dissipate the signal. Also, sites constructed with large amounts of 'fill material' can make interpretation of GPR results difficult. Brine-saturated soils, clays, and other conductive materials can inhibit the use of GPR to any useful depth. However, GPR has been used in the gulf coast of the US in high water table/clay conditions to identify shallow utilities. Since GR incidents typically involve a depth shallower than 3 feet, GPR surveys should not be eliminated based on this factor alone.

- Generally, for a point area, i.e. drilling location, an area 20-30 feet/ 6-9 meters should be surveyed around the point. Usually a grid with 2-3 survey lines/paths is performed, but a "tighter" grid with more survey lines can be requested. Surveying a larger area allows the equipment to cross the utility multiple times and thereby increase the probability of detection. For large area surveys, a similar methodology is deployed, with the survey extending out 20-30 feet/ 6-9 meters beyond the area of excavation.

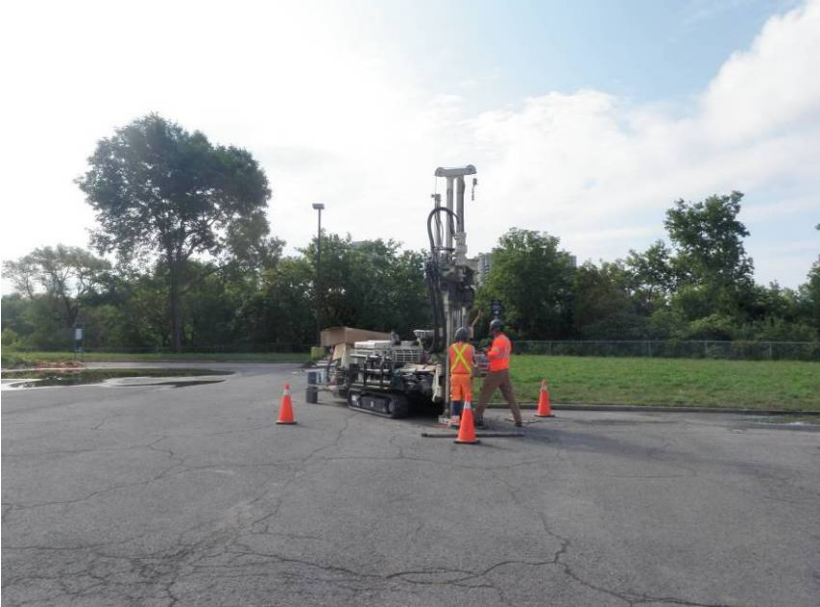
Phase Two ESA University of Ottawa (200 Lees Avenue, Ontario)		1329-1102
Photo ID 1

Date 10/08/11		
Direction SE		
Description Drilling FZ-BH11-1D.

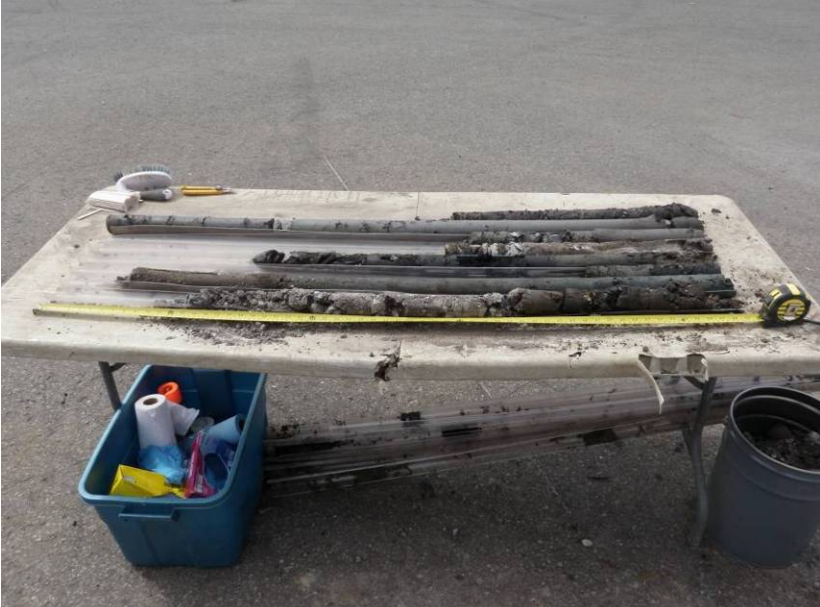
Phase Two ESA University of Ottawa (200 Lees Avenue, Ontario)		1329-1102
Photo ID 2

Date 10/08/11		
Direction N		
Description Soil cores collected from FZ-BH11-6D.

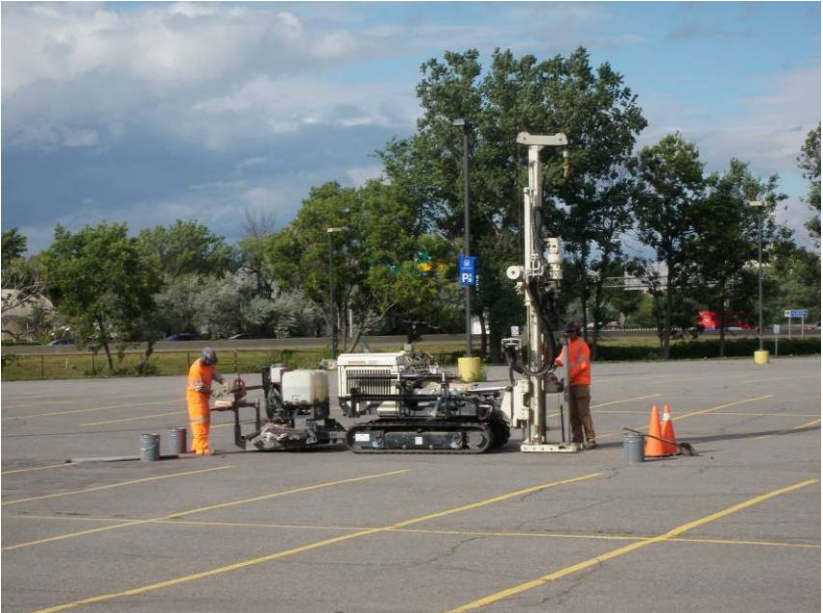
Phase Two ESA University of Ottawa (200 Lees Avenue, Ontario)		1329-1102
Photo ID 3

Date 11/08/11		
Direction E		
Description Drilling FZ-MW11-2.

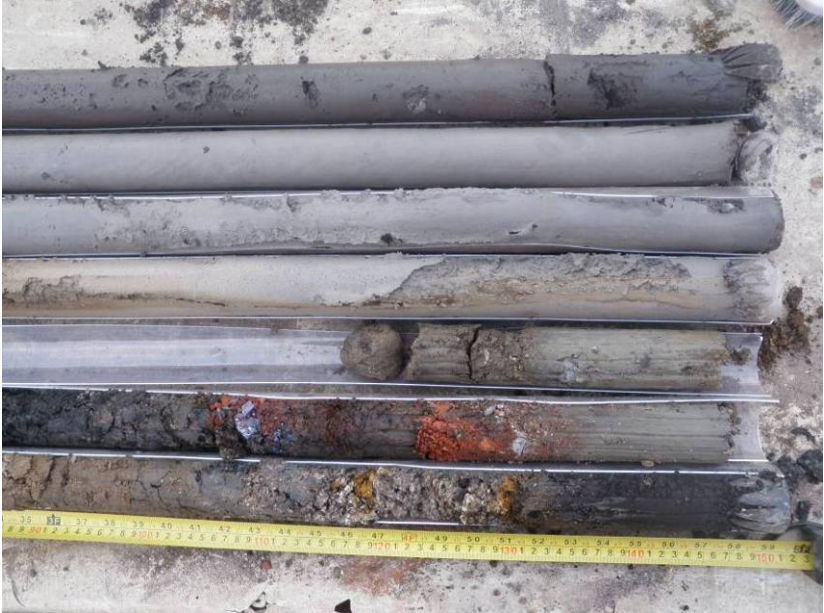
Phase Two ESA University of Ottawa (200 Lees Avenue, Ontario)		1329-1102
Photo ID 5

Date 11/08/11		
Direction E		
Description Soil cores collected from FZ-MW11-2 (Cinder & Ash FILL).

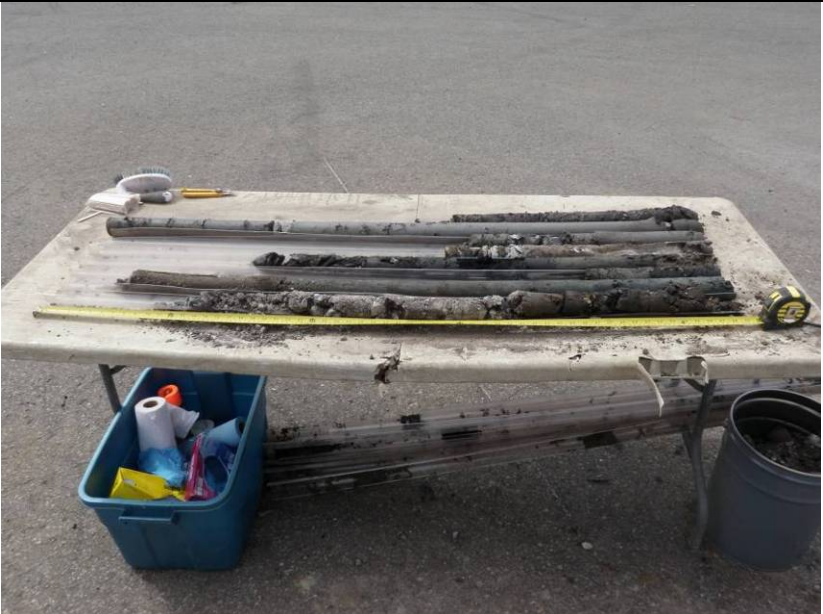
Phase Two ESA University of Ottawa (200 Lees Avenue, Ontario)		1329-1102
Photo ID 6

Date 11/08/11		
Direction N		
Description Soil cores from FZ-BH11-6D.
