**Phase One Environmental Site Assessment
University of Ottawa
200 Lees Avenue Ottawa, Ontario**

FINAL REPORT

Project No. 1329-1101
September 2, 2011

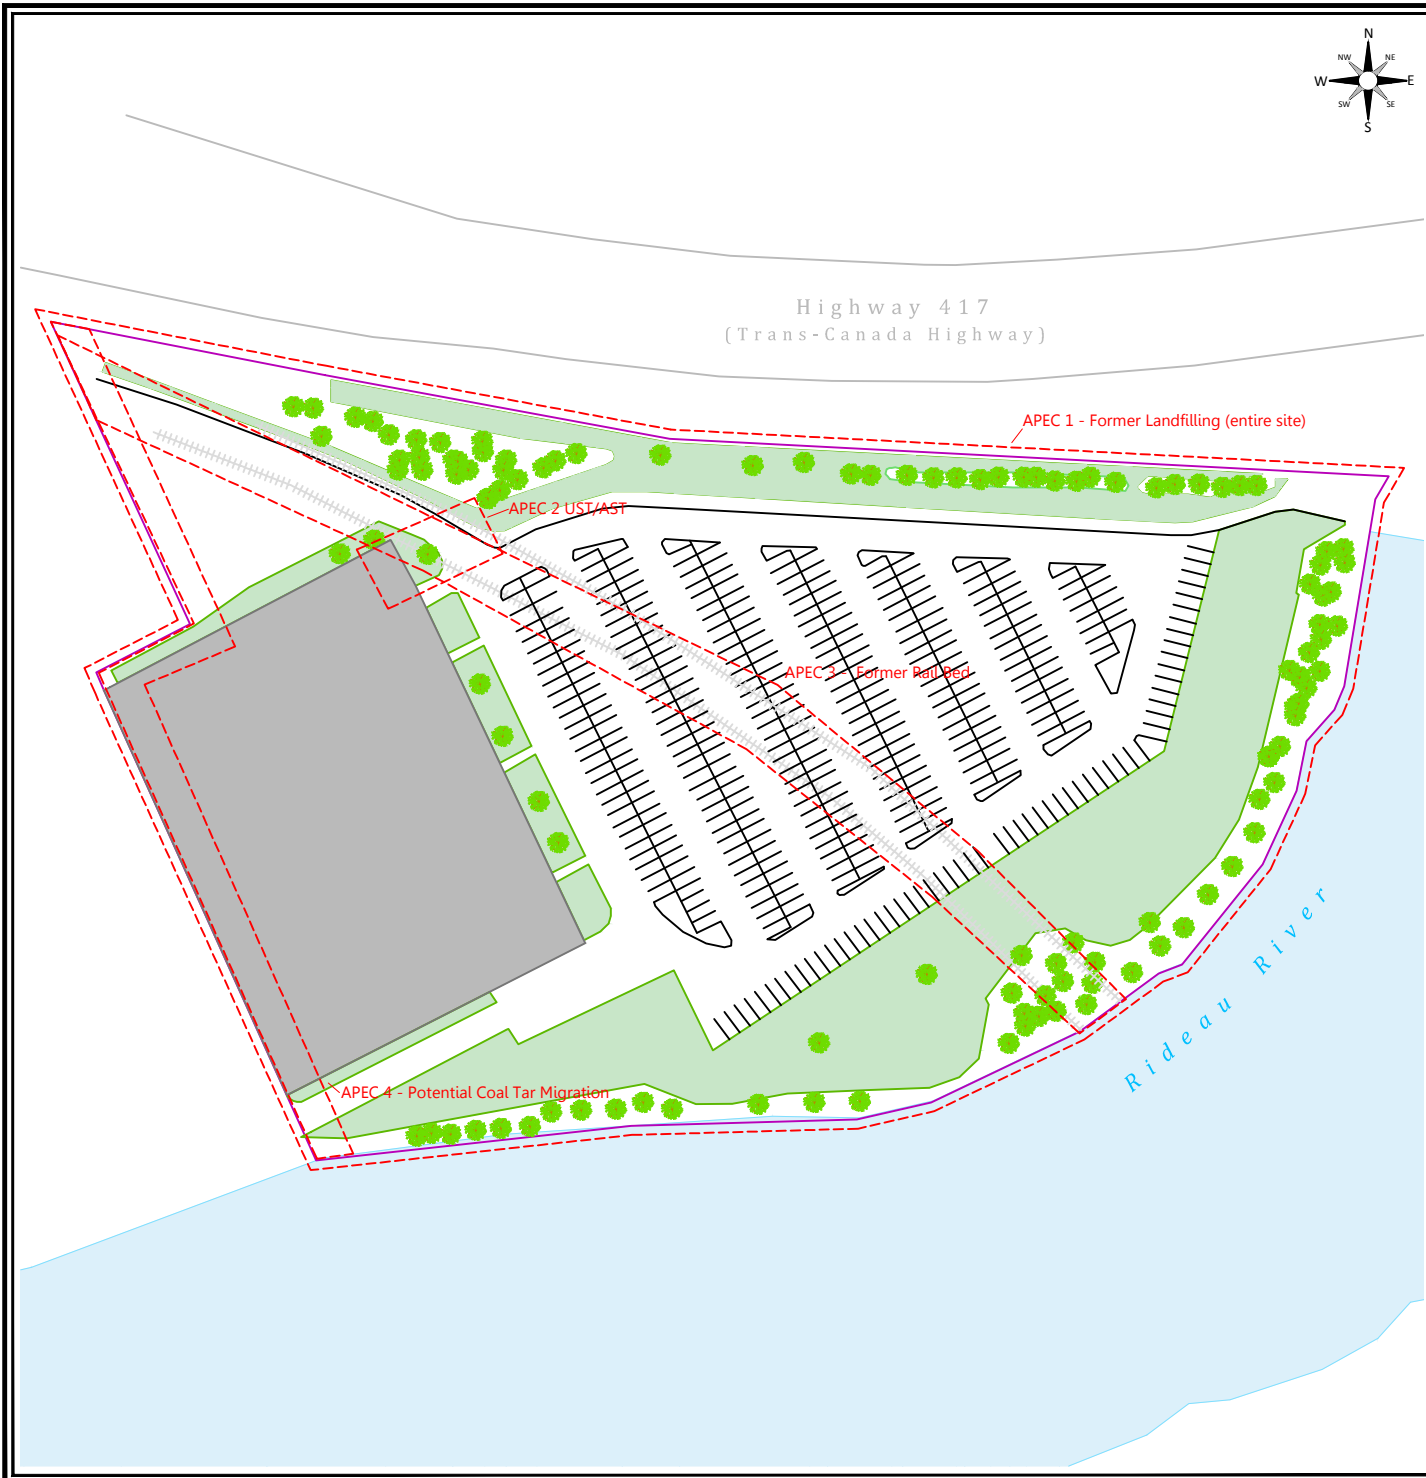
Figure 5

- Site Boundary
- Building
- Area of Potential Environmental Concern (APEC)
- Former Rail Alignment

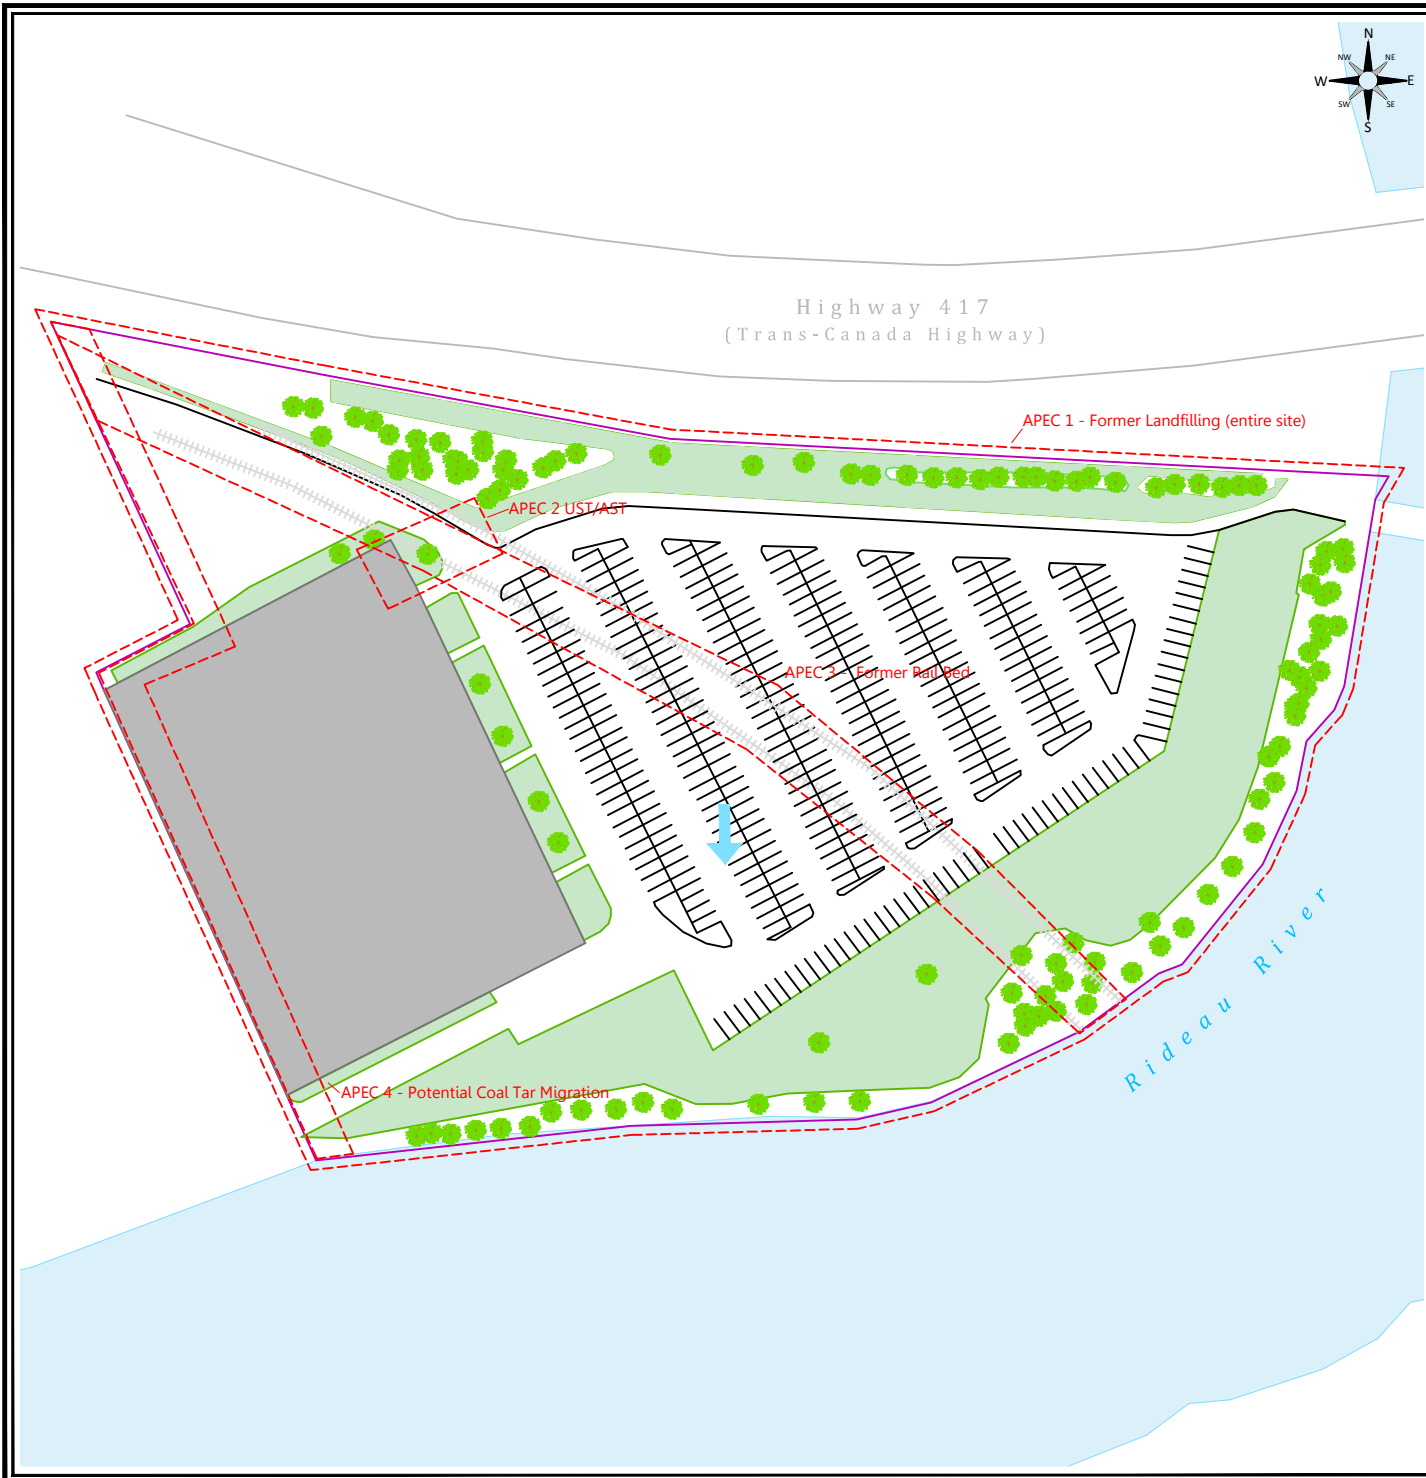
Title: Conceptual Site Model - Phase One ESA Study Area	
 • CONSULTING • ENGINEERING • TECHNOLOGIES •	Project: Phase One ESA Eastern Portion of 200 Lees Avenue, Ottawa
	Date: July 2011
Client: University of Ottawa	
 0 80 160 240 320 Meters 1:5,500	
Figure 7

- Site Boundary
- Building
- Area of Potential Environmental Concern (APEC)
- Former Rail Alignment
- ➔ Current Radial Groundwater Flow Direction (Golder, 2003)

The phase one ESA Conceptual Site Model (CSM) is shown on Figures 7 and 8, Appendix A. The CSM shows:

Potentially contaminating activities on-site (or that may have impacted areas on-site) are Asphalt and Bitumen Manufacturing, Coal Gasification; Gasoline and Associated Products Stored in Fixed Tanks; Commercial Autobody Shops, Treatment of Sewage, Rail Yards, Tracks and Spurs; and Waste Disposal and Waste Management. These activities and their locations are shown on the CSM figure, Figure 7 in Appendix A.

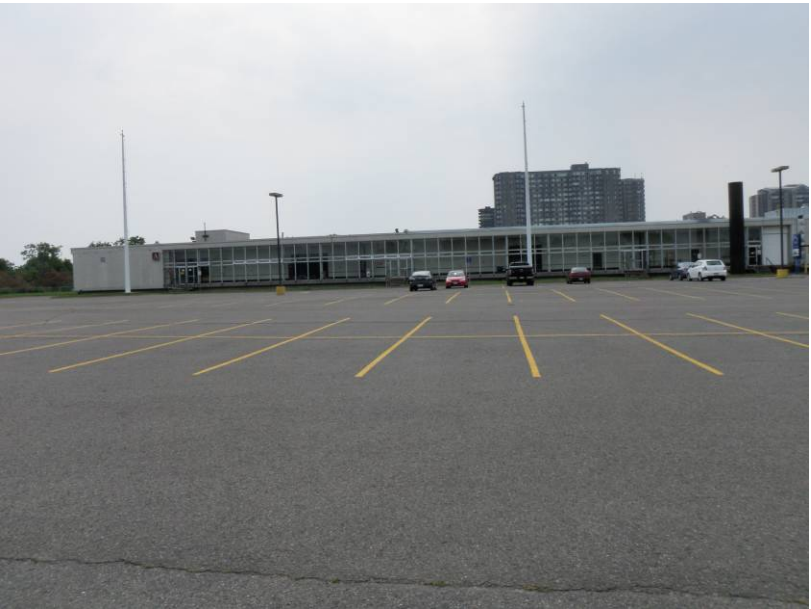
Phase I Environmental Site Assessment Rideau Campus, University of Ottawa		1329-1101
Photo ID 1

Date 11/07/2011		
Direction W		
Description View of east side of Building A. Note exhaust stack and antenna towers in front of building.

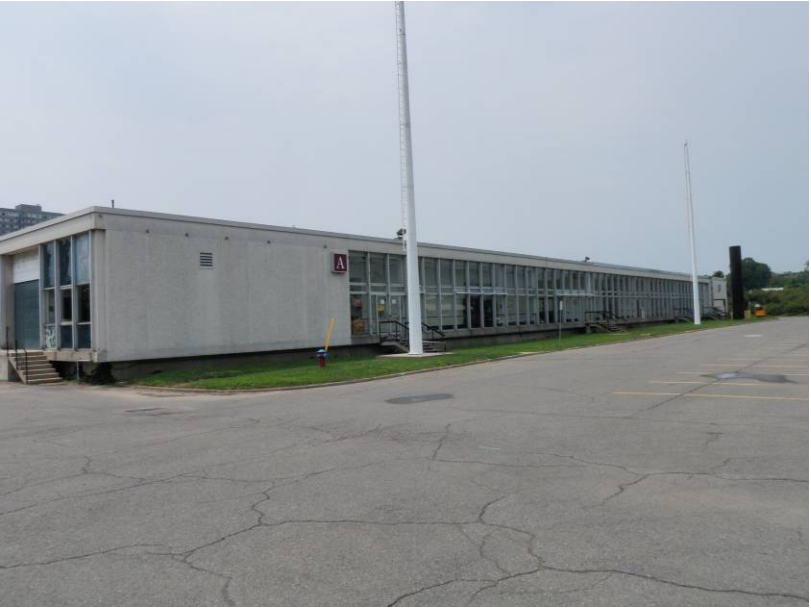
Phase I Environmental Site Assessment Rideau Campus, University of Ottawa		1329-1101
Photo ID 2

Date 11/07/2011		
Direction NW		
Description View of Building A looking at the SE corner. Note the loading dock at left of photo.

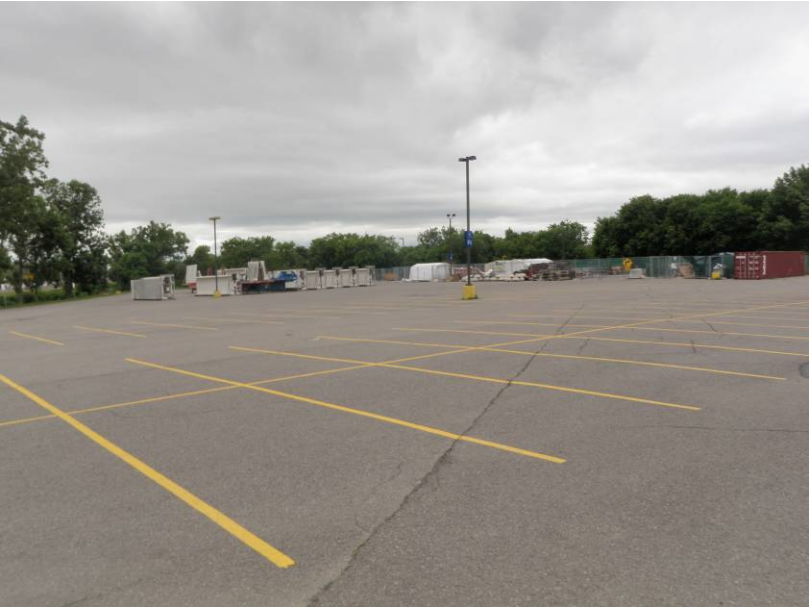
Phase I Environmental Site Assessment Rideau Campus, University of Ottawa		1329-1101
Photo ID 4

Date 29/6/2011		
Direction SE		
Description View SE of parking lot and looking towards fenced storage and garbage/compost area.

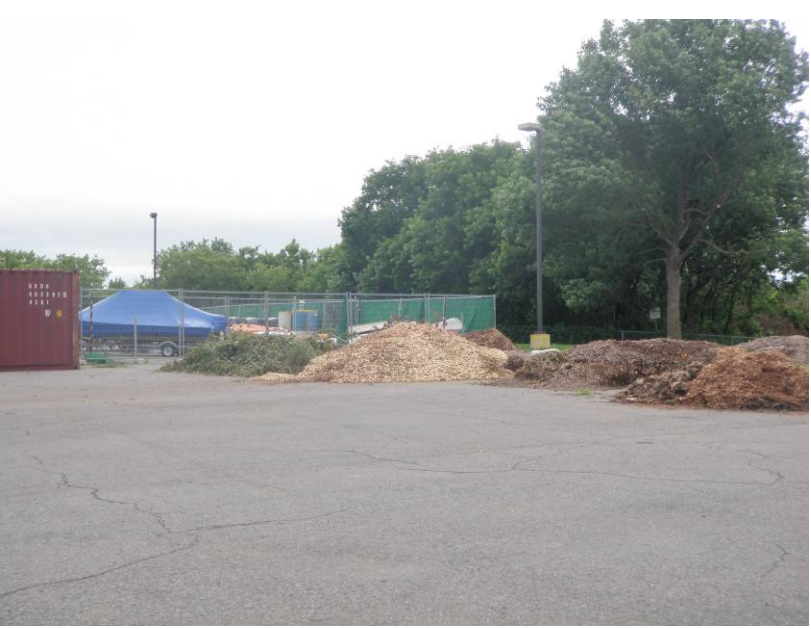
Phase I Environmental Site Assessment Rideau Campus, University of Ottawa		1329-1101
Photo ID 6

Date 29/06/2011		
Direction SE		
Description View of exposed piles of landscaping materials. Note fenced area in background.

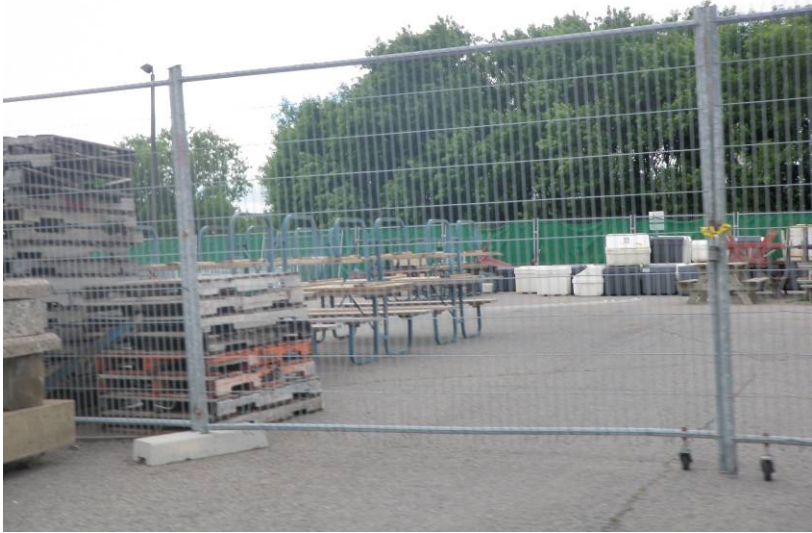
Phase I Environmental Site Assessment Rideau Campus, University of Ottawa		1329-1101
Photo ID 7

Date 29/06/2011		
Direction S		
Description Fenced outdoor storage area. Consists of picnic tables and wooden pallets. Located at the SE corner of the parking lot.

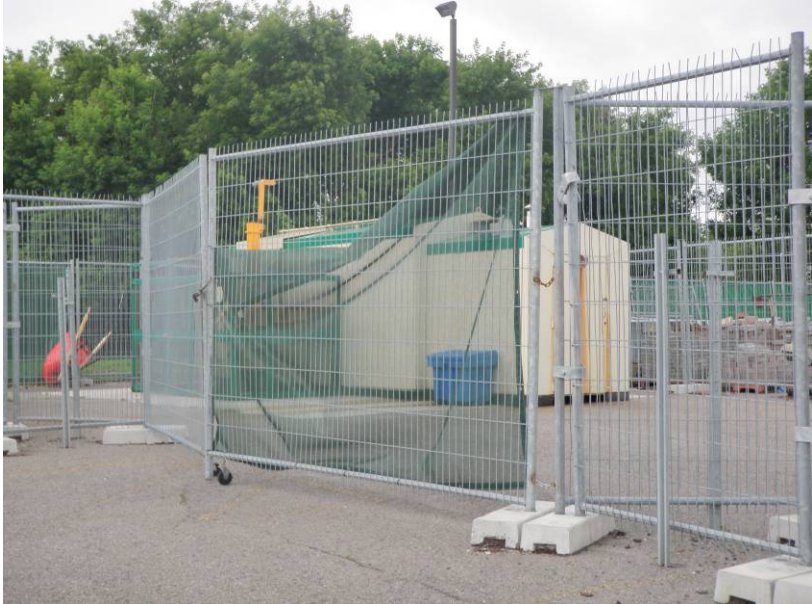
Phase I Environmental Site Assessment Rideau Campus, University of Ottawa		1329-1101
Photo ID 8

Date 29/06/2011		
Direction SSE		
Description View of composter shed at the southeast corner of the parking lot.

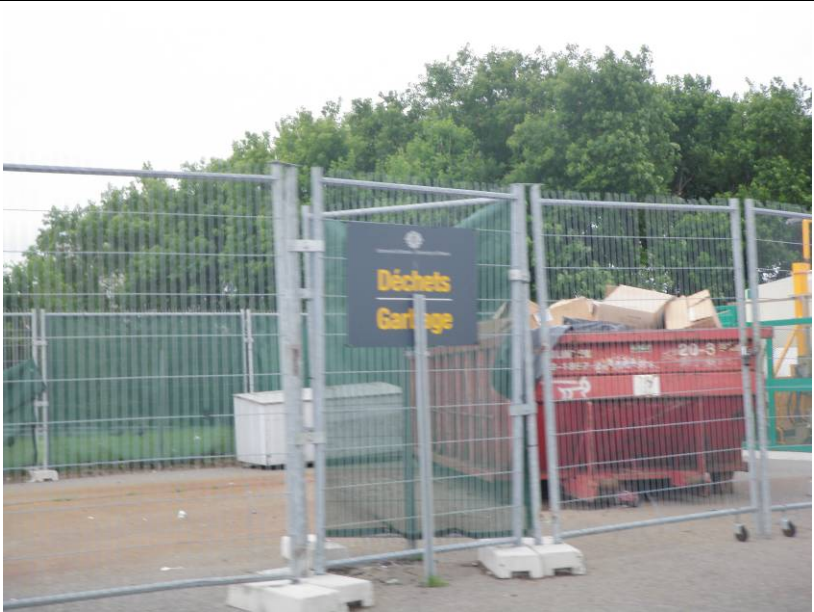
Phase I Environmental Site Assessment Rideau Campus, University of Ottawa		1329-1101
Photo ID 9

Date 29/6/2011		
Direction E		
Description Garbage area for wastes at the southeast corner of the parking lot.

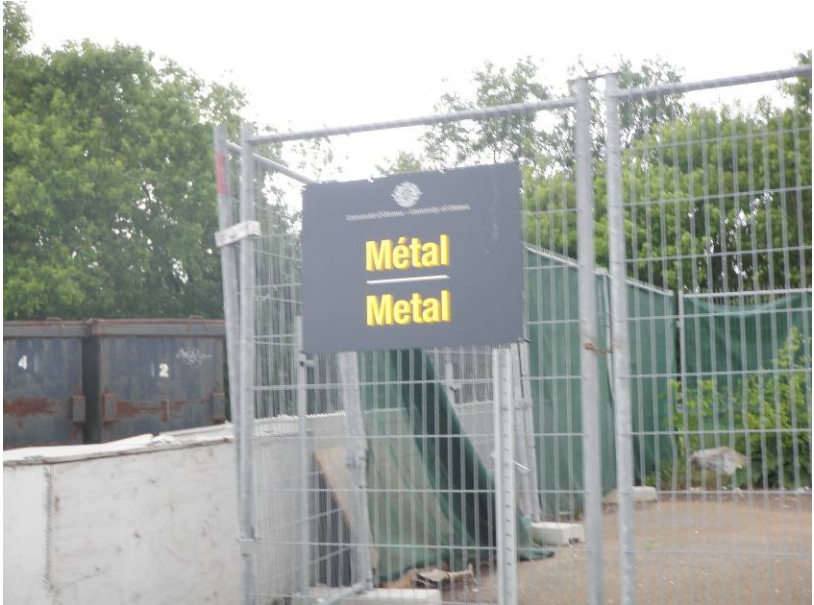
Phase I Environmental Site Assessment Rideau Campus, University of Ottawa		1329-1101
Photo ID 10

Date 29/06/2011		
Direction E		
Description Garbage area for metal materials at the southeast corner of the parking lot.

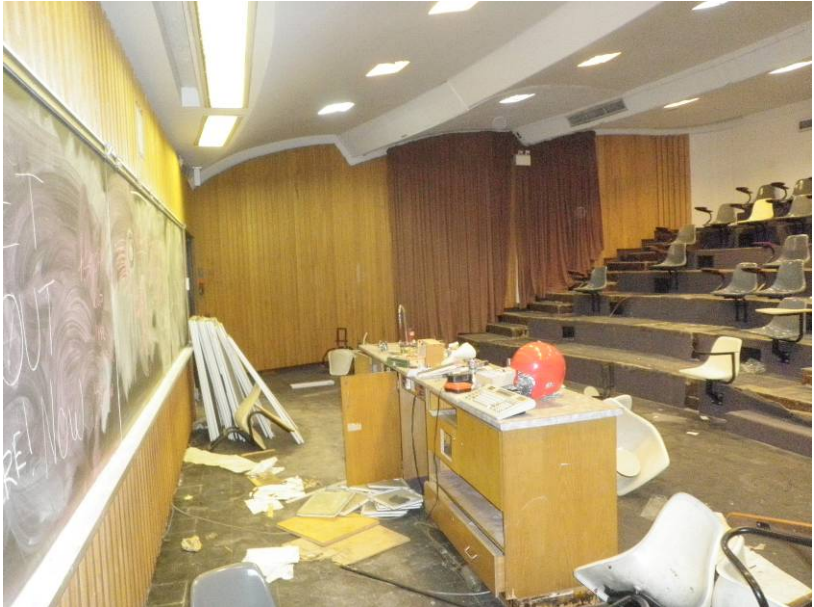
Phase I Environmental Site Assessment Rideau Campus, University of Ottawa		1329-1101
Photo ID 12

Date 29/6/2011		
Direction NW		
Description Rm. 130. Lecture Hall that has not been renovated and remains in a state of disrepair.

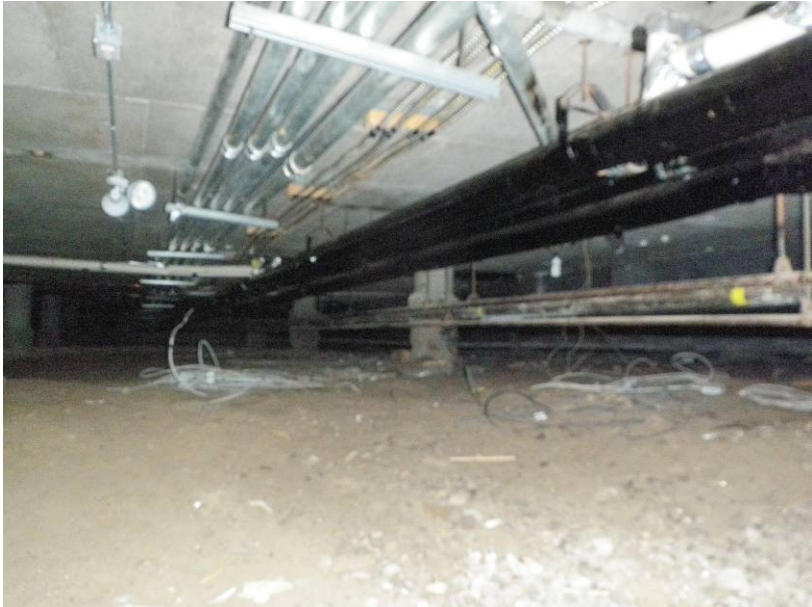
Phase I Environmental Site Assessment Rideau Campus, University of Ottawa		1329-1101
Photo ID 13

Date 29/6/2011		
Direction N/A		
Description View of the crawl space of Building A. This area was accessed in the stairwell down to the boiler room. Note the numerous piping infrastructure.

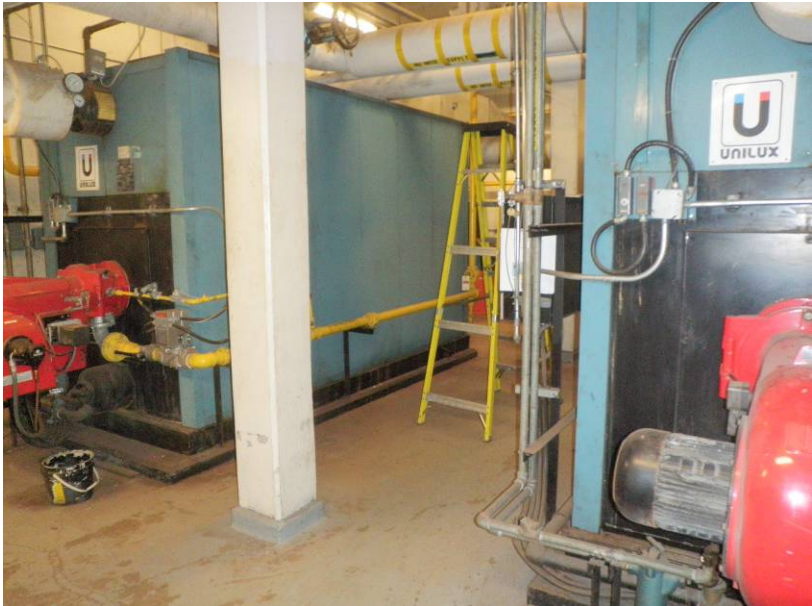
Phase I Environmental Site Assessment Rideau Campus, University of Ottawa		1329-1101
Photo ID 14

Date 29/06/2011		
Direction E		
Description Side by side hot water boilers in basement of Building A. Looking towards the east.

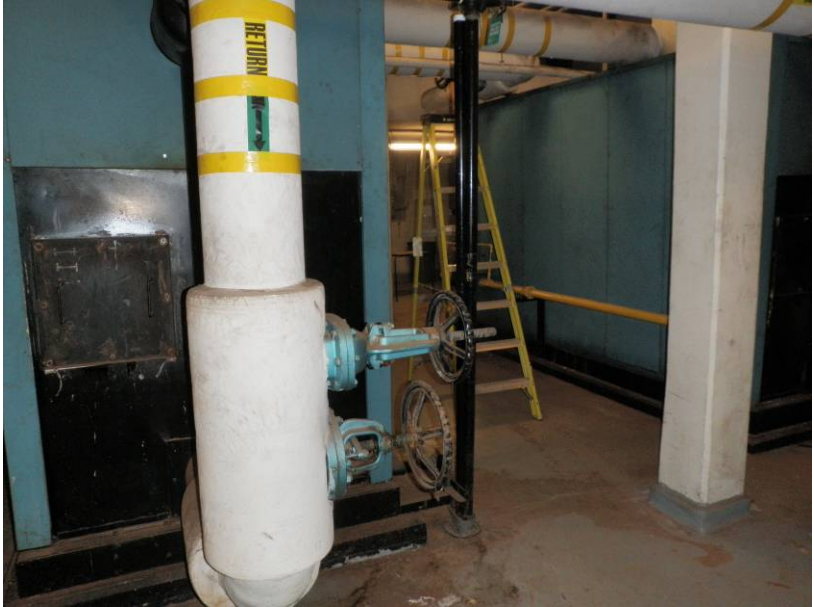
Phase I Environmental Site Assessment Rideau Campus, University of Ottawa		1329-1101
Photo ID 15

Date 29/06/2011		
Direction SE		
Description Side by side hot water boilers in basement of Building A. Looking towards the SE corner of the building.

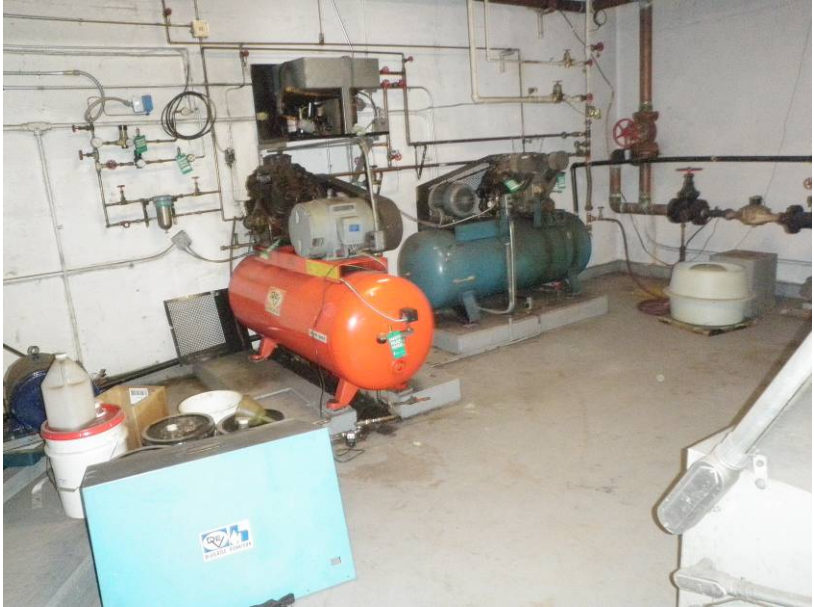
Phase I Environmental Site Assessment Rideau Campus, University of Ottawa		1329-1101
Photo ID 16

Date 29/06/2011		
Direction NW		
Description Compressors in the NW corner of the boiler room. Note the pails of oils/lubricants to the left of the orange compressor.

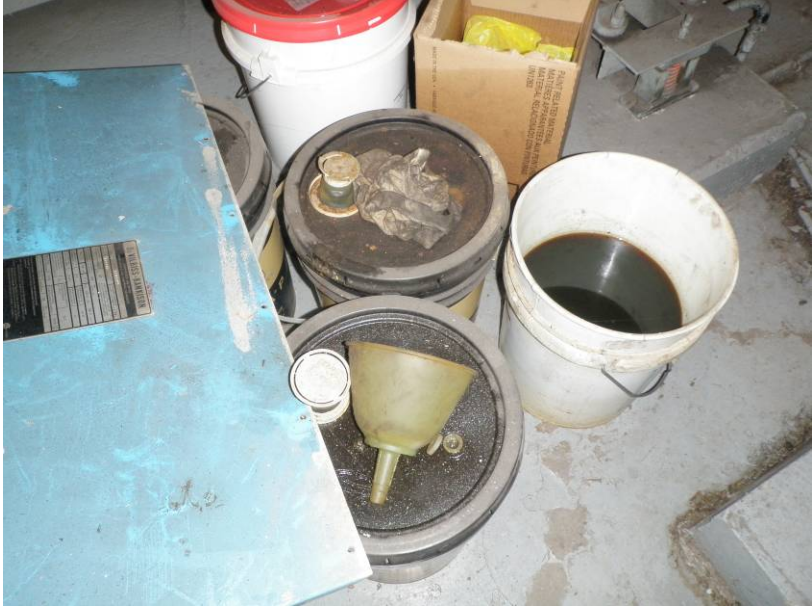
Phase I Environmental Site Assessment Rideau Campus, University of Ottawa		1329-1101
Photo ID 17

Date 29/06/2011		
Direction N/A		
Description Oil/lubricants on the floor beside the compressors. Pails labelled as Shell Corena P68 High Performance compressor oil. Note the open pail.

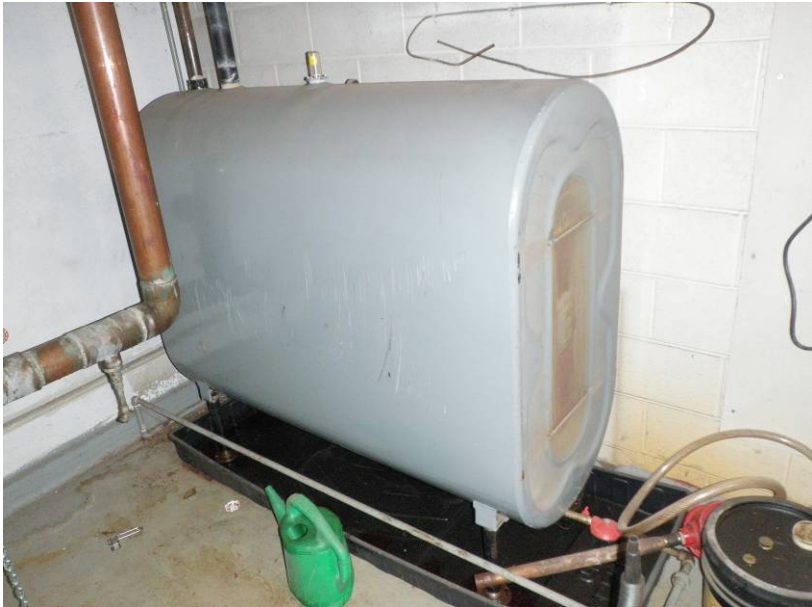
Phase I Environmental Site Assessment Rideau Campus, University of Ottawa		1329-1101
Photo ID 18

Date 29/06/2011		
Direction NE		
Description AST along the north wall of the boiler room. This AST feeds the back-up generator. Note the secondary containment under AST.

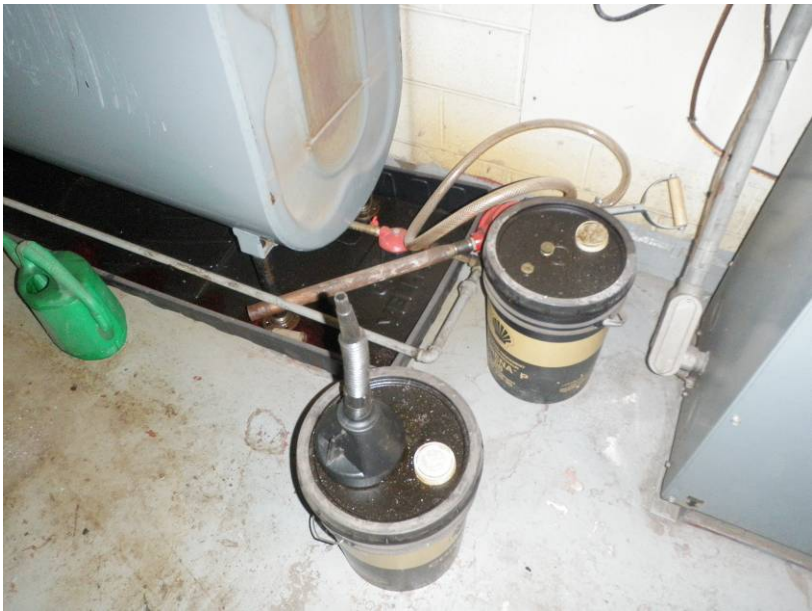
Phase I Environmental Site Assessment Rideau Campus, University of Ottawa		1329-1101
Photo ID 19

Date 29/06/2011		
Direction N/A		
Description Two pails of Shell Corena P68 High Performance compressor oil beside AST.

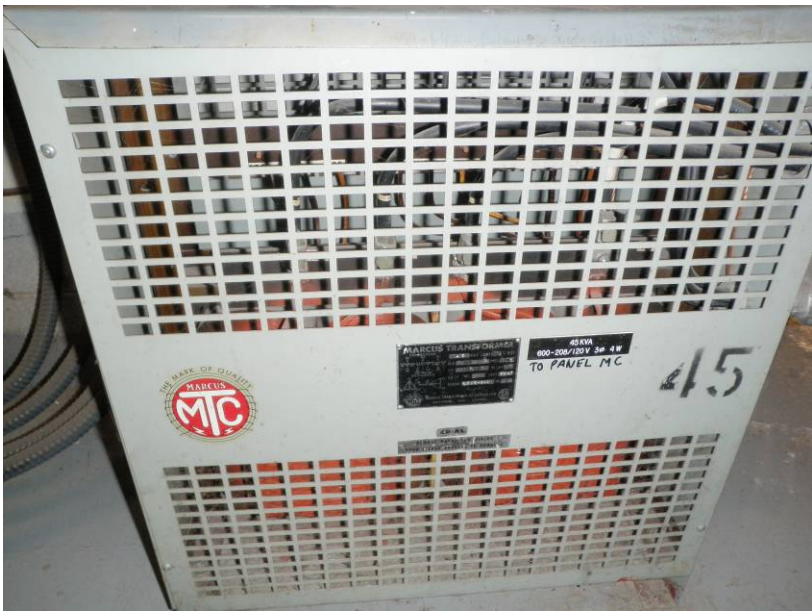
Date 29/06/2011		
Direction W		
Description Transformer in a small room housing electrical panels. Unknown if contains PCBs.

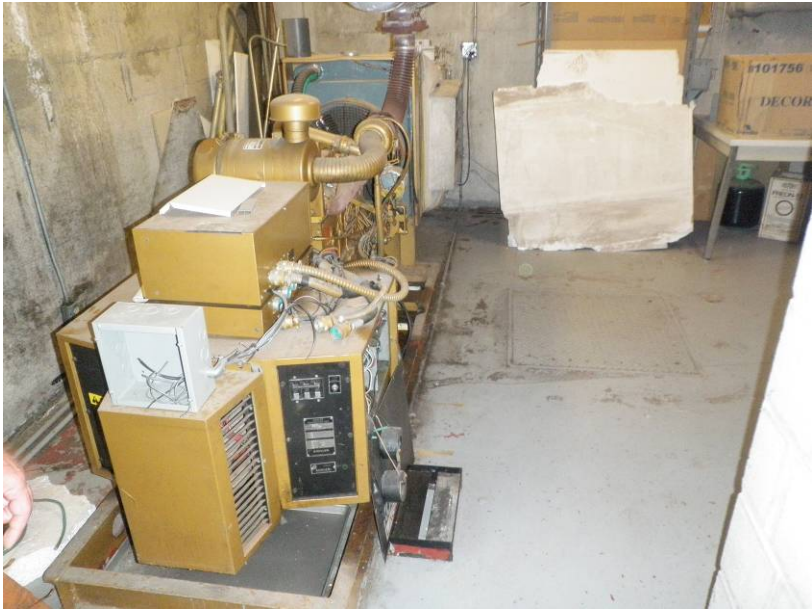
Date 29/06/2011		
Direction E		
Description Back-up diesel generator located in the NE corner of the boiler room. It appears to have not been in use for some time. Note the sump hole to the right on floor.

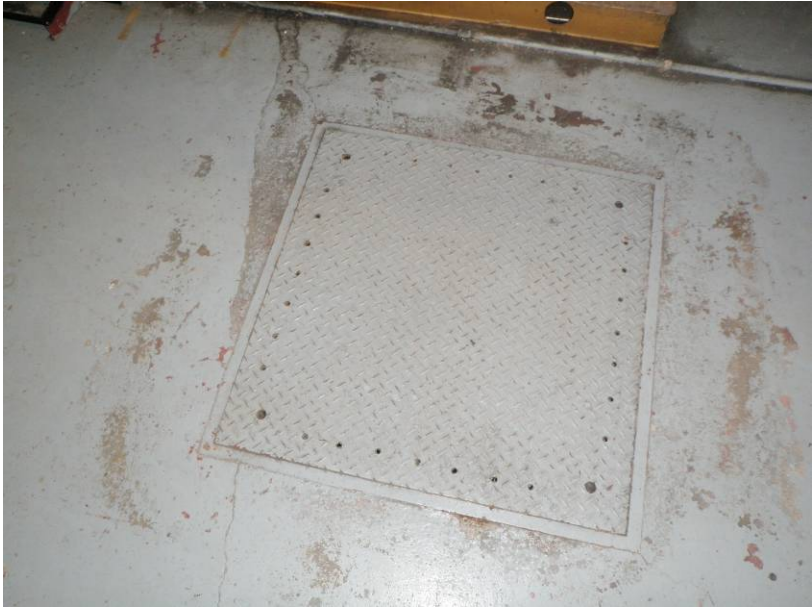
Date 29/6/2011		
Direction N/A		
Description Sump hole adjacent to generator. Grate was not able to be removed. Approx. 2 ft x 2 ft in size.

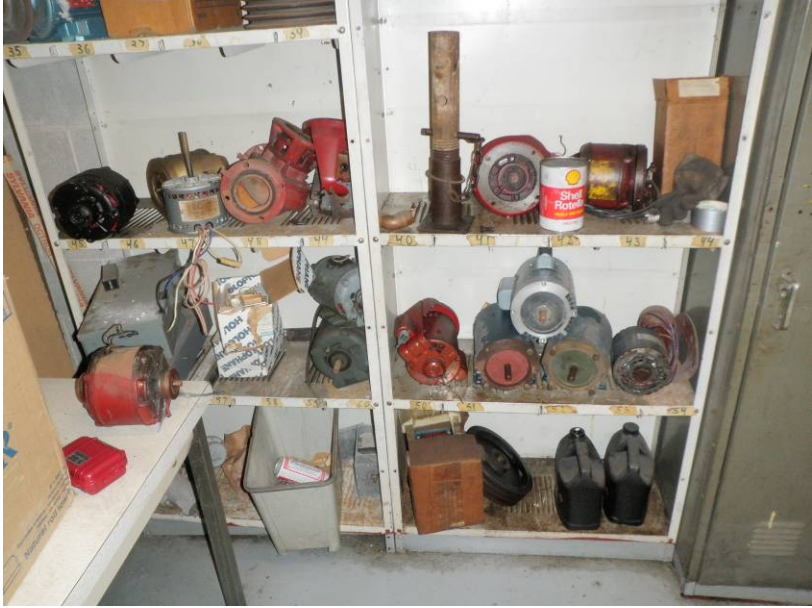
<p>Phase I Environmental Site Assessment Rideau Campus, University of Ottawa</p>		<p>1329-1101</p>
<p>Photo ID 23</p>

<p>Date 29/06/2011</p>		
<p>Direction SE</p>		
<p>Description Spare engine parts and equipment in the boiler room. Adjacent to the generator.</p>

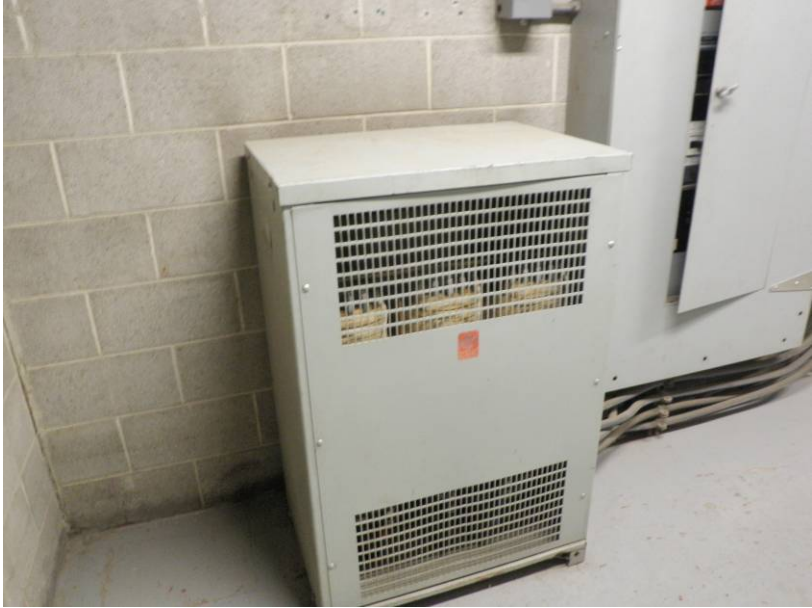
<p>Date 29/06/2011</p>		
<p>Direction W</p>		
<p>Description Transformer in a small room housing electrical panels along the north wall. Unknown if contains PCBs. AST is directly behind wall.</p>

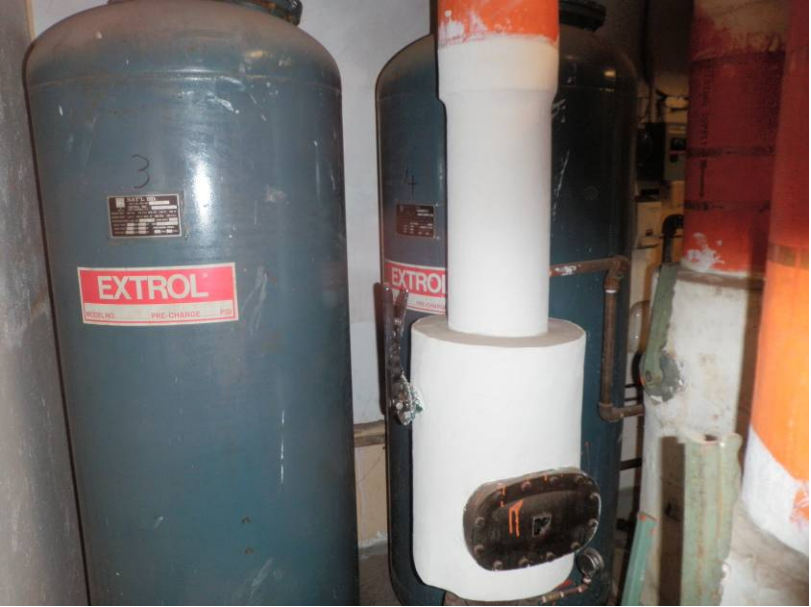
Phase I Environmental Site Assessment Rideau Campus, University of Ottawa		1329-1101
Photo ID 25

Date 29/6/2011		
Direction W		
Description Hot water tanks along west wall of boiler room. Four tanks in total.

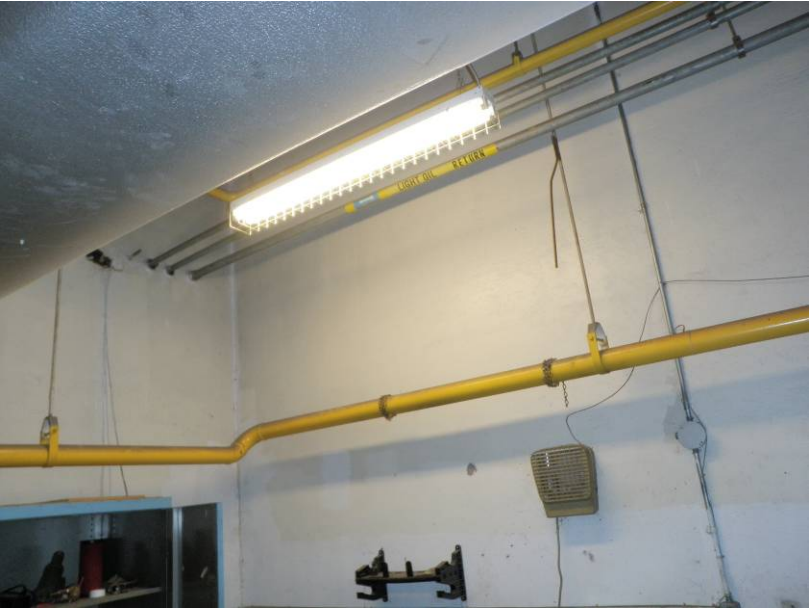
Date 29/06/2011		
Direction N/A		
Description Fluorescent light ballasts and piping (utilities) entering Building A on the eastern exterior wall of the boiler room.

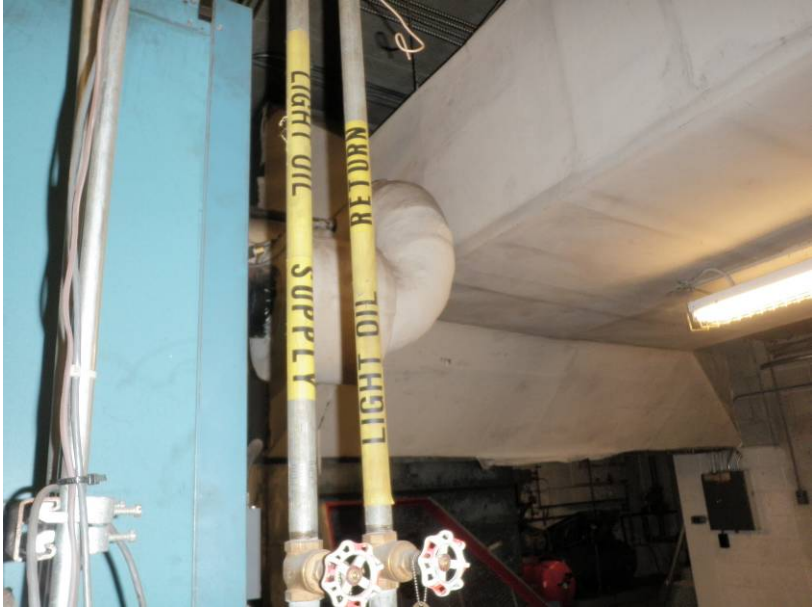
Date 29/6/2011		
Direction N/A		
Description Example of piping clearly labelled in boiler room. Suspected that the light oil lines connect to UST on the exterior of Building A.

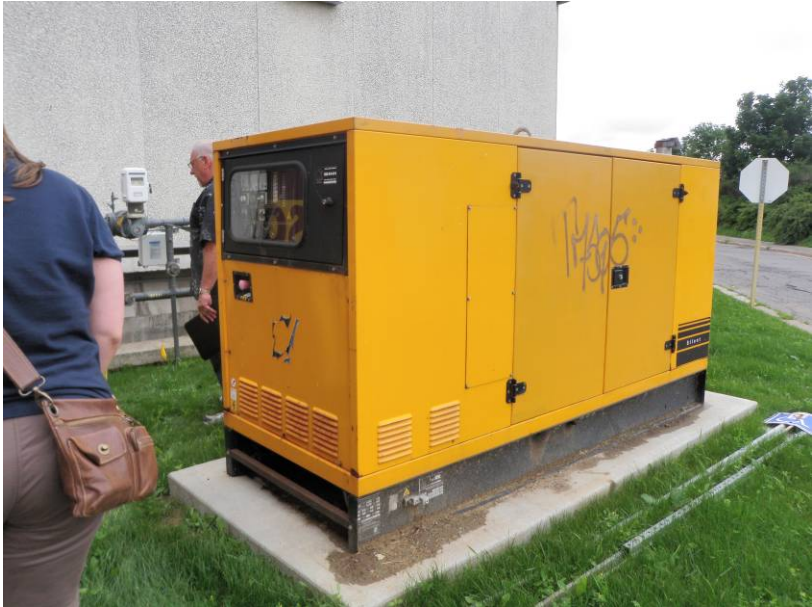
Date 29/6/2011		
Direction W		
Description Emergency generator at NE exterior corner of Building A. Generator is housed on a cement pad and internal fuel source of approx. 360 litres.

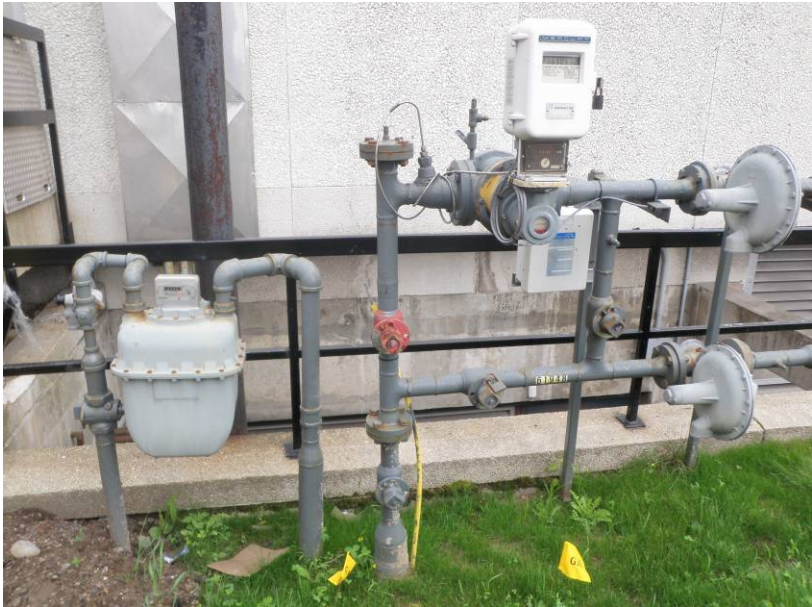
Phase I Environmental Site Assessment Rideau Campus, University of Ottawa		1329-1101
Photo ID 29

Date 29/6/2011		
Direction W		
Description Municipality of Ottawa water and hydro metres. Directly behind is a stairwell to the basement boiler room and unknown room (could not open door at time of site recon.).

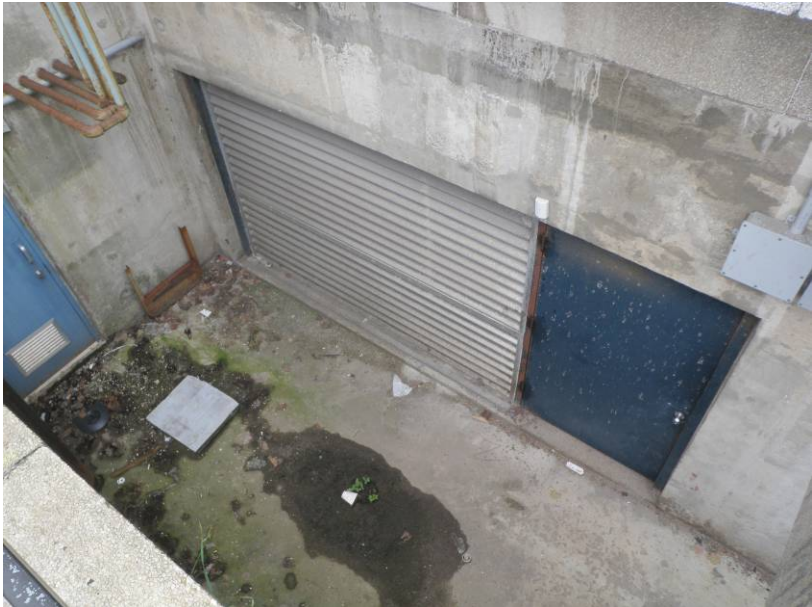
Phase I Environmental Site Assessment Rideau Campus, University of Ottawa		1329-1101
Photo ID 30

Date 29/6/2011		
Direction N/A		
Description Stairwell to basement. Dark blue door on right leads to boiler room. Light blue door on left could not be opened.

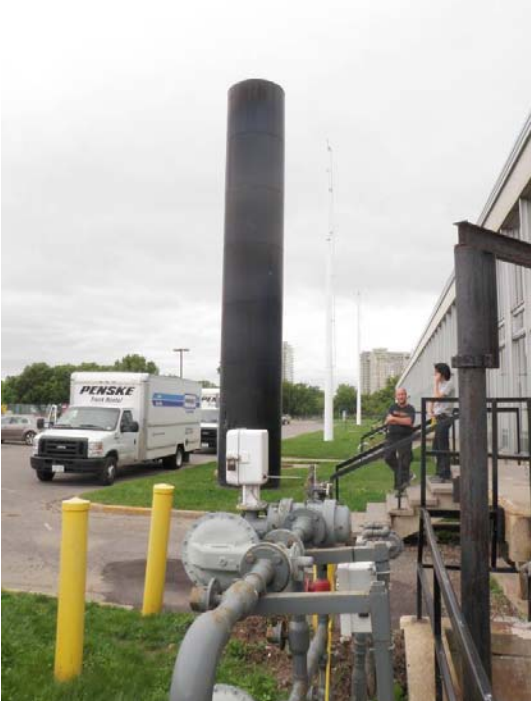
Phase I Environmental Site Assessment Rideau Campus, University of Ottawa		1329-1101
Photo ID 31

Date 29/6/2011		
Direction SE		
Description Large exhaust stack for boiler room. Behind note the two large white antennas where purpose of them is unknown.

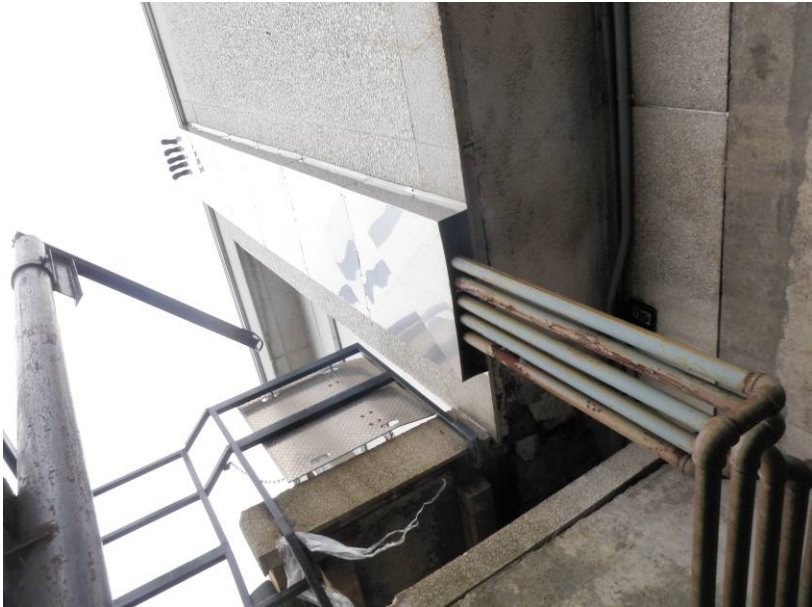
Phase I Environmental Site Assessment Rideau Campus, University of Ottawa		1329-1101
Photo ID 32

Date 29/6/2011		
Direction N/A		
Description Exhaust pipes leading from door could not open in stairwell at NE corner of Building A.

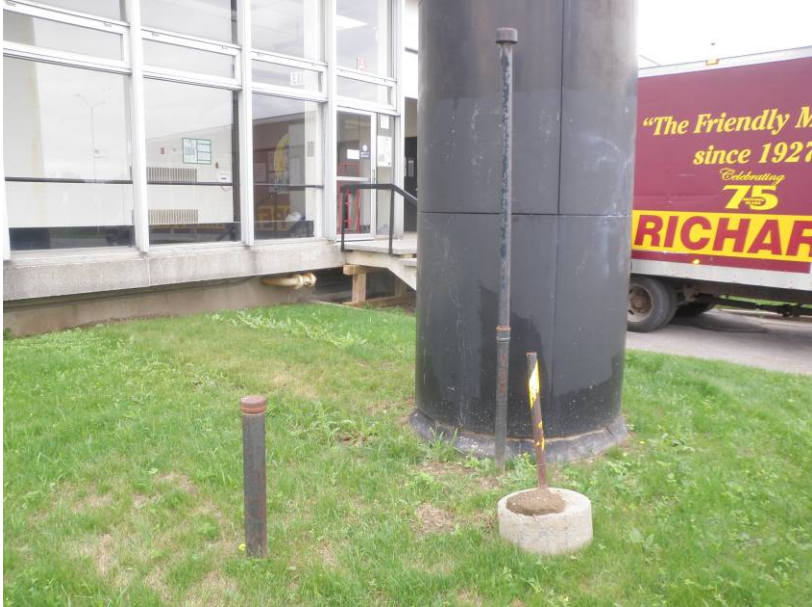
Date 29/6/2011		
Direction NW		
Description Fill and vent pipes. Confirmed UST location. Boiler room exhaust in background. Loading dock to right of Building A entrance.

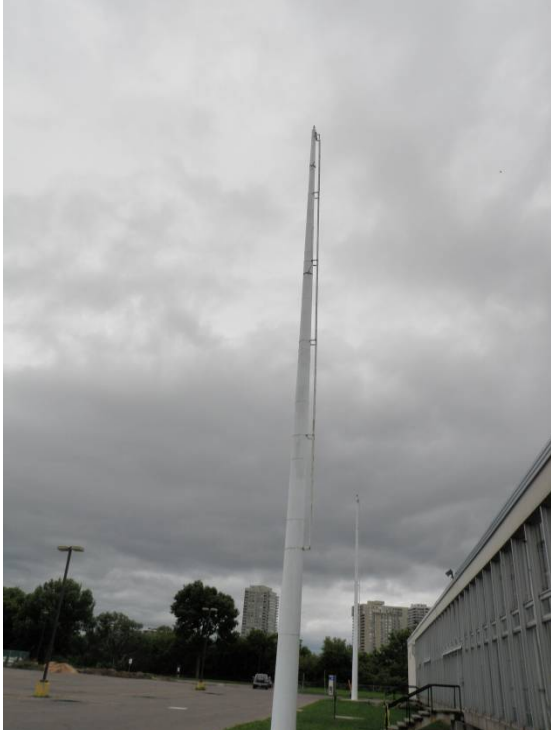
Phase I Environmental Site Assessment Rideau Campus, University of Ottawa		1329-1101
Photo ID 34

Date 29/6/2011		
Direction SE		
Description Large white antennas. Purpose is unknown. There is a cement anchor in grass directly between the two antennas (near stairs at bottom of photo).

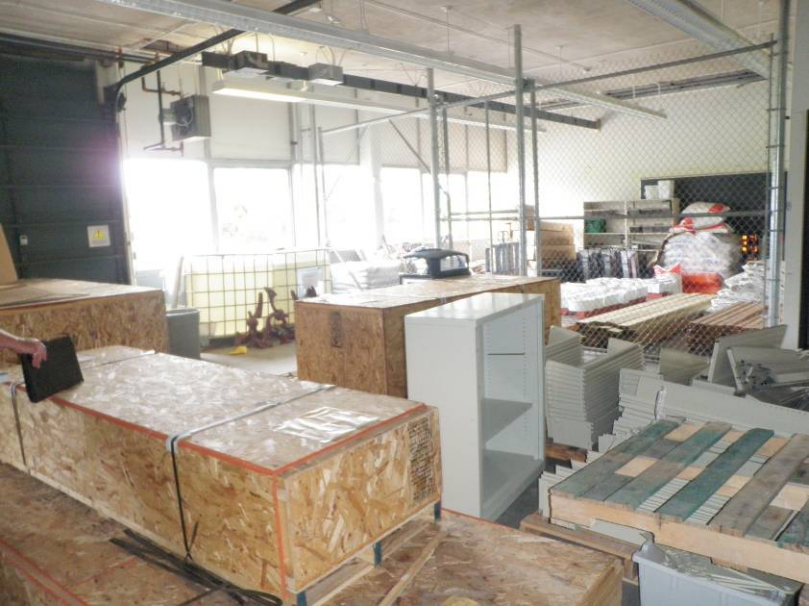
Phase I Environmental Site Assessment Rideau Campus, University of Ottawa		1329-1101
Photo ID 35

Date 29/6/2011		
Direction SW		
Description Rm. A102. Used as storage. Liquid salt solution in contains along back wall.

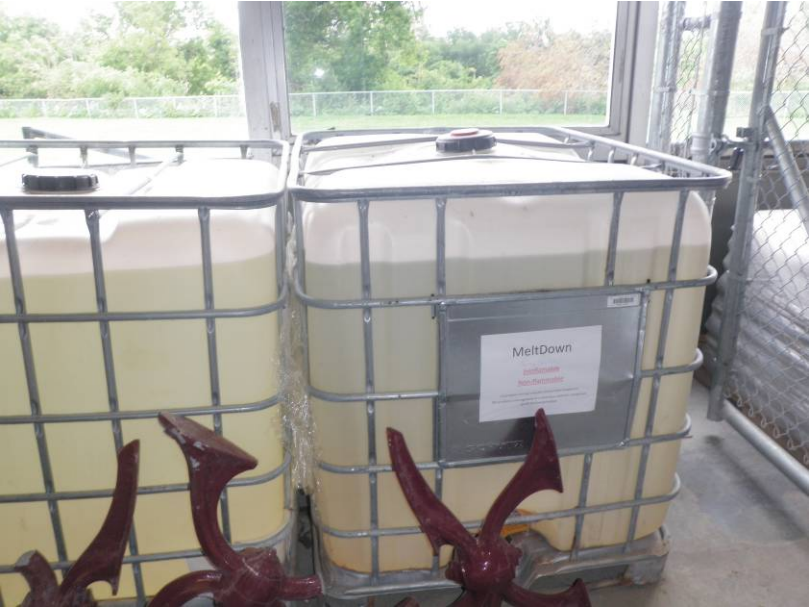
Phase I Environmental Site Assessment Rideau Campus, University of Ottawa		1329-1101
Photo ID 36

Date 29/6/2011		
Direction N/A		
Description Container with the liquid salt solution for winter road maintenance.

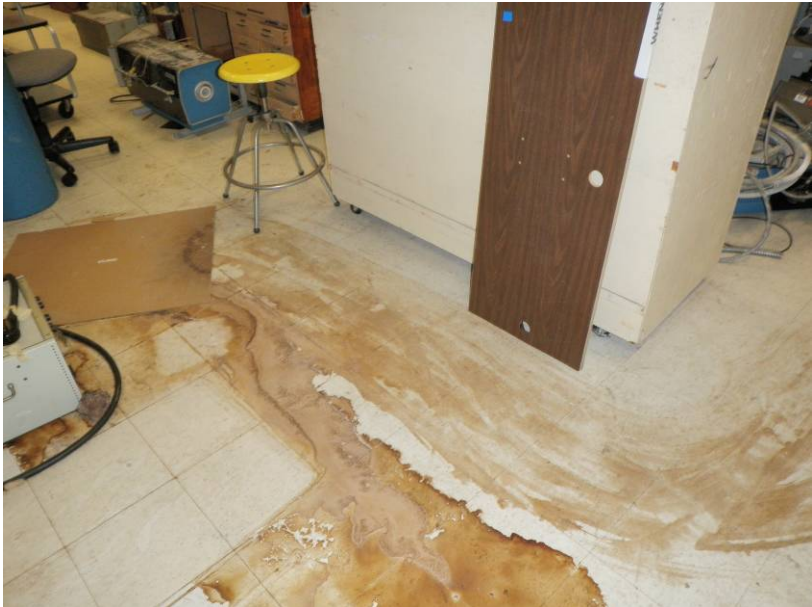
Date 29/6/2011		
Direction N/A		
Description Rm. A111 – Floor stain. Unknown substance, but has been smeared. Dry during site recon. No odours noted.
