**Phase One Environmental Site Assessment
University of Ottawa
200 Lees Avenue Ottawa, Ontario**

FINAL REPORT

Project No. 1329-1101
September 2, 2011

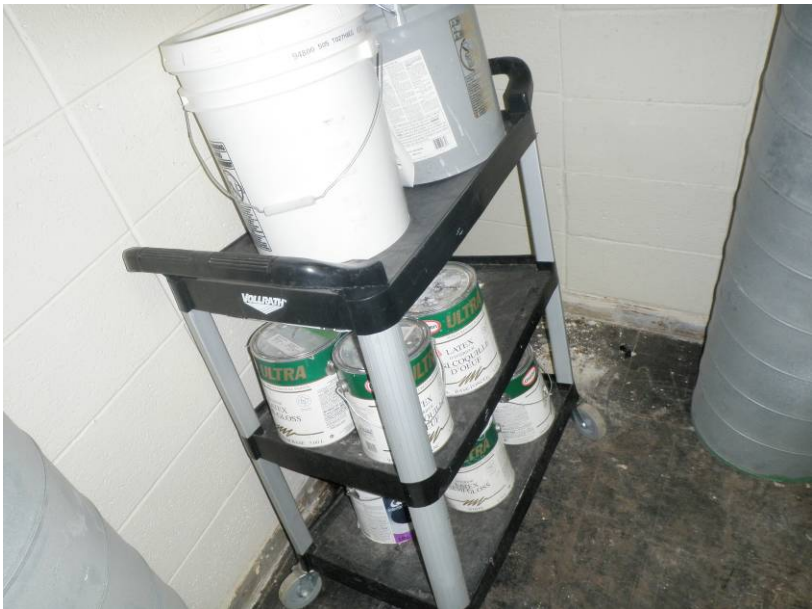
Phase I Environmental Site Assessment Rideau Campus, University of Ottawa		1329-1101
Photo ID 40

Date 29/6/2011		
Direction N/A		
Description Rm. A110 – An old laboratory. Closed and sealed paint cans. No odours or spills noted.

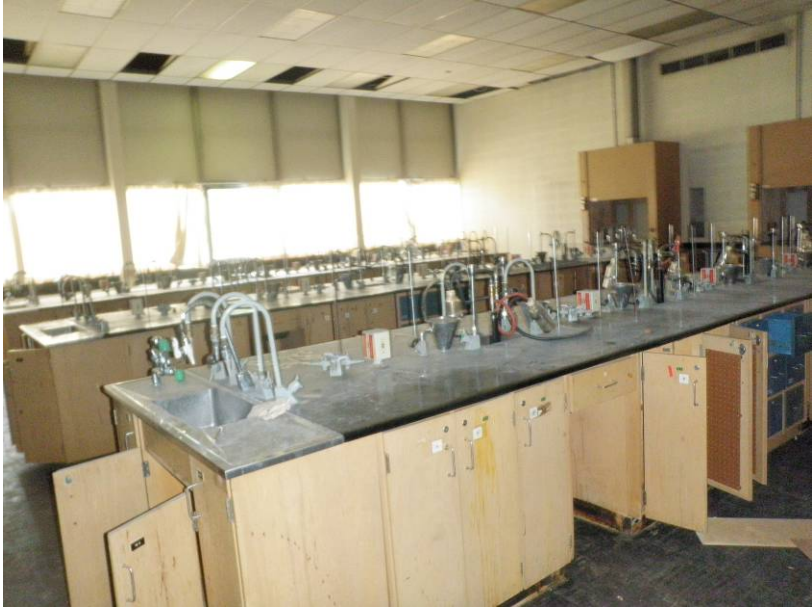
Date 29/6/2011		
Direction SW		
Description Rm. A104. "Organic Chemistry" lab room. Original to Algonquin college days. Room had a strong chemical odour, all chemicals had been removed.

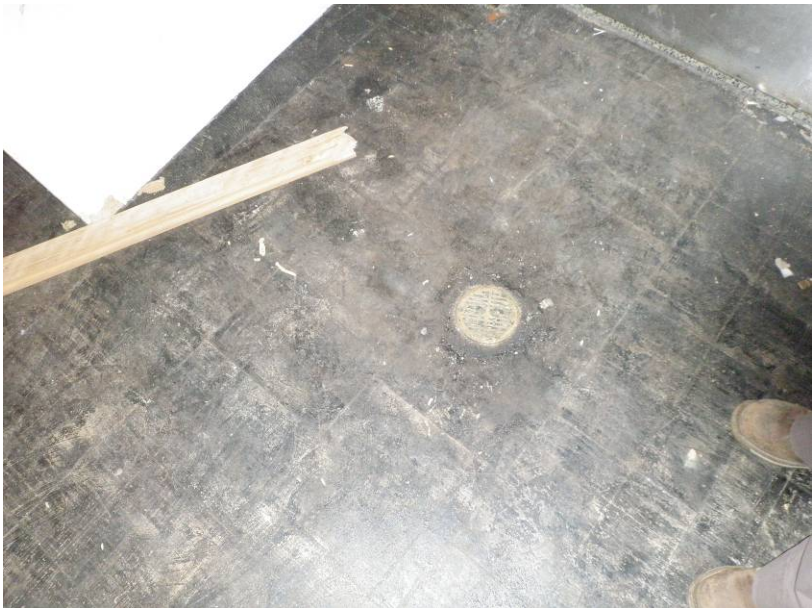
Date 29/6/2011		
Direction N/A		
Description Floor drains present in all old laboratory room. Suspected connected to municipal storm/sewer system but not confirmed.

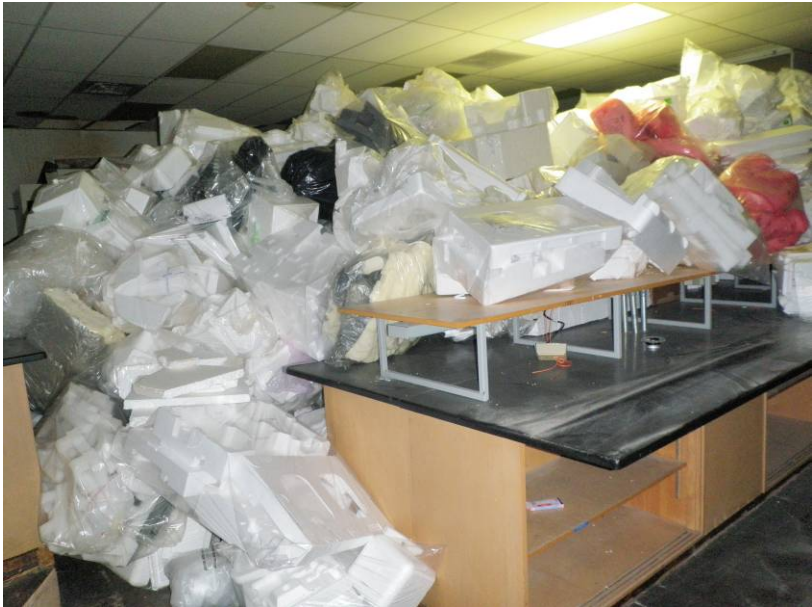
Phase I Environmental Site Assessment Rideau Campus, University of Ottawa		1329-1101
Photo ID 43

Date 29/6/2011		
Direction SE		
Description Rm. A113. Old laboratory. Now used as recycling storage. Full of styrofoam during site reconnaissance.

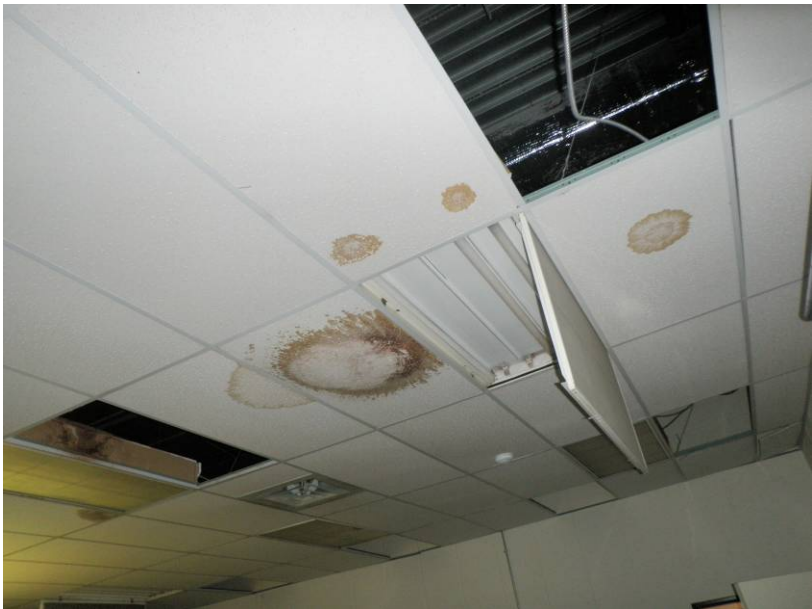
Date 29/6/2011		
Direction N/A		
Description Water stains on ceiling of Rm. A113.

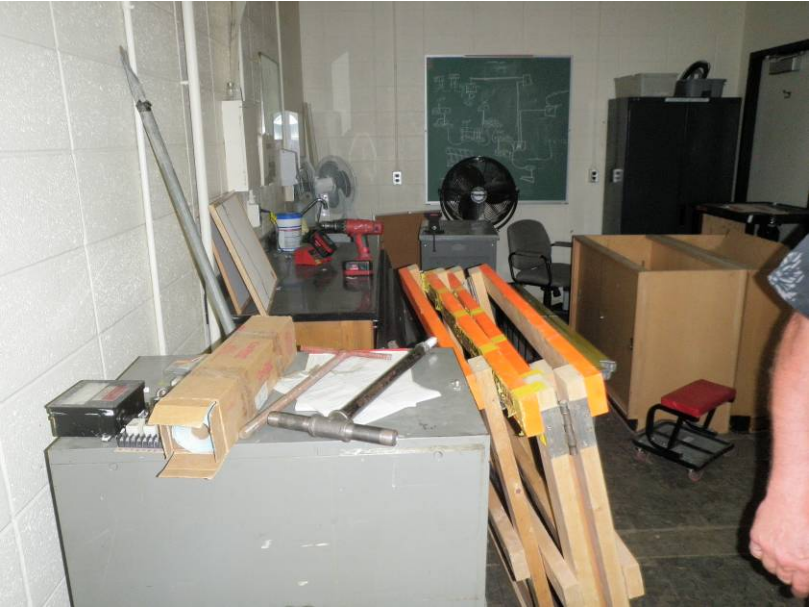
Phase I Environmental Site Assessment Rideau Campus, University of Ottawa		1329-1101
Photo ID 48

Date 29/6/2011		
Direction SSE		
Description Control room beside stairwell to basement. Rm. # unknown. Houses computer system and electrical panels. Rarely used.

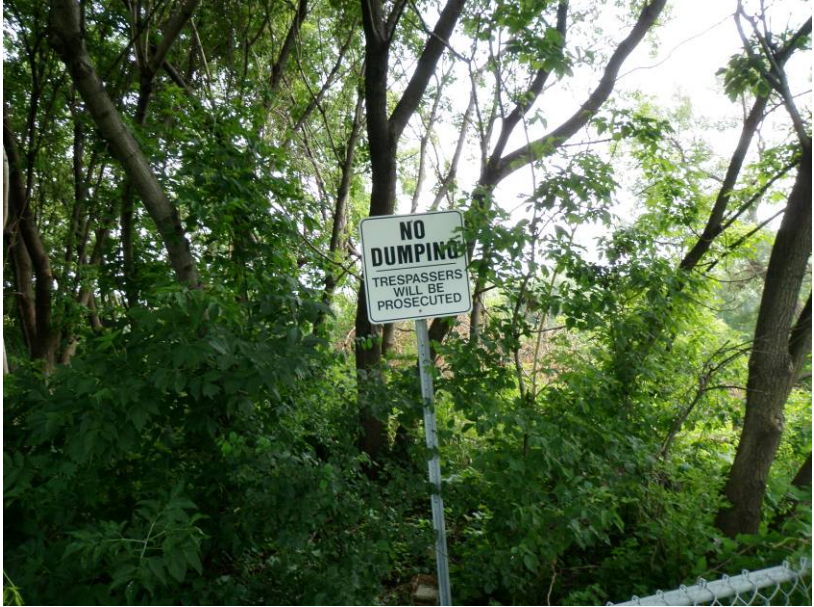
Phase I Environmental Site Assessment Rideau Campus, University of Ottawa		1329-1101
Photo ID 49

Date 11/07/2011		
Direction SE		
Description View towards the Rideau River looking SE. Note the U of O property fence in bottom right corner. Heavily vegetated and steep bank from fence to river.

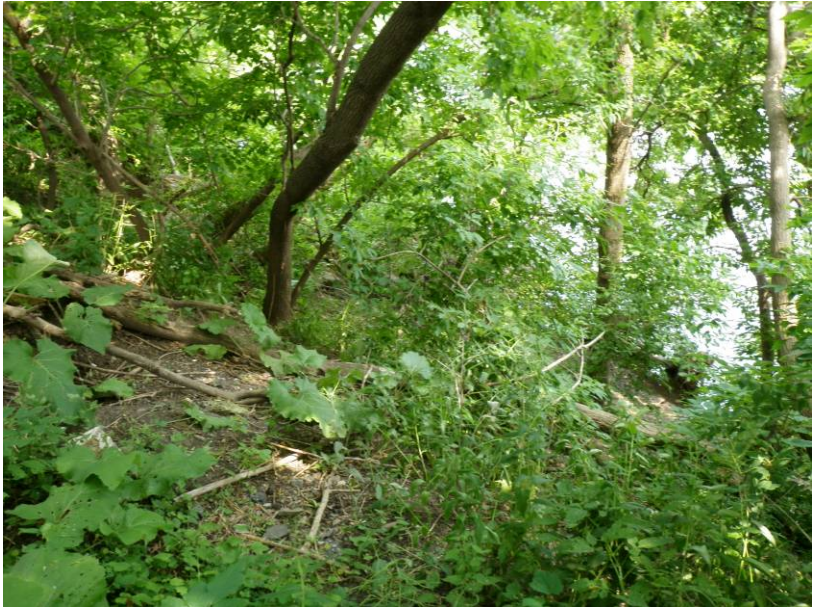
Phase I Environmental Site Assessment Rideau Campus, University of Ottawa		1329-1101
Photo ID 50

Date 11/07/2011		
Direction S		
Description View toward the Rideau River looking south from fence line. Steep bank down to river evident.

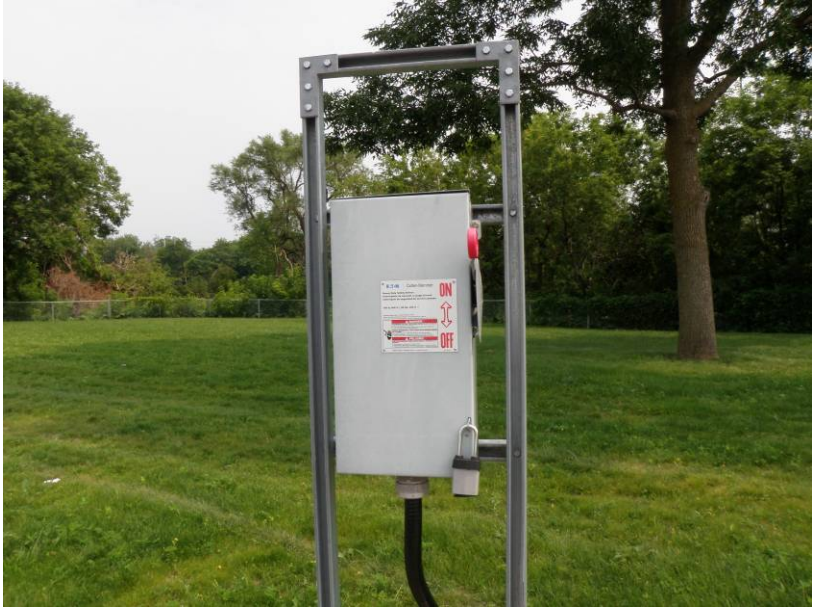
Phase I Environmental Site Assessment Rideau Campus, University of Ottawa		1329-1101
Photo ID 51

Date 11/07/2011		
Direction SSE		
Description Power supply master switch near SW corner of parking lot. The property line fence is visible in background.

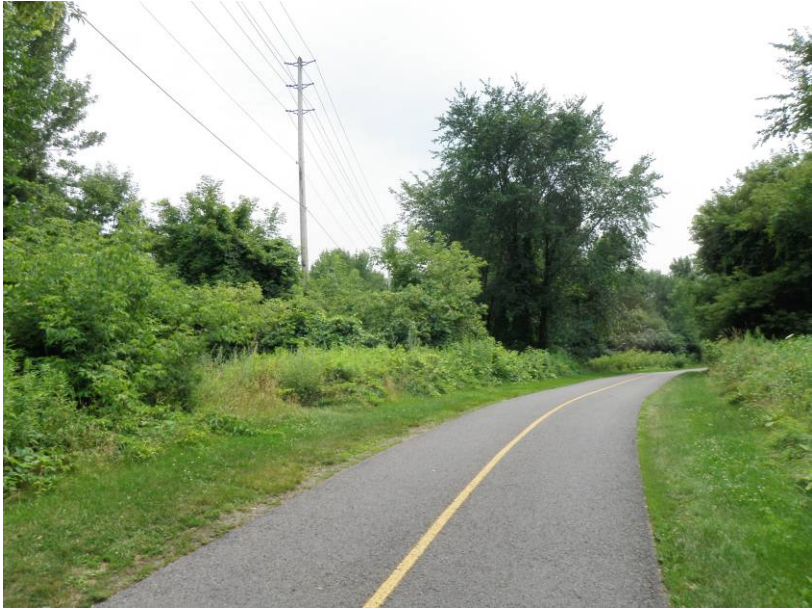
Phase I Environmental Site Assessment Rideau Campus, University of Ottawa		1329-1101
Photo ID 53

Date 11/07/2011		
Direction SE		
Description View of National Capital Commission pathway on the south side of Rideau River. Area heavily vegetated. Rideau River on right of pathway.

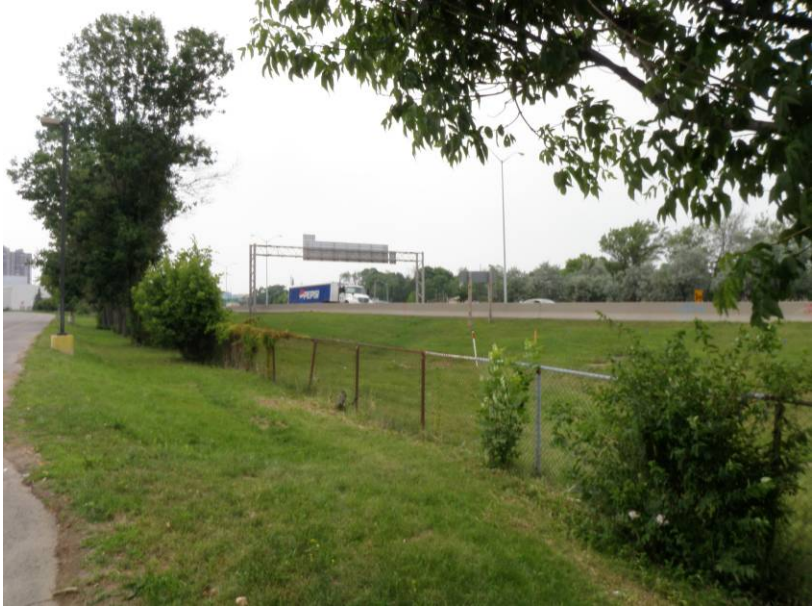
Phase I Environmental Site Assessment Rideau Campus, University of Ottawa		1329-1101
Photo ID 54

Date 11/07/2011		
Direction W		
Description View of highway 417 towards the west. U of O property fence line in forefront.

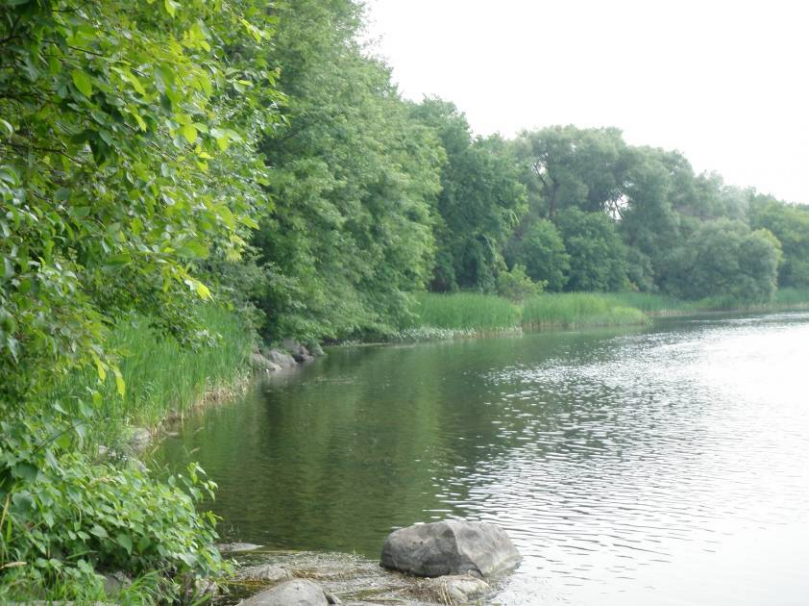
Phase I Environmental Site Assessment Rideau Campus, University of Ottawa		1329-1101
Photo ID 55

Date 11/07/2011		
Direction S		
Description View of the south side bank of the Rideau River.

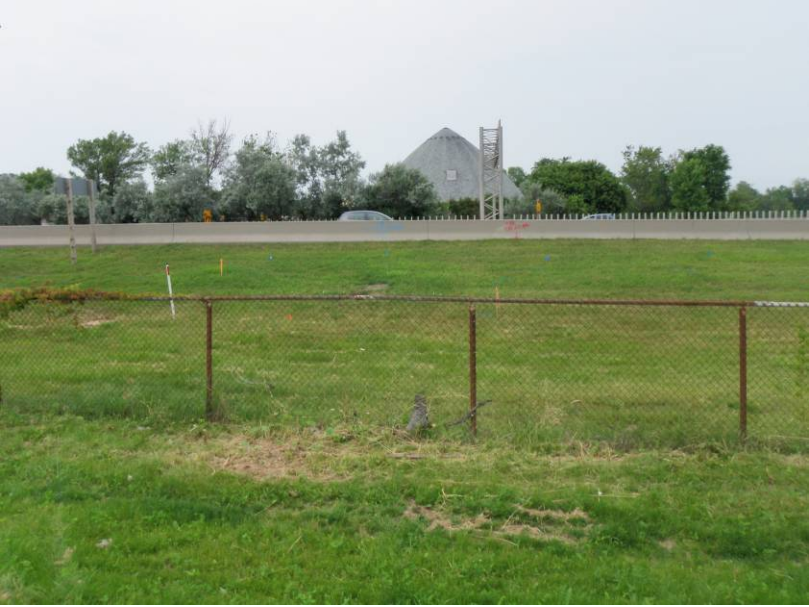
Phase I Environmental Site Assessment Rideau Campus, University of Ottawa		1329-1101
Photo ID 56

Date 11/07/2011		
Direction N		
Description View north towards highway 417 and City of Ottawa municipal yard (large cone in background).

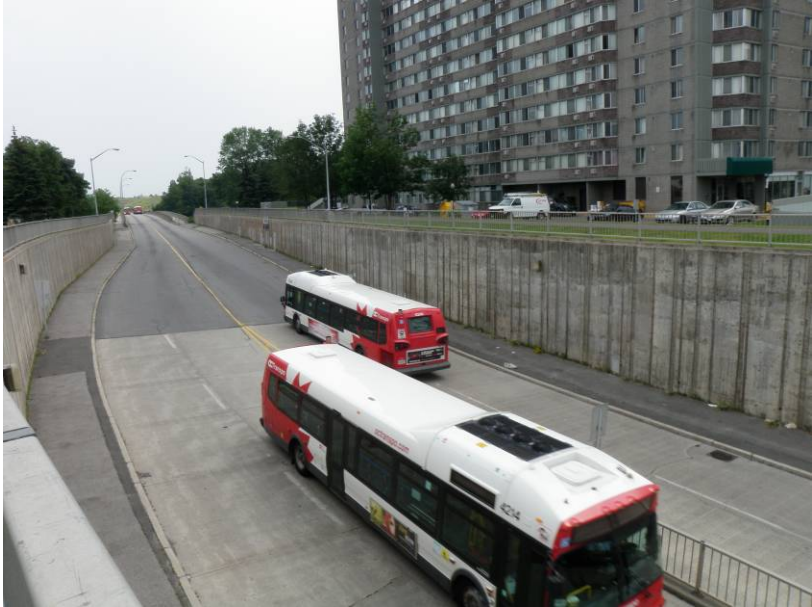
Phase I Environmental Site Assessment Rideau Campus, University of Ottawa		1329-1101
Photo ID 57

Date 11/07/2011		
Direction SSW		
Description View of transitway looking south towards the Rideau River. Residential properties in the background to the right.

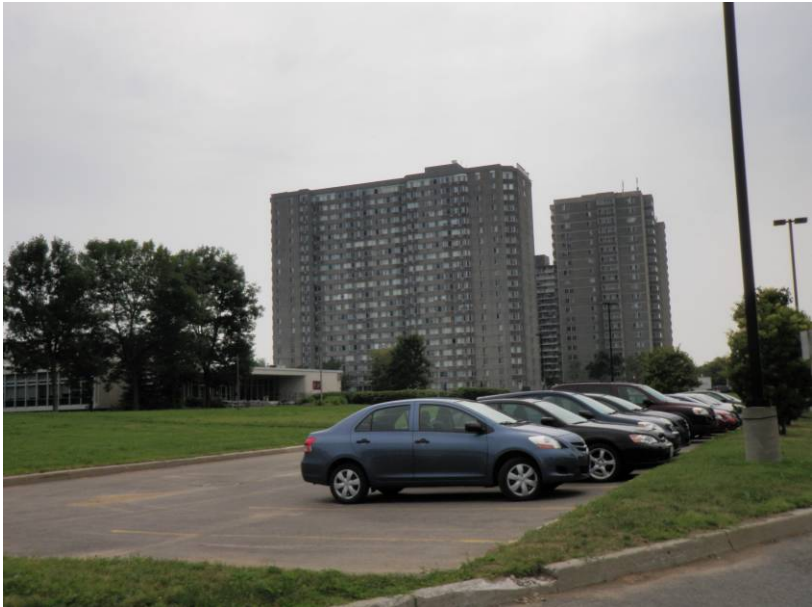
Phase I Environmental Site Assessment Rideau Campus, University of Ottawa		1329-1101
Photo ID 58

Date 11/07/2011		
Direction SW		
Description 200 Lees Ave. Building C and parking lot for Building C. Residential properties in the background, west of transitway.
