**Supplementary Phase 2 Environmental Site
Assessment and Remedial Options Assessment
191 and 193 Lees Avenue
Ottawa, Ontario**

Prepared for:
City of Ottawa
Real Estate Partnerships & Development Office
Realty Services Branch
110 Laurier Ave. W., 5th Floor
Ottawa, ON K1P 1J1

Document ID: 11-200-11_Lees Ave Suppl Phase 2 ESA and ROA_R0

February 4, 2013

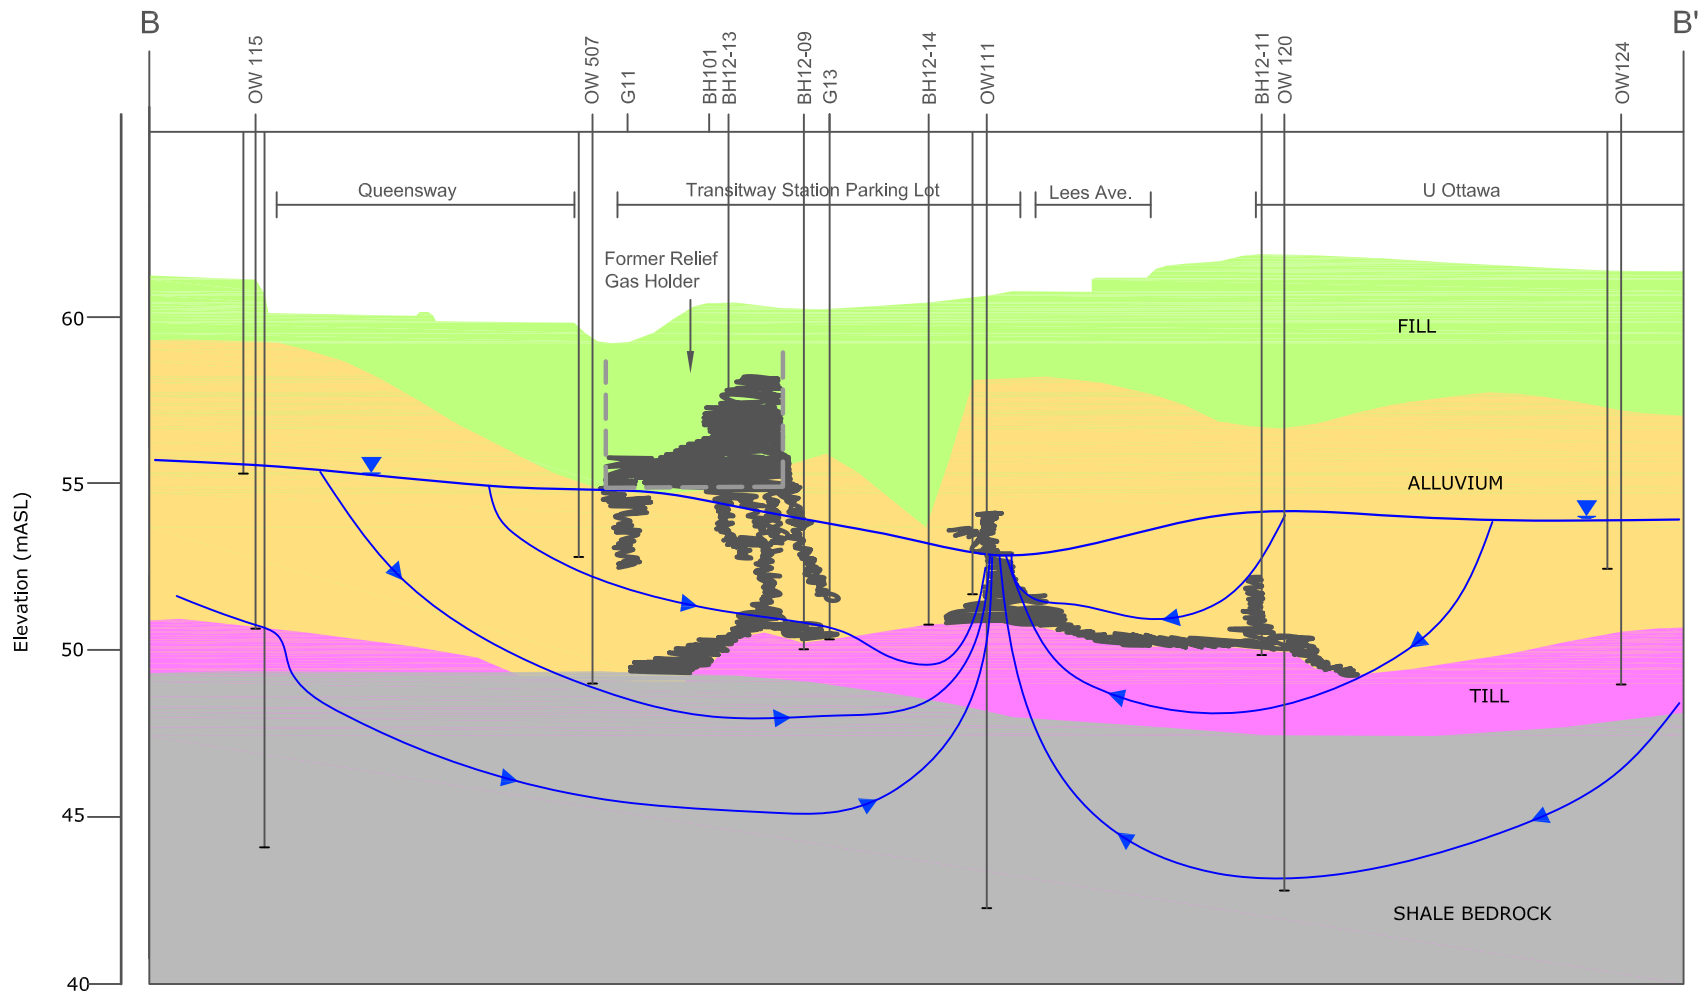
Figure 2.2 illustrates the CSM along a vertical cross section constructed from southwest to northeast across the site. Figure 2.3 shows the CSM along a vertical cross section constructed northwest to southeast east of the Transitway. Figure 2.1 shows the location of the cross sections as well as the site layout, historical gas plant structures, and boreholes and monitoring wells. Figures 2.2 and 2.3 show the geological and hydrostratigraphic units, the occurrence of buried former gas plant structures that are APECs today, the pattern of groundwater flow to the deep groundwater collection system installed below the Transitway bus lanes, and the presence of pooled and residual saturation coal tar in the subsurface of the site. Figures 2.2 and 2.3 are based on current and historical investigations including the results of the Supplementary Phase 2 ESA borehole drilling and sampling.

The dense till is absent in several areas below the Transitway Station parking lot and below the Transitway bus lanes. The upper few metres of the bedrock are weathered and fractured.

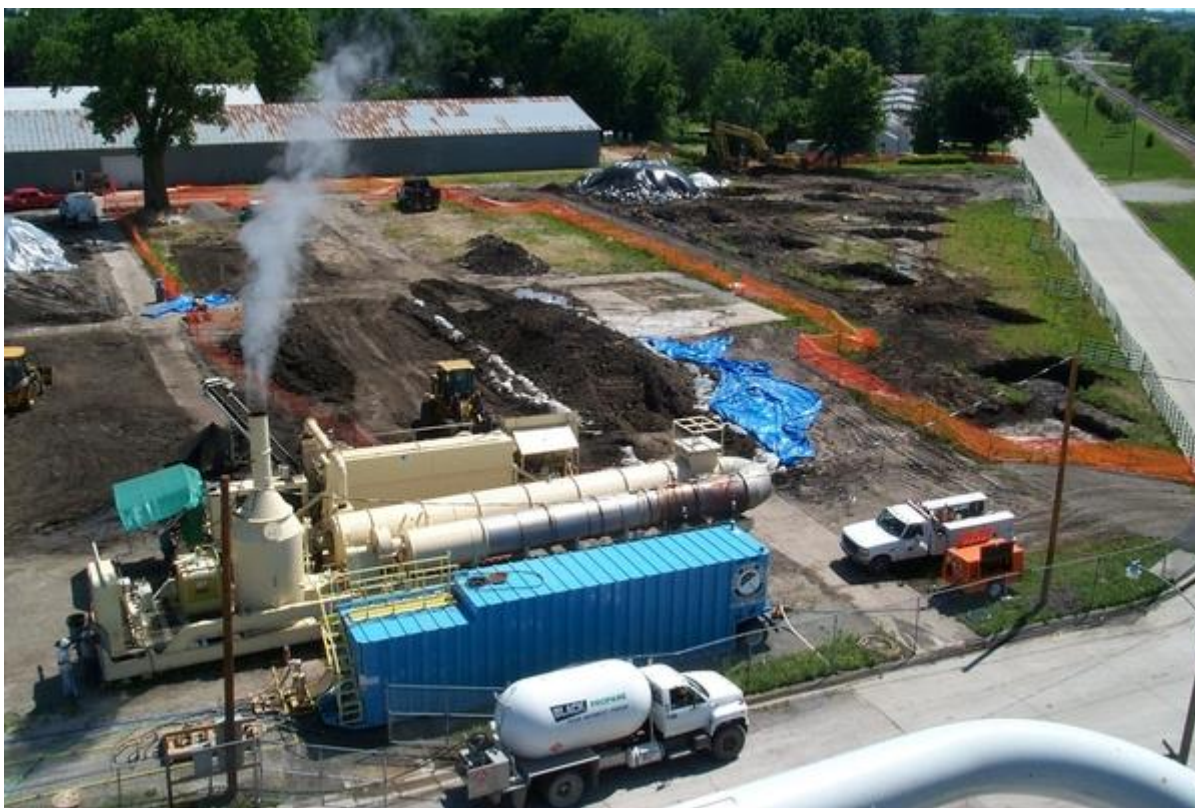
Figure 5.2 Surface Equipment for Ex-Situ Thermal Desorption Treatment

Figure 5.2 shows the surface equipment required for ex-situ thermal desorption treatment at a site in New Jersey with a similar size to the 191 Lees Avenue parking lot.

Benefits of this technology include high production rates if using larger equipment and proven removal of total and carcinogenic PAHs. Limitations of this technology include potential air emissions of by-products that may need treatment, high organic content soil (e.g., peat) is not suitable, and wet soil (saturated) requires dewatering prior to treatment. Treatment rates range from 8 to 45 tons per hour depending on the size of dryer unit used. Estimated costs for thermal desorption range from approximately \$100 to \$200 per tonne of soil, including general contracting (excavation), confirmation sampling, management, permits and transportation.

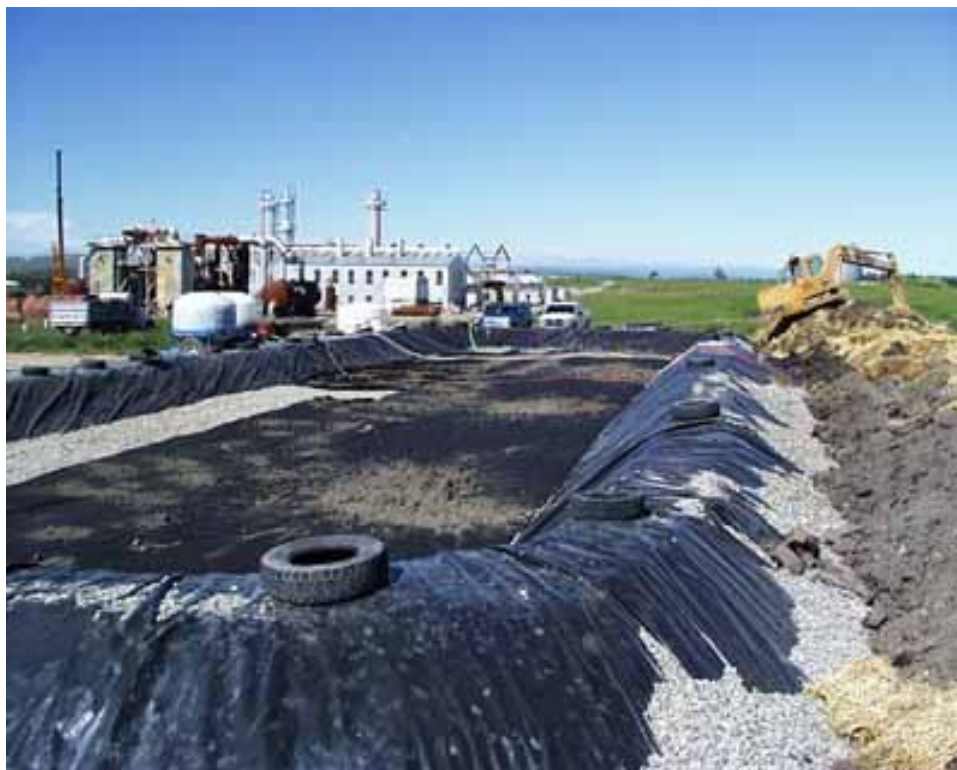
Figure 5.3 Example of Biopile Technology Used to Treat Petroleum Contamination

Biopile treatment is a variation of composting where excavated soils are mixed with soil amendments (i.e. nutrients, moisture, or bulking agents such as wood chips) and placed in piles in a treatment area. Typically, biopiles require a leachate collection system and some form of aeration. Figure 5.3 shows an example of a biopile used to treat petroleum contamination.

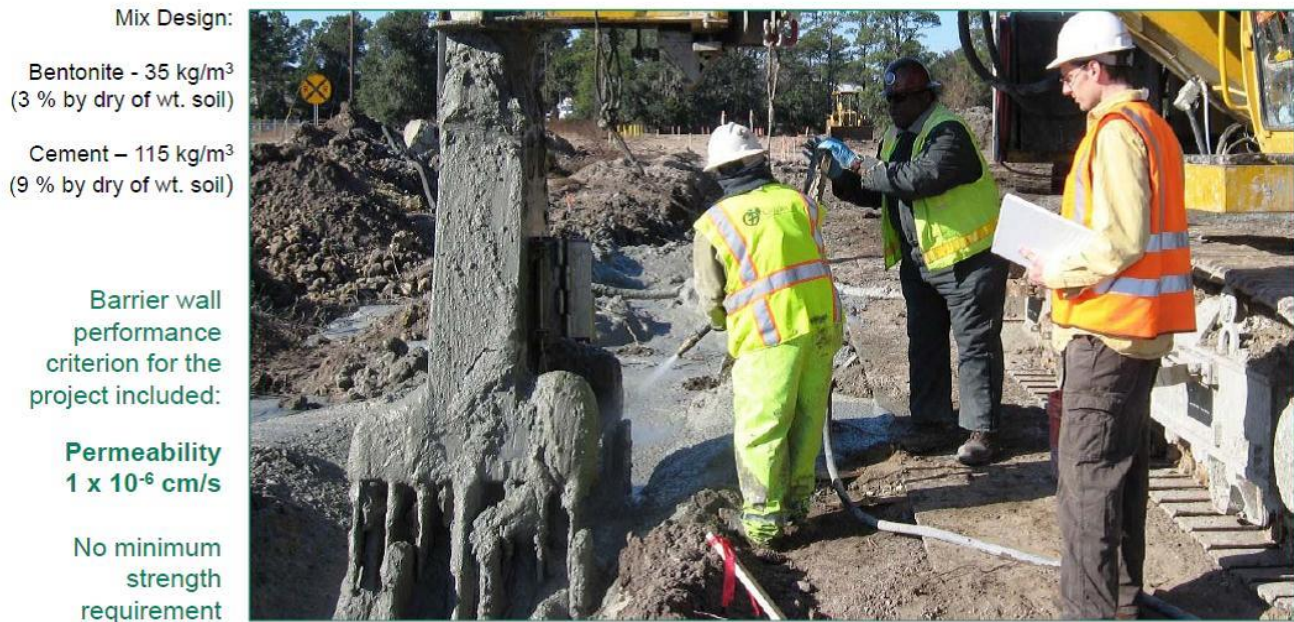
Figure 5.7 Outer Barrier Wall Construction using Cutter Soil Mixing at US EPA's Brunswick, Georgia Superfund Site

An attractive feature of cement-based S/S is that it can incorporate contaminant sorbents such as clays and activated carbon used either as a pre-treatment or as additives in the cement mix. Figure 5.7 shows a soil mix barrier wall (soil+cement+clay) being constructed at a Superfund site with a design criterion of 1×10^{-8} m/s.
