Phase One Environmental Site Assessment

Proposed Site Redevelopment – 200 Lees Avenue, Ottawa, Ontario

A001049

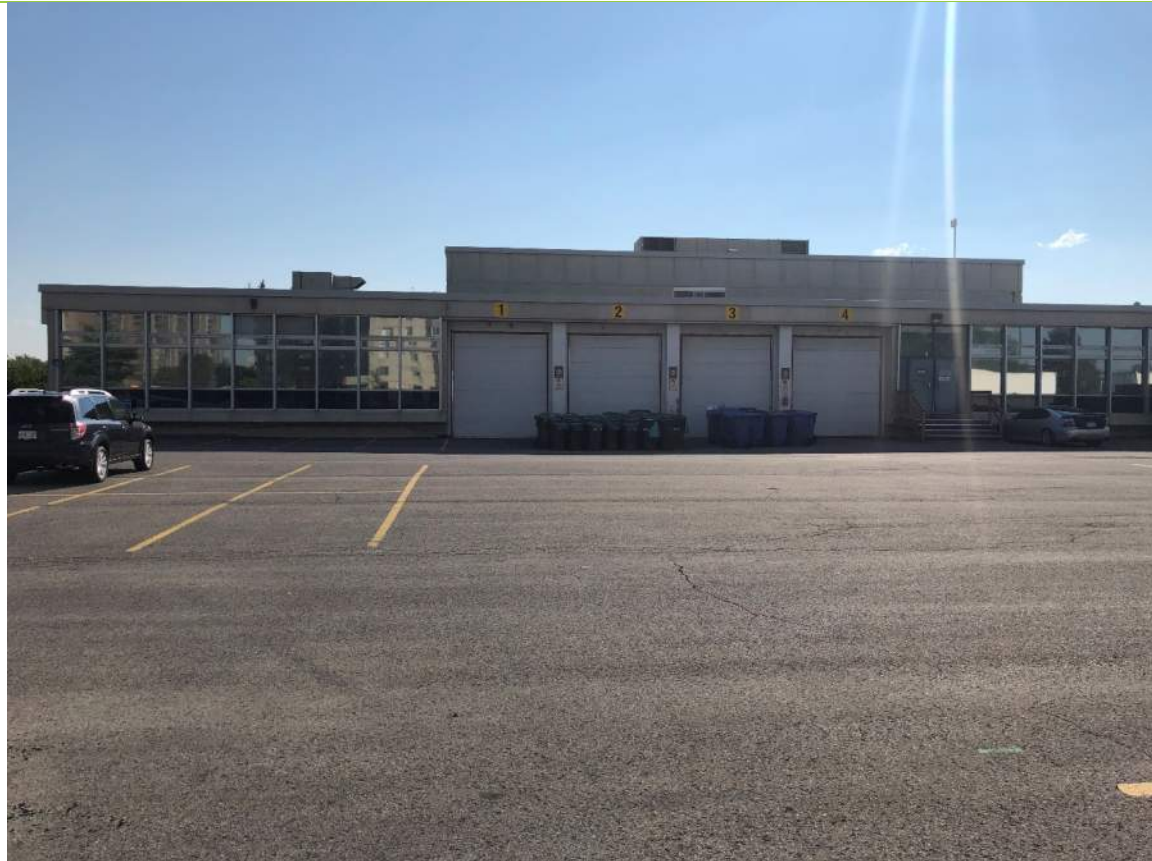
Site Location		
Site Location – Part of 200 Lees Avenue, Ottawa, Ontario		
Photo #	Date	Cardinal Direction
1	07/08/20	East
Description		
<p>Photo of Site. From west parking lot looking east. To the east is Building C. To the west are residential apartment towers. To the north is OC Transpo Lees Station and Highway 417.</p>

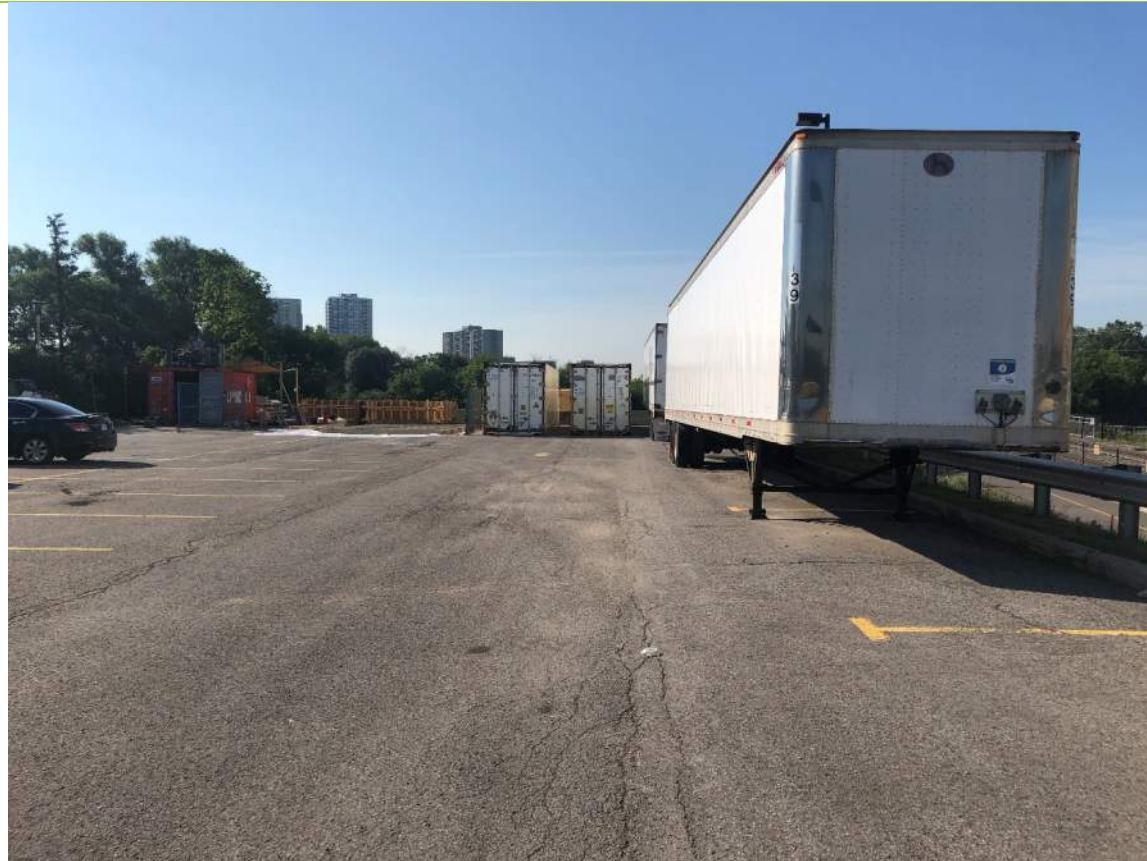
Site Location		
Site Location – Part of 200 Lees Avenue, Ottawa, Ontario		
Photo #	Date	Cardinal Direction
2	07/08/20	South
Description		
<p>Photo of Site. From west parking lot looking south. Storage containers used to store hand sanitizer during COVID-19. To the east is Building C. To the west are residential apartment towers. To the north is OC Transpo Lees Station and Highway 417.</p>

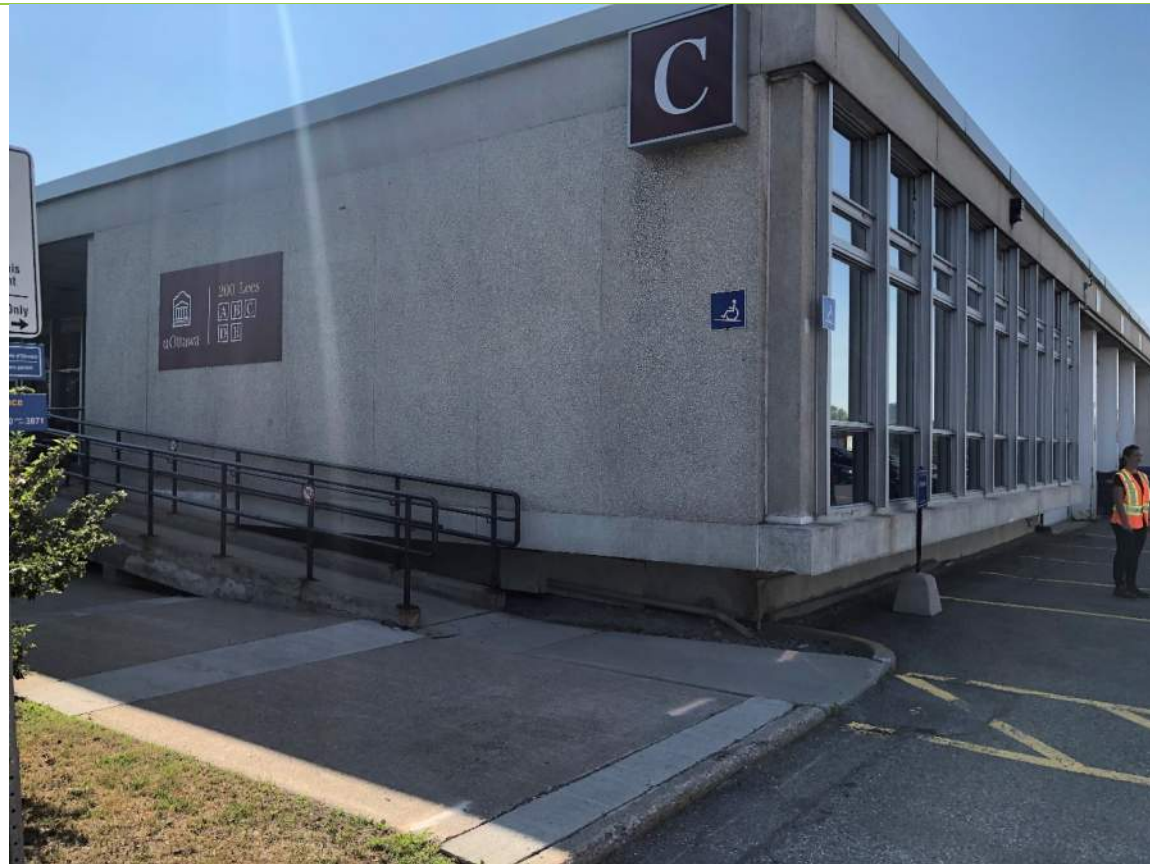
Site Location		
Site Location – Part of 200 Lees Avenue, Ottawa, Ontario		
Photo #	Date	Cardinal Direction
3	07/08/20	South
Description		
<p>Photo of Site. From west parking lot looking south southeast. Building C entrance to the left. Exterior materials include stucco and concrete block mortar.</p>

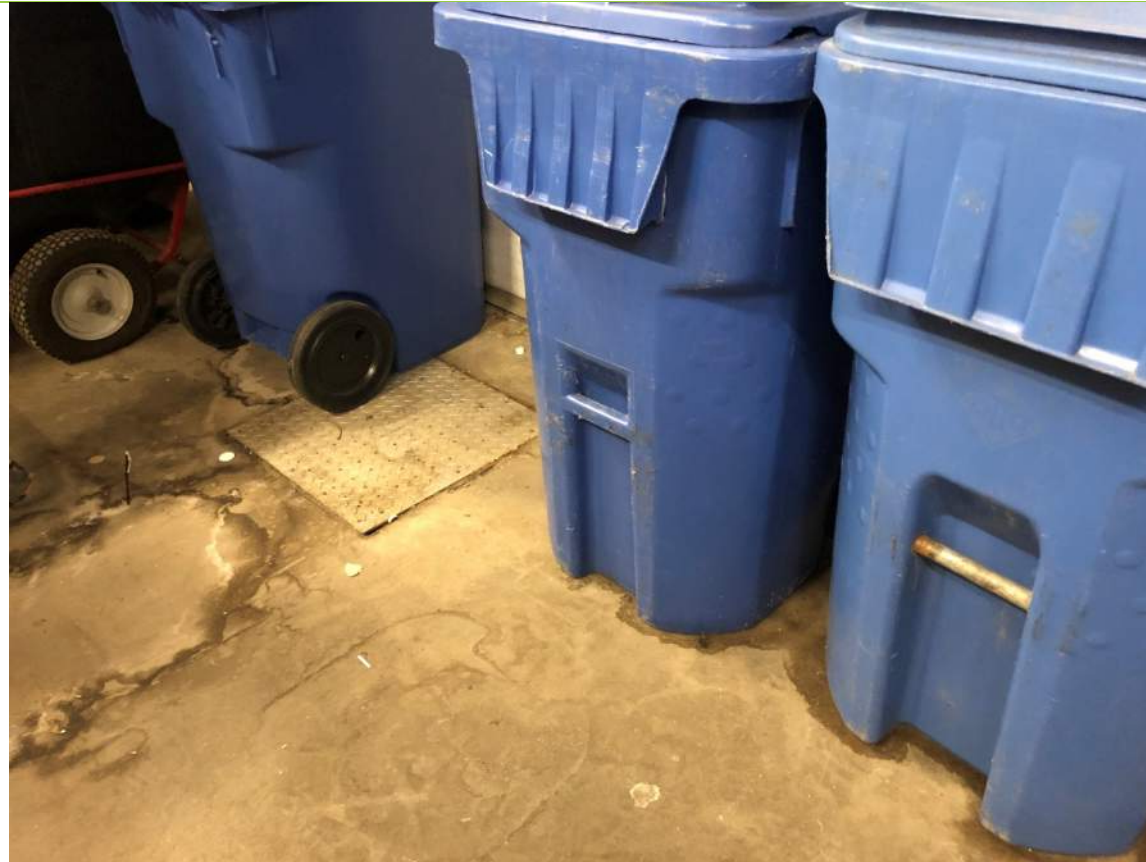
Site Location		
Site Location – Part of 200 Lees Avenue, Ottawa, Ontario		
Photo #	Date	Cardinal Direction
4	07/08/20	-
Description		
<p>Photo of Building C garage interior. Minor staining likely do to condensation.</p>

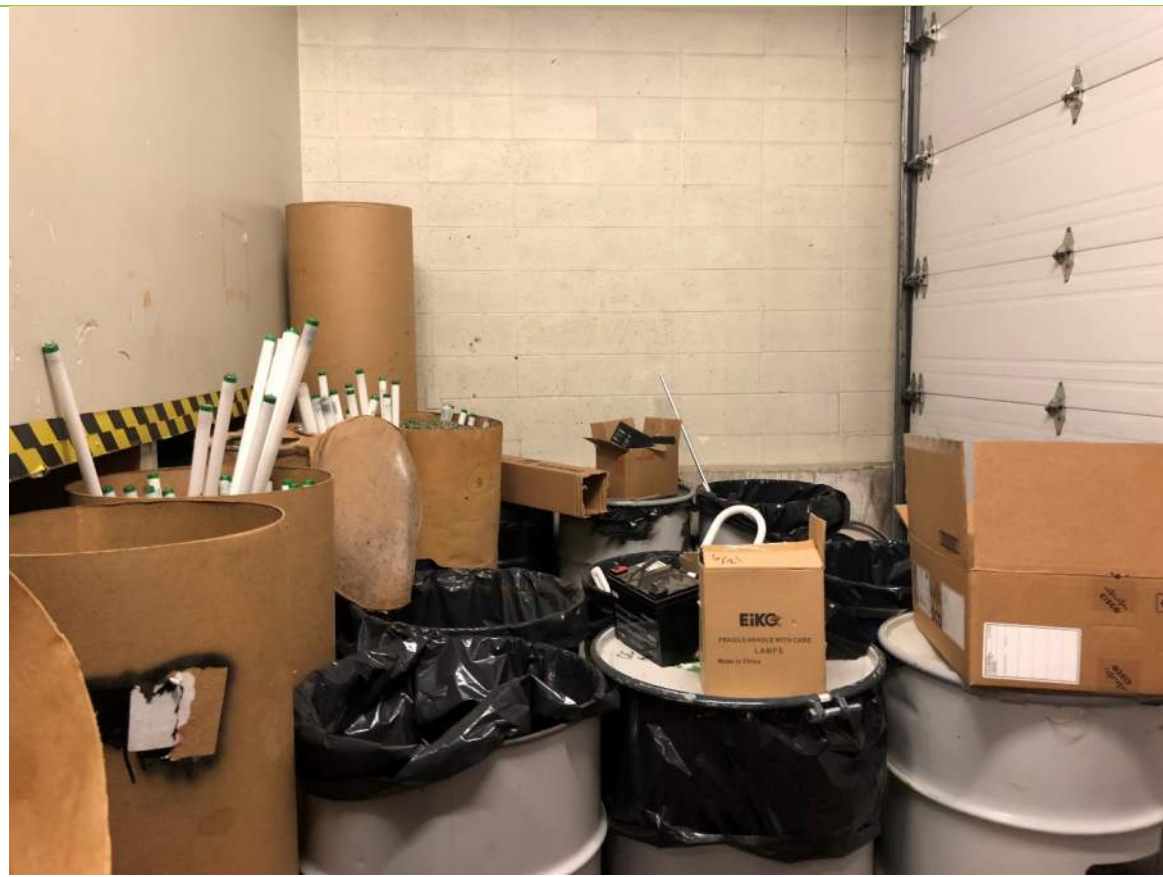
Site Location		
Site Location – Part of 200 Lees Avenue, Ottawa, Ontario		
Photo #	Date	Cardinal Direction
5	07/08/20	-
Description		
<p>Photo of Building C interior—garage. Storage of used fluorescent bulbs and batteries. No evidence of spills or leaking from batteries.</p>

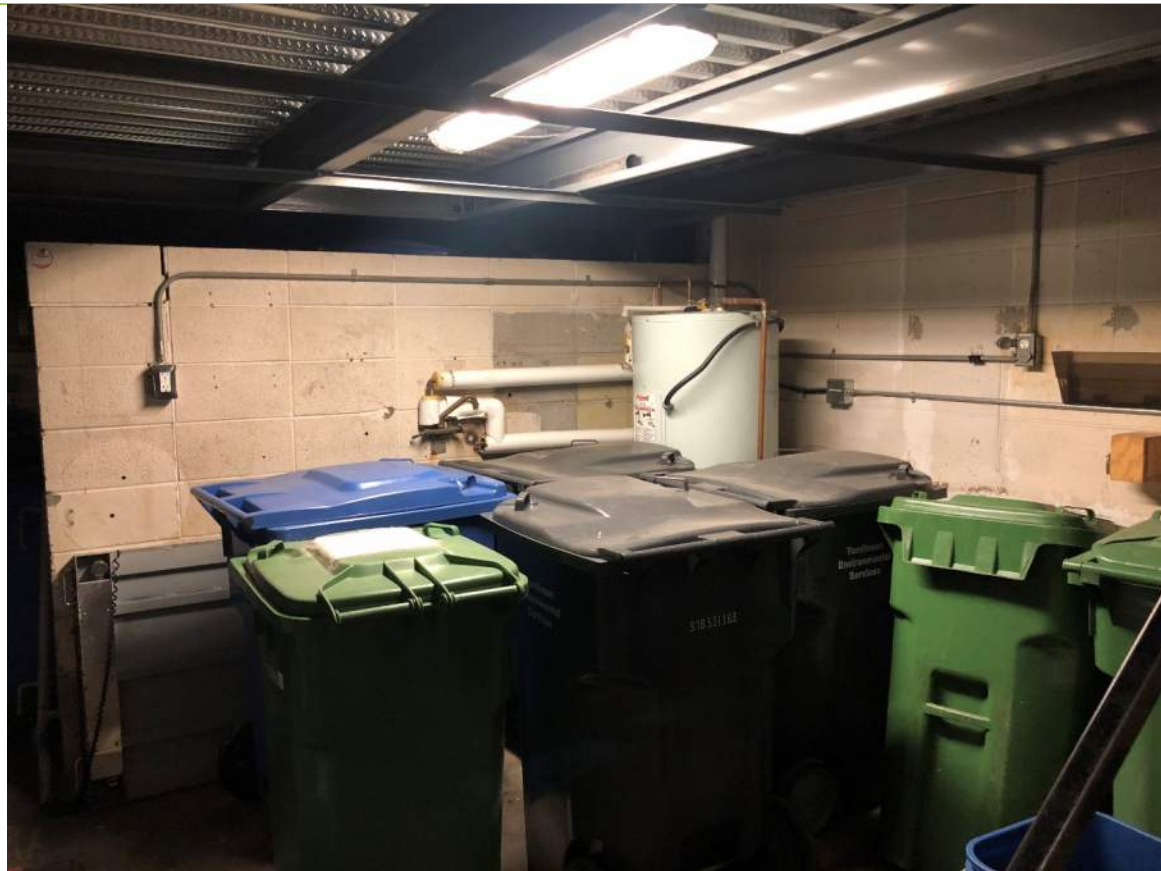
Site Location		
Site Location – Part of 200 Lees Avenue, Ottawa, Ontario		
Photo #	Date	Cardinal Direction
5	07/08/20	-
Description		
<p>Photo of Building C interior—garage. Waste bins and hot water tank. Tank was in good condition—no signs of rust, damage, or leaks.</p>

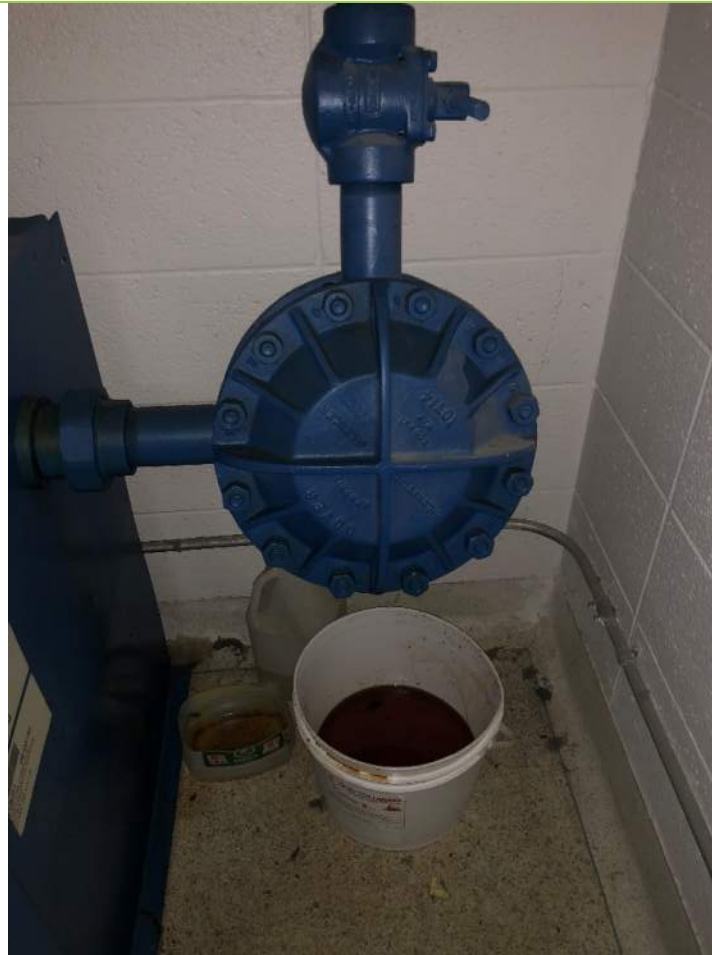
Site Location		
Site Location – Part of 200 Lees Avenue, Ottawa, Ontario		
Photo #	Date	Cardinal Direction
6	07/08/20	-
Description		
<p>Photo of interior of Building C Elevator mechanical room. Lubricant dripping from elevator motor. Catch bucket in place and no signs of staining on floor.</p>

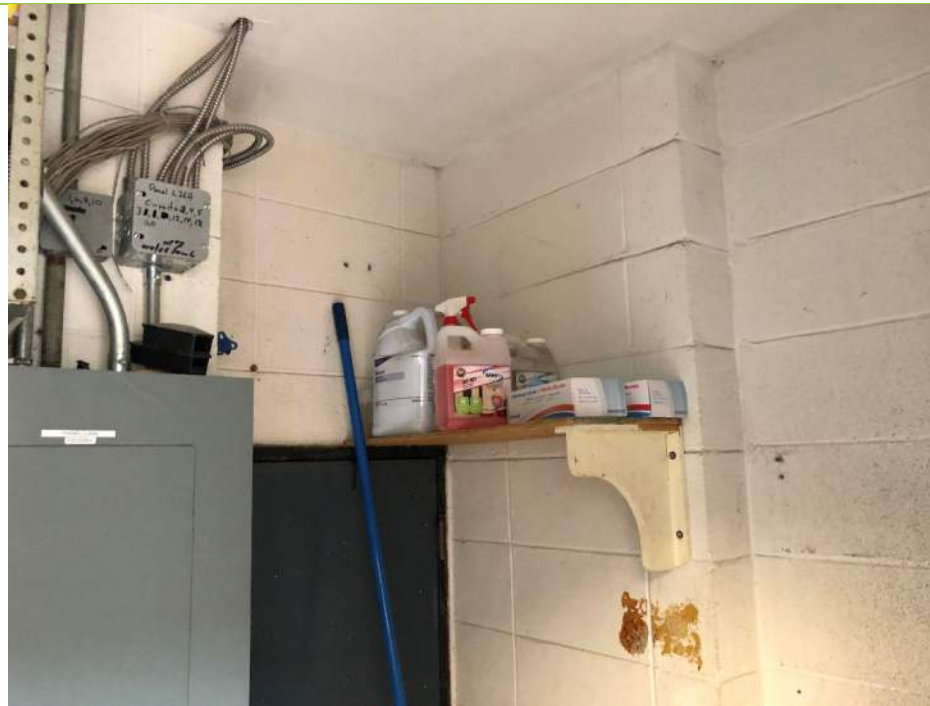
Site Location		
Site Location – Part of 200 Lees Avenue, Ottawa, Ontario		
Photo #	Date	Cardinal Direction
7	07/08/20	-
Description		
<p>Photo of Building C interior— C109 storage room. Stored cleaners and supplies. No evidence of spills or staining.</p>

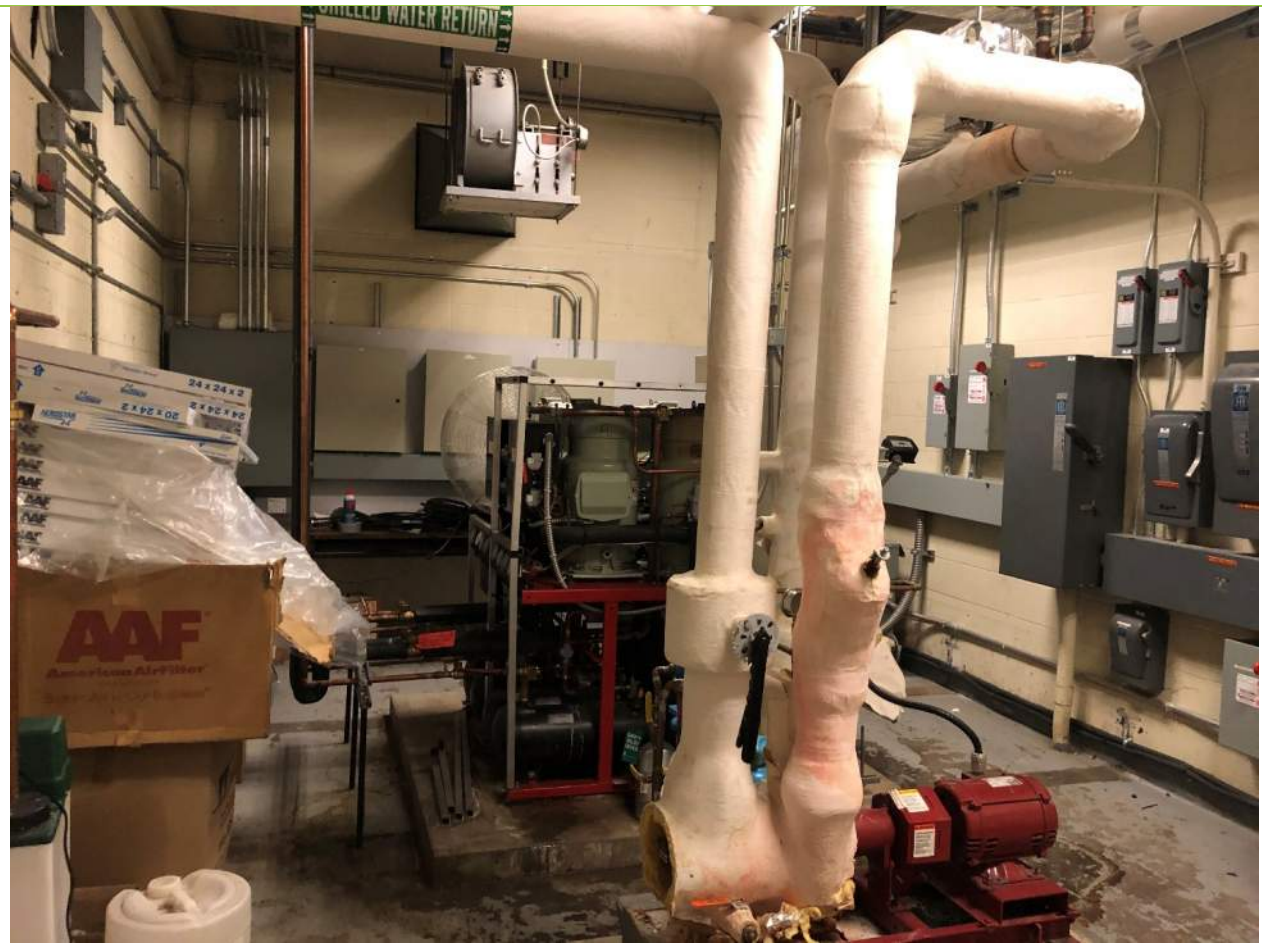
Site Location		
Site Location – Part of 200 Lees Avenue, Ottawa, Ontario		
Photo #	Date	Cardinal Direction
8	07/08/20	-
Description		
<p>Photo of interior—Building B mechanical room B151. Piping to and from air chilling inverter motor unit.</p>

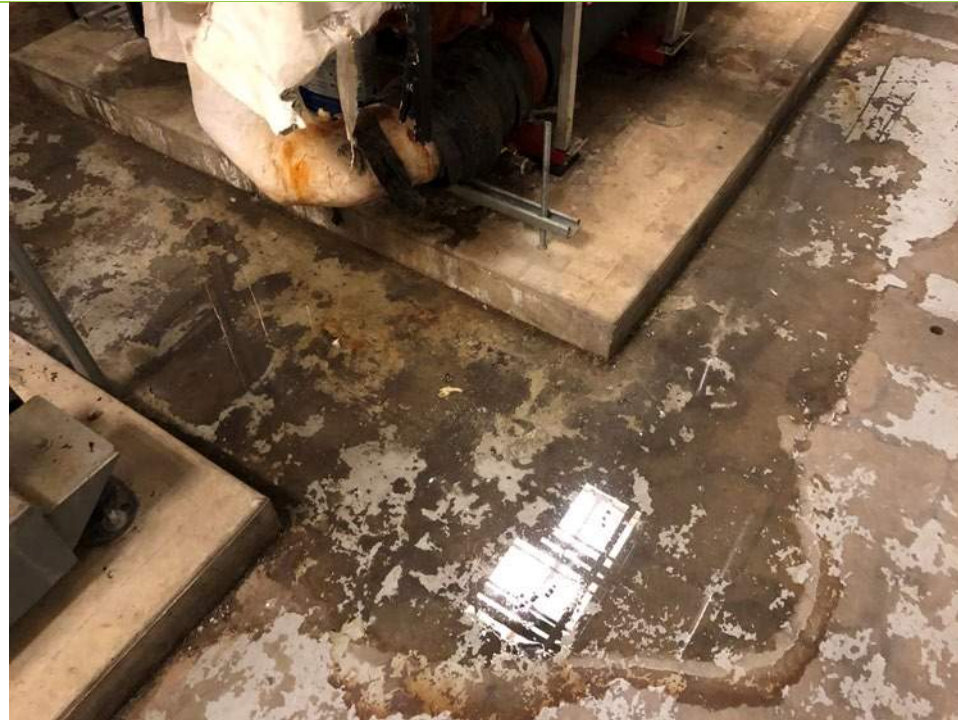
Site Location		
Site Location – Part of 200 Lees Avenue, Ottawa, Ontario		
Photo #	Date	Cardinal Direction
9	07/08/20	-
Description		
<p>Photo of interior—Building B mechanical room B151. Condensate pools and staining on ground around chilled water return piping.</p>

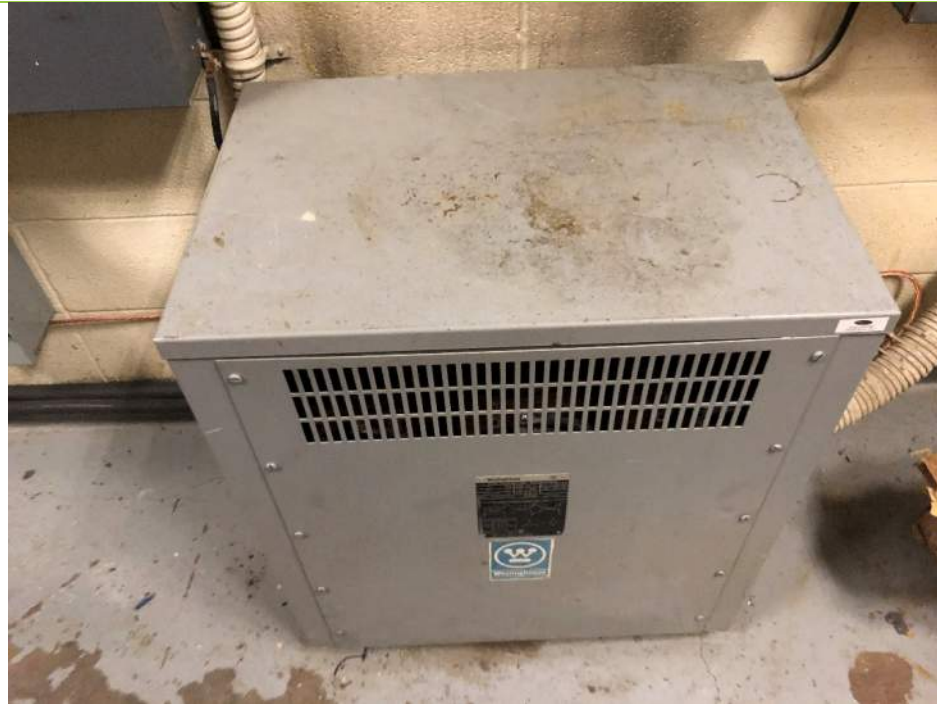
Site Location		
Site Location – Part of 200 Lees Avenue, Ottawa, Ontario		
Photo #	Date	Cardinal Direction
10	07/08/20	-
Description		
Photo of interior—Building B mechanical room B151. Dry style transformer.

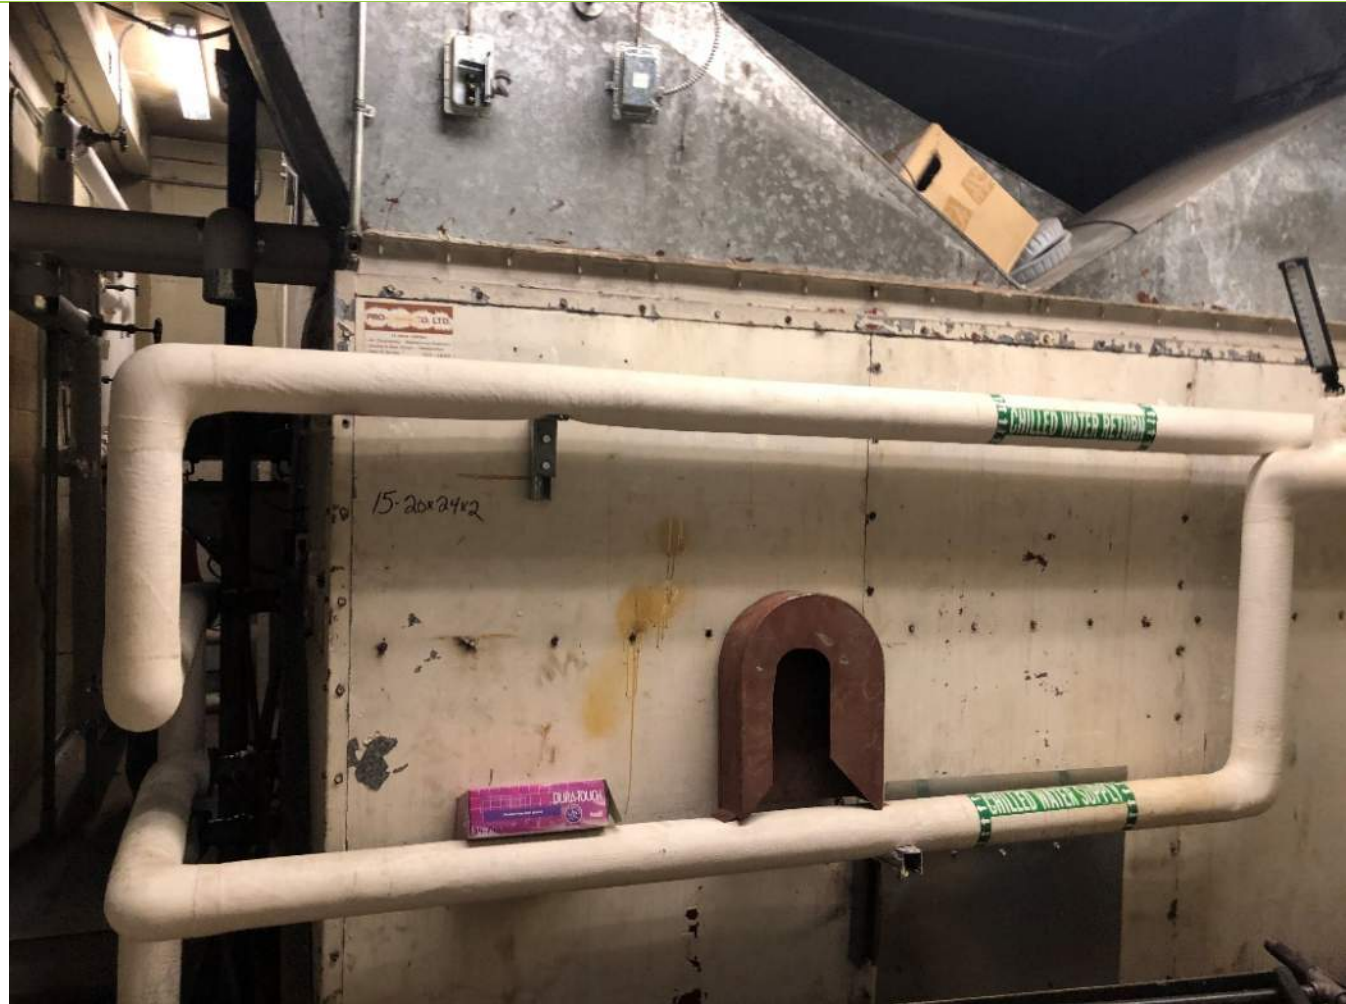
**Photo of interior—
Building B mechanical
room B150. Air
conditioning cabinet and
chilled water insulated
piping.**

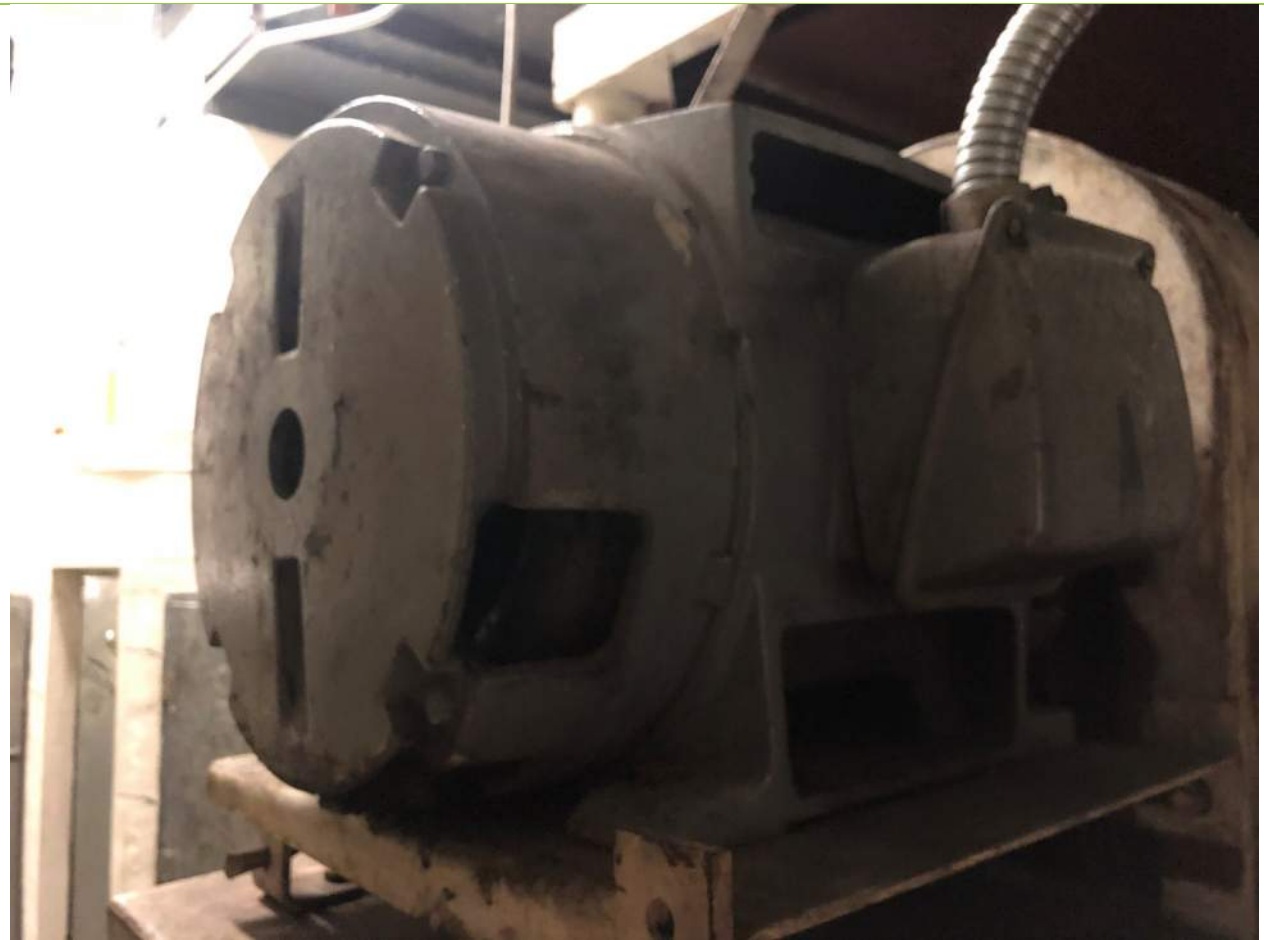
Site Location		
Site Location – Part of 200 Lees Avenue, Ottawa, Ontario		
Photo #	Date	Cardinal Direction
13	07/08/20	-
Description		
<p>Photo of interior—Building B mechanical room B151. HVAC blower unit.</p>

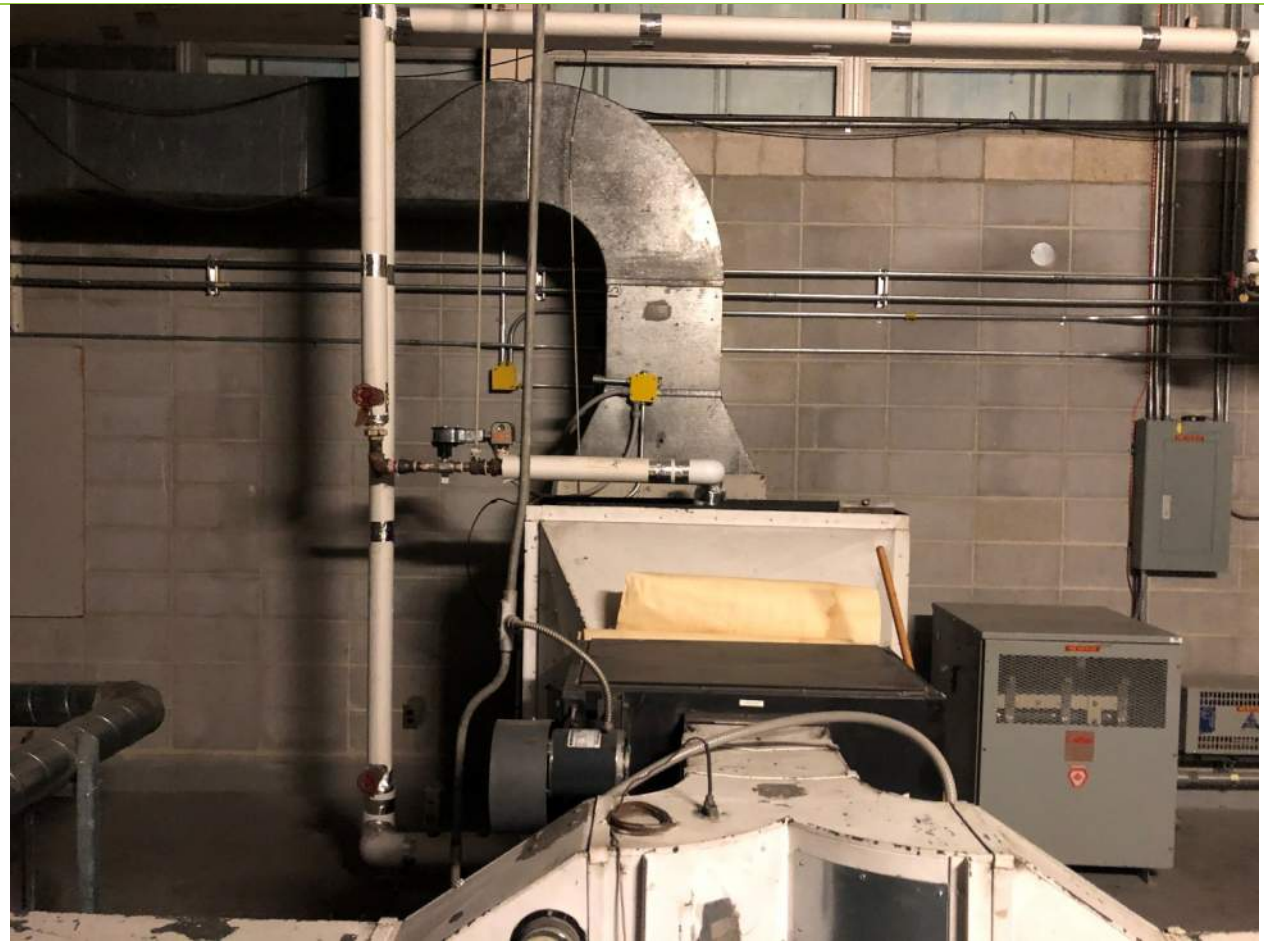
Site Location		
Site Location – Part of 200 Lees Avenue, Ottawa, Ontario		
Photo #	Date	Cardinal Direction
14	07/08/20	-
Description		
<p>Photo of interior—Building D mechanical room. HVAC ducts and HVAC inverter motor. Transformer located against wall is a dry style transformer.</p>

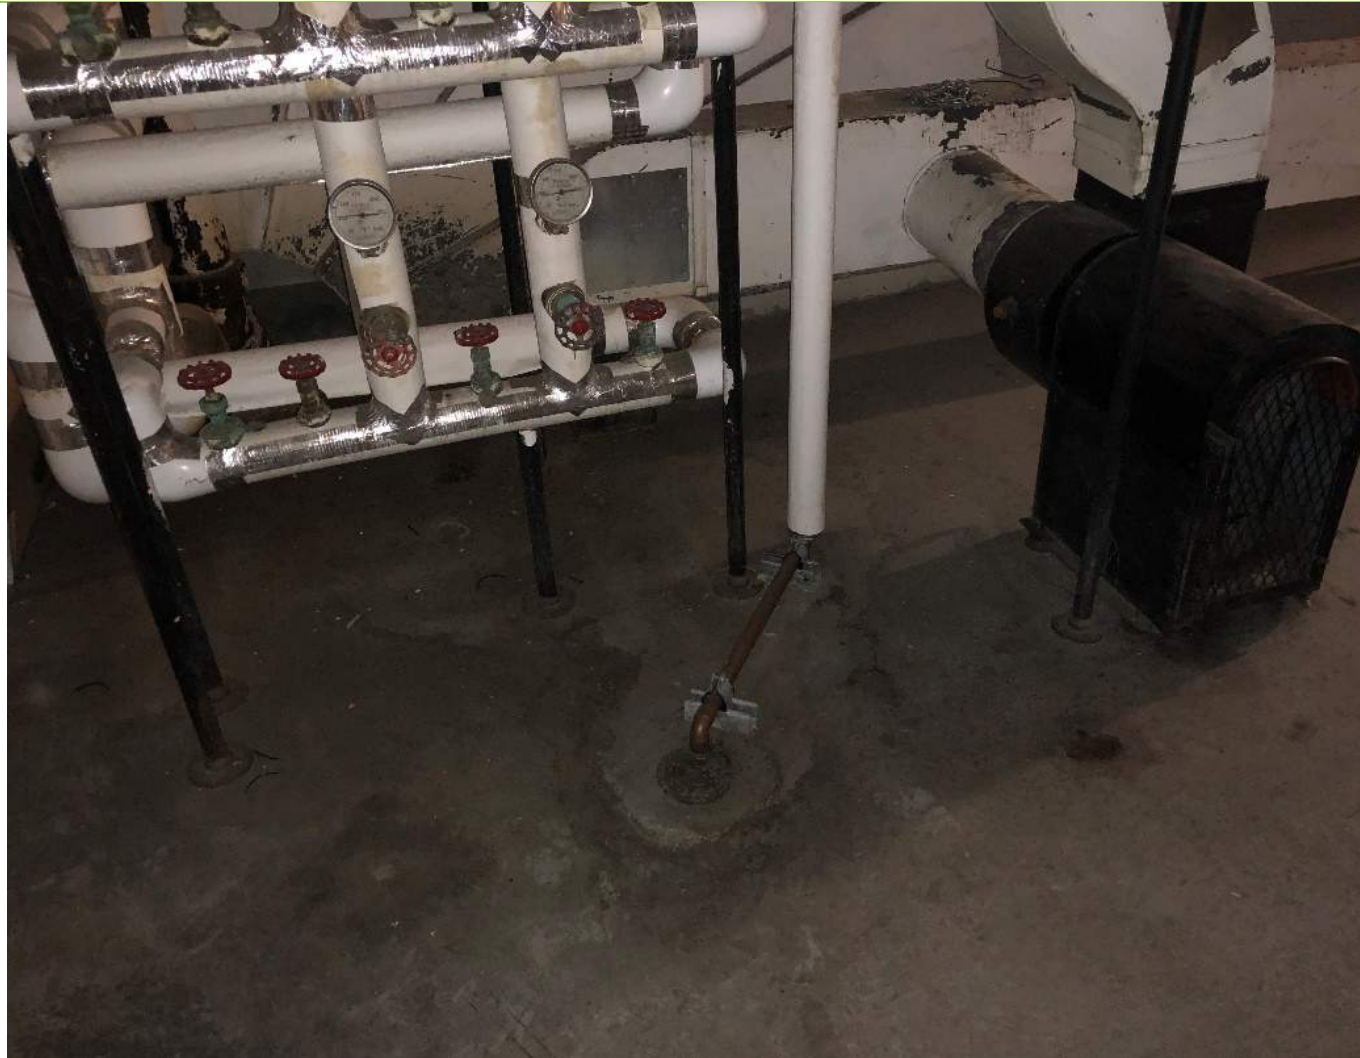
**Photo of interior—
Building D mechanical
room. Floor drain.
Evidence of minor
staining. No standing
condensate pools.**

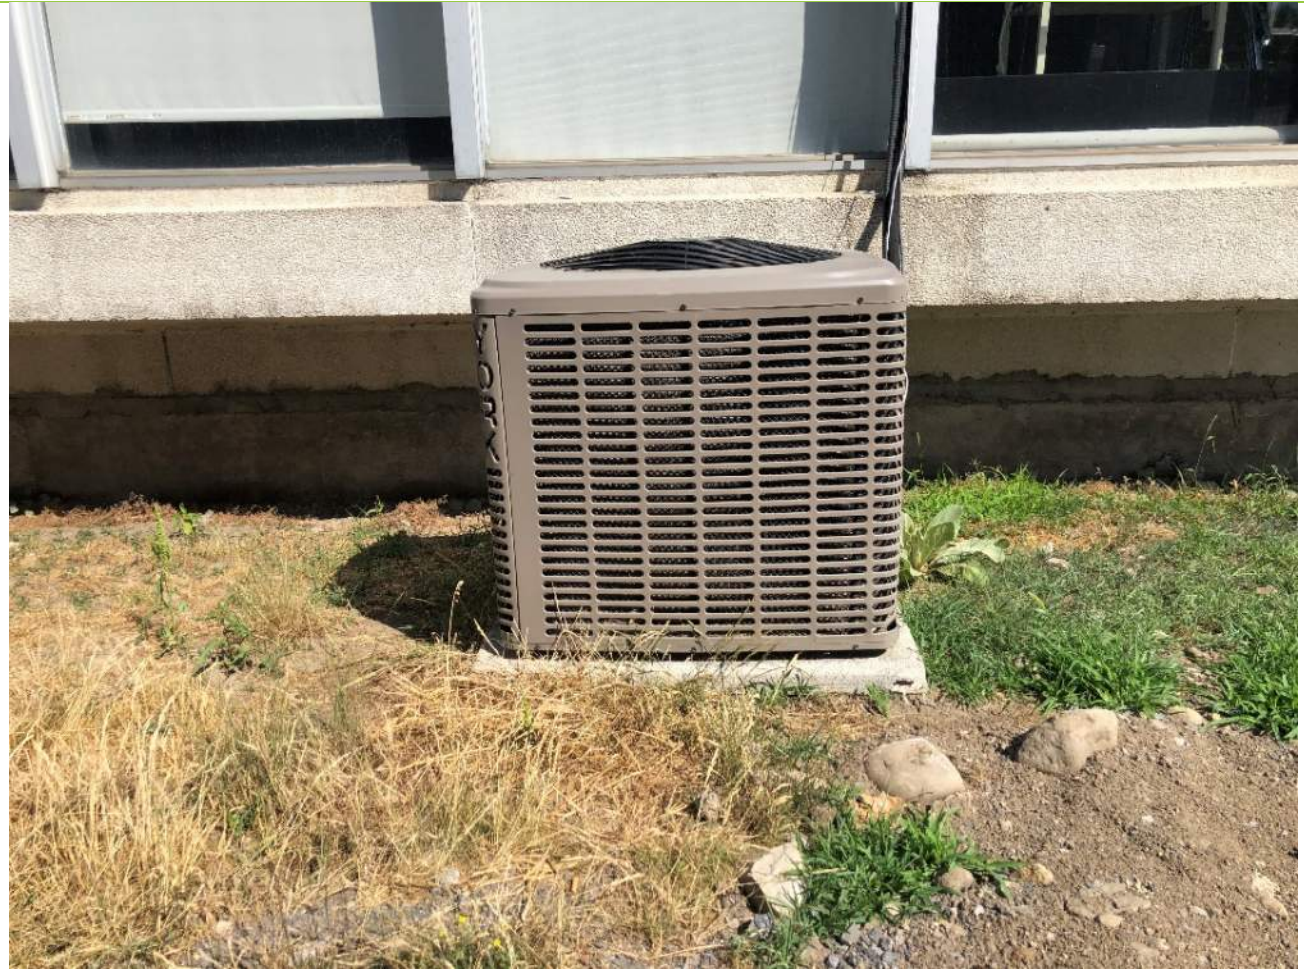
Site Location		
Site Location – Part of 200 Lees Avenue, Ottawa, Ontario		
Photo #	Date	Cardinal Direction
17	07/08/20	North
Description		
<p>Photo of site. Exterior AC unit attached to the south side of Building C. Good condition.</p>

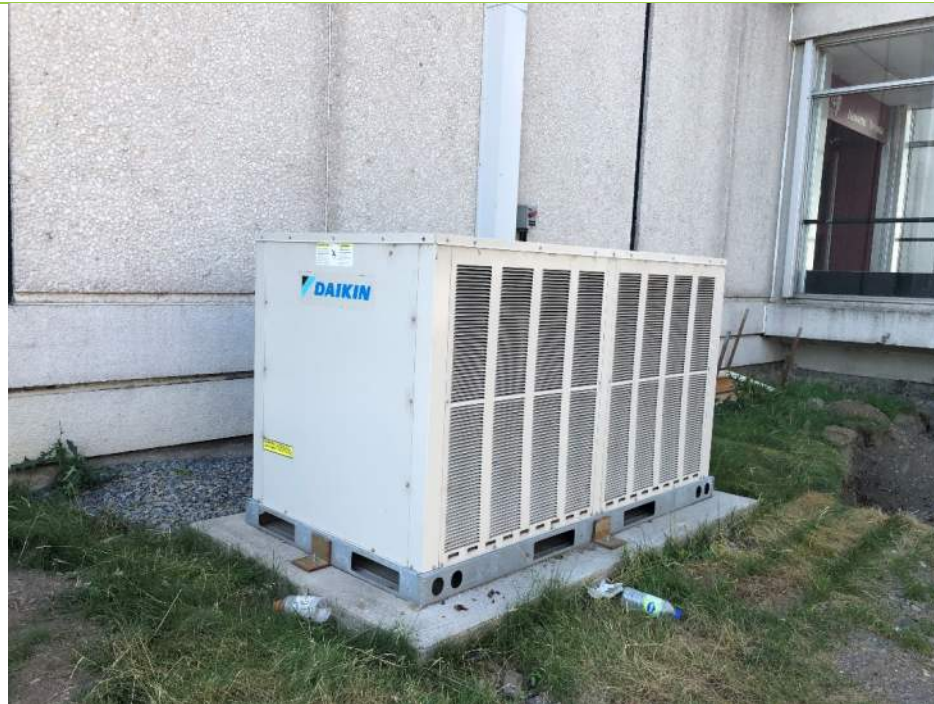
Site Location		
Site Location – Part of 200 Lees Avenue, Ottawa, Ontario		
Photo #	Date	Cardinal Direction
18	07/08/20	South
Description		
<p>Photo of site. Exterior AC unit attached to the north side of Building D. Good condition.</p>

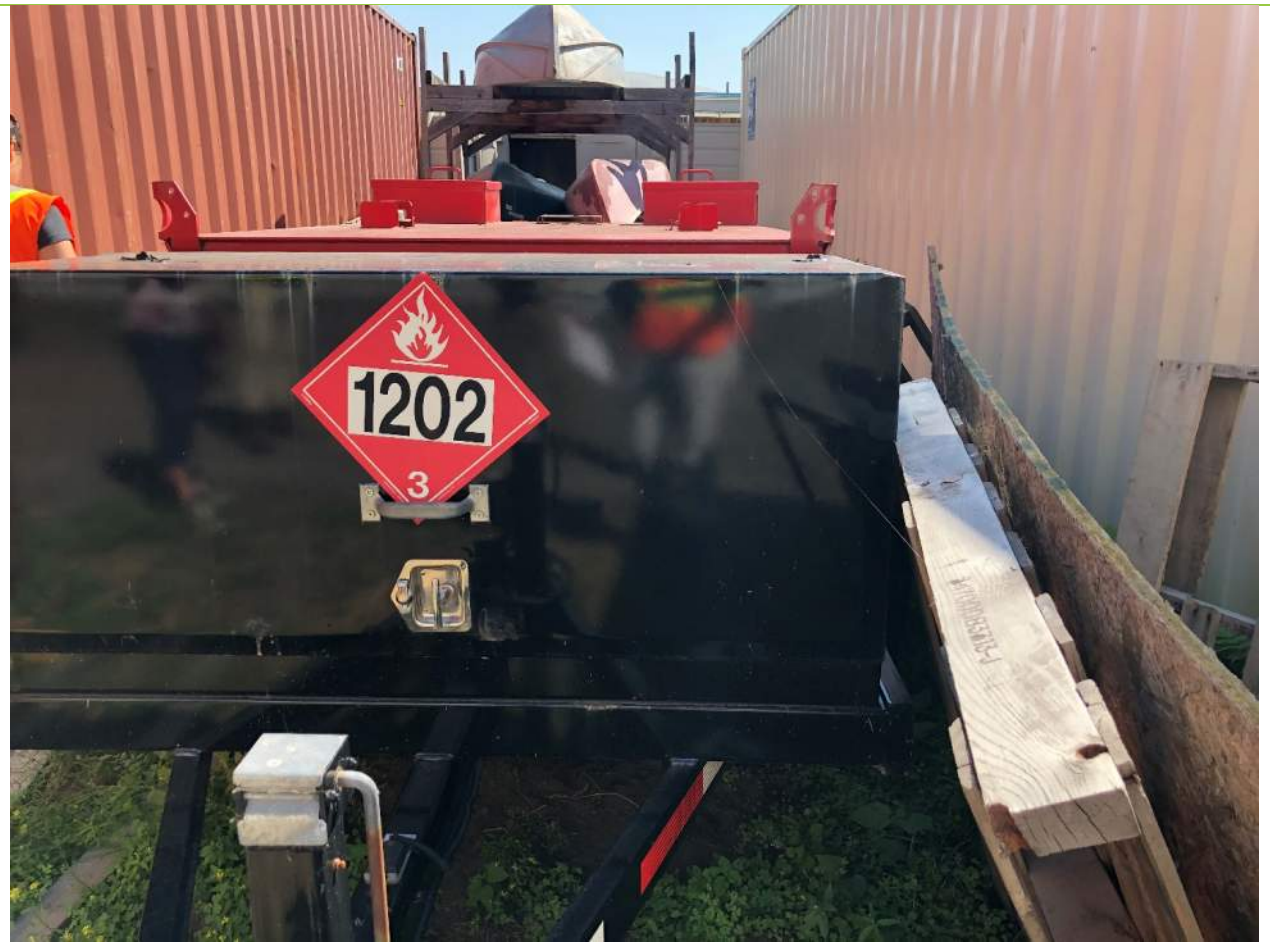
Site Location		
Site Location – Part of 200 Lees Avenue, Ottawa, Ontario		
Photo #	Date	Cardinal Direction
19	07/08/20	South
Description		
<p>Photo of site. Mobile fuel tank located in storage yard to the east of Building D. Contents unverified. Slight rusting of top of tank. No evidence of leaking or recent spills.</p>

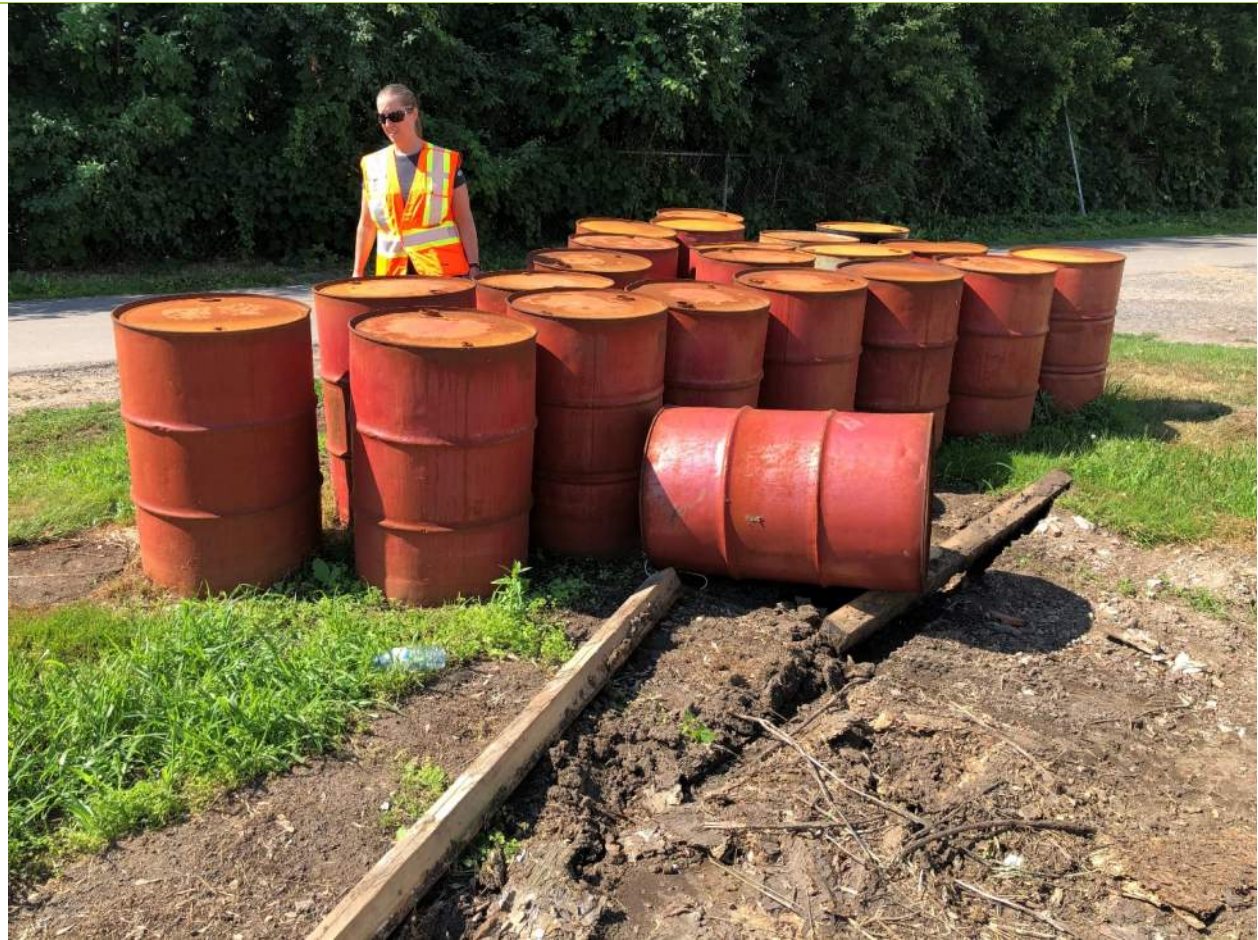
Site Location		
Site Location – Part of 200 Lees Avenue, Ottawa, Ontario		
Photo #	Date	Cardinal Direction
20	07/08/20	South
Description		
<p>Photo of site. Empty drums located in storage yard to the east of Building D. Contents unverified. Rusting. No evidence of leaking or recent spills.</p>

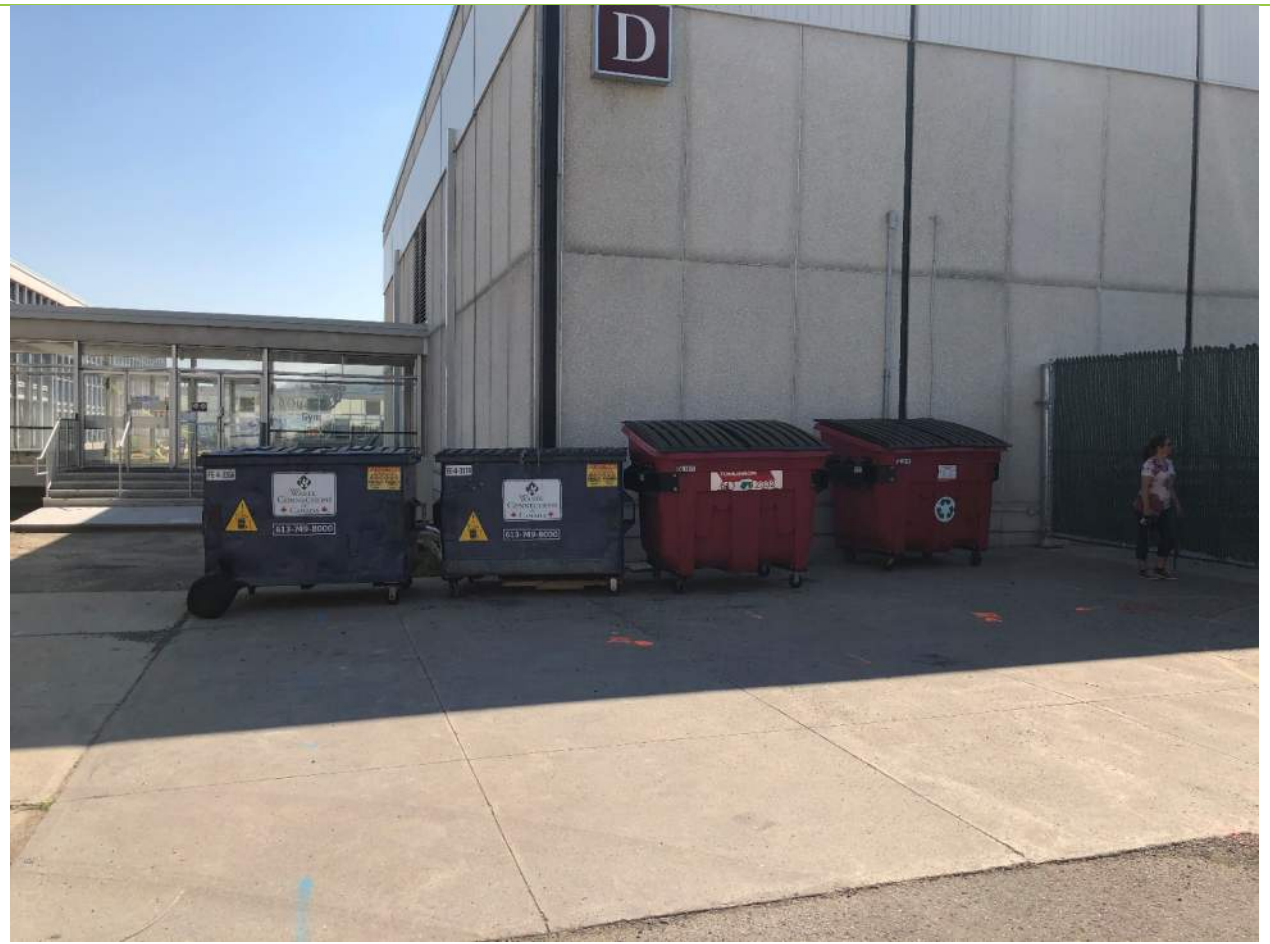
Site Location		
Site Location – Part of 200 Lees Avenue, Ottawa, Ontario		
Photo #	Date	Cardinal Direction
21	07/08/20	East
Description		
<p>Photo of site. Waste bins located at the northwest corner of Building D. No evidence of recent spills and no staining of the concrete.</p>

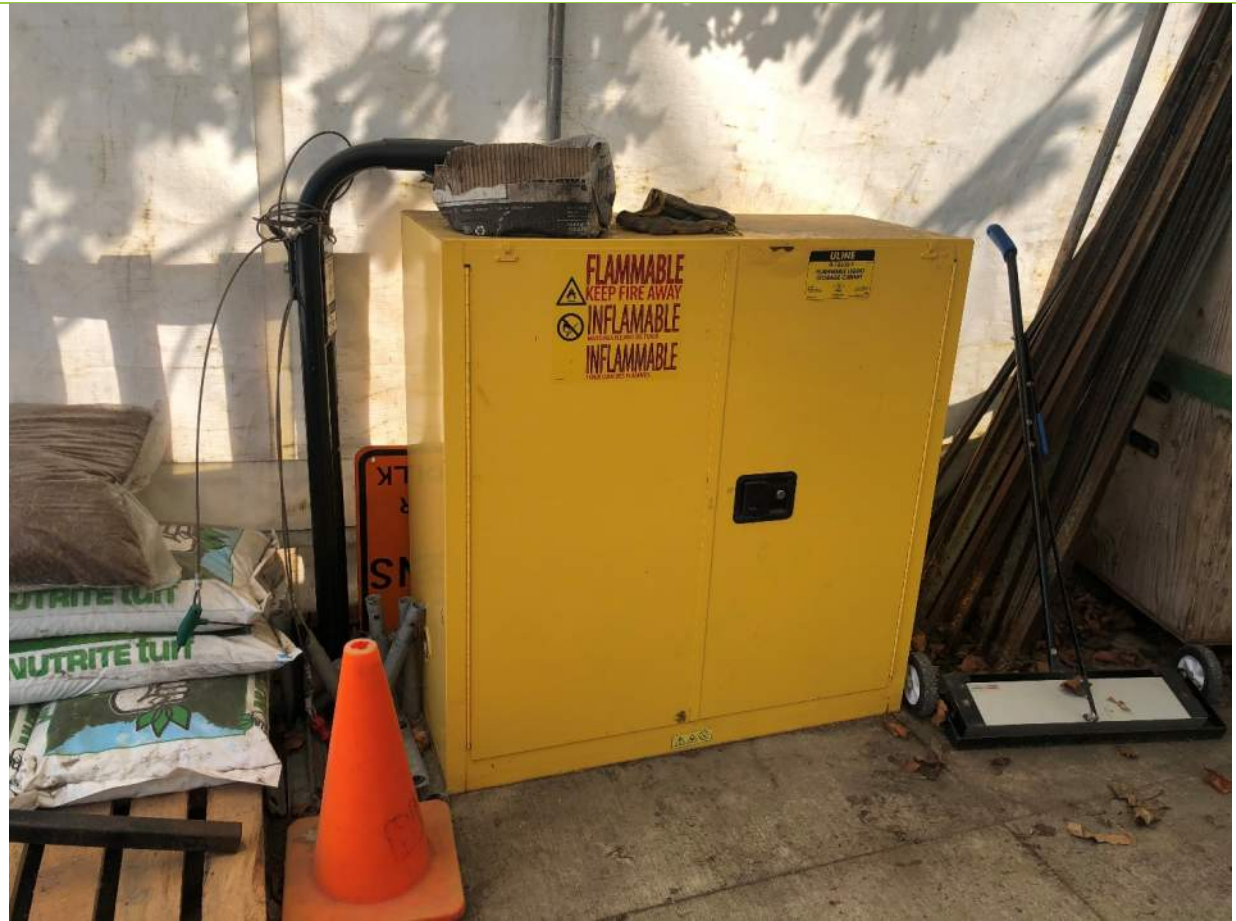
Site Location		
Site Location – Part of 200 Lees Avenue, Ottawa, Ontario		
Photo #	Date	Cardinal Direction
22	07/08/20	east
Description		
<p>Photo of site. Waste bins located at the east side of Building D. Flammable liquids locker was secured. No sign of rust or damage to locker. No evidence of stains or recent spills.</p>
