Phase One Environmental Site Assessment

Proposed Site Redevelopment – 200 Lees Avenue, Ottawa, Ontario

A001049

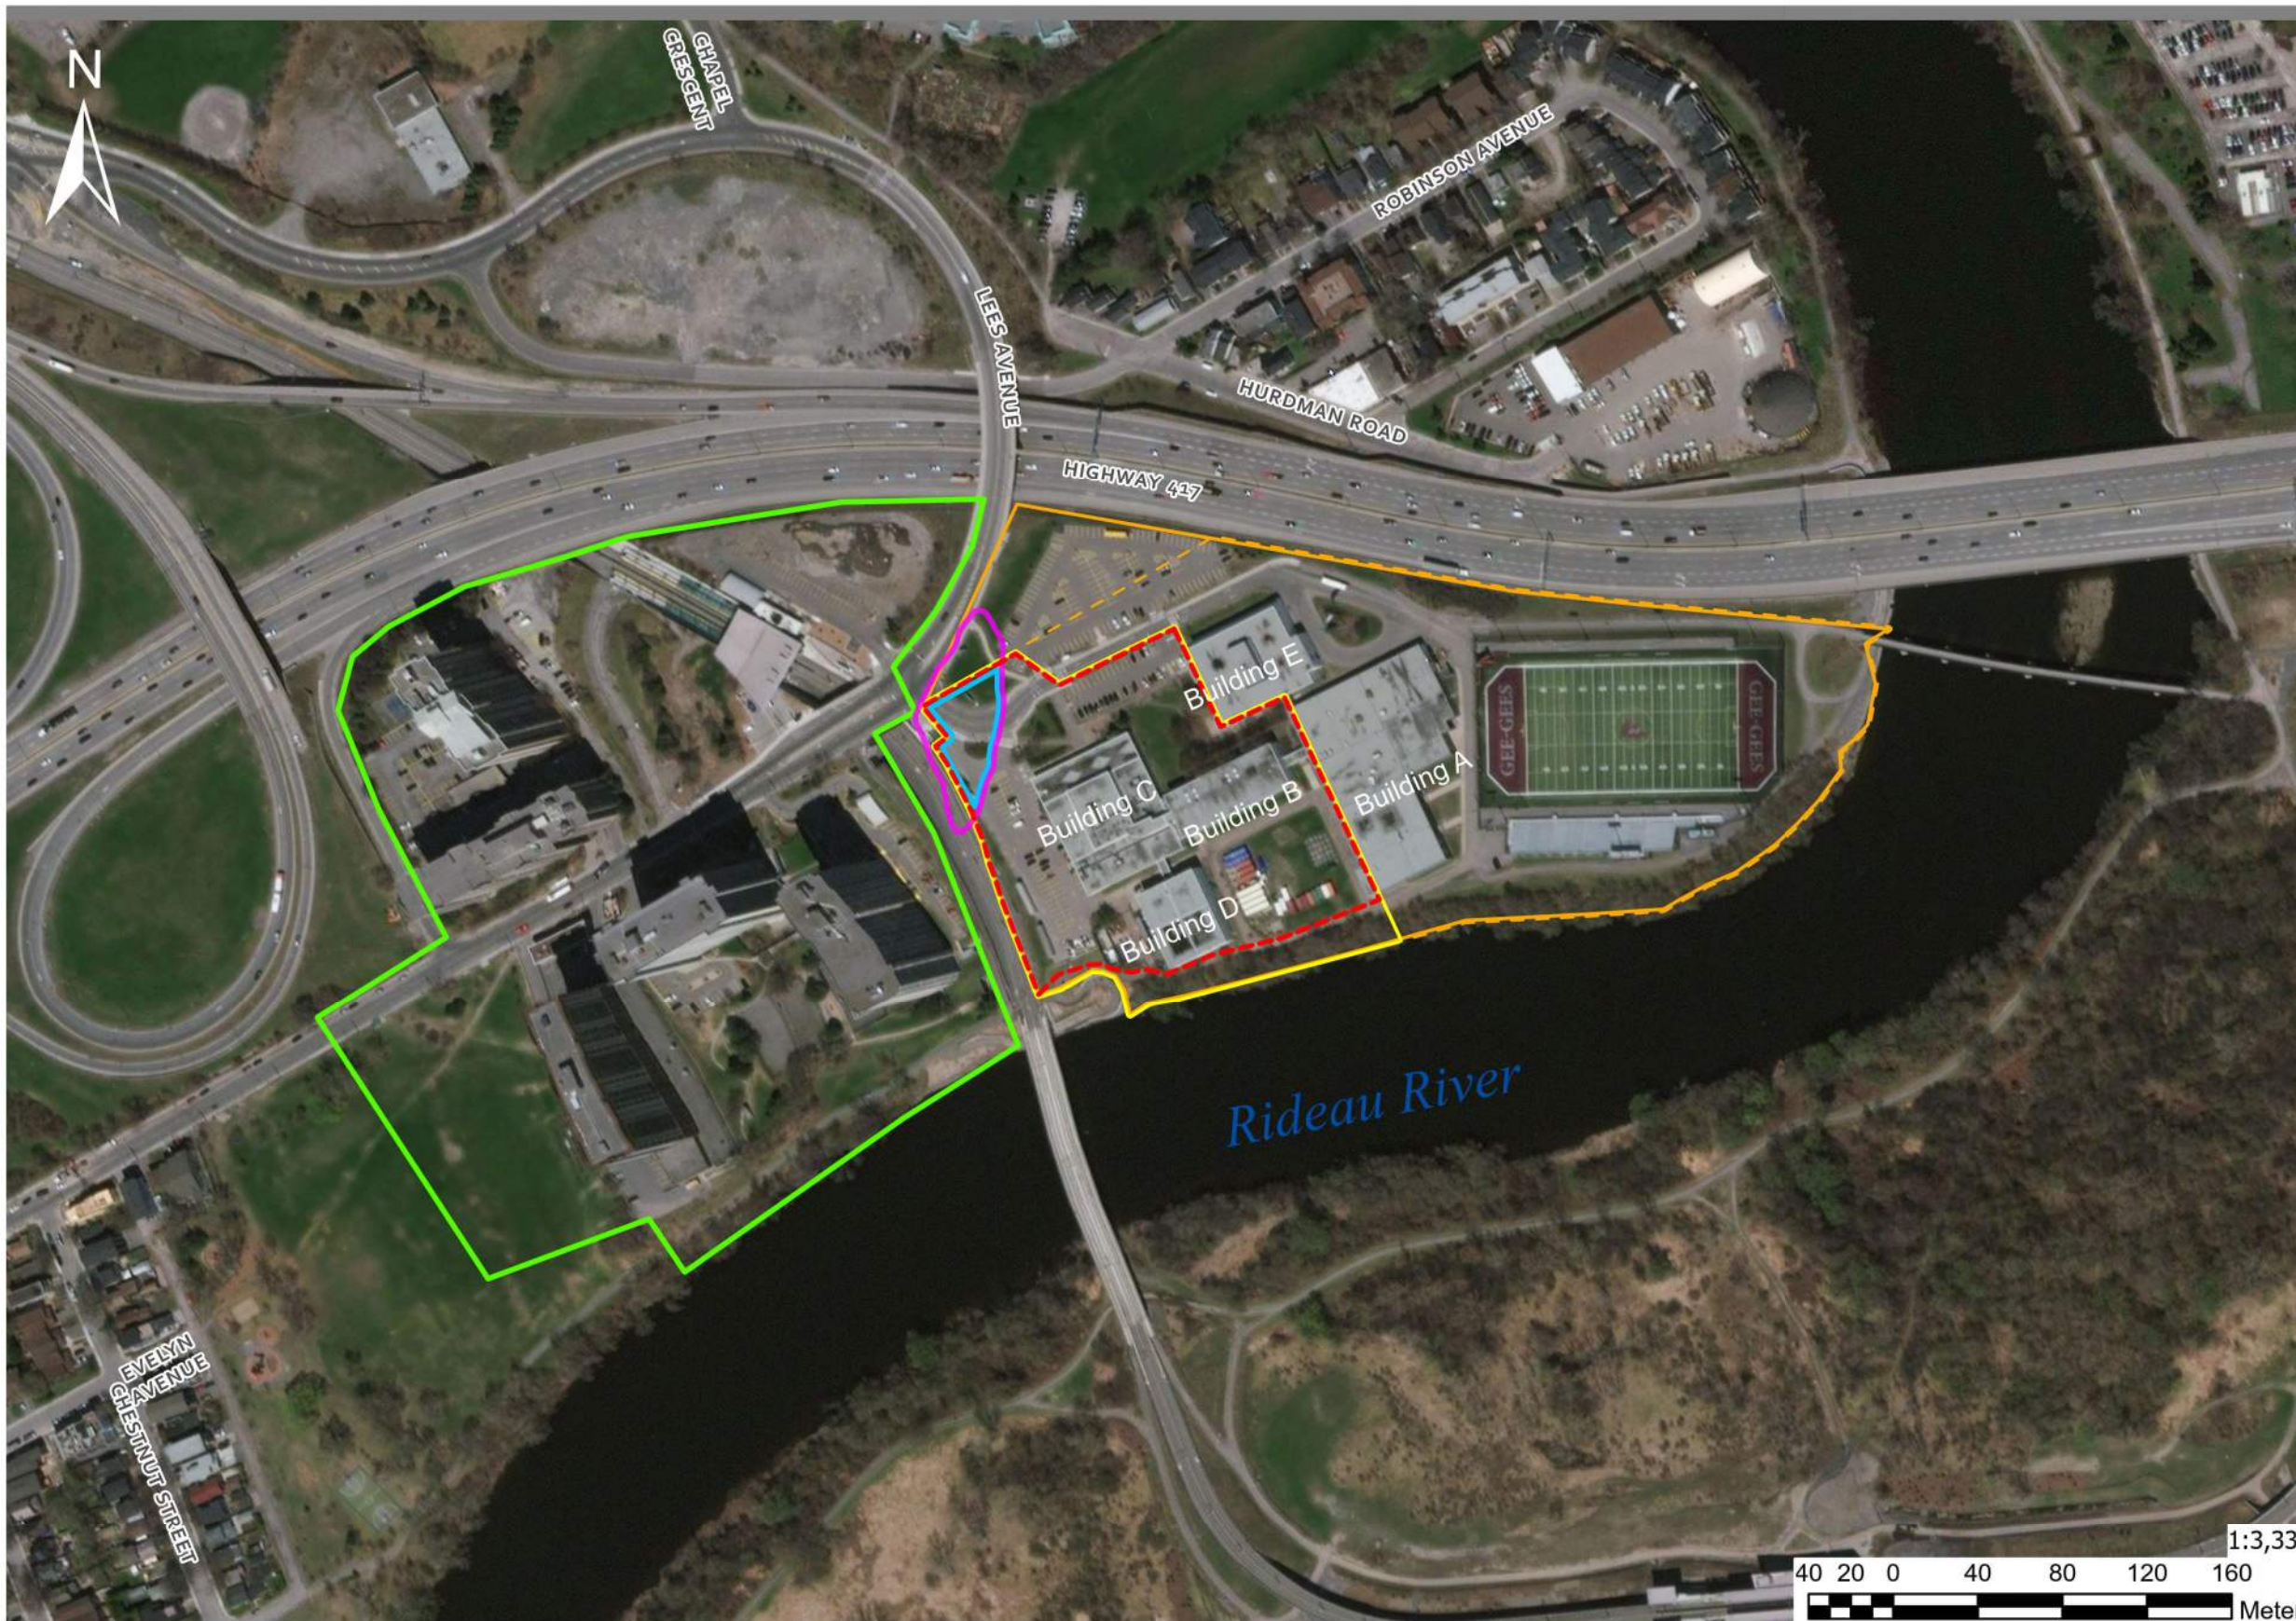
- - - Phase Two Study Area
- - - Property Parcel
- - - Estimated Extent of Coal Tar Impacts on uOttawa property (from off-site sources)
- Areas of Potential Environmental Concern (APEC)**
- APEC A: Historic Landfill
- APEC B: Historic coal tar impacts
- Potentially Contaminating Activity (PCA)**
- Waste Disposal and Waste Management (58) PCA
- Asphalt and Bitumen Manufacturing (5) and Coal Gasification (9) PCA

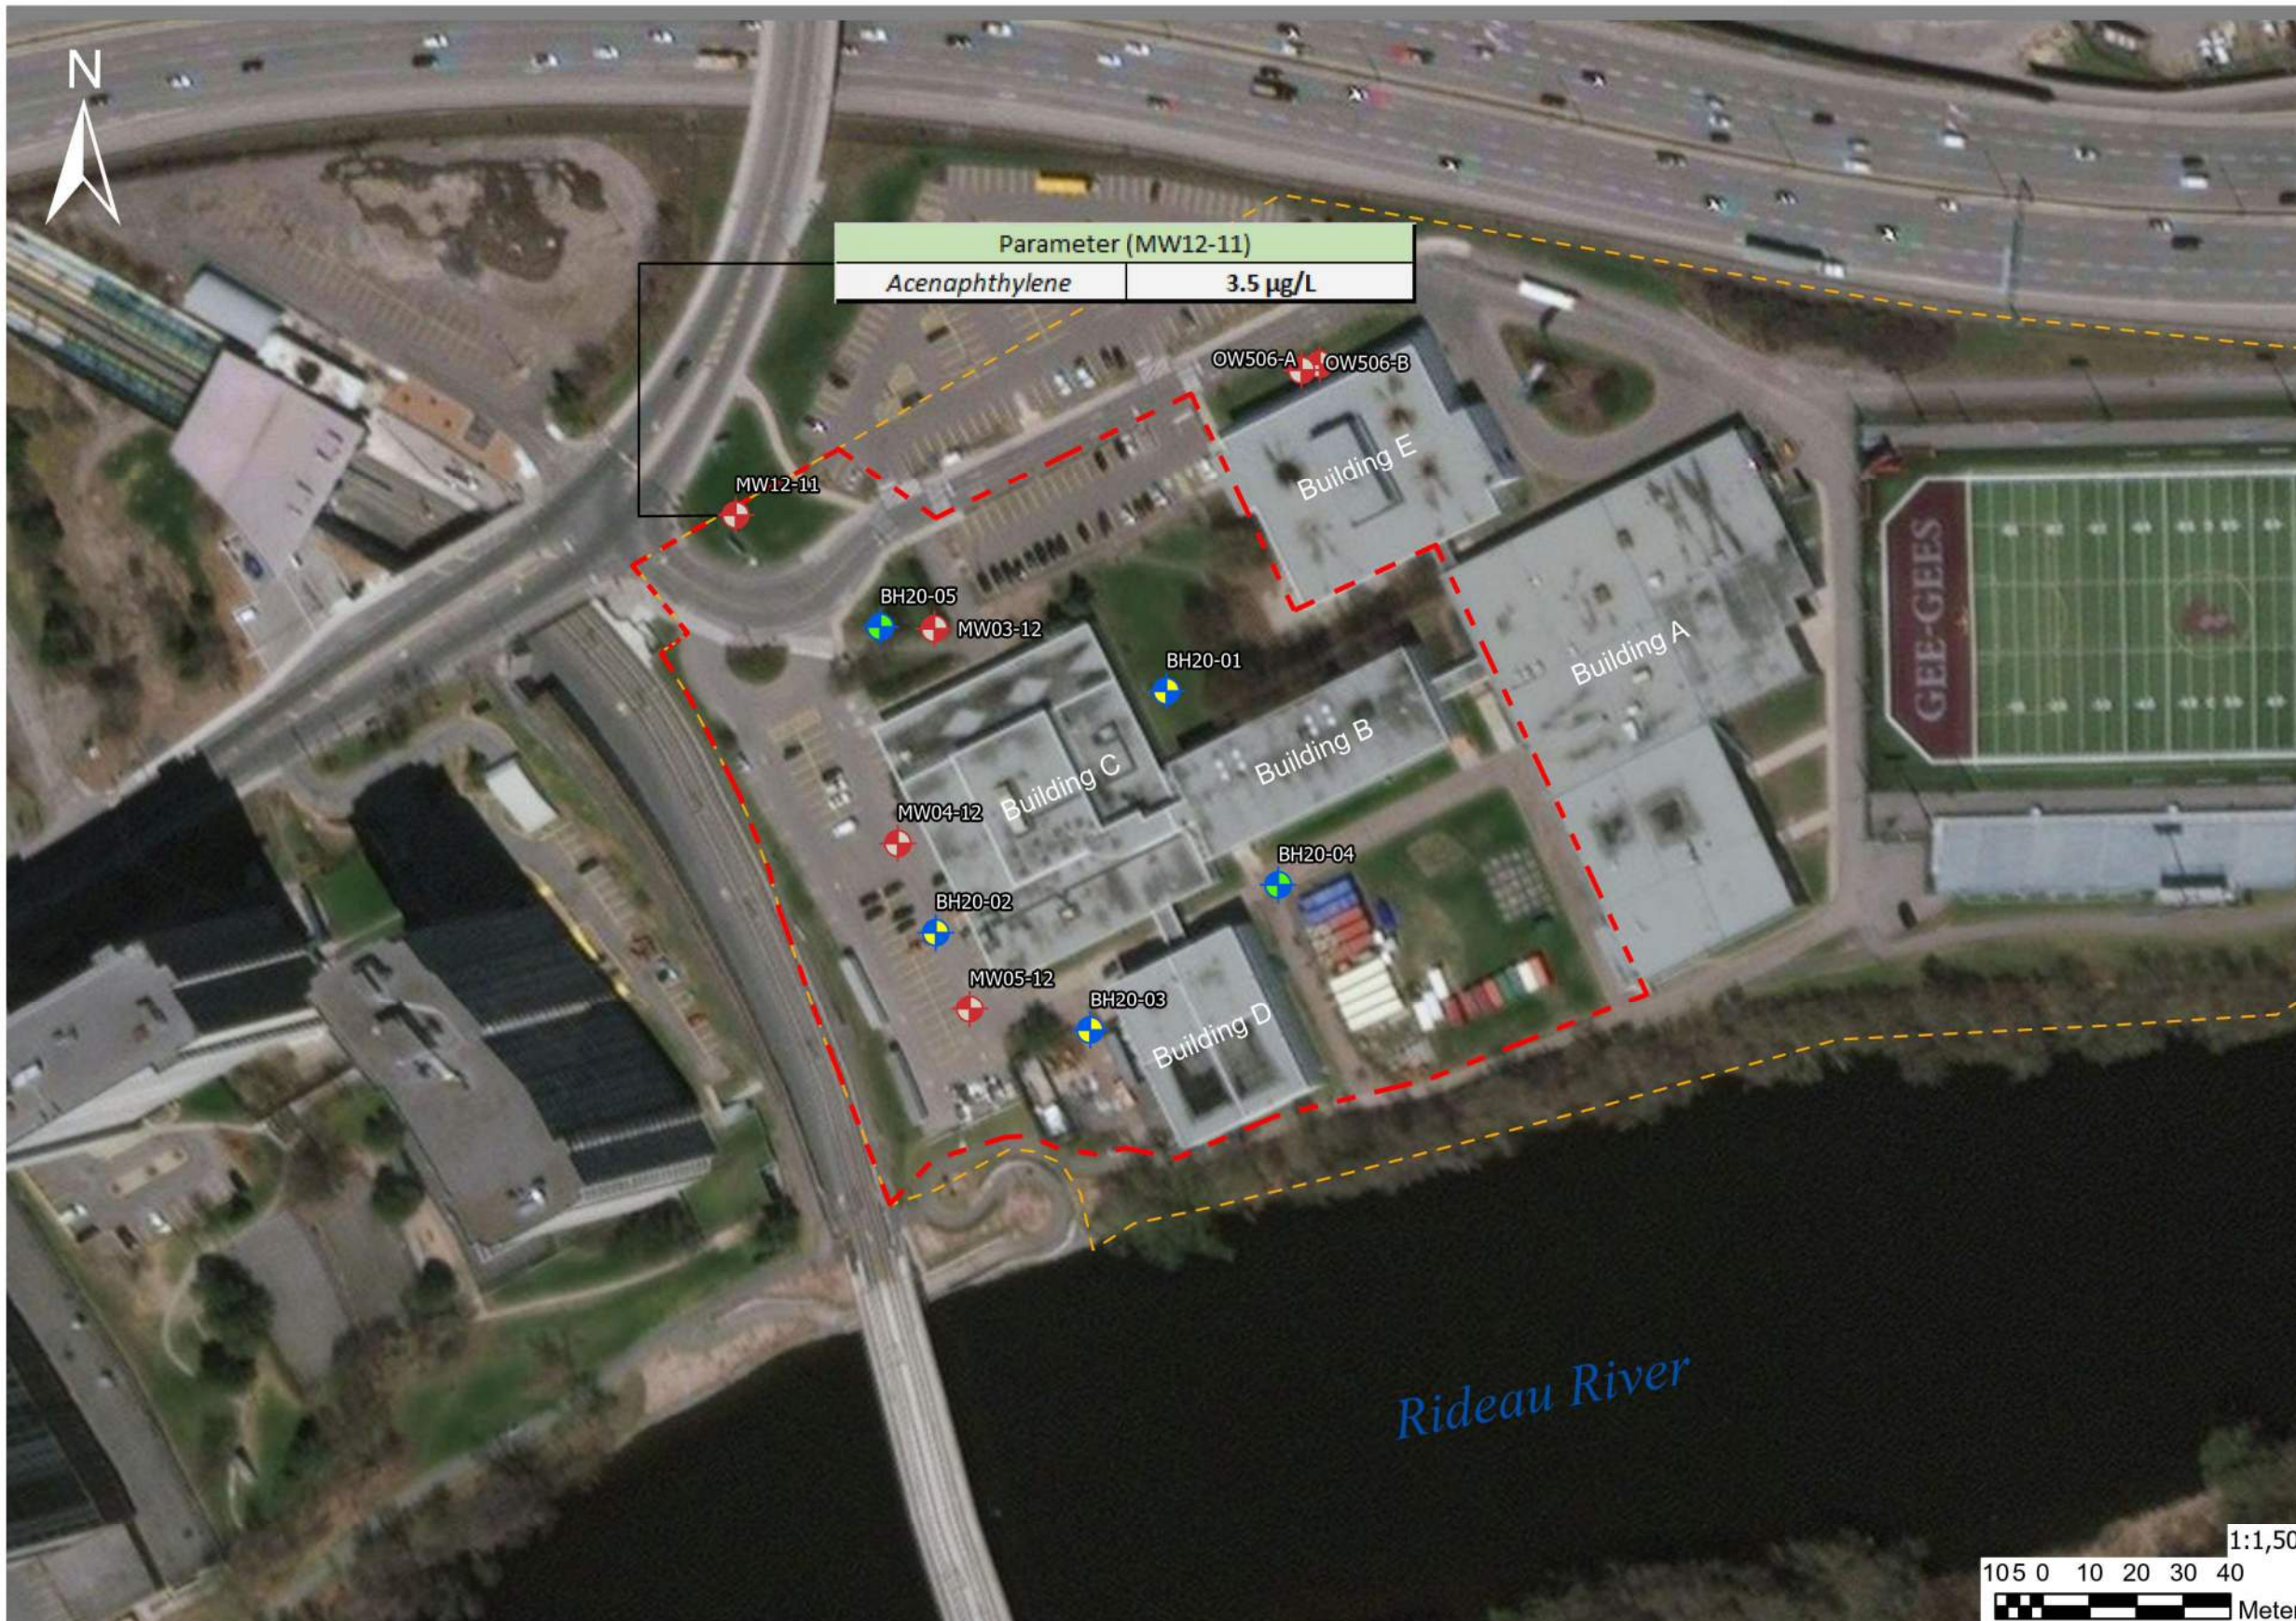
Figure 8 - Soil Analytical Results with Exceedances above SCS (2020)

General Notes:
 1: Full Depth Generic Site Condition Standards in a Non-Potable Ground Water Condition - Community Property Use - Coarse Grained Soils
 - Dimensions on the plan should be read and not measured.
 Figures are to be reviewed and interpreted with the associated report.
 Any errors or omissions should be reported to CIMA+. The boundaries, areas and title deeds must be verified by a surveyor.

The analytical results for the soil samples collected during borehole drilling are summarized in **Table 4 (Appendix B)** and concentrations above the applicable SCS are noted on **Figure 8 (Appendix A)**. The Laboratory Certificates of Analysis are provided in **Appendix F**.

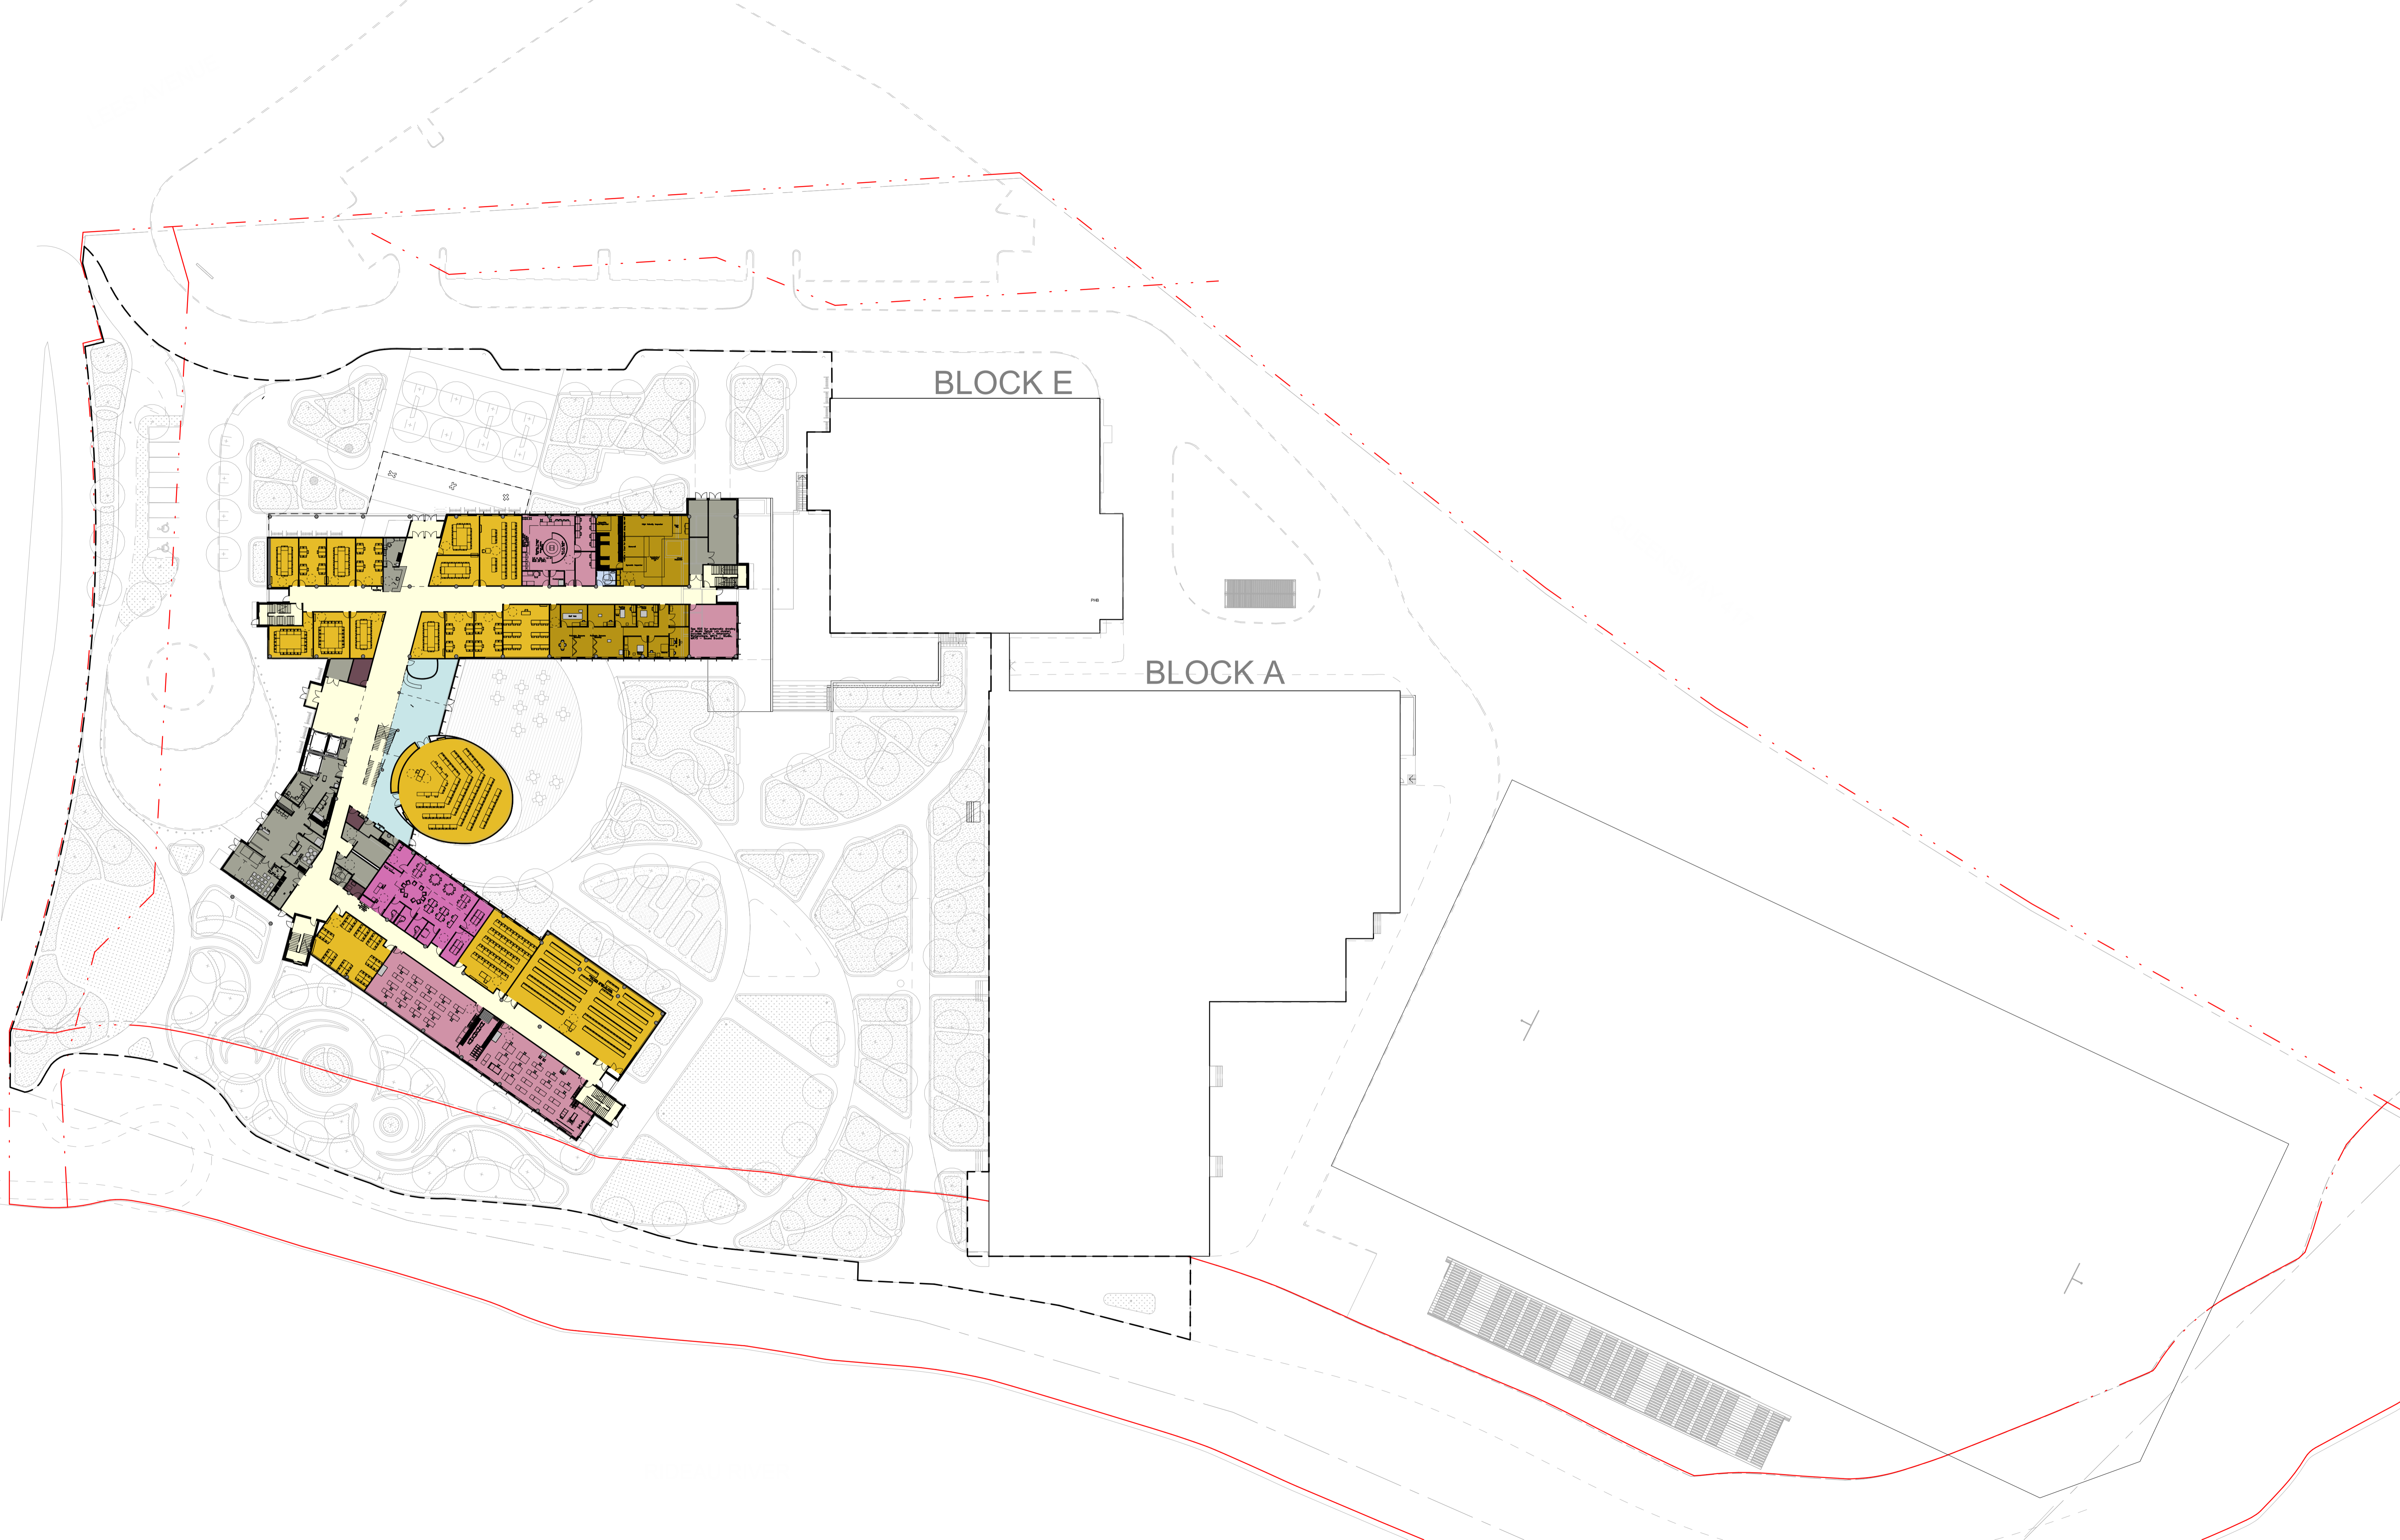
Figure 8 - Soil Analytical Results with Exceedances above SCS (2020)

General Notes:
 1: Full Depth Generic Site Condition Standards in a Non-Potable Ground Water Condition - Community Property Use - Coarse Grained Soils
 - Dimensions on the plan should be read and not measured.
 Figures are to be reviewed and interpreted with the associated report.
 Any errors or omissions should be reported to CIMA+. The boundaries, areas and title deeds must be verified by a surveyor.

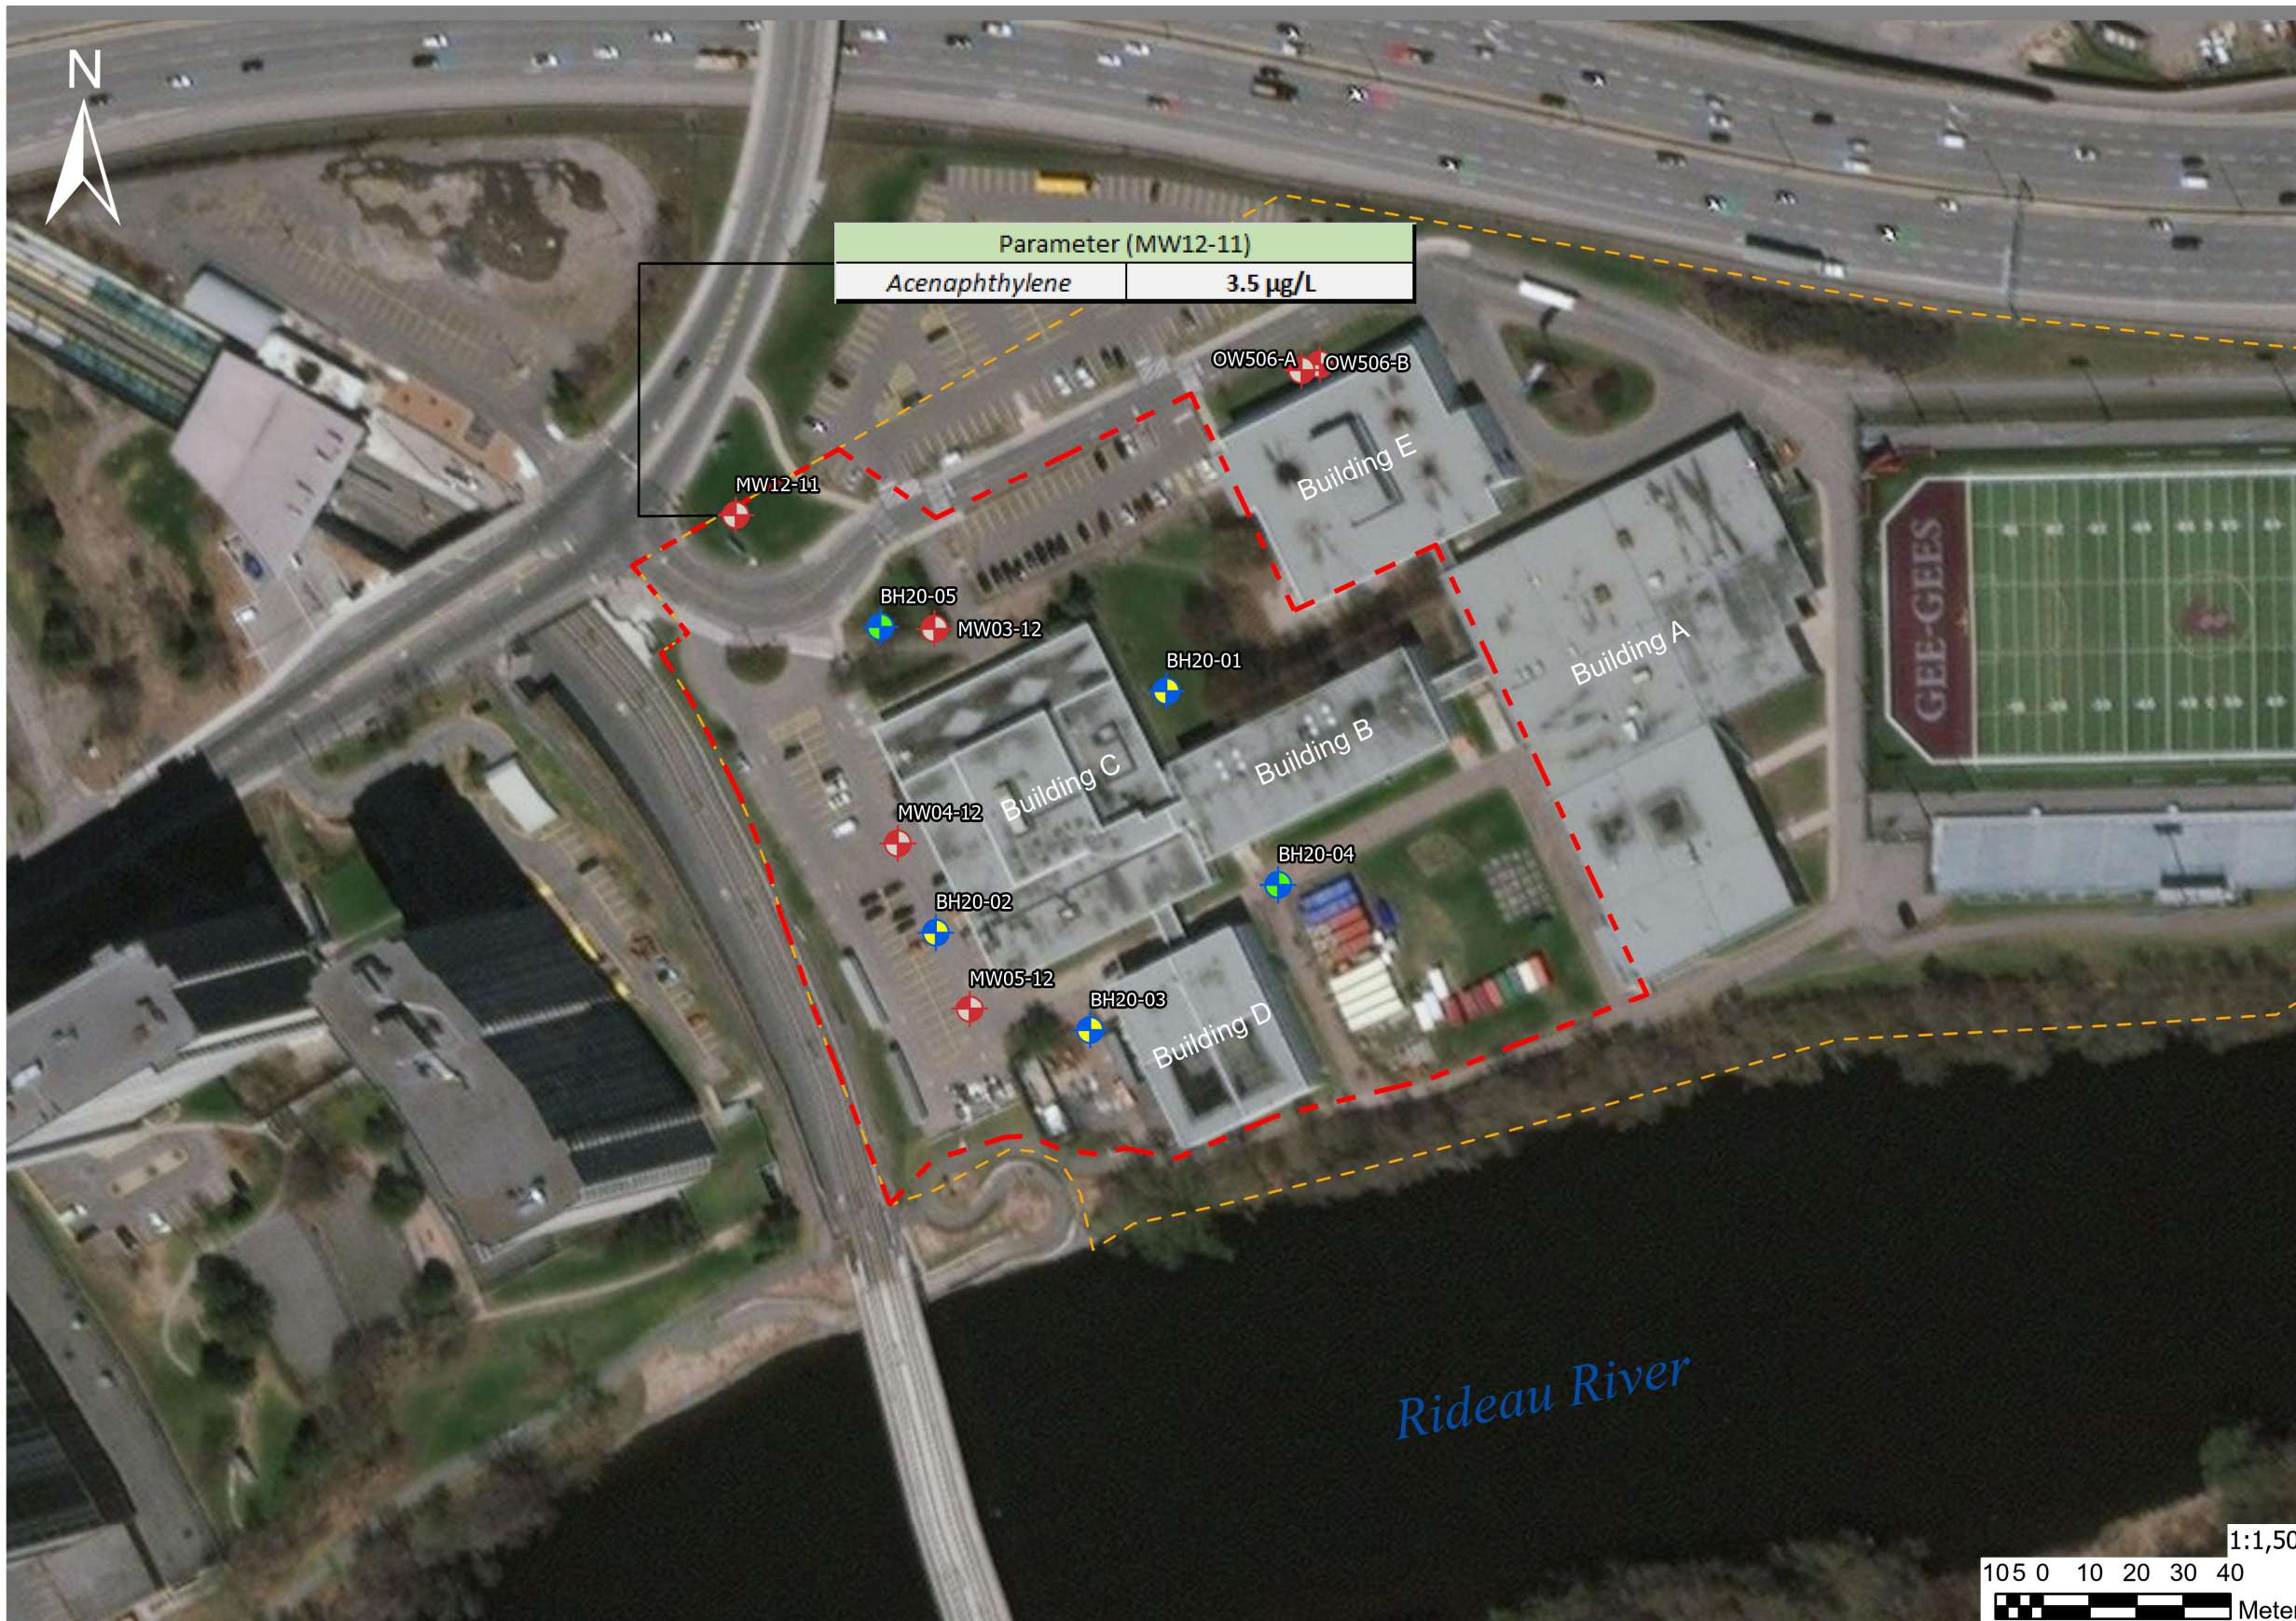
Figure 9 - Groundwater Analytical Results with Exceedances above SCS (2020)

- ▬ Phase Two Study Area
- ▬ Property Parcel
- Monitoring well locations (Geofirma, 2013; Franz, 2013; uOttawa, 2019)
- Monitoring Well Locations (CIMA, 2020)
- Monitoring Well Locations (Golder, 2020)

Standards ¹ - Table 3 SCS (PAH)	
Parameter	µg/L
Naphthalene	1400
Acenaphthylene	1.8
Acenaphthene	600
Fluorene	400
Phenanthrene	580
Anthracene	2.4
Fluoranthene	130
Pyrene	68
Benzo(a)anthracene	4.7
Chrysene	1
Benzo(b)fluoranthene	0.75
Benzo(k)fluoranthene	0.4
Benzo(a)pyrene	0.81
Indeno(1,2,3-cd)pyrene	0.2
Dibenz(a,h)anthracene	0.52
Benzo(g,h,i)perylene	0.2
2-and 1-methyl Naphthalene	1800

The analytical results for the groundwater samples collected during the July 2020 sampling are provided in **Table 5 (Appendix B)** and concentrations above the applicable SCS are noted on **Figure 9 (Appendix A)**. The Laboratory Certificates of Analysis for all analyses are provided in **Appendix F**.

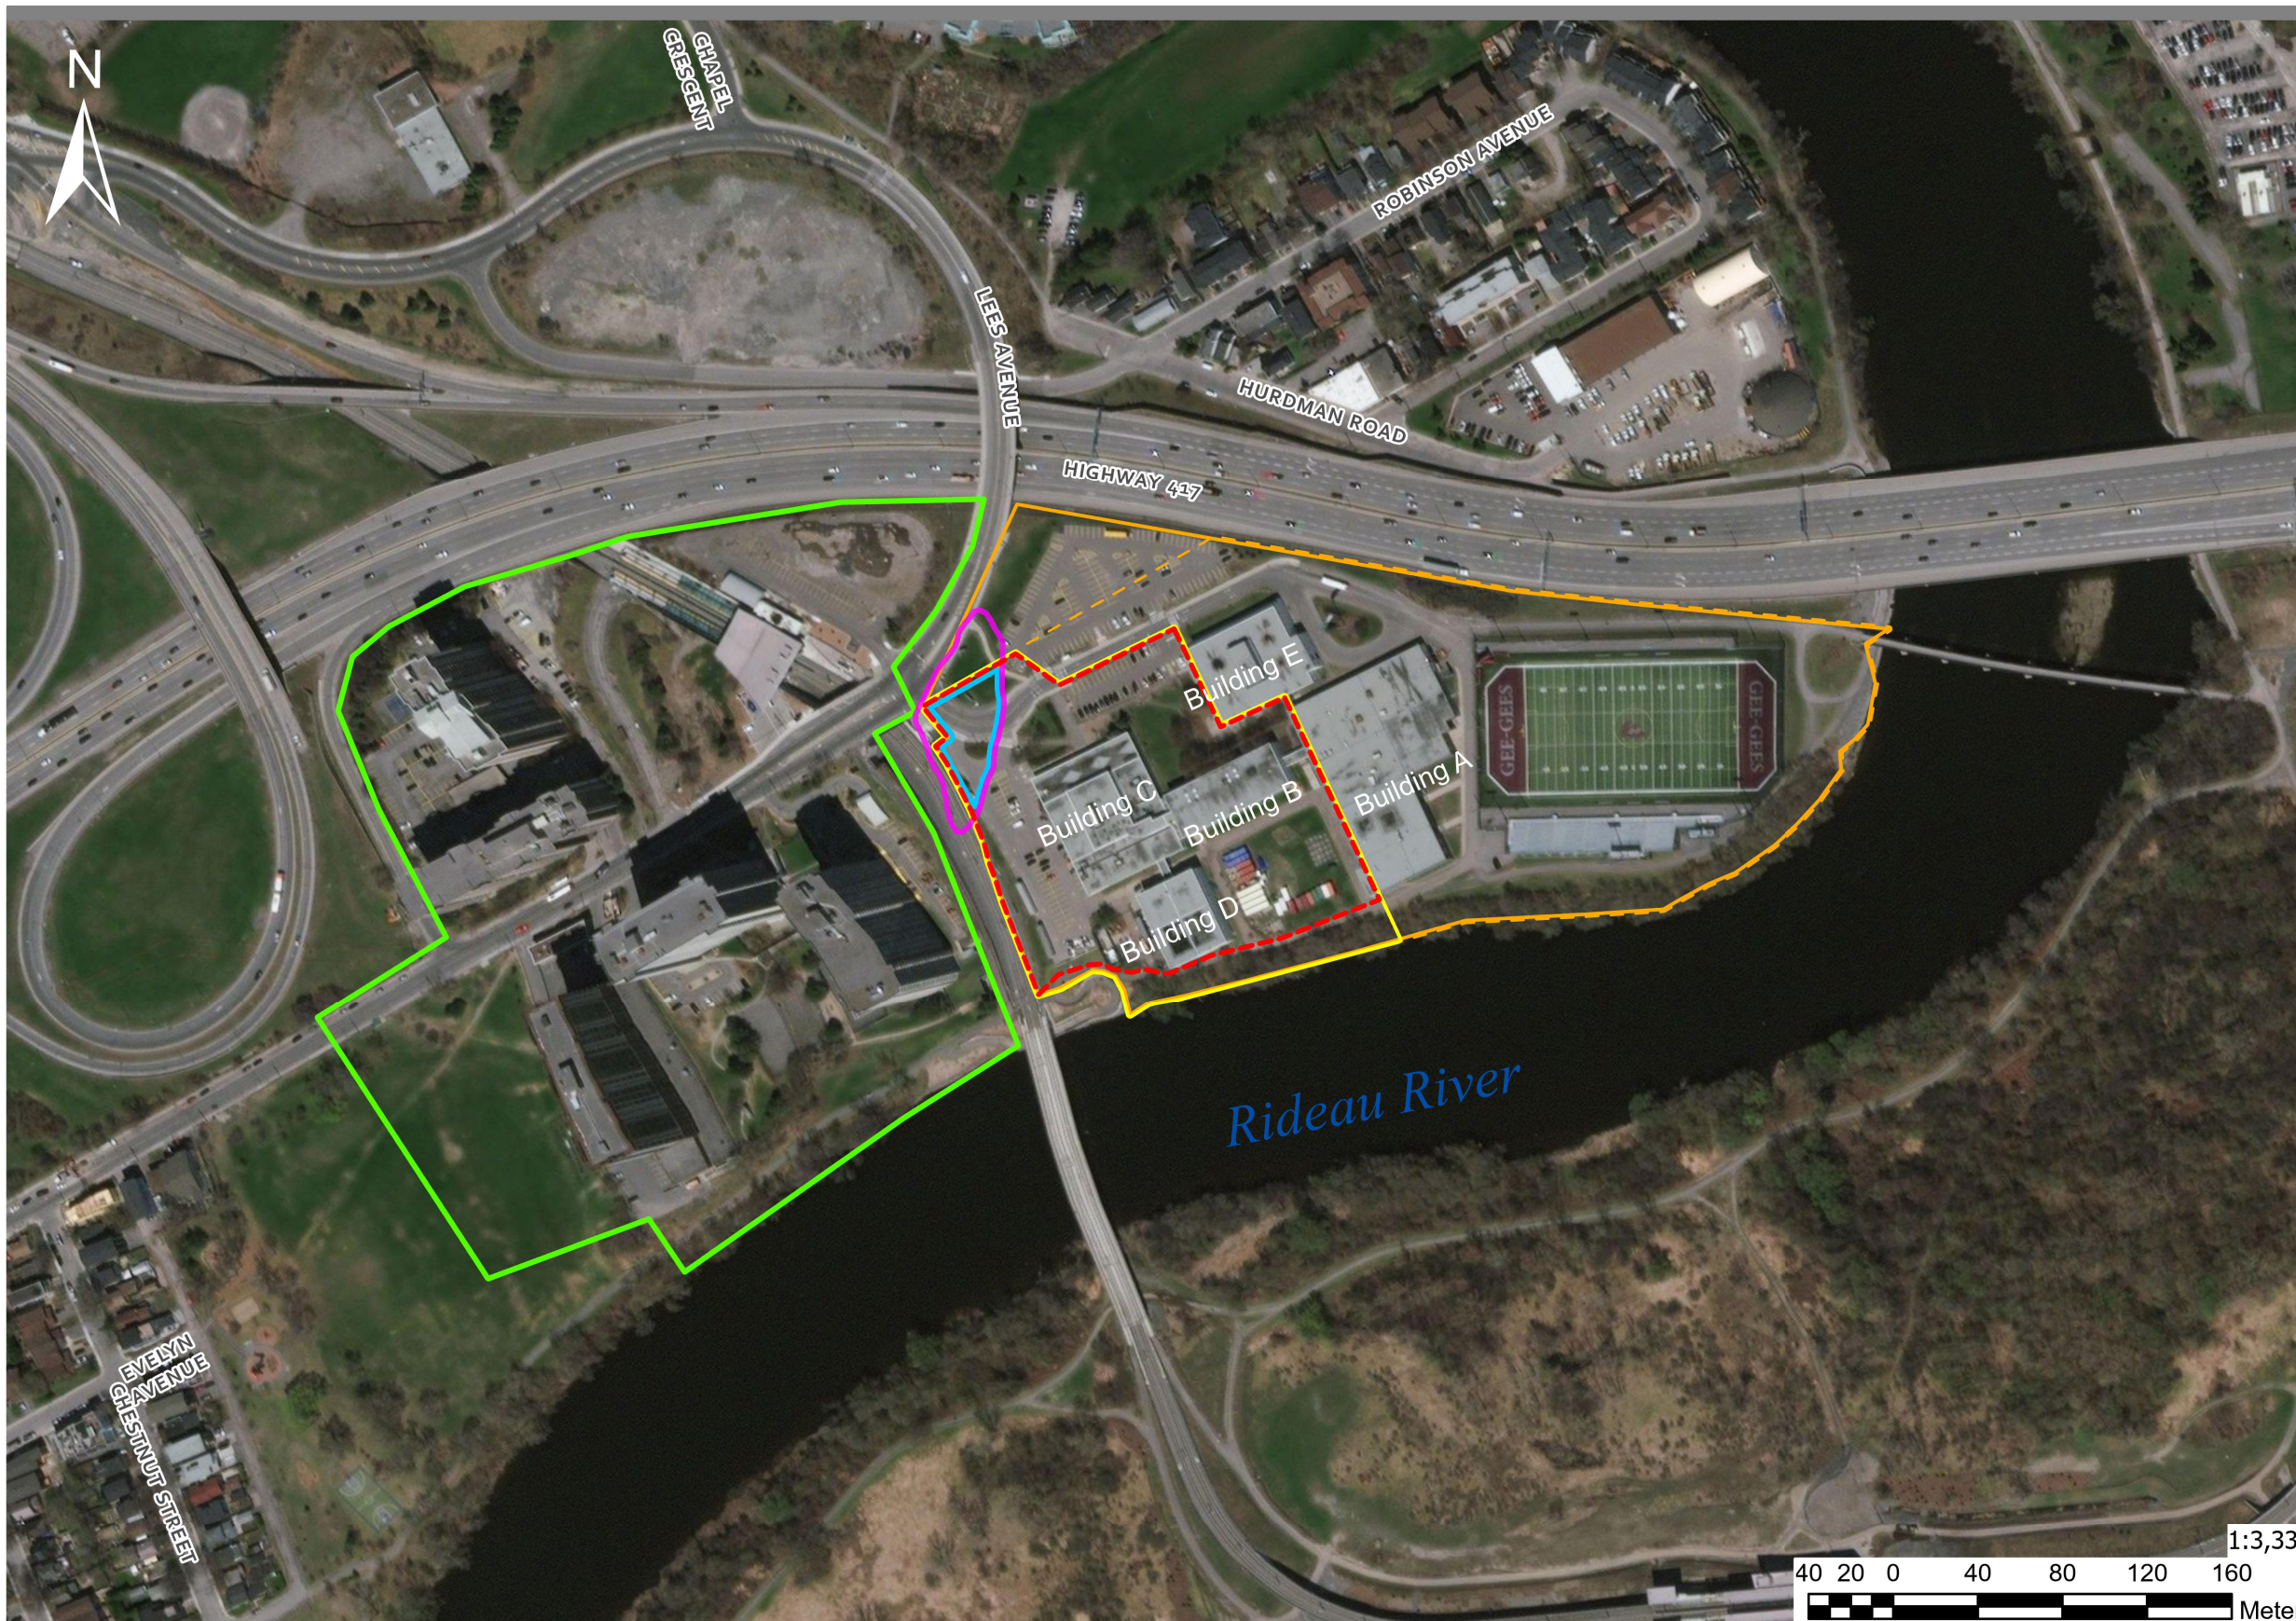
- Phase Two Study Area
 - Property Parcel
 - Estimated Extent of Coal Tar Impacts on uOttawa property (from off-site sources)
- Areas of Potential Environmental Concern (APEC)**
- APEC A: Historic Landfill
 - APEC B: Historic coal tar impacts
- Potentially Contaminating Activity (PCA)**
- Waste Disposal and Waste Management (58) PCA
 - Asphalt and Bitumen Manufacturing (5) and Coal Gasification (9) PCA

Based on the results of the Phase One ESA (CIMA+, 2020), APEC identified for the Site are listed below. The general areas of the Site pertaining to each APEC are depicted in **Figure 5 (Appendix A)**.

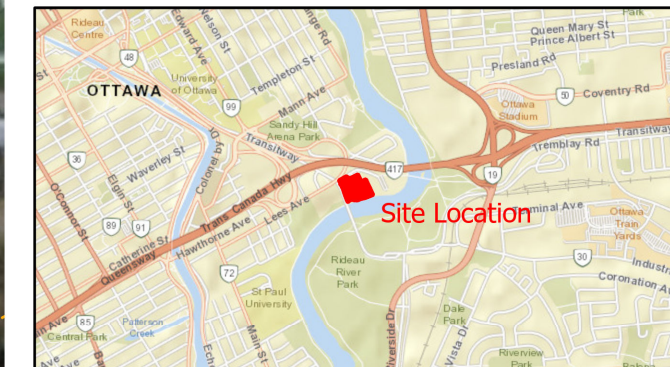
Figure 7 - Groundwater Elevation and Overburden Flow Direction

- Phase Two Study Area
- Property Parcel
- Monitoring Well Locations (CIMA+, 2020)
- Monitoring Well Locations (Golder, 2020)
- Monitoring well locations (Geofirma, 2013; Franz, 2013; uOttawa, 2019)
- Groundwater elevations (July 2020) - in meters above sea level (m asl)*
- Overburden groundwater flow direction

The groundwater levels within the shallow overburden units (fill and alluvium) is between 5.80 and 9.07 mbgs and range in elevation between 54.01 and 56.56 masl. Groundwater elevations and interpreted groundwater flow direction within the shallow overburden is provided in **Figure 7 (Appendix A)**. The flow within the shallow overburden is towards the northwest. The flow is consistent with that reported by others as being strongly influenced by the Transitway Station groundwater collection system (Geofirma, 2013). The water level in BH20-05 (4.65 mbgs) was noted to be an outlier at levels higher than others on-Site but this does not change the interpretation of overall groundwater flow. The groundwater divide, previously reported by others (Franz, 2013) was not noted on-Site as part of this investigation as no component of groundwater flow was observed to be towards the south and the Rideau River.

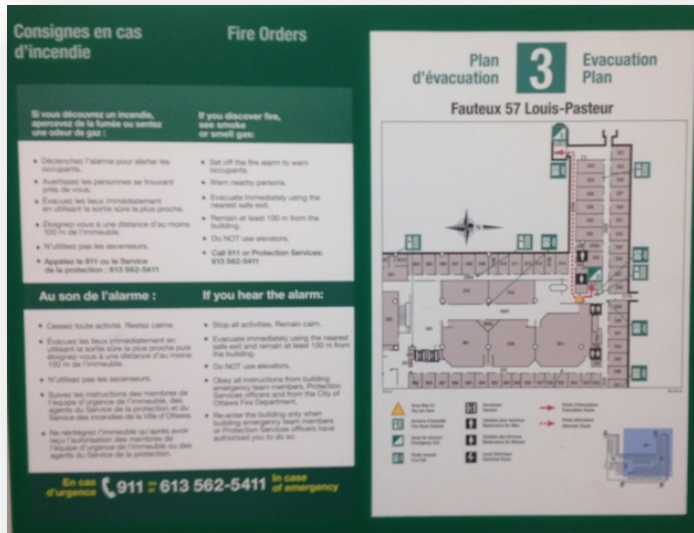
Figure 5 – an example of building evacuation routes posted within buildings.

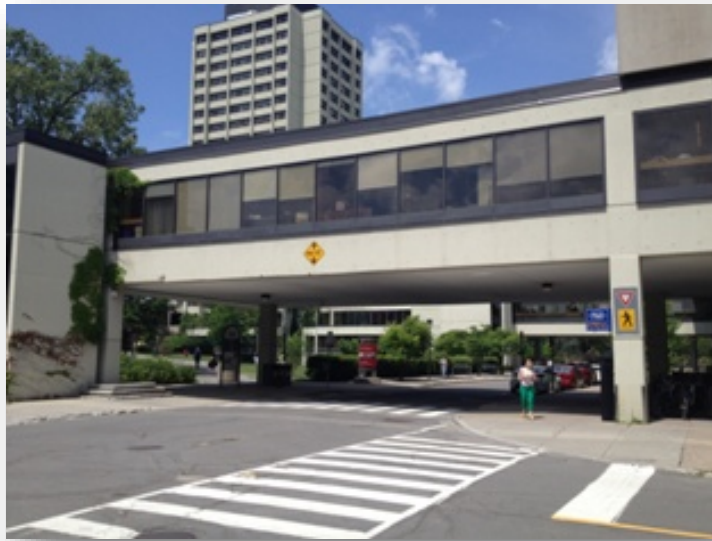
Figure 7 – photo of the overpass located at Fauteux Hall

Vehicular circulation may pass underneath pedestrian overpasses that span the roadways over top of Louis-Pasteur Pvt., Jean-Jacques Lussier Pvt., and University Pvt. The clearance height markings are clearly posted on the overpasses. The overpass heights are not uniform; therefore prior to navigating the campus routes with large equipment, please verify clearance heights to avoid damage to equipment and / or the building.

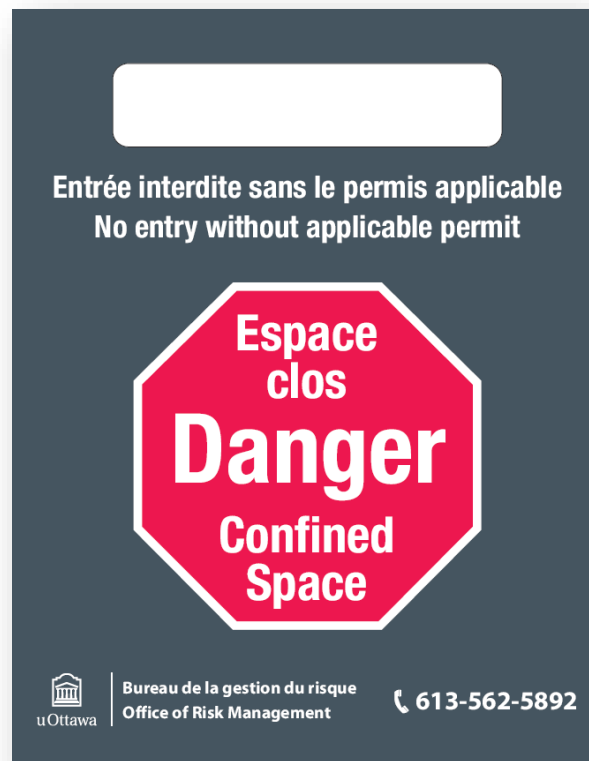
Figure 8 – uOttawa confined space signage; posted at entry points to confined spaces.

The white space at the top of the sign is reserved for the identification number of the confined space. This number is written in and denotes the corresponding hazard assessment and entry permit for the space.
