Phase I - Environmental Site Assessment

18 Louisa Street Ottawa, Ontario

Tel: (613) 226-7381 Fax: (613) 226-6344 www.patersongroup.ca April 30, 2021

Report: PE5281-1

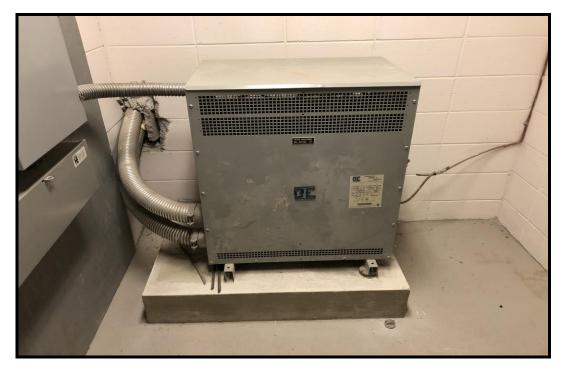
An electrical transformer unit was identified within the ground floor electrical room of the subject building. The transformer was noted to be a dry-type transformer, with no cooling oil contained inside. The presence of this transformer is not considered to pose an environmental concern to the subject site.

Photograph 5: View of a dry-type, pad-mounted transformer, located within the ground floor electrical room.

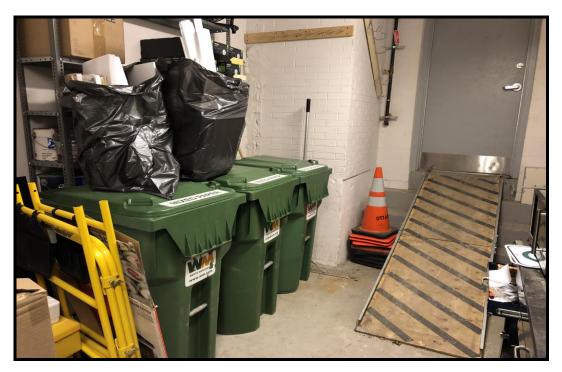
Solid, non-hazardous domestic waste and recyclable products are stored in metal bins adjacent to the exterior of the subject building and are collected by a licensed contractor on a regular basis. No environmental concerns were identified with respect to waste management practices on the subject site.

Photograph 6: View of a waste storage area, located within the ground floor utility room of the subject building.
