Phase Two Environmental Site Assessment

770 and 774 Bronson Avenue and 557 Cambridge Street, Ottawa, Ontario

OTT-22019409-A0

2022-10-06

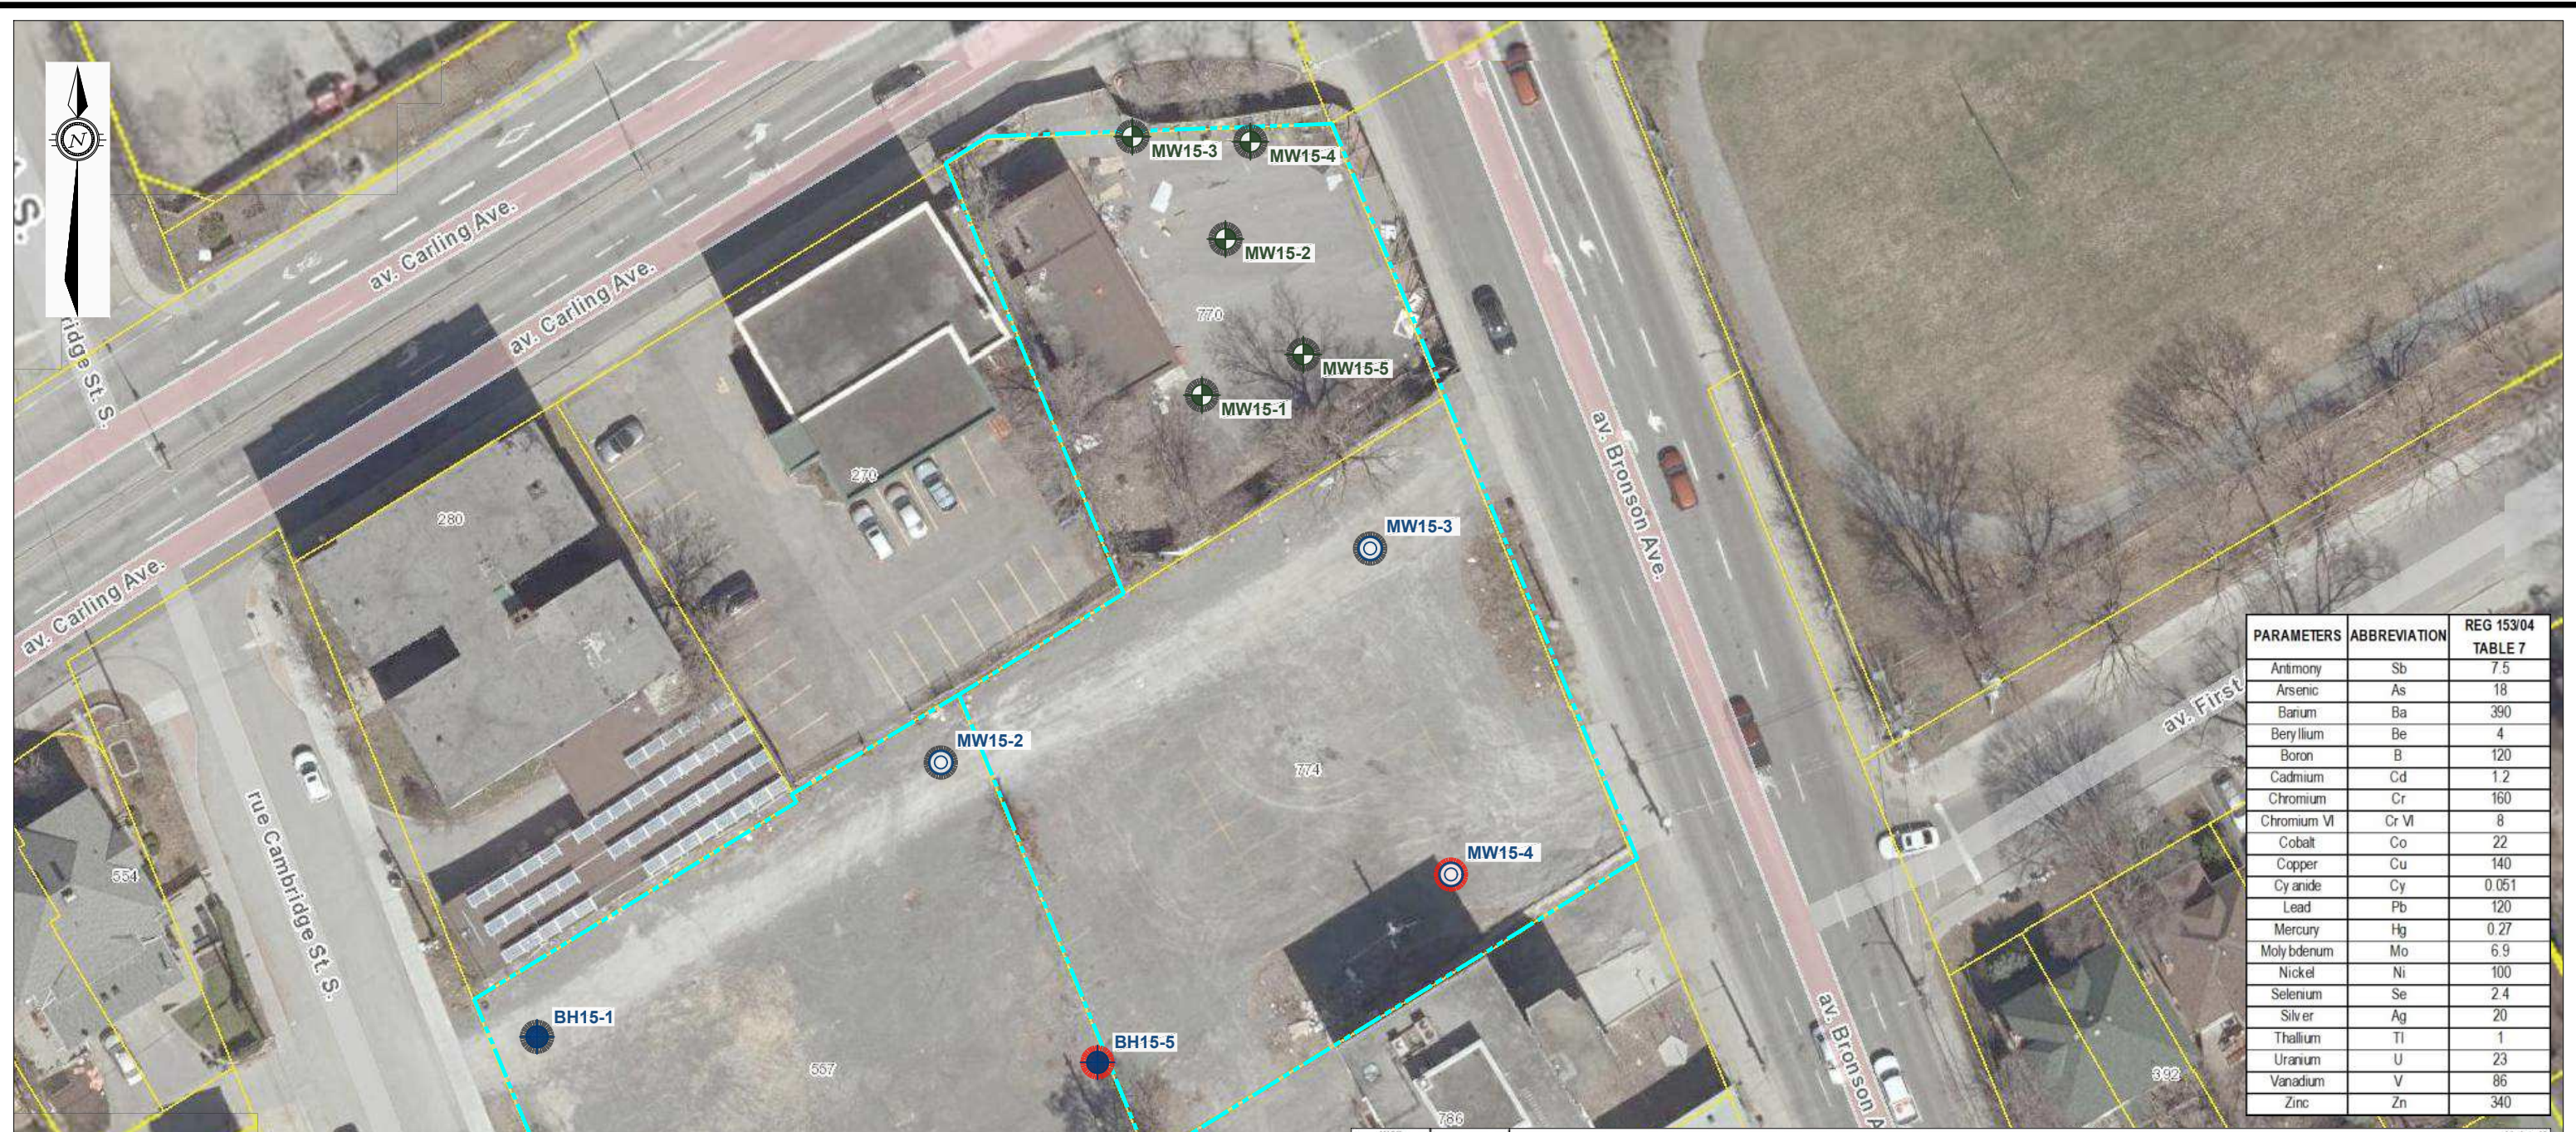
DATE OCTOBER 2022	CLIENT: PHASE TWO ENVIRONMENTAL SITE ASSESSMENT 770 & 774 BRONSON AVENUE + 557 CAMBRIDGE STREET, OTTAWA, ON	project no. OTT-22019409-A0
DESIGN LW	CHECKED MM	scale 1:500
DRAWN BY AS		SOIL ANALYTICAL RESULTS – PAH
		FIG 8
