Phase One Environmental Site Assessment

770 and 774 Bronson Avenue and 557 Cambridge Street, Ottawa, Ontario

Katasa Groupe

OTT-22019409-A0

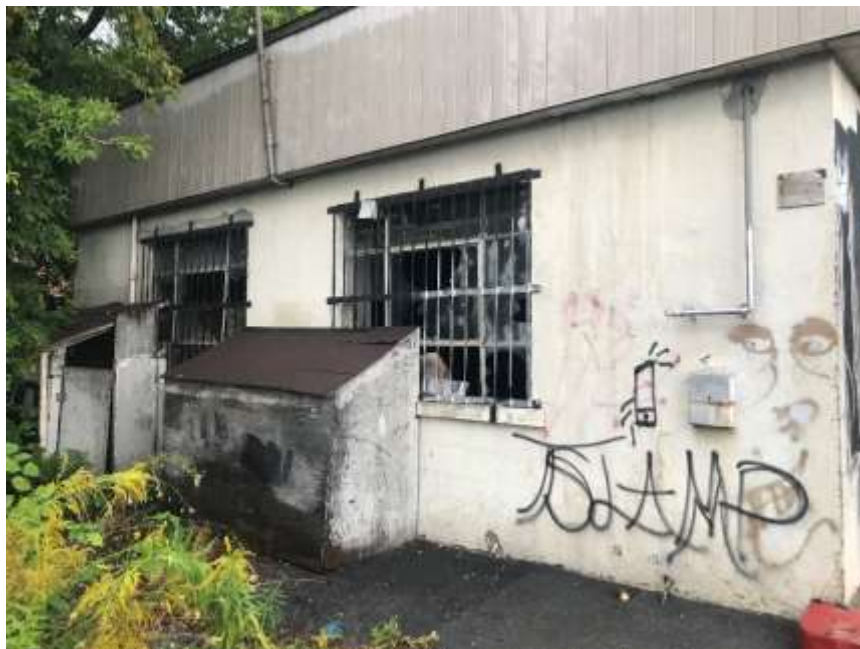
Photograph No. 2

View of the south side of the garage, location of former heating oil AST and waste oil AST.

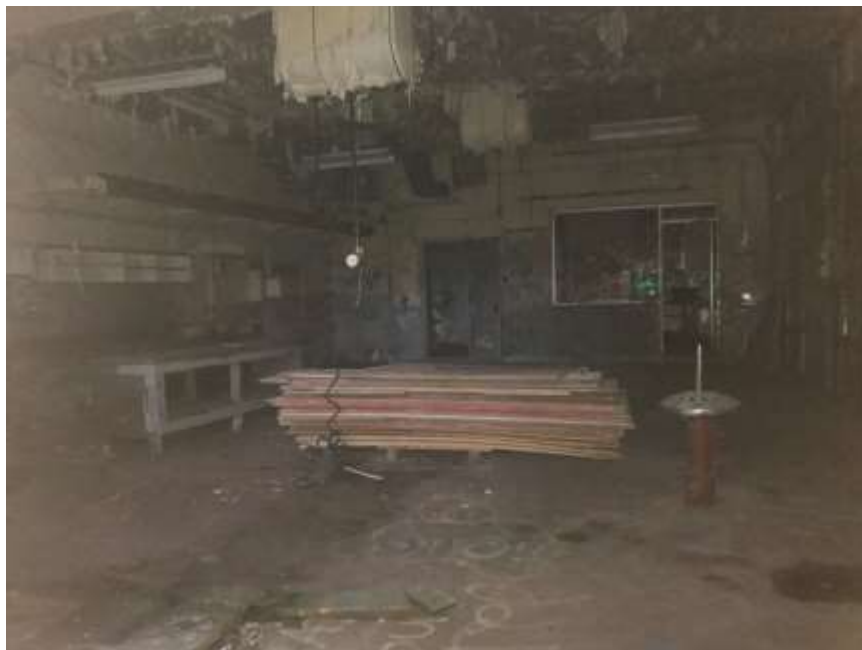
Photograph No. 3

View of the garage interior.

Based on the age of the building, LBPs may be present. In the building at 770 Bronson Avenue. The painted surfaces observed during EXP's site visit were observed to be in poor condition.

The building is abandoned and open to the elements. Interior finishes were observed to be in poor condition.

A three-chamber oil/water separator was identified in the garage in the 2015 Phase One ESA. The condition of the oil/water separator could not be verified during the site visit.

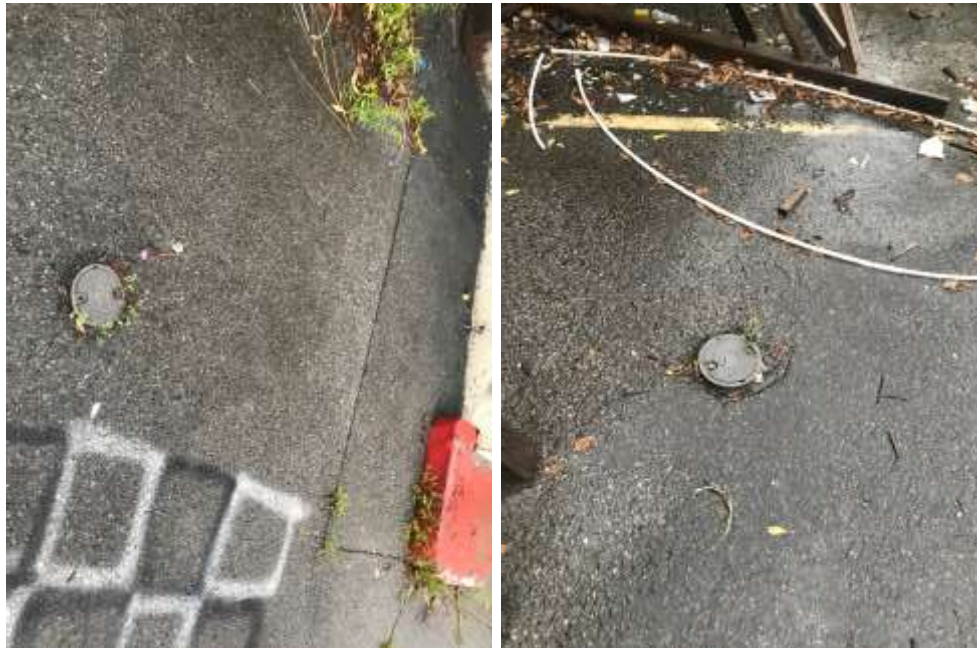
Photograph No. 4

View of monitoring wells at 770 Bronson Avenue.

Five monitoring wells were observed at 770 Bronson Avenue. No other monitoring wells were observed on the Phase One property.

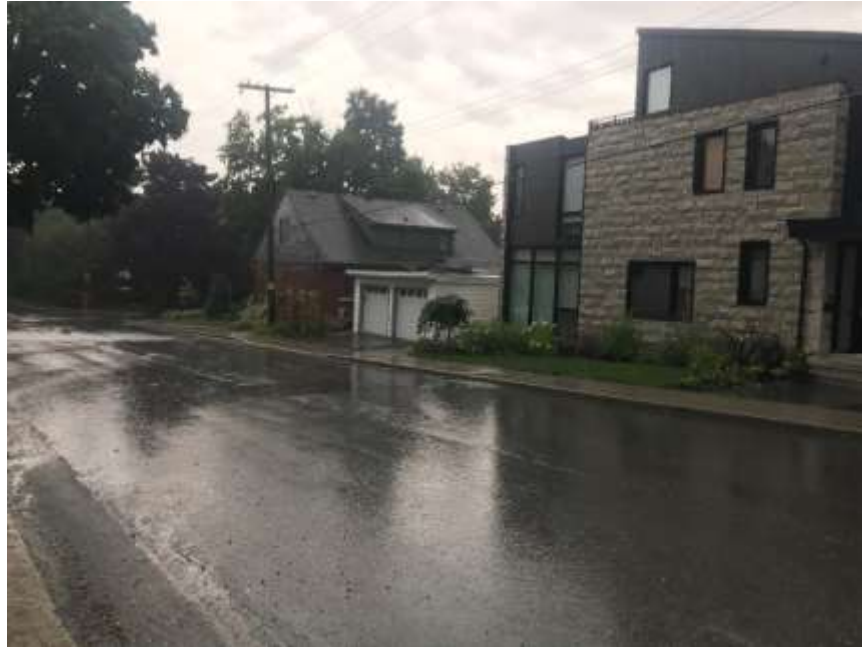
Photograph No. 7

View of adjacent residential properties along Cambridge Street.

No environmental concerns relating to the adjacent properties were observed at the time of the site visit.

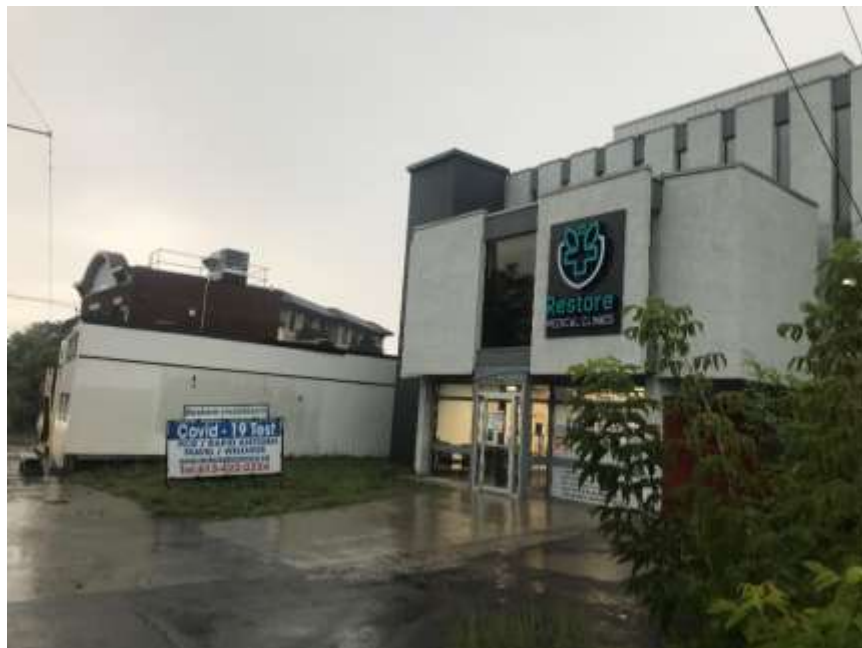
Photograph No. 8

View of adjacent commercial properties along Bronson Avenue.
