**Phase One Environmental Site Assessment Update**  
**1055 Klondike Road**  
**Ottawa, Ontario**

**Phase One Environmental Site Assessment Update**  
**1055 Klondike Road**  
Ottawa, Ontario

June 10, 2021  
Project: 64153.85

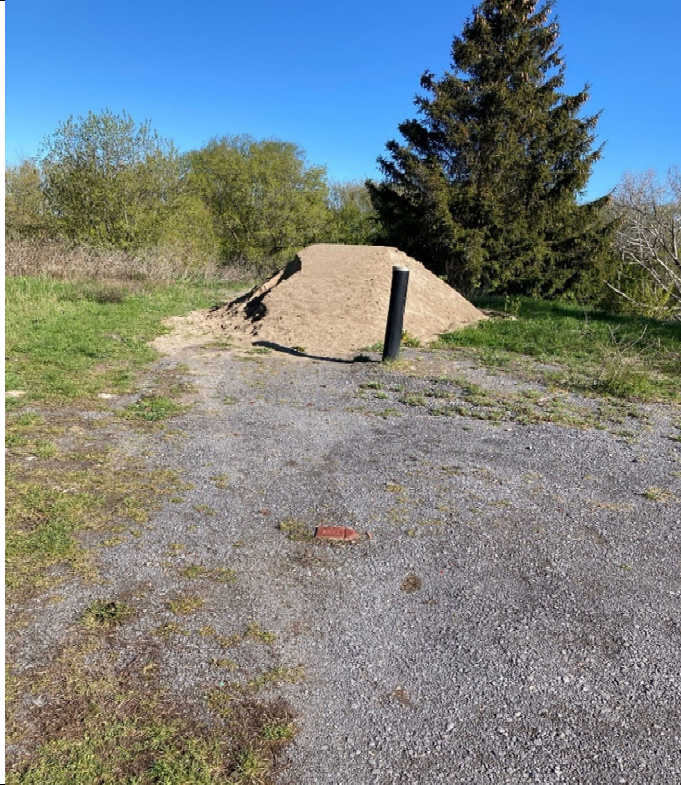
Photograph I1: Unknown fill within the subject site. The unknown fill was observed at the end of the gravel path in the centre of the subject site. The origin of the fill was determined during the interview with site representative Brian Saumure.

Additionally, during the site reconnaissance, potential fill material pile of unknown quality was observed on the subject property. Unknown fill was observed at the end of the gravel path in close proximity to the historical residential building footprint. Upon discussing the origins of the unknown fill pile during an interview with the site representative, Brian Saumure, it was determined that this fill was recently brought in by Latimer Excavating from a sand pit on Vances Side Road in Dunrobin as part of the demolition and reinstatement work following the on-site fires. This fill was used to fill in the hole which was the crawl space of the former residential building. This fill was identified as an APEC during the Phase One investigation

completed by GEMTEC in 2018 and was sampled for metals, PAHs, BTEX and PHCs during the Phase Two investigation completed by GEMTEC in 2019. Soil results indicated zinc contaminated soil from within the footprint of the former historical structures. No PAHs, BTEX, or PHCs impacted soil or groundwater were identified. However, the fill material observed during the borehole drilling program as part of the 2018 geotechnical investigation pre-dates the fire re-instatement fill brought in from the Latimer site and thus, would still be considered fill of unknown quality.

- Mr. Saumure identified the fill of unknown origin at the end of the gravel path observed during the site reconnaissance to be fill which was brought in by Latimer Excavating from a sand pit on Vances Side Road in Dunrobin as part of the demolition. This fill was used to fill in the hole which was the crawl space of the former residential building; and;

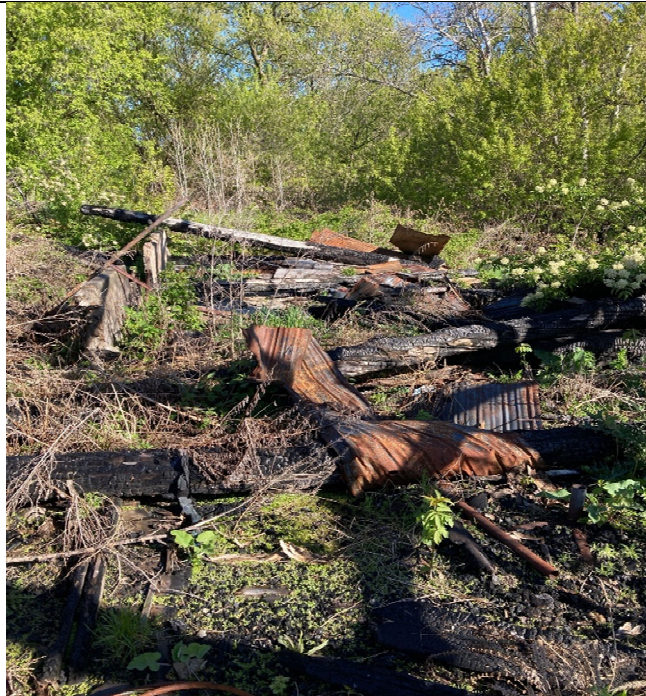
Photograph I2: Remnant burnt building materials and debris from the fire in July 2018 observed towards the centre of the subject site approximately 10 meters northeast from building footprint of the historical residential structure.

- A fire occurred in July 2018 causing significant damage to the remaining third historical structure on site. Remnant burnt building materials and debris were observed in the historical building footprint approximately 10 meters northeast from the two other historical building footprints - *OT #2- Debris from Historical Fire*.

- Remnant burnt building materials and debris was observed towards the centre of the subject site approximately 10 meters northeast from building footprint of the historical residential structure; and,

Stained vegetation was observed among the remnant burnt building materials and debris in the historical building footprint of the third structure on the subject site approximately 10 meters northeast from the two other historical building footprints which burnt down in June 2018.

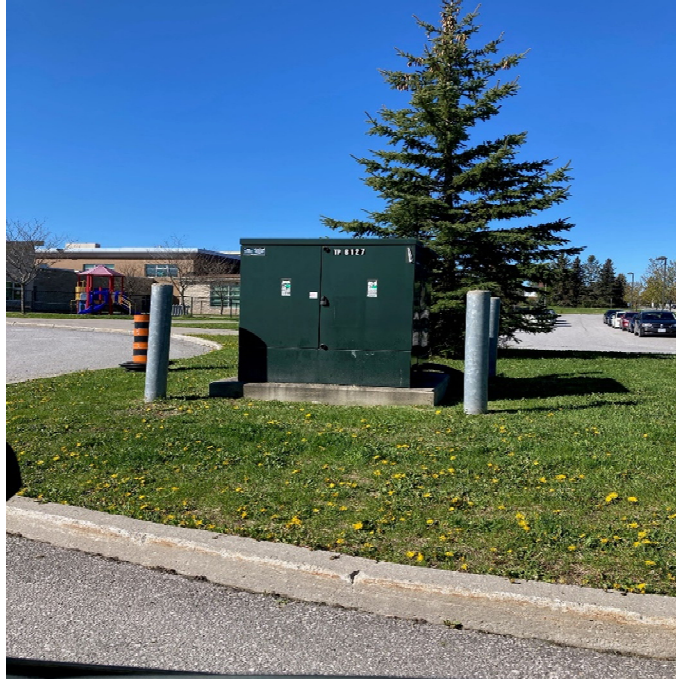
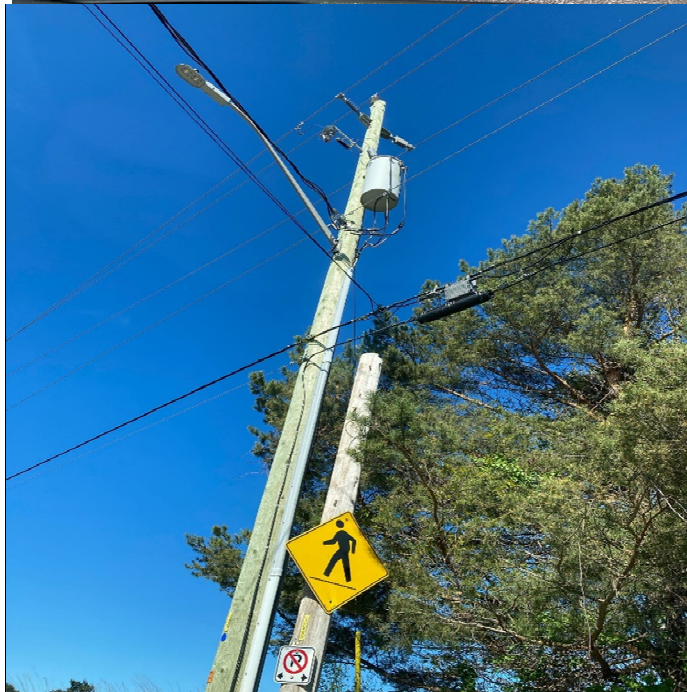
Pole mounted and pad mounted transformers were identified in the study area the time of site reconnaissance. The transformers appeared to be in good condition with no evidence of leaking or staining.

Photograph I3: Pole and pad mounted transformers identified throughout the study area.
