**Servicing and Stormwater
Management Report – 2829
Dumaurier Avenue**

Stantec Project No. 160401596

May 28, 2025

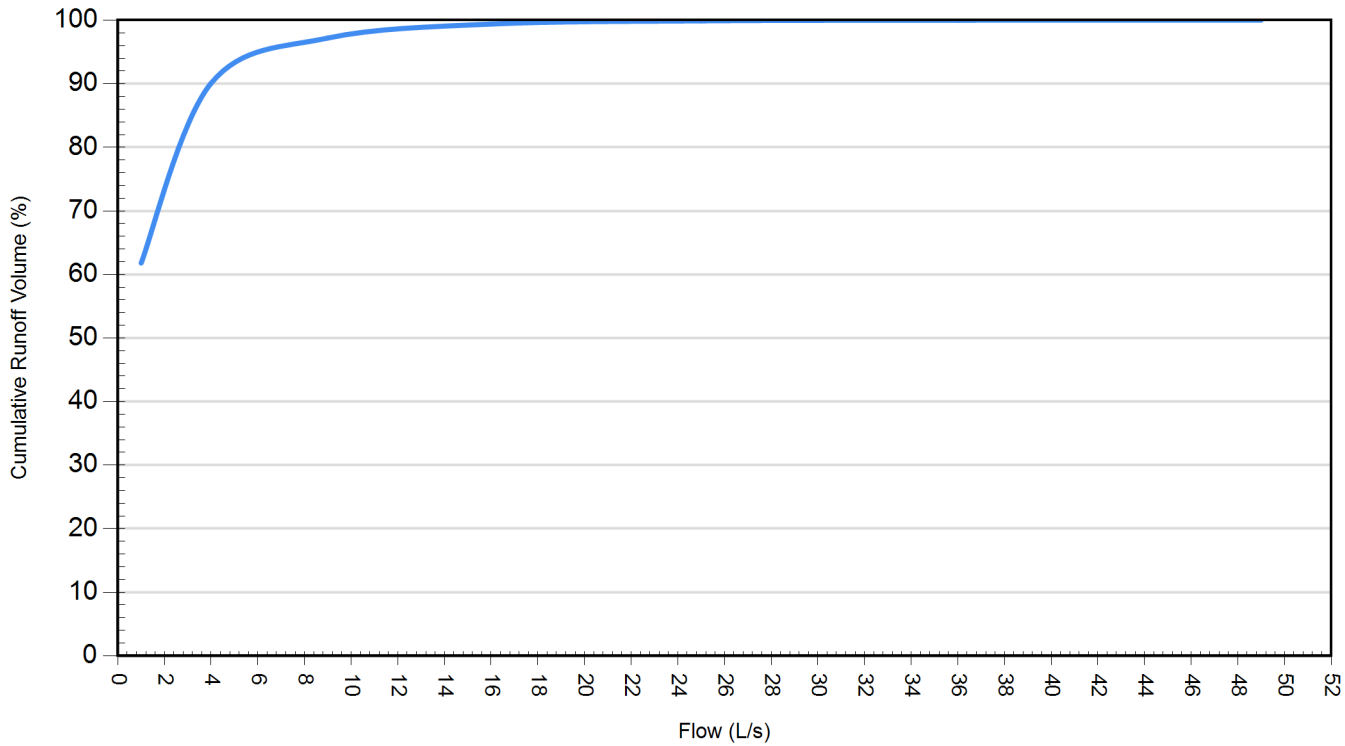
Cumulative Runoff Volume by Runoff Rate

For area: 0.17(ha), imperviousness: 99.90%, rainfall station: OTTAWA MACDONALD-CARTIER INT'L A
