**1199 NEWMARKET HOLDINGS INC.  
GEOTECHNICAL INVESTIGATION**

Property located at 1195, Newmarket Street in Ottawa, Ontario  
N/Ref.: 13340

NOVEMBER 2019  
Revised: **JUNE 2022**

**Object: GEOTECHNICAL STUDY**  
Commercial Building of one (1) storey without basement  
Property located at 1195, Newmarket Street in Ottawa, Ontario

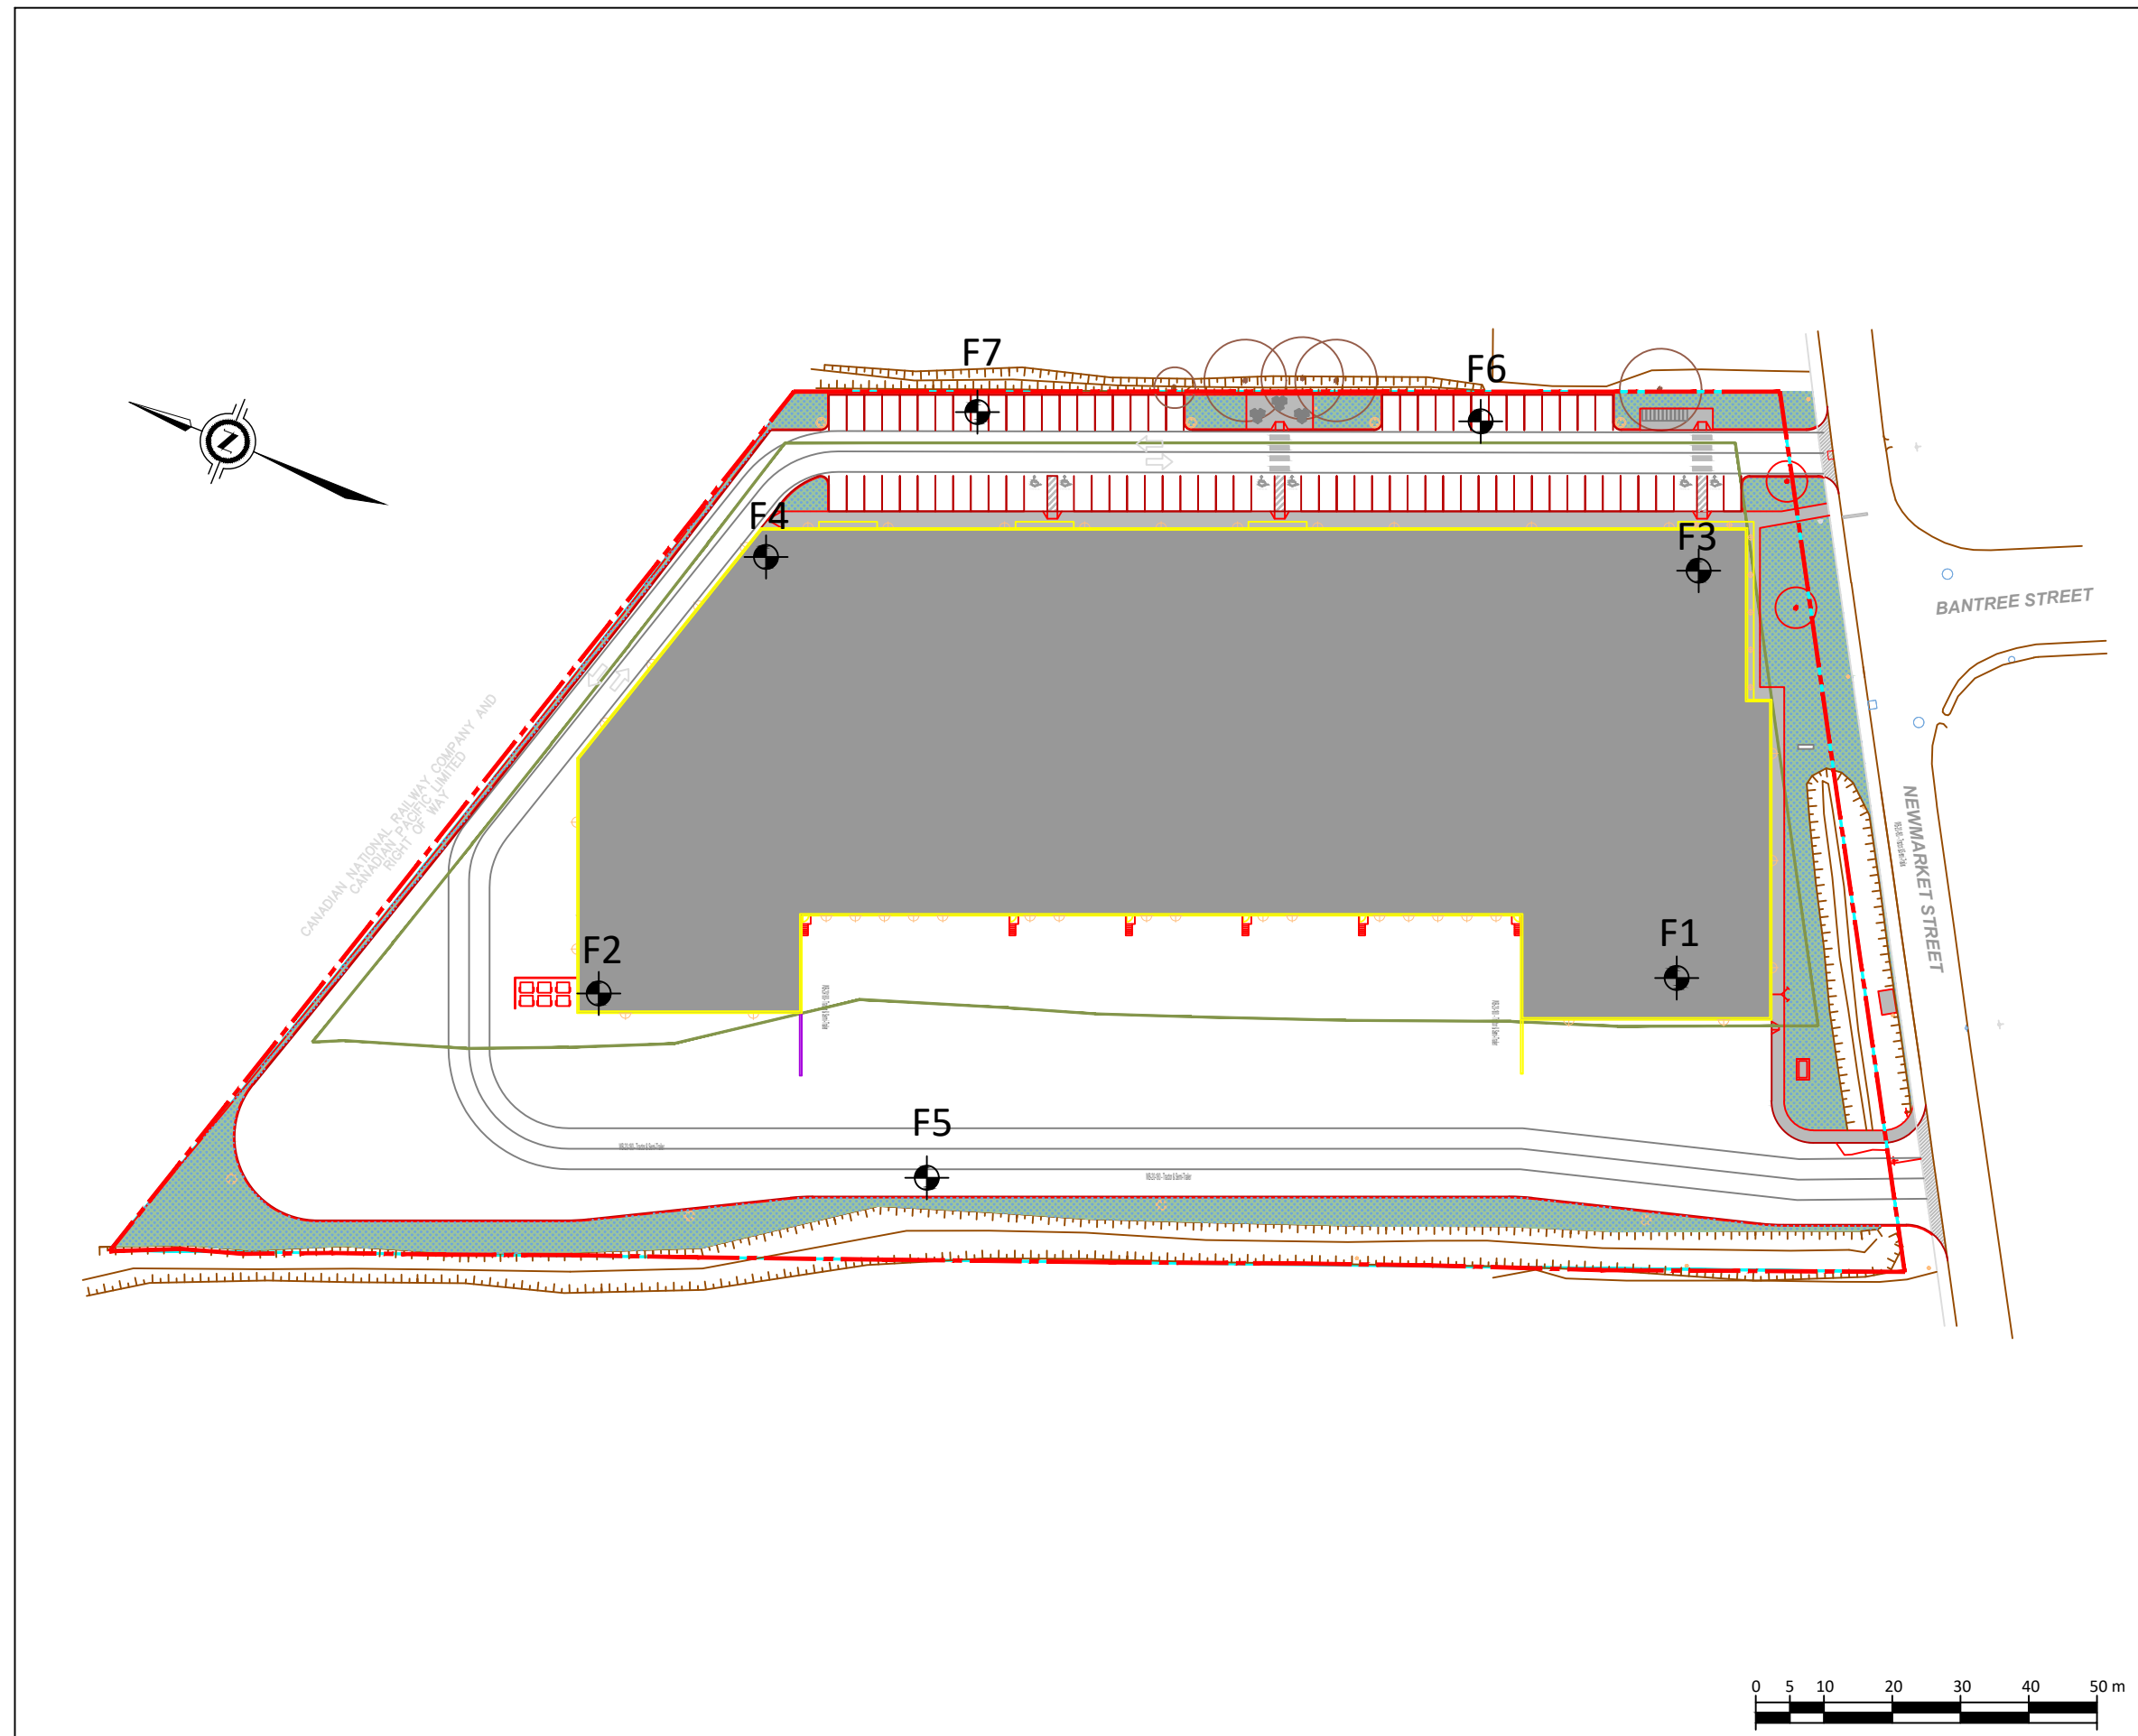
Figure  
**1**

Drawing title  
**SURVEY LOCATION**

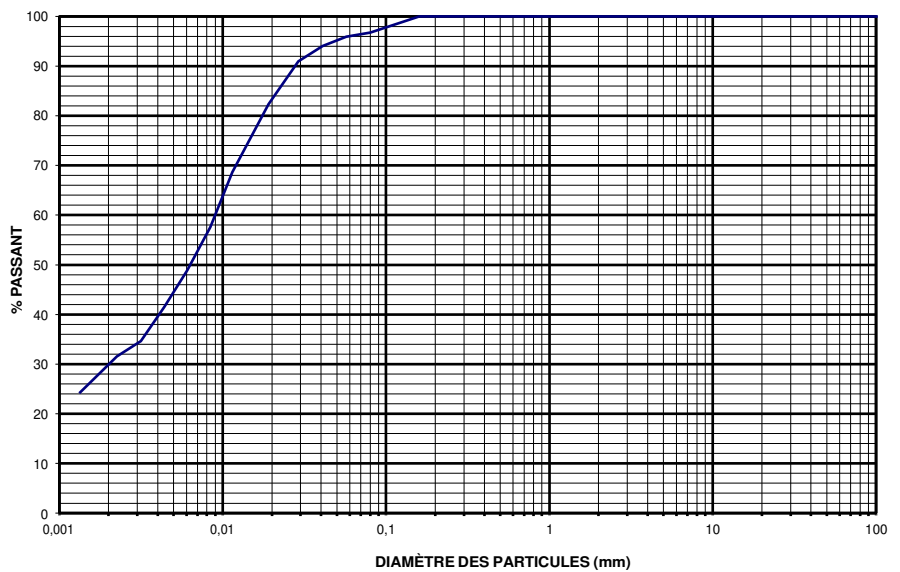
**COURBE GRANULOMÉTRIQUE**

ANALYSE GRANULOMÉTRIQUE		SÉDIMENTOMÉTRIE		
		TEMPS (MIN)	DIAMÈTRE (MM)	% PASSANT
112 mm	100			
80 mm	100	0,5	0,057	95,9
56 mm	100	1	0,041	94,1
40 mm	100	2	0,029	91,0
28 mm	100	5	0,019	82,3
20 mm	100	15	0,011	68,7
14 mm	100	30	0,008	57,5
10 mm	100	60	0,006	48,9
5 mm	100	120	0,004	41,5
2,5 mm	100	240	0,003	34,7
1,25 mm	100	480	0,002	31,6
630 µm	100	1440	0,001	24,1
315 µm	100			
160 µm	100			
80 µm	96,8

Argile %	29
Silt %	67
Sable %	3
Gravier %	0

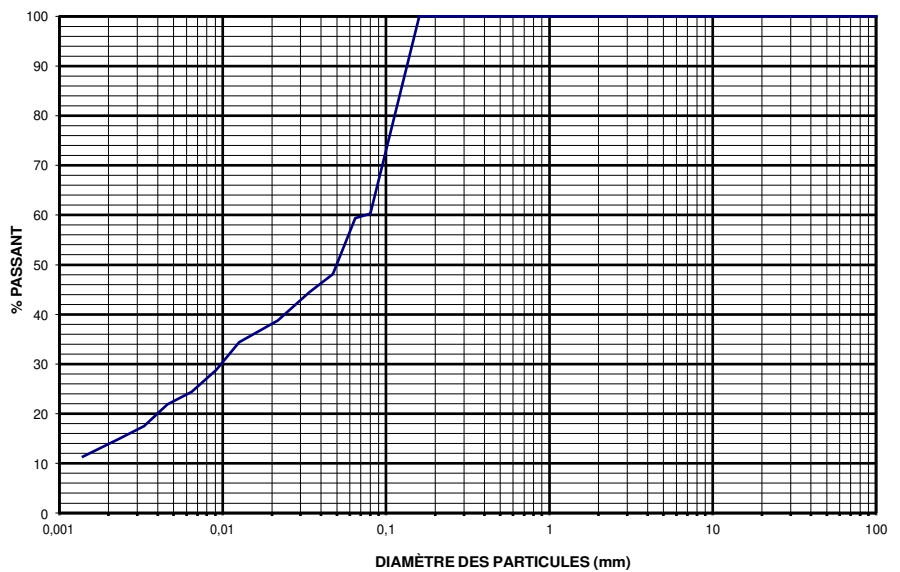
**COURBE GRANULOMÉTRIQUE**

ANALYSE GRANULOMÉTRIQUE		SÉDIMENTOMÉTRIE		
		TEMPS (MIN)	DIAMÈTRE (MM)	% PASSANT
112 mm	100			
80 mm	100	0,5	0,065	59,4
56 mm	100	1	0,047	48,1
40 mm	100	2	0,034	44,4
28 mm	100	5	0,022	38,8
20 mm	100	15	0,013	34,4
14 mm	100	30	0,009	28,8
10 mm	100	60	0,006	24,4
5 mm	100	120	0,005	21,9
2,5 mm	100	240	0,003	17,5
1,25 mm	100	480	0,002	15,0
630 µm	100	1440	0,001	11,3
315 µm	100			
160 µm	100			
80 µm	60,3

Argile %	14
Silt %	46
Sable %	40
Gravier %	0

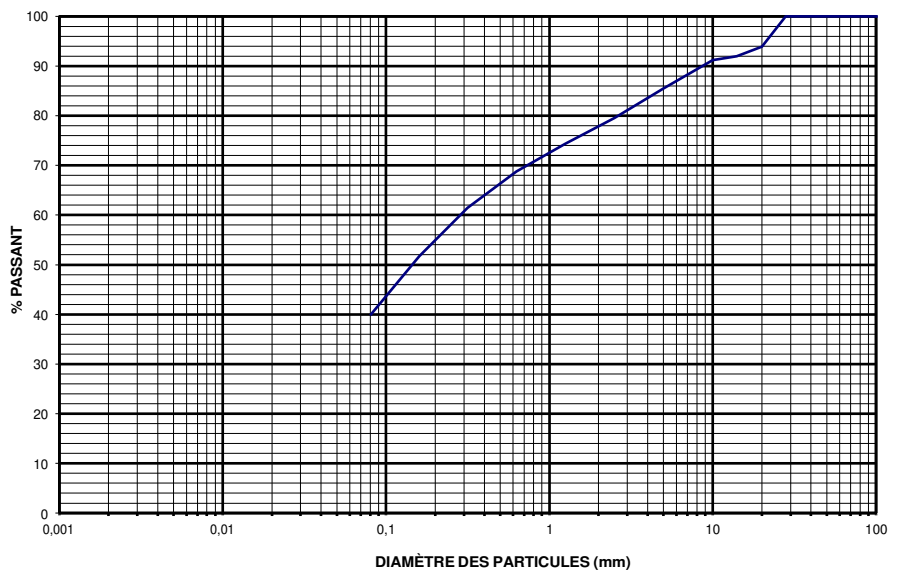
**COURBE GRANULOMÉTRIQUE**

ANALYSE GRANULOMÉTRIQUE		SÉDIMENTOMÉTRIE		
		TEMPS (MIN)	DIAMÈTRE (MM)	% PASSANT
112 mm	100			
80 mm	100	0,5		
56 mm	100	1		
40 mm	100	2		
28 mm	100	5		
20 mm	94	15		
14 mm	92	30		
10 mm	91	60		
5 mm	85	120		
2,5 mm	80	240		
1,25 mm	74	480		
630 µm	69	1440		
315 µm	61			
160 µm	52			
80 µm	39,8

Argile %	0
Silt %	40
Sable %	46
Gravier %	15

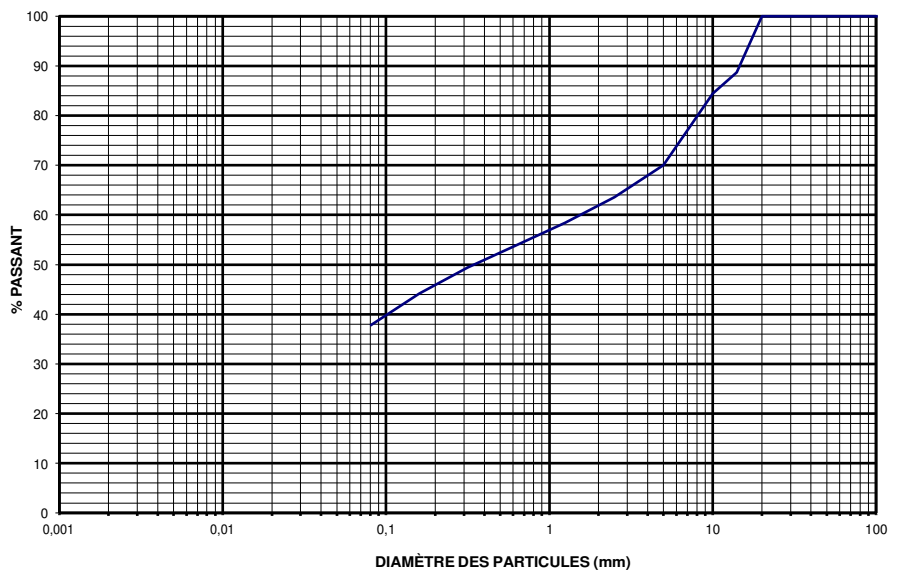
**COURBE GRANULOMÉTRIQUE**

ANALYSE GRANULOMÉTRIQUE		SÉDIMENTOMÉTRIE		
		TEMPS (MIN)	DIAMÈTRE (MM)	% PASSANT
112 mm	100			
80 mm	100	0,5		
56 mm	100	1		
40 mm	100	2		
28 mm	100	5		
20 mm	100	15		
14 mm	89	30		
10 mm	84	60		
5 mm	70	120		
2,5 mm	64	240		
1,25 mm	58	480		
630 µm	54	1440		
315 µm	49			
160 µm	44			
80 µm	37,7

Argile %	0
Silt %	38
Sable %	32
Gravier %	30

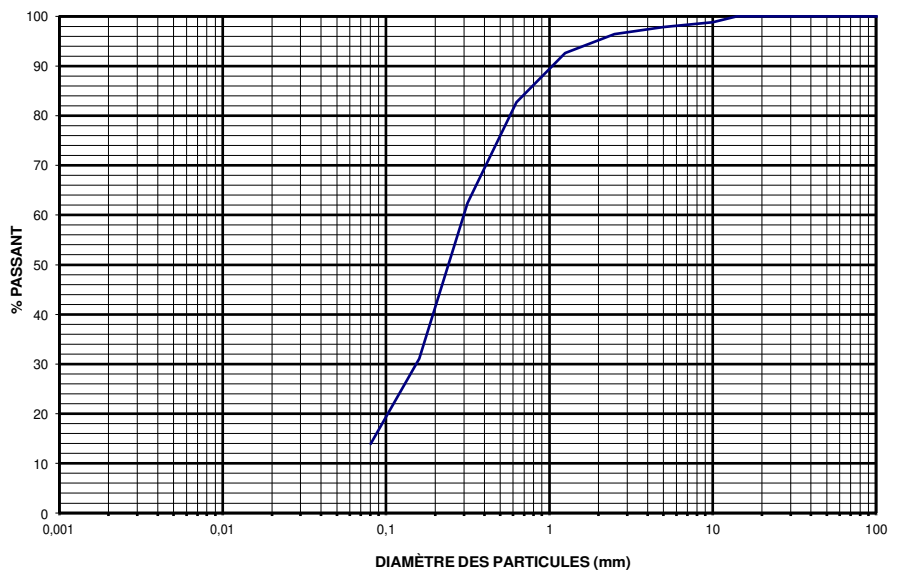
**COURBE GRANULOMÉTRIQUE**

ANALYSE GRANULOMÉTRIQUE		SÉDIMENTOMÉTRIE		
		TEMPS (MIN)	DIAMÈTRE (MM)	% PASSANT
112 mm	100			
80 mm	100	0,5		
56 mm	100	1		
40 mm	100	2		
28 mm	100	5		
20 mm	100	15		
14 mm	100	30		
10 mm	99	60		
5 mm	98	120		
2,5 mm	96	240		
1,25 mm	93	480		
630 µm	83	1440		
315 µm	62			
160 µm	31			
80 µm	13,8

Argile %	0
Silt %	14
Sable %	84
Gravier %	2

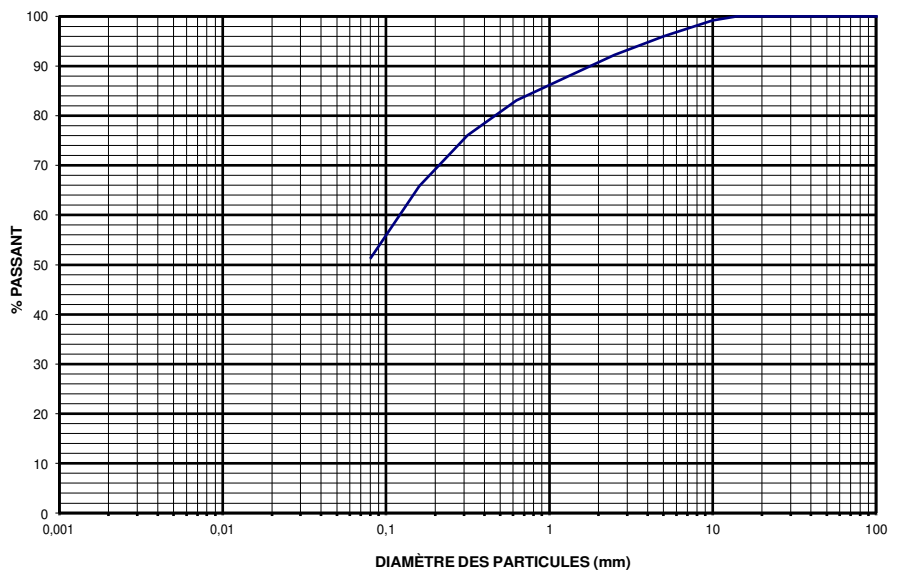
**COURBE GRANULOMÉTRIQUE**

ANALYSE GRANULOMÉTRIQUE		SÉDIMENTOMÉTRIE		
		TEMPS (MIN)	DIAMÈTRE (MM)	% PASSANT
112 mm	100			
80 mm	100	0,5		
56 mm	100	1		
40 mm	100	2		
28 mm	100	5		
20 mm	100	15		
14 mm	100	30		
10 mm	99	60		
5 mm	96	120		
2,5 mm	92	240		
1,25 mm	88	480		
630 µm	83	1440		
315 µm	76			
160 µm	66			
80 µm	51,2

Argile %	0
Silt %	51
Sable %	45
Gravier %	4

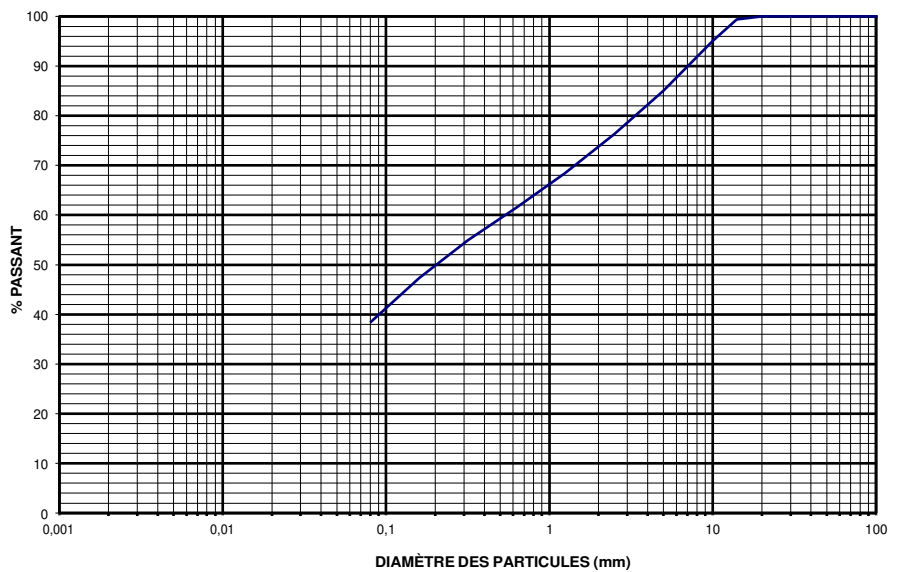
**COURBE GRANULOMÉTRIQUE**

ANALYSE GRANULOMÉTRIQUE		SÉDIMENTOMÉTRIE		
		TEMPS (MIN)	DIAMÈTRE (MM)	% PASSANT
112 mm	100			
80 mm	100	0,5		
56 mm	100	1		
40 mm	100	2		
28 mm	100	5		
20 mm	100	15		
14 mm	99	30		
10 mm	95	60		
5 mm	85	120		
2,5 mm	76	240		
1,25 mm	68	480		
630 µm	62	1440		
315 µm	55			
160 µm	47			
80 µm	38,4

Argile %	0
Silt %	38
Sable %	47
Gravier %	15

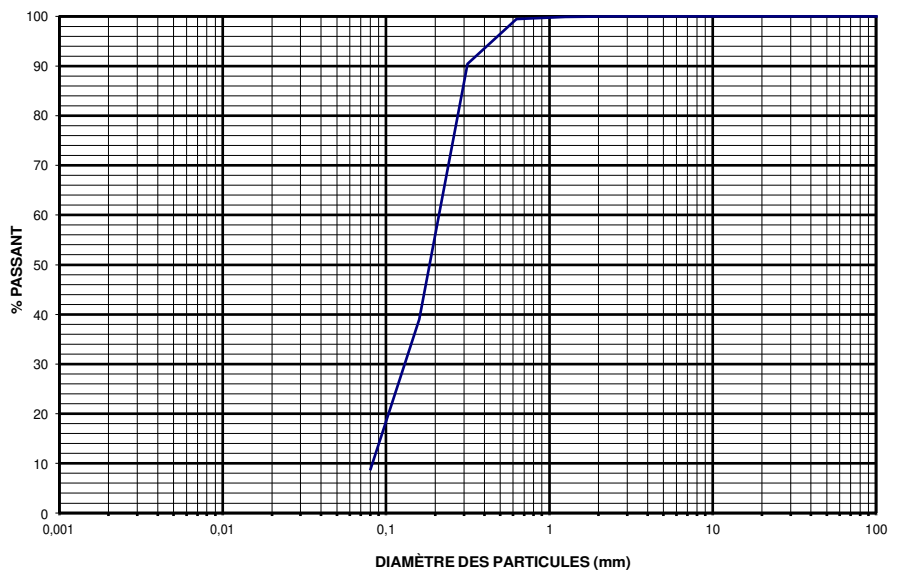
**COURBE GRANULOMÉTRIQUE**

ANALYSE GRANULOMÉTRIQUE		SÉDIMENTOMÉTRIE		
		TEMPS (MIN)	DIAMÈTRE (MM)	% PASSANT
112 mm	100			
80 mm	100	0,5		
56 mm	100	1		
40 mm	100	2		
28 mm	100	5		
20 mm	100	15		
14 mm	100	30		
10 mm	100	60		
5 mm	100	120		
2,5 mm	100	240		
1,25 mm	100	480		
630 µm	99	1440		
315 µm	90			
160 µm	39			
80 µm	8,6

Argile %	0
Silt %	9
Sable %	91
Gravier %	0

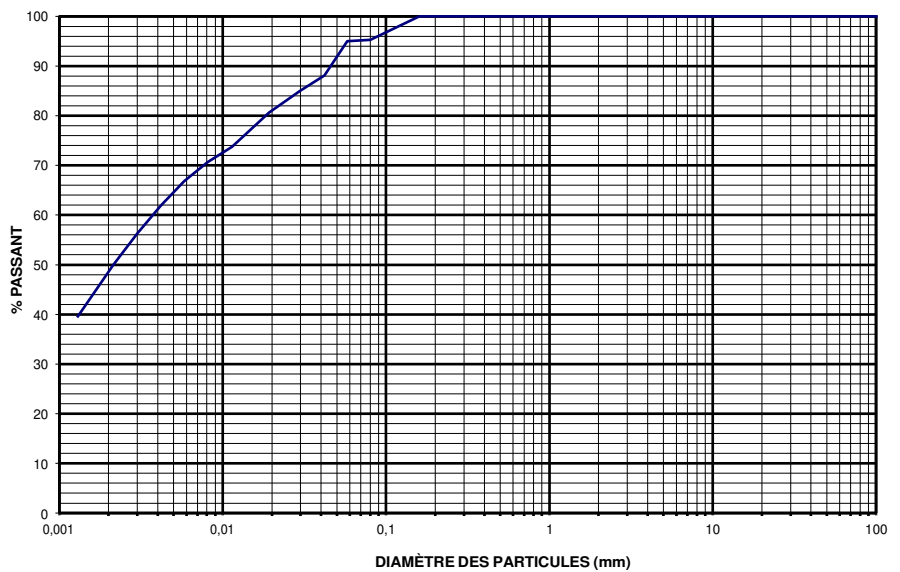
**COURBE GRANULOMÉTRIQUE**

ANALYSE GRANULOMÉTRIQUE		SÉDIMENTOMÉTRIE		
		TEMPS (MIN)	DIAMÈTRE (MM)	% PASSANT
112 mm	100			
80 mm	100	0,5	0,058	95,0
56 mm	100	1	0,042	88,1
40 mm	100	2	0,030	85,0
28 mm	100	5	0,019	80,6
20 mm	100	15	0,011	73,8
14 mm	100	30	0,008	70,6
10 mm	100	60	0,006	66,9
5 mm	100	120	0,004	61,9
2,5 mm	100	240	0,003	56,3
1,25 mm	100	480	0,002	50,0
630 µm	100	1440	0,001	39,4
315 µm	100			
160 µm	100			
80 µm	95,3

Argile %	48
Silt %	47
Sable %	5
Gravier %	0

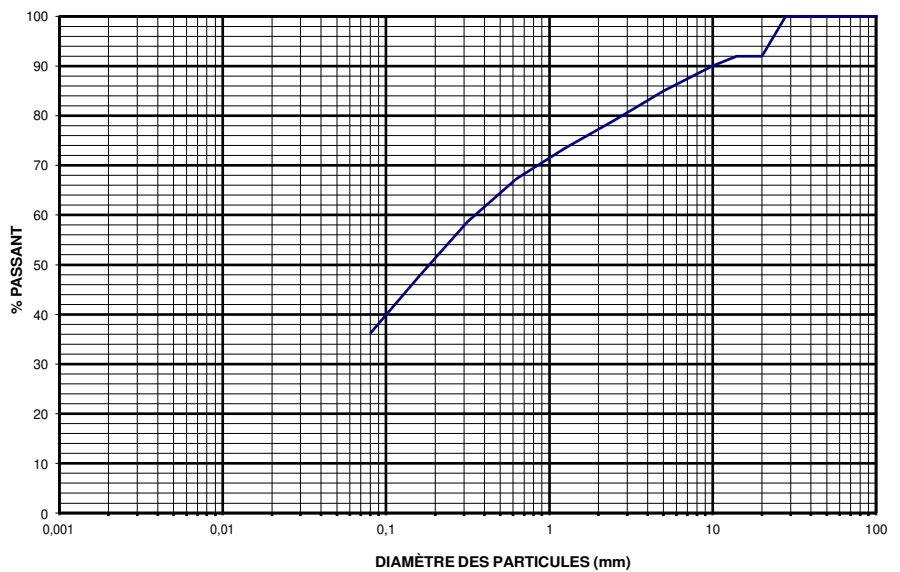
**COURBE GRANULOMÉTRIQUE**

ANALYSE GRANULOMÉTRIQUE		SÉDIMENTOMÉTRIE		
		TEMPS (MIN)	DIAMÈTRE (MM)	% PASSANT
112 mm	100			
80 mm	100	0,5		
56 mm	100	1		
40 mm	100	2		
28 mm	100	5		
20 mm	92	15		
14 mm	92	30		
10 mm	90	60		
5 mm	85	120		
2,5 mm	79	240		
1,25 mm	73	480		
630 µm	67	1440

Argile %	0
Silt %	36
Sable %	49
Gravier %	15

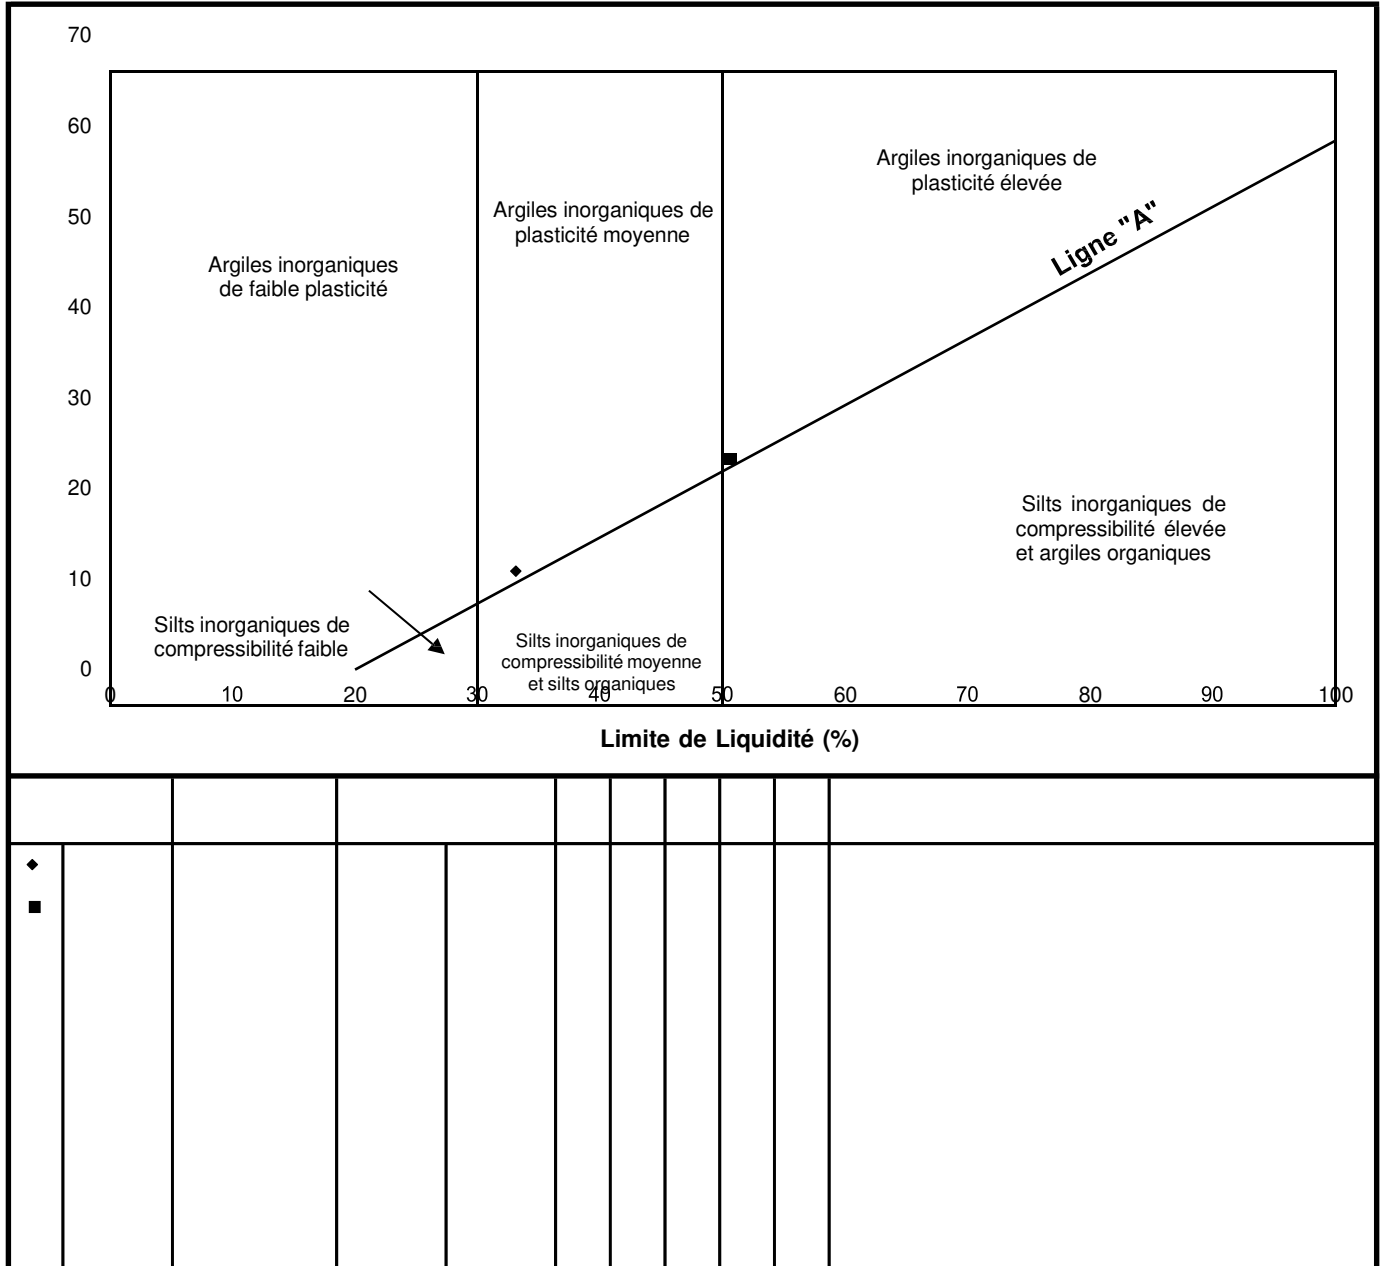
## ABAQUE DE PLASTICITÉ (Compilation des résultats)

CLIENT: 1199 NEWMARKET HOLDINGS INC.  
 PROJET: Warehouse Newmarket  
 SITE: 1195, Newmarket street, Ottawa  
 DOSSIER: 13340
