**1199NEWMARKET HOLDINGS INC.
GEOTECHNICAL INVESTIGATION**

Property located at 1195, Newmarket Street in Ottawa, Ontario
N/Ref.: 13340

Revised: October 25, 2021
Original: November 22nd 2019

Object: GEOTECHNICAL STUDY
Commercial Building of one (1) storey without basement
Property located at 1195, Newmarket Street in Ottawa, Ontario

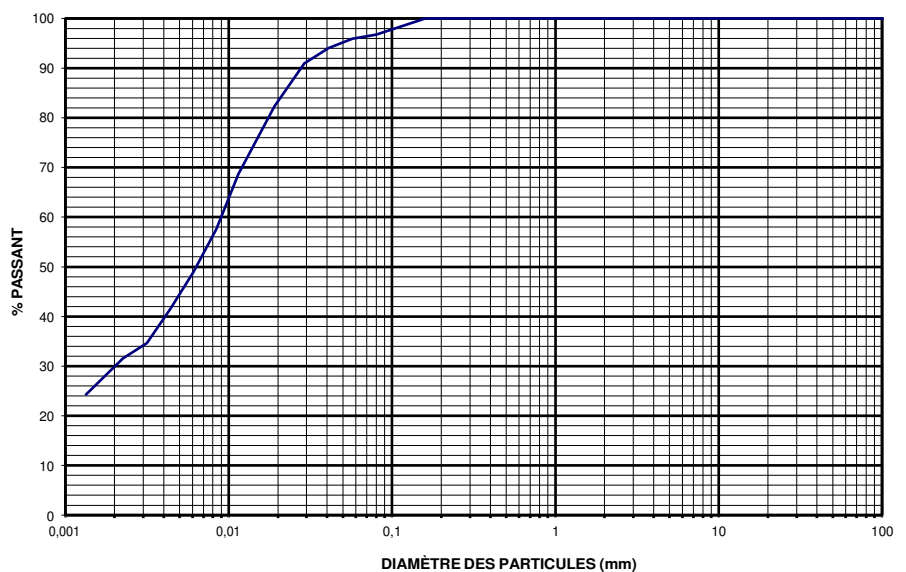
COURBE GRANULOMÉTRIQUE

ANALYSE GRANULOMÉTRIQUE		SÉDIMENTOMÉTRIE		
		TEMPS (MIN)	DIAMÈTRE (MM)	% PASSANT
112 mm	100			
80 mm	100	0,5	0,057	95,9
56 mm	100	1	0,041	94,1
40 mm	100	2	0,029	91,0
28 mm	100	5	0,019	82,3
20 mm	100	15	0,011	68,7
14 mm	100	30	0,008	57,5
10 mm	100	60	0,006	48,9
5 mm	100	120	0,004	41,5
2,5 mm	100	240	0,003	34,7
1,25 mm	100	480	0,002	31,6
630 µm	100	1440	0,001	24,1

Argile %	29
Silt %	67
Sable %	3
Gravier %	0

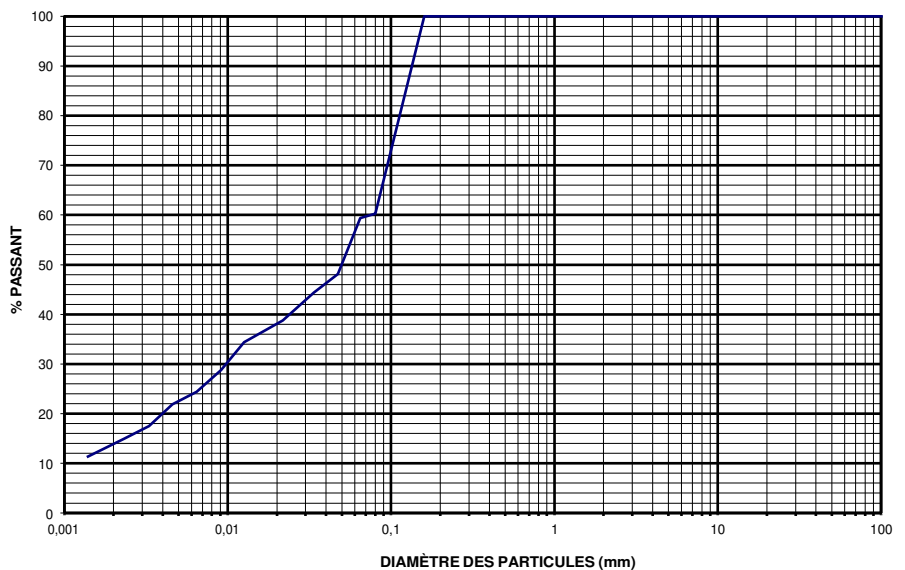
COURBE GRANULOMÉTRIQUE

ANALYSE GRANULOMÉTRIQUE		SÉDIMENTOMÉTRIE		
		TEMPS (MIN)	DIAMÈTRE (MM)	% PASSANT
112 mm	100			
80 mm	100	0,5	0,065	59,4
56 mm	100	1	0,047	48,1
40 mm	100	2	0,034	44,4
28 mm	100	5	0,022	38,8
20 mm	100	15	0,013	34,4
14 mm	100	30	0,009	28,8
10 mm	100	60	0,006	24,4
5 mm	100	120	0,005	21,9
2,5 mm	100	240	0,003	17,5
1,25 mm	100	480	0,002	15,0
630 µm	100	1440	0,001	11,3
315 µm	100			
160 µm	100			
80 µm	60,3

Argile %	14
Silt %	46
Sable %	40
Gravier %	0

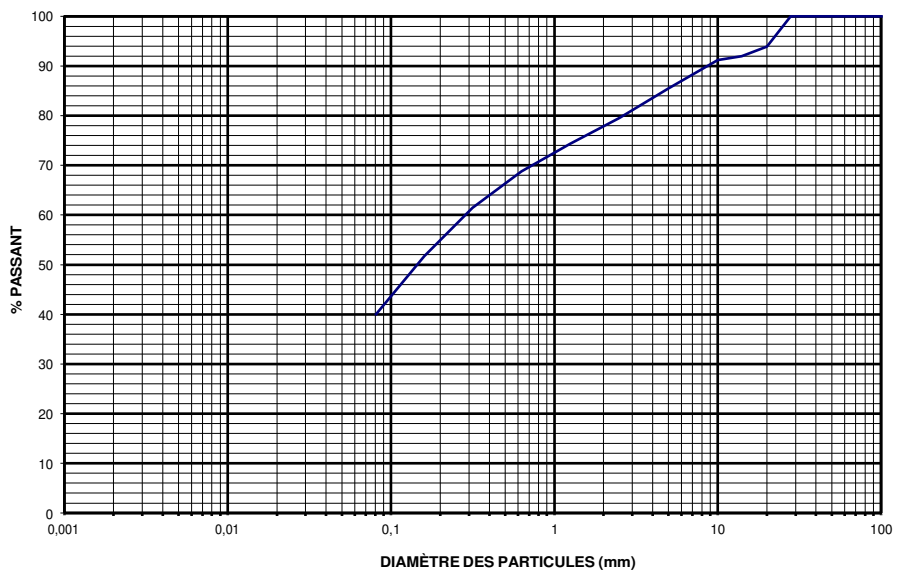
COURBE GRANULOMÉTRIQUE

ANALYSE GRANULOMÉTRIQUE		SÉDIMENTOMÉTRIE		
		TEMPS (MIN)	DIAMÈTRE (MM)	% PASSANT
112 mm	100			
80 mm	100	0,5		
56 mm	100	1		
40 mm	100	2		
28 mm	100	5		
20 mm	94	15		
14 mm	92	30		
10 mm	91	60		
5 mm	85	120		
2,5 mm	80	240		
1,25 mm	74	480		
630 µm	69	1440

Argile %	0
Silt %	40
Sable %	46
Gravier %	15

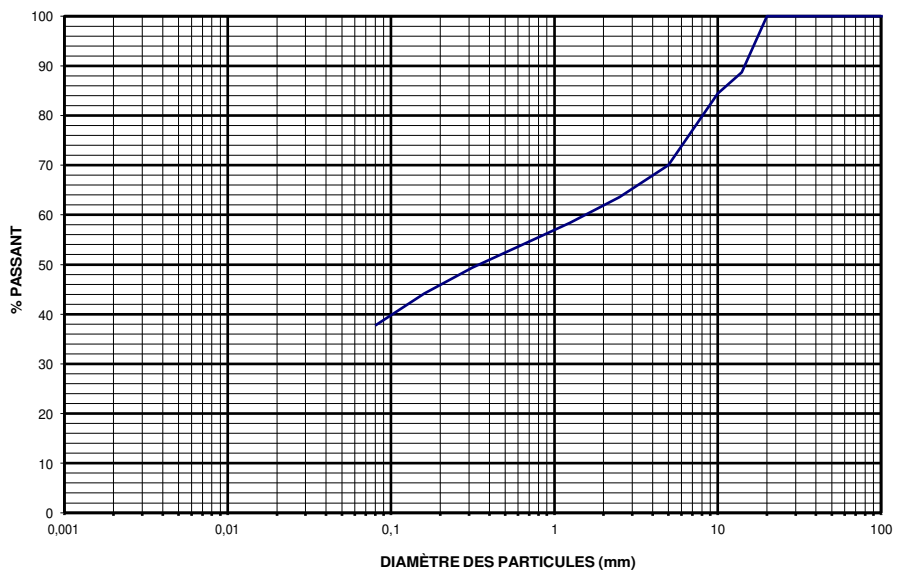
COURBE GRANULOMÉTRIQUE

ANALYSE GRANULOMÉTRIQUE		SÉDIMENTOMÉTRIE		
		TEMPS (MIN)	DIAMÈTRE (MM)	% PASSANT
112 mm	100			
80 mm	100	0,5		
56 mm	100	1		
40 mm	100	2		
28 mm	100	5		
20 mm	100	15		
14 mm	89	30		
10 mm	84	60		
5 mm	70	120		
2,5 mm	64	240		
1,25 mm	58	480		
630 µm	54	1440

Argile %	0
Silt %	38
Sable %	32
Gravier %	30

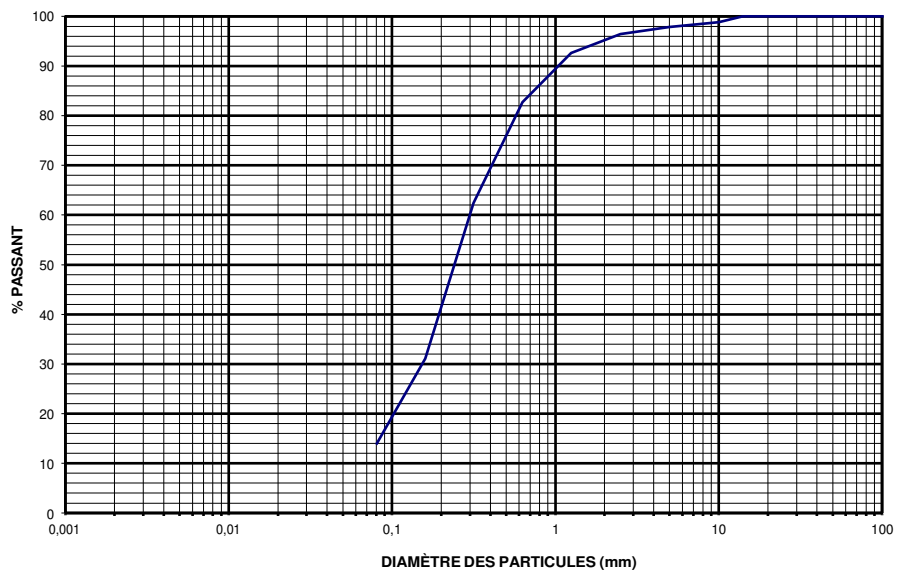
COURBE GRANULOMÉTRIQUE

ANALYSE GRANULOMÉTRIQUE		SÉDIMENTOMÉTRIE		
		TEMPS (MIN)	DIAMÈTRE (MM)	% PASSANT
112 mm	100			
80 mm	100	0,5		
56 mm	100	1		
40 mm	100	2		
28 mm	100	5		
20 mm	100	15		
14 mm	100	30		
10 mm	99	60		
5 mm	98	120		
2,5 mm	96	240		
1,25 mm	93	480		
630 µm	83	1440		
315 µm	62			
160 µm	31			
80 µm	13,8

Argile %	0
Silt %	14
Sable %	84
Gravier %	2

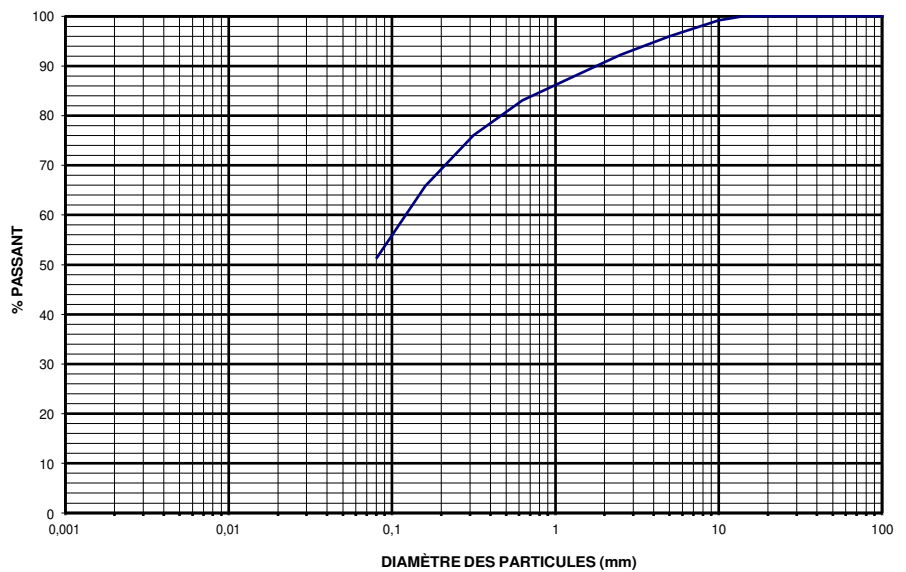
COURBE GRANULOMÉTRIQUE

ANALYSE GRANULOMÉTRIQUE		SÉDIMENTOMÉTRIE		
		TEMPS (MIN)	DIAMÈTRE (MM)	% PASSANT
112 mm	100			
80 mm	100	0,5		
56 mm	100	1		
40 mm	100	2		
28 mm	100	5		
20 mm	100	15		
14 mm	100	30		
10 mm	99	60		
5 mm	96	120		
2,5 mm	92	240		
1,25 mm	88	480		
630 µm	83	1440		
315 µm	76			
160 µm	66			
80 µm	51,2

Argile %	0
Silt %	51
Sable %	45
Gravier %	4

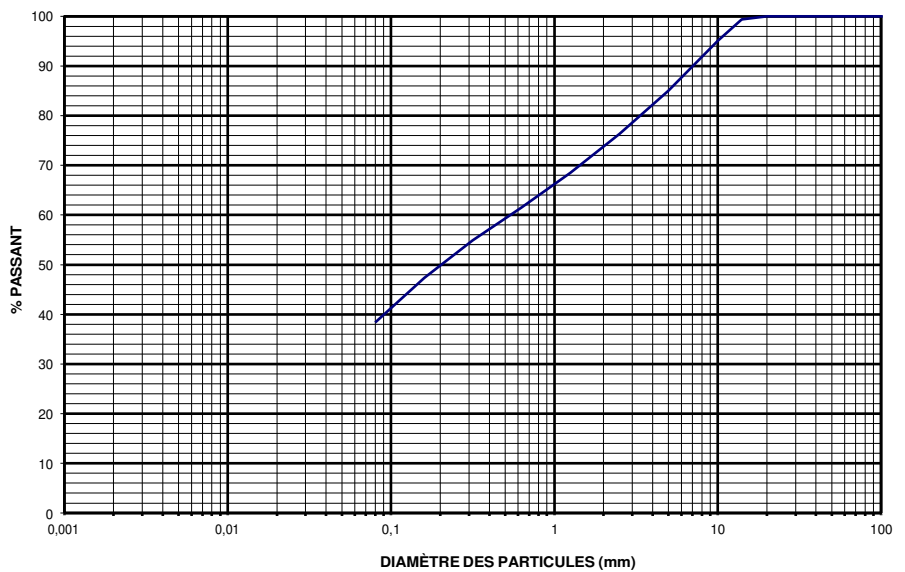
COURBE GRANULOMÉTRIQUE

ANALYSE GRANULOMÉTRIQUE		SÉDIMENTOMÉTRIE		
		TEMPS (MIN)	DIAMÈTRE (MM)	% PASSANT
112 mm	100			
80 mm	100	0,5		
56 mm	100	1		
40 mm	100	2		
28 mm	100	5		
20 mm	100	15		
14 mm	99	30		
10 mm	95	60		
5 mm	85	120		
2,5 mm	76	240		
1,25 mm	68	480		
630 µm	62	1440		
315 µm	55			
160 µm	47			
80 µm	38,4

Argile %	0
Silt %	38
Sable %	47
Gravier %	15

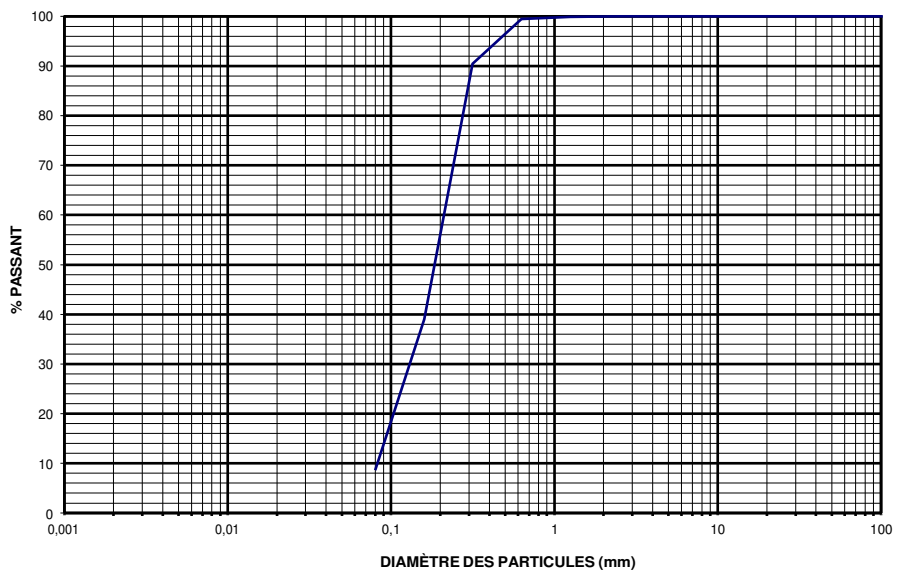
COURBE GRANULOMÉTRIQUE

ANALYSE GRANULOMÉTRIQUE		SÉDIMENTOMÉTRIE		
		TEMPS (MIN)	DIAMÈTRE (MM)	% PASSANT
112 mm	100			
80 mm	100	0,5		
56 mm	100	1		
40 mm	100	2		
28 mm	100	5		
20 mm	100	15		
14 mm	100	30		
10 mm	100	60		
5 mm	100	120		
2,5 mm	100	240		
1,25 mm	100	480		
630 µm	99	1440		
315 µm	90			
160 µm	39			
80 µm	8,6

Argile %	0
Silt %	9
Sable %	91
Gravier %	0

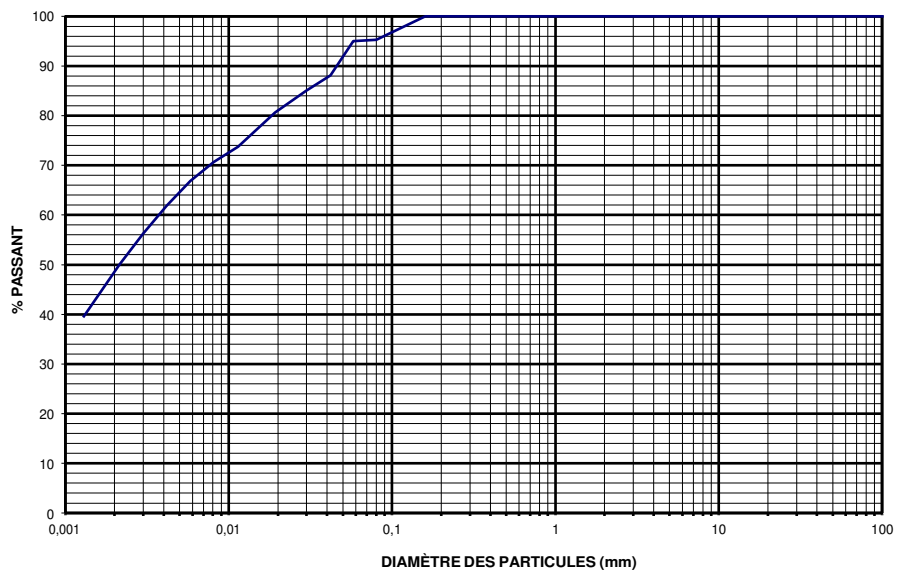
COURBE GRANULOMÉTRIQUE

ANALYSE GRANULOMÉTRIQUE		SÉDIMENTOMÉTRIE		
		TEMPS (MIN)	DIAMÈTRE (MM)	% PASSANT
112 mm	100			
80 mm	100	0,5	0,058	95,0
56 mm	100	1	0,042	88,1
40 mm	100	2	0,030	85,0
28 mm	100	5	0,019	80,6
20 mm	100	15	0,011	73,8
14 mm	100	30	0,008	70,6
10 mm	100	60	0,006	66,9
5 mm	100	120	0,004	61,9
2,5 mm	100	240	0,003	56,3
1,25 mm	100	480	0,002	50,0
630 µm	100	1440	0,001	39,4

Argile %	48
Silt %	47
Sable %	5
Gravier %	0

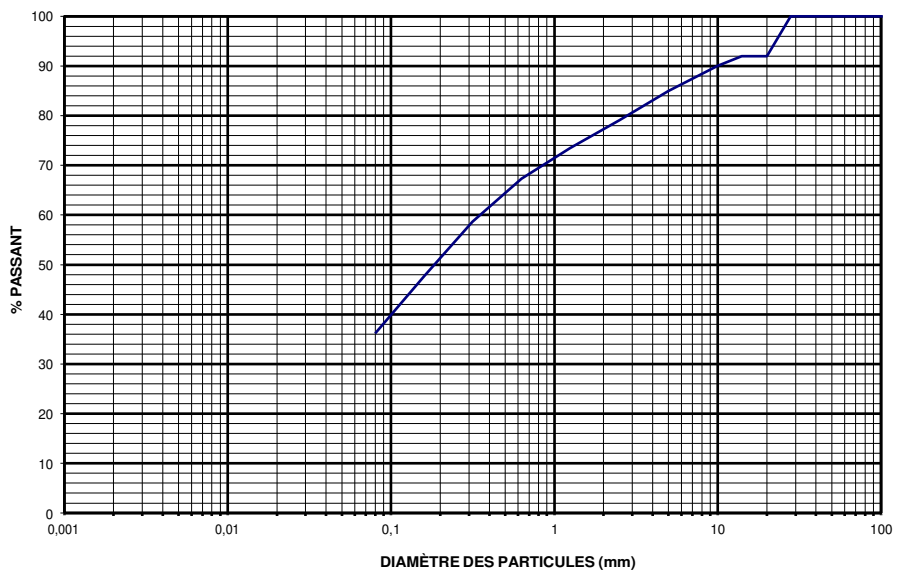
COURBE GRANULOMÉTRIQUE

ANALYSE GRANULOMÉTRIQUE		SÉDIMENTOMÉTRIE		
		TEMPS (MIN)	DIAMÈTRE (MM)	% PASSANT
112 mm	100			
80 mm	100	0,5		
56 mm	100	1		
40 mm	100	2		
28 mm	100	5		
20 mm	92	15		
14 mm	92	30		
10 mm	90	60		
5 mm	85	120		
2,5 mm	79	240		
1,25 mm	73	480		
630 µm	67	1440		
315 µm	59			
160 µm	48			
80 µm	36,1

Argile %	0
Silt %	36
Sable %	49
Gravier %	15

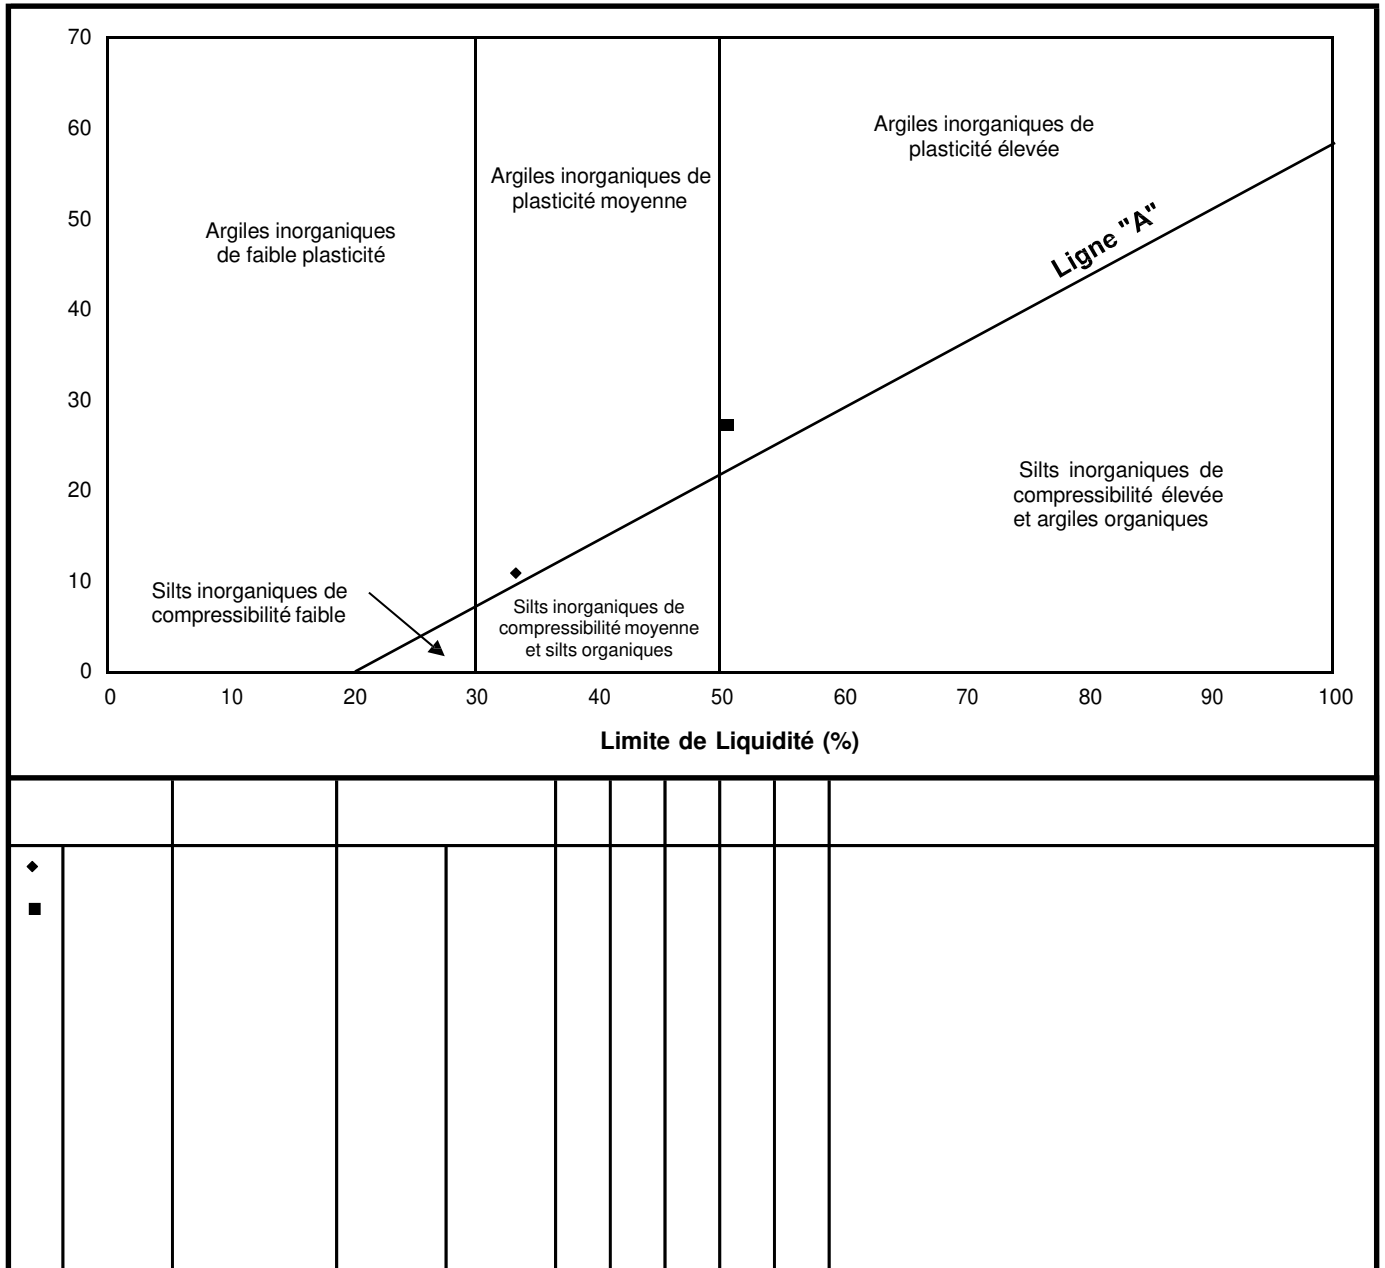
ABAQUE DE PLASTICITÉ (Compilation des résultats)

CLIENT: 1199 NEWMARKET HOLDINGS INC.
PROJET: Warehouse Newmarket
SITE: 1199, Newmarket street, Ottawa
DOSSIER: 13340

Beneath the fill layer at the location of boreholes BH1 and BH6, the native soil composed of a clayey silt with traces of sand (BH1) and of a clay and silt with traces of sand (BH6). This cohesive soil is wet, stiff in consistency and has a thickness of 0.5 and 1.9 m, at the location of BH6 and BH1 respectively. A summary of the geotechnical tests performed on the clay deposit are presented in the following Table 1 and 2, while the detailed laboratory results can be found in Appendix 3. This test includes particles size analysis, water content determination (Wn), Atterberg Limits (LL, PL, and IP, IL).
