# **Phase II – Environmental Site Assessment**

134 Nelson Street  
Ottawa, Ontario

Prepared for Smart Living Properties

**Report: PE5929-3  
December 19, 2023**

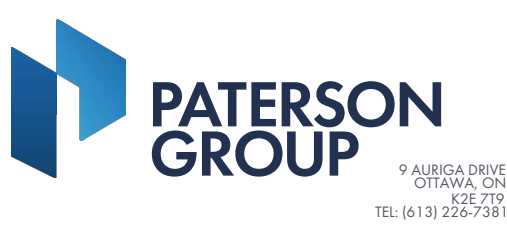
SMART LIVING PROPERTIES  
**PHASE II - ENVIRONMENTAL SITE ASSESSMENT**  
 134 NELSON STREET  
 OTTAWA, ONTARIO  
 Title: **CROSS SECTION A-A' - SOIL (VOCs, PHCs, PCBs, SAR, pH)**

**SOIL RESULT COMPLIES WITH THE MECP TABLE 3 STANDARDS**

**SOIL RESULT EXCEEDS THE MECP TABLE 3 STANDARDS**
