Phase I Environmental Site Assessment

1291 Summerville Avenue
Ottawa, Ontario

Concorde Management Development

Report: PE5083-1

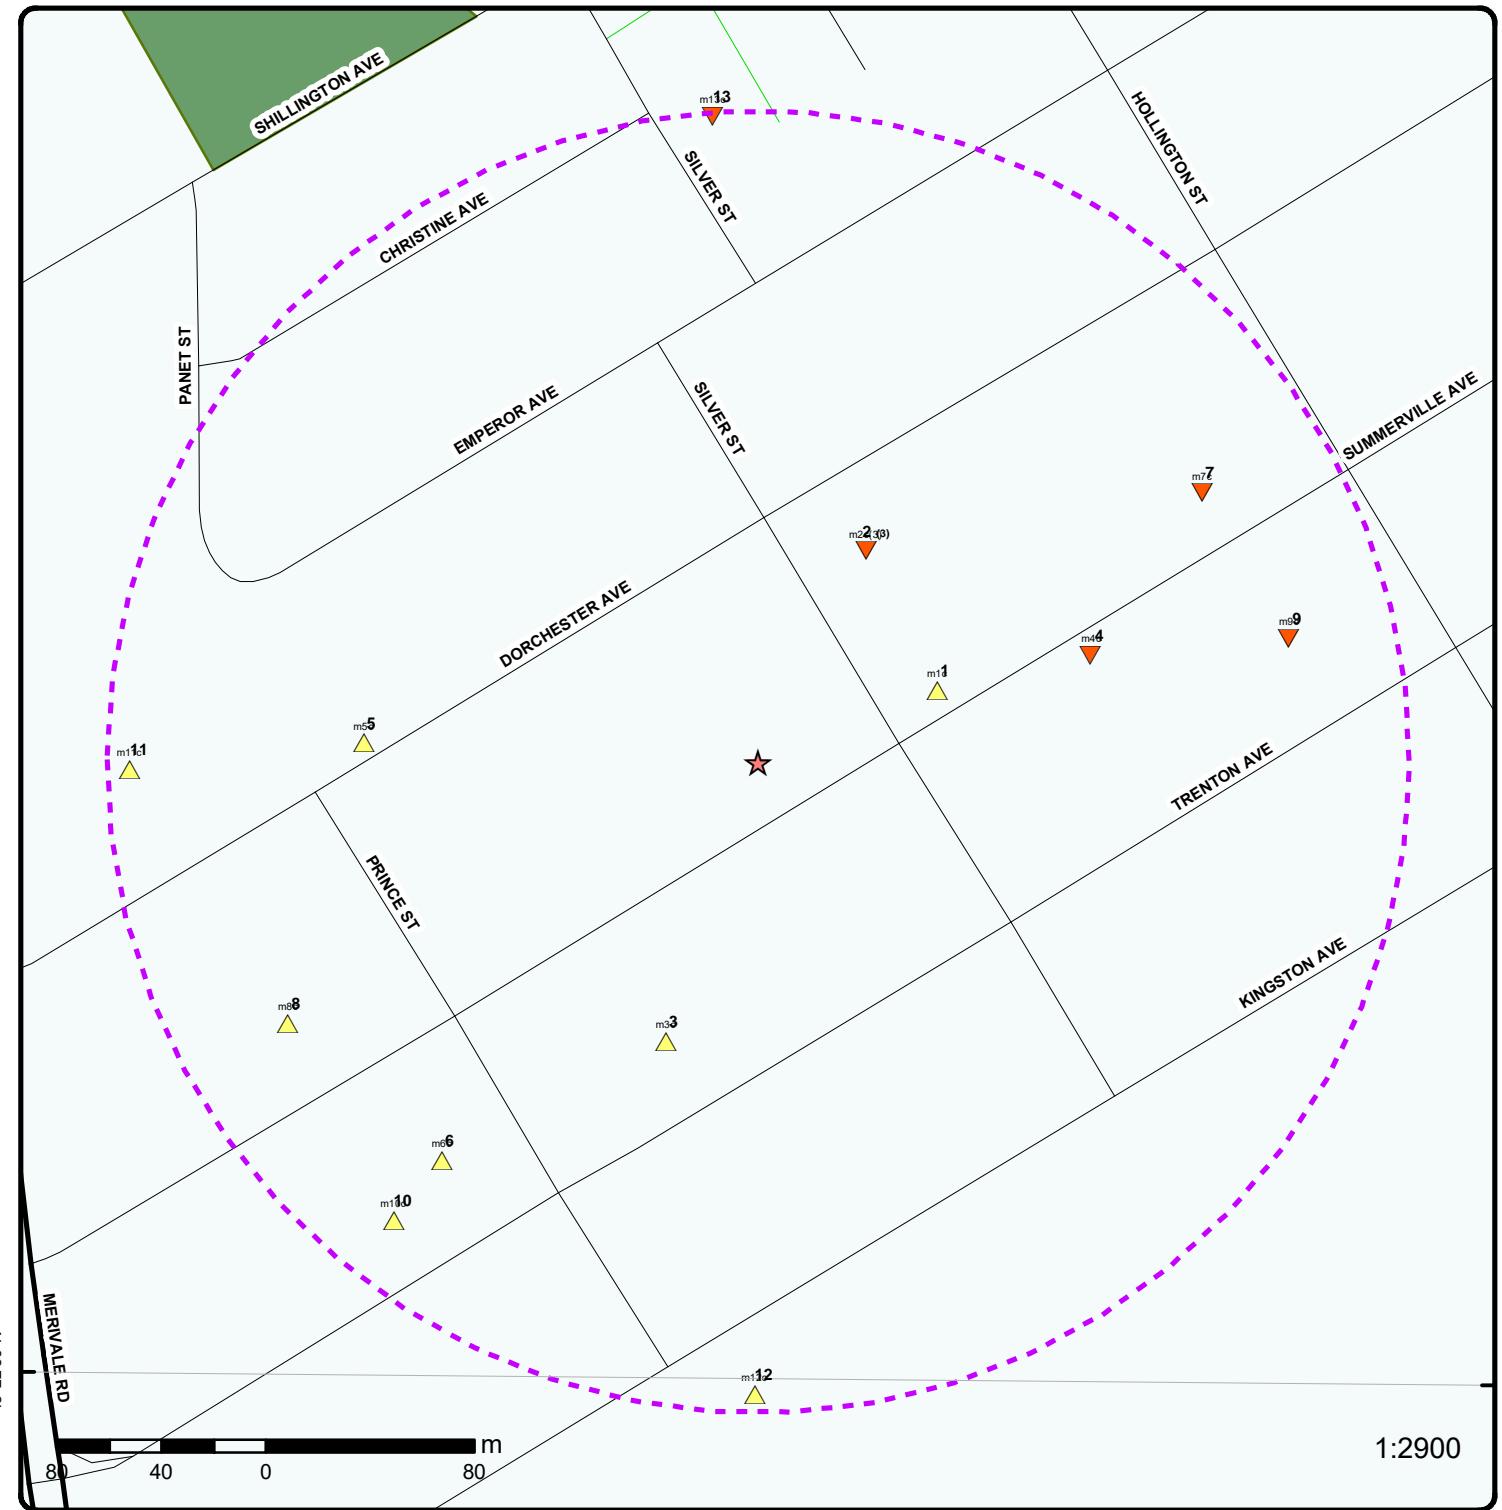
Map : 0.25 Kilometer Radius

<u>Equal/Higher Elevation</u>	<u>Address</u>	<u>Direction</u>	<u>Distance (m)</u>	<u>Map Key</u>
	ON	SW	195.10	6
	<i>Well ID:</i> 1508490			
	lot 33 con 2 ON	W	241.35	11
	<i>Well ID:</i> 1510611

<u>Lower Elevation</u>	<u>Address</u>	<u>Direction</u>	<u>Distance (m)</u>	<u>Map Key</u>
	ON	E	209.07	9
	<i>Well ID:</i> 1508931
