# Hydrogeological and Impact Assessment Report

**Proposed Commercial Development, 301  
Somme Street, Ottawa, Ontario**

Consolidated Fastfrate (Ottawa) Holdings Inc.

September 22, 2022

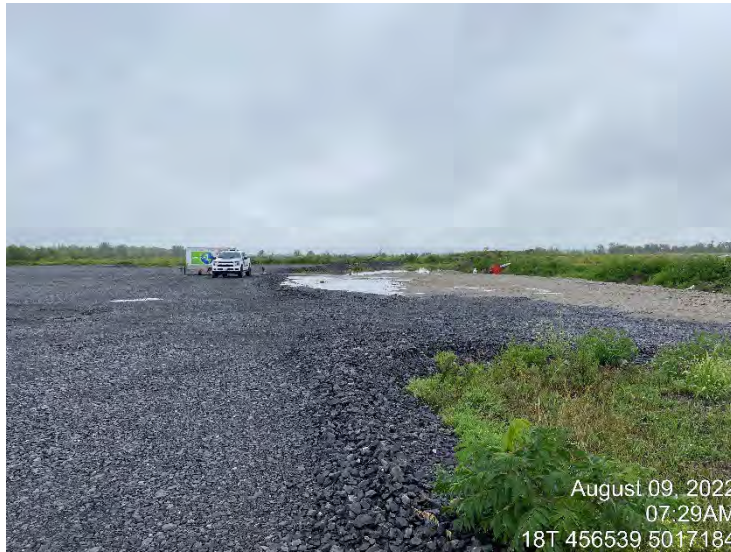
Photo 1 - View of drilled water well on the Site used during pumping test and proposed building area showing ground improvement.

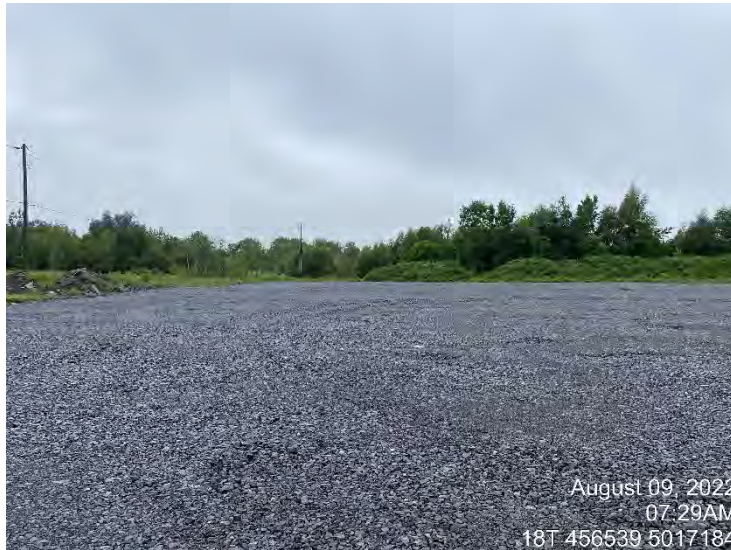
Photo 2 - View of ground improvement area.

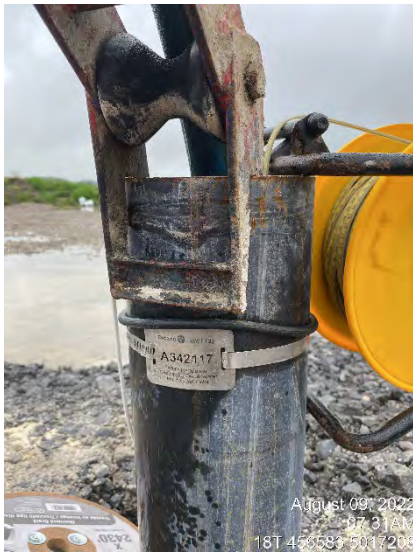
Photo 3 - Wellhead at pumped water well A342117.

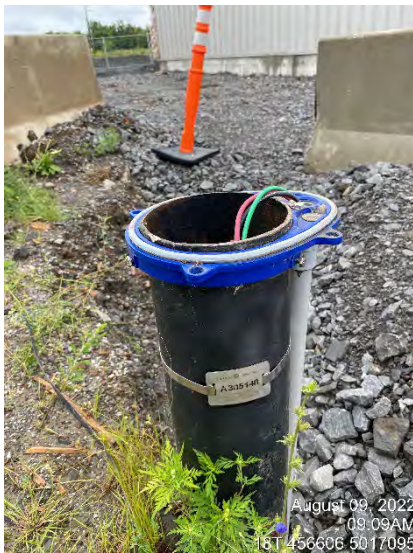
Photo 4 - Observation well (ID A305146) used during pumping test for monitoring of potential interference effects.

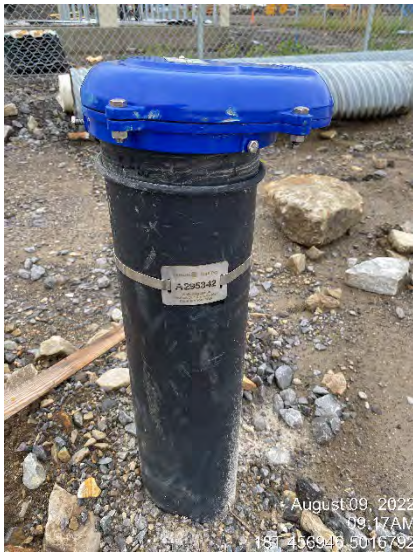
Photo 5 - Observation well (ID A295342) used during pumping test for monitoring of potential interference effects.

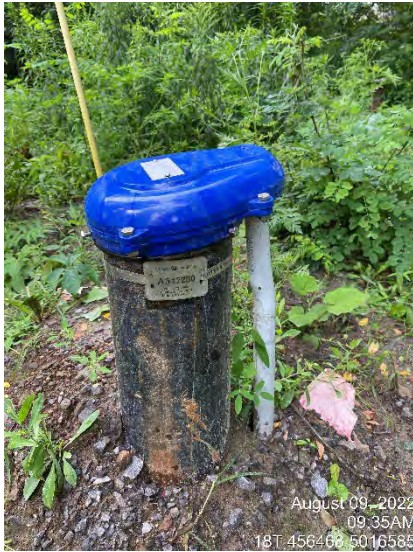
Photo 6 - Observation well (ID A342260) used during pumping test for monitoring of potential interference effects.

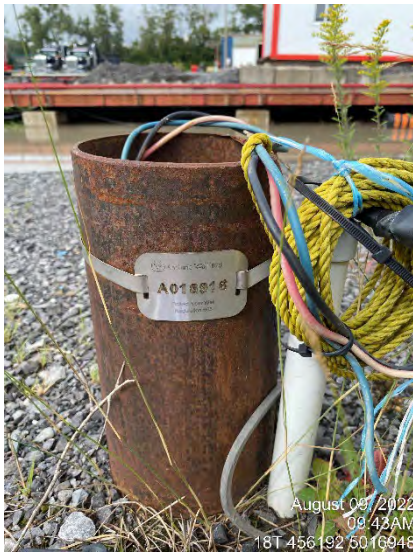
Photo 7 - Observation well (ID A018916) used during pumping test for monitoring of potential interference effects.

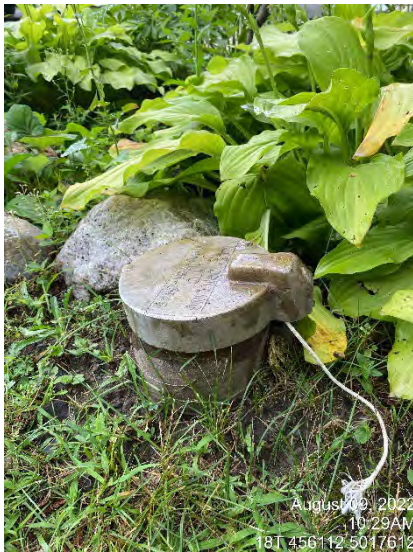
Photo 8 - Observation well at 4885 Hawthorne Road used during pumping test for monitoring of potential interference effects.

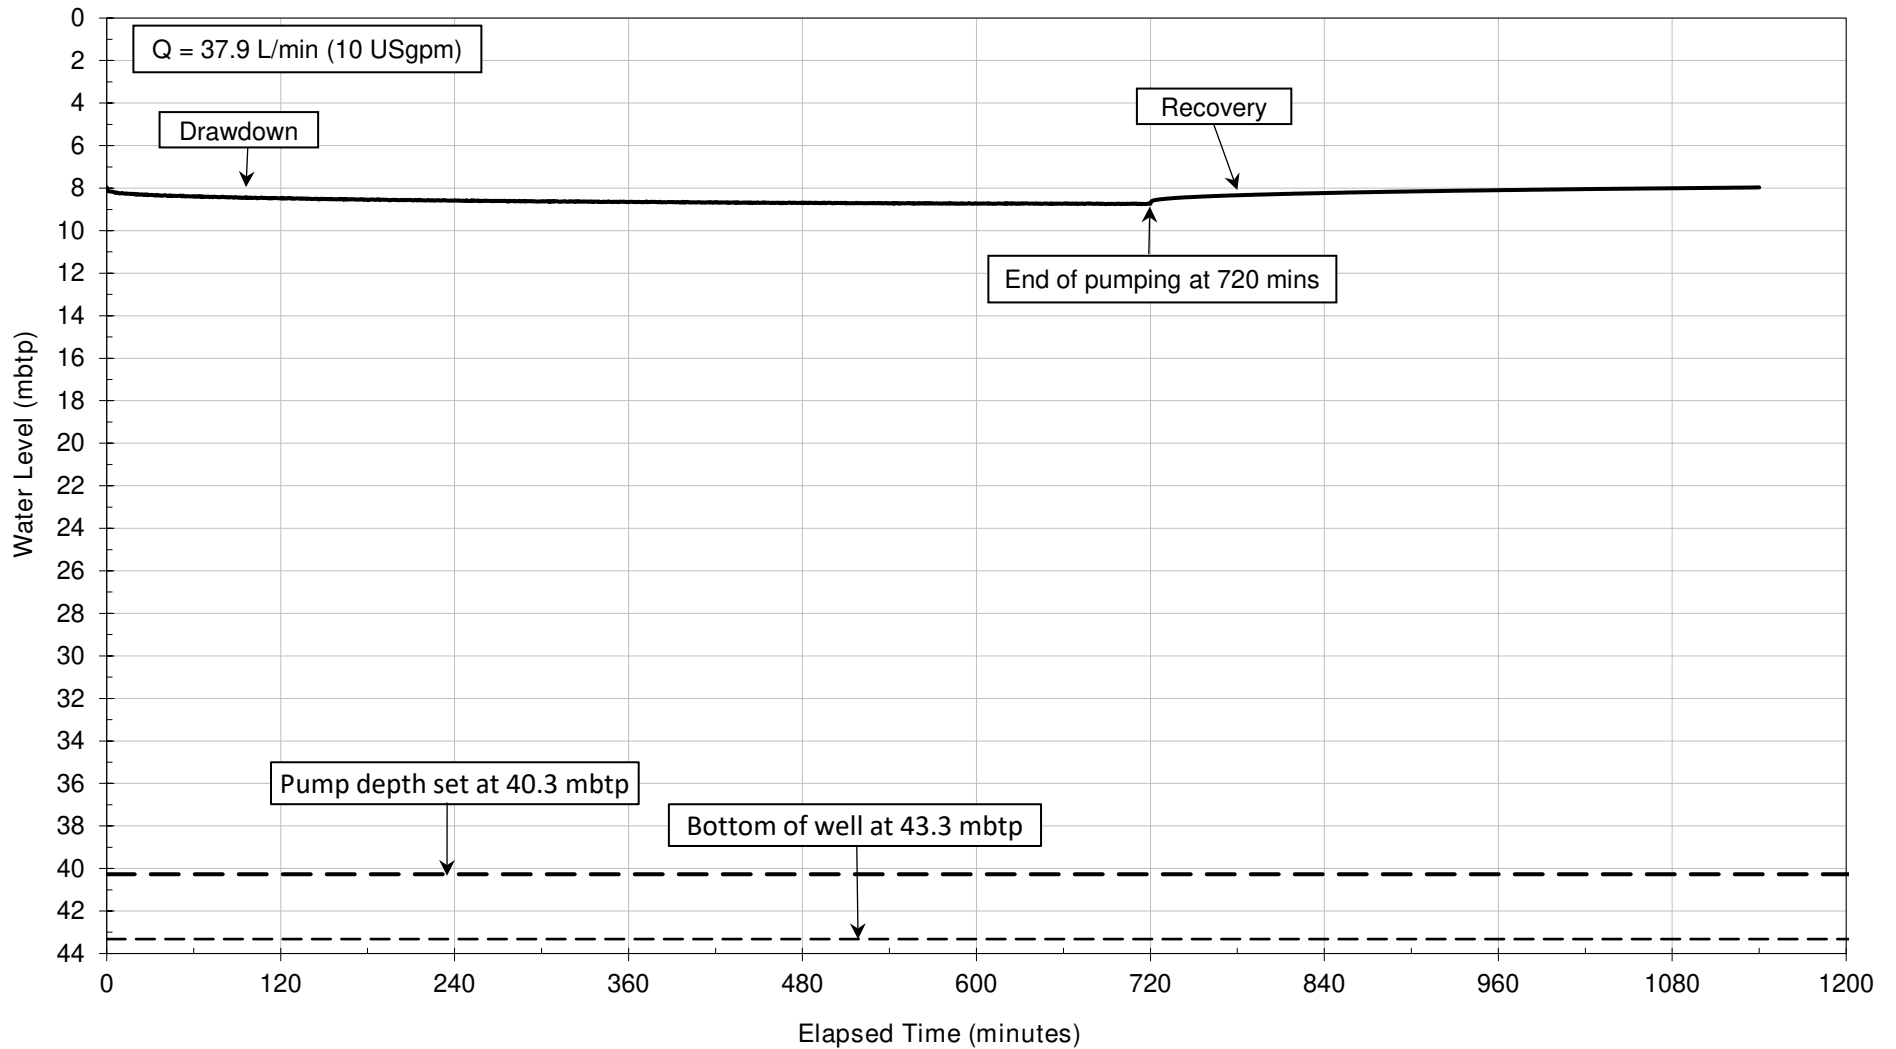
PUMP HISTORY CURVE  
Well A342117: August 9-10, 2022

Drilled Water Well  
MECP Well ID: A342117  
Static Level = 7.96 mbtp (7.31 mbgs)

GHD completed a constant rate pumping test of well A342117 on August 9, 2022 to assess aquifer conditions and evaluate the availability of a suitable groundwater resource for the proposed commercial development. The pumping test was conducted for twelve (12) hours at a constant rate of 37.8 L/min (10 gpm). Recovery measurements were collected after the pumping was completed.
