Hydrogeological and Impact Assessment Report

**Proposed Commercial Development, 301
Somme Street, Ottawa, Ontario**

Consolidated Fastfrate (Ottawa) Holdings Inc.

September 22, 2022

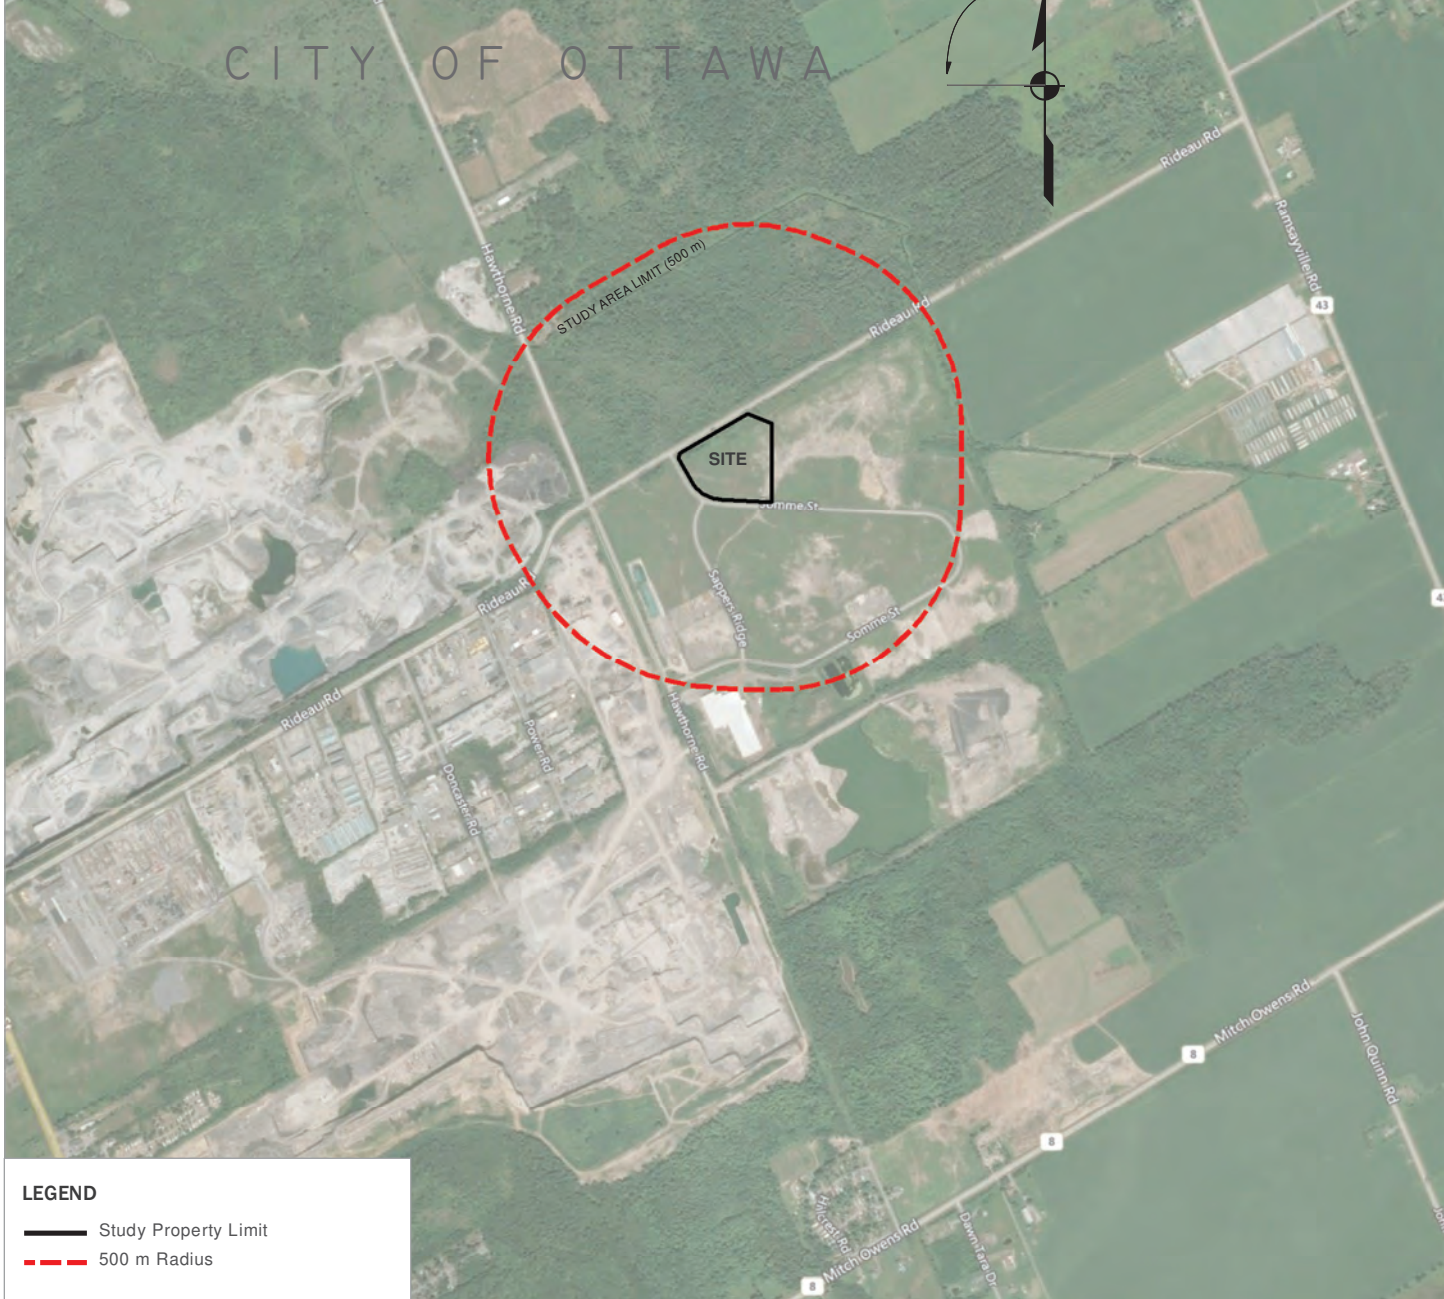
FIGURE 1
Created by: Will Pridham

**HYDROGEOLOGY ASSESSMENT
SITE LOCATION PLAN**

GHD Limited (GHD) was retained by Consolidated Fastfrate (Ottawa) Holdings Inc. to conduct a hydrogeological impact assessment in support of a proposed commercial development at the intersection of Rideau Road and Somme Street in Ottawa (the Site). The municipal address is 301 Somme Street, Ottawa, Ontario and is geographically located at Lot 26, Gloucester Concession 6 from the Rideau River. The Site encompasses an area on the order of 7.0 ha (17.4 acres) and is currently vacant of structures. The development will be privately serviced with a well and septic system. The location of the Site is provided on the **Site Location Plan, Figure 1**.
