Hydrogeological Assessment Report

Proposed Commercial Development
Rideau Road and Somme Street
Gloucester Con 6 from Rideau River, Lot 26
Ottawa, Ontario

Prepared for: Consolidated Fastfrate
(Ottawa) Holdings Inc.

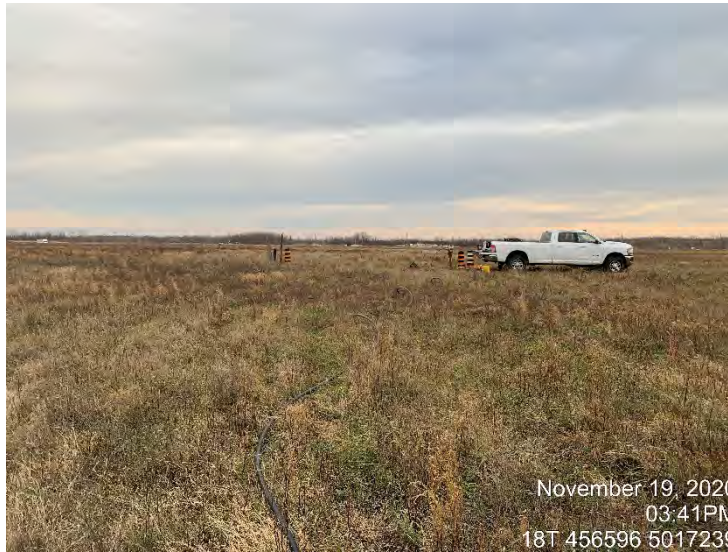
Photo 1 - View of drilled test well on the Site used during pumping test.

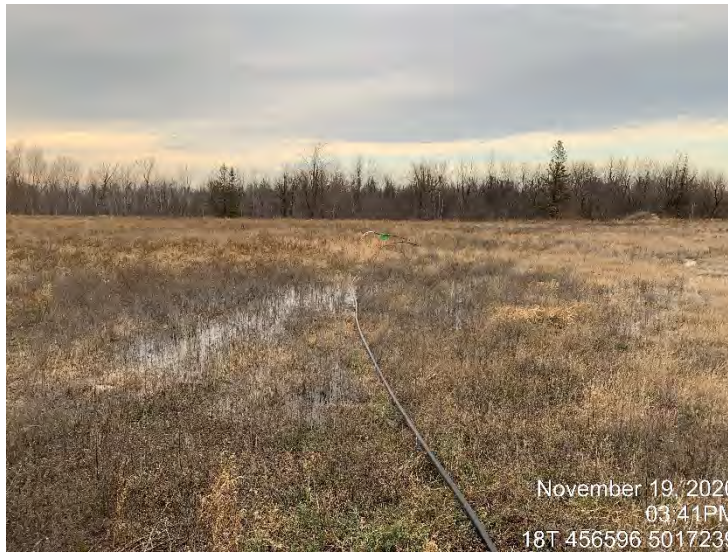
Photo 2 - View of discharge area looking across the Site.

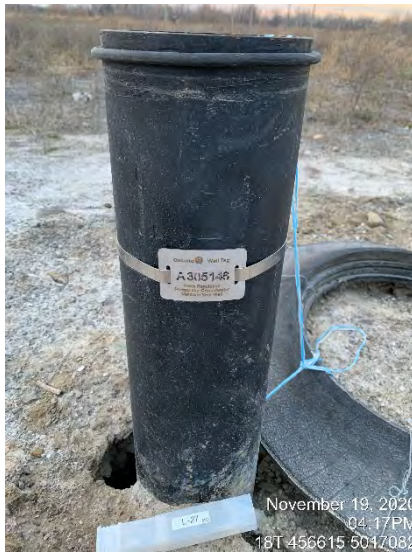
Photo 3 - Example of observation well (ID A305146) used during pumping test for monitoring of potential interference effects.

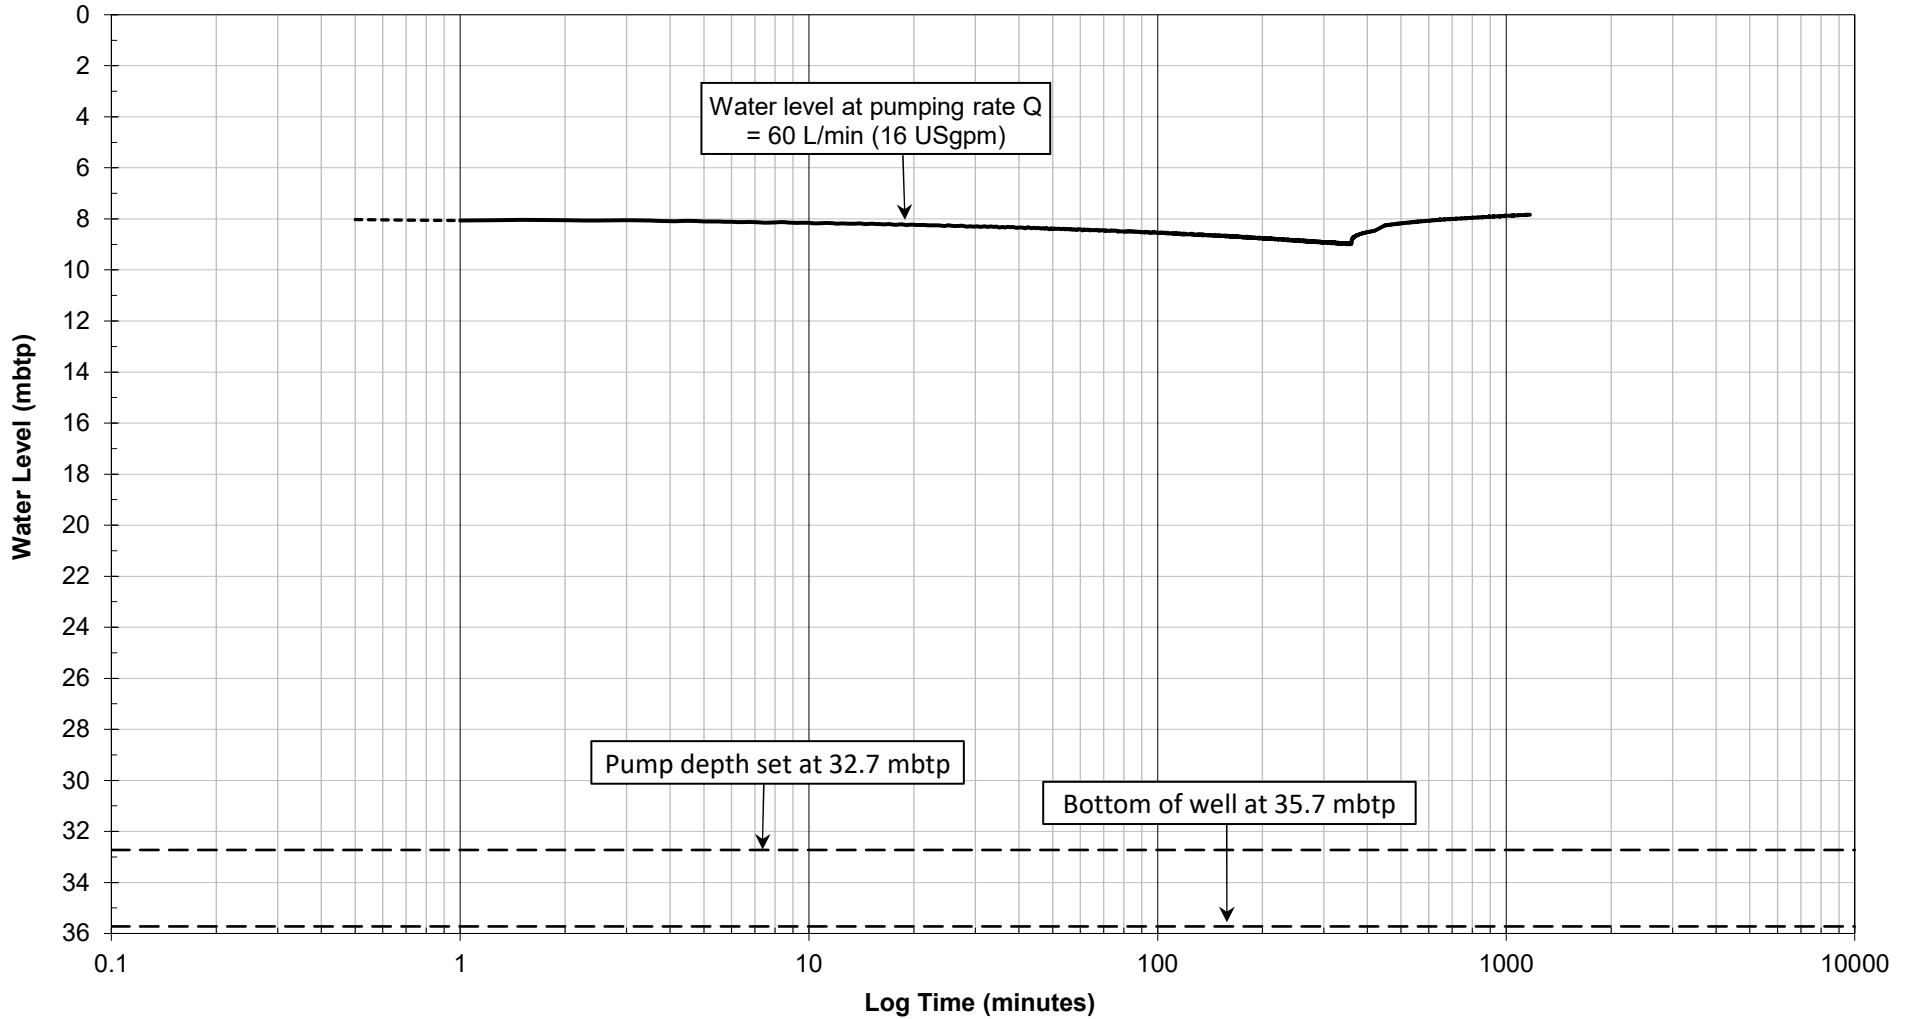
CONSTANT RATE TEST: WATER LEVEL vs LOG TIME
TW-2: November 19-20, 2020

Drilled Test Well (TW-2)
 MECP Well ID: 1527383
 Static Level = 7.83 mbtp (6.90 mbgs)

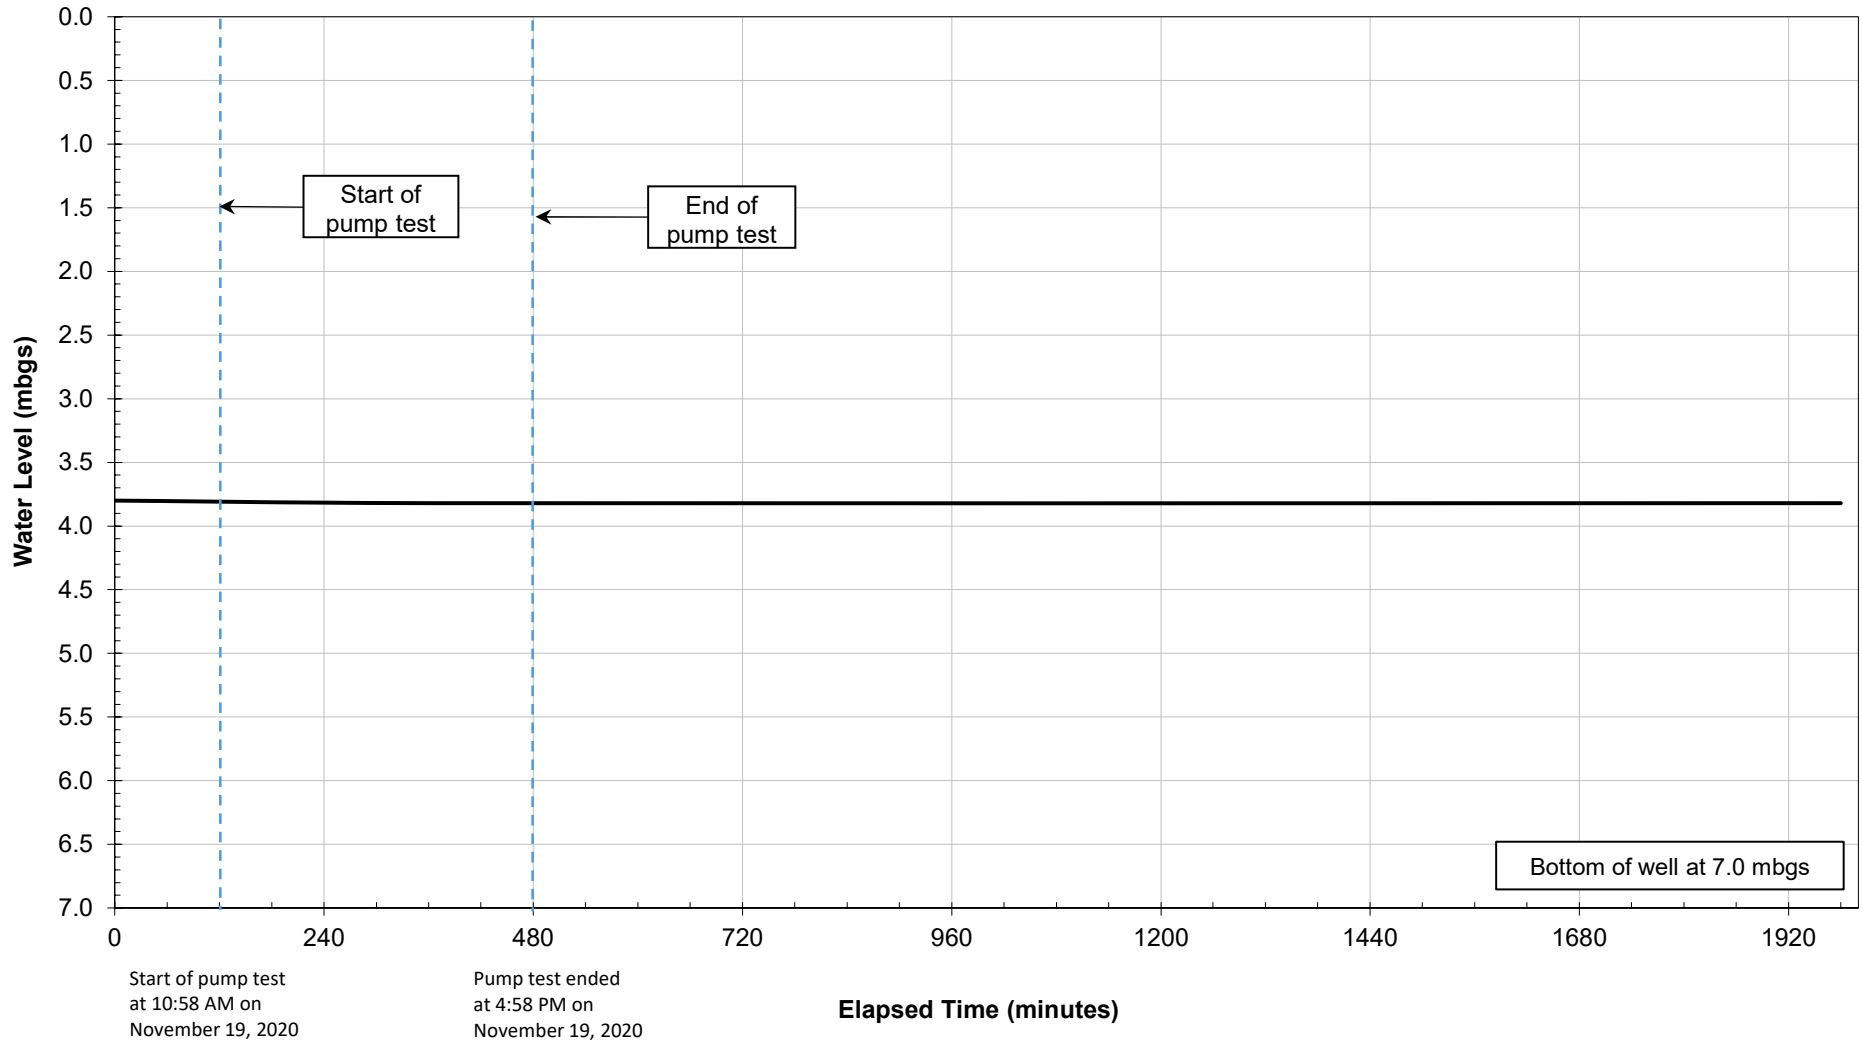
**MW1-20
OBSERVATION WELL
November 19 - 20, 2020**

Observation Well - MW1-20
MECP Well Tag No. A290162
Static Level = 3.8 mbgs
