Phase I-Environmental Site Assessment

257-277 King Edward Avenue and
260 Murray Street
Ottawa, Ontario

July 13, 2021
Report: PE5193-1

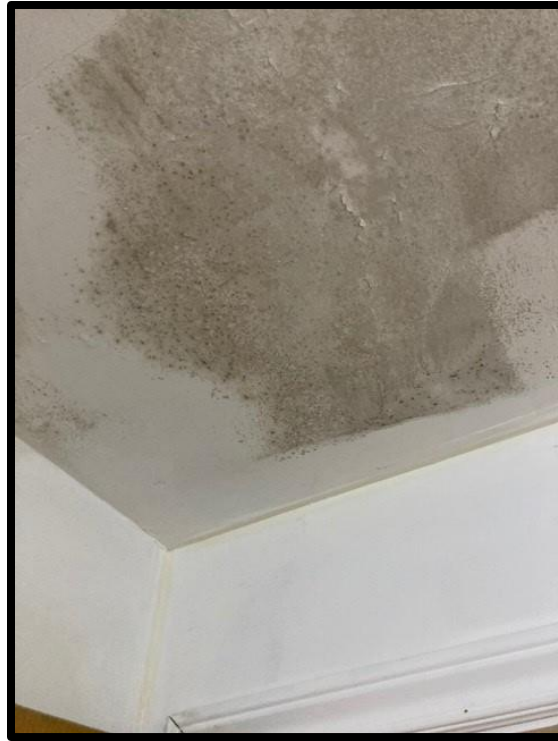
Photograph 3: Mold growth in the basement of 257-259 King Edward Avenue.
