Phase II Environmental Site Assessment

100 Argyle Avenue
Ottawa, Ontario

100 Argyle Corporation

Report: PE4365-4

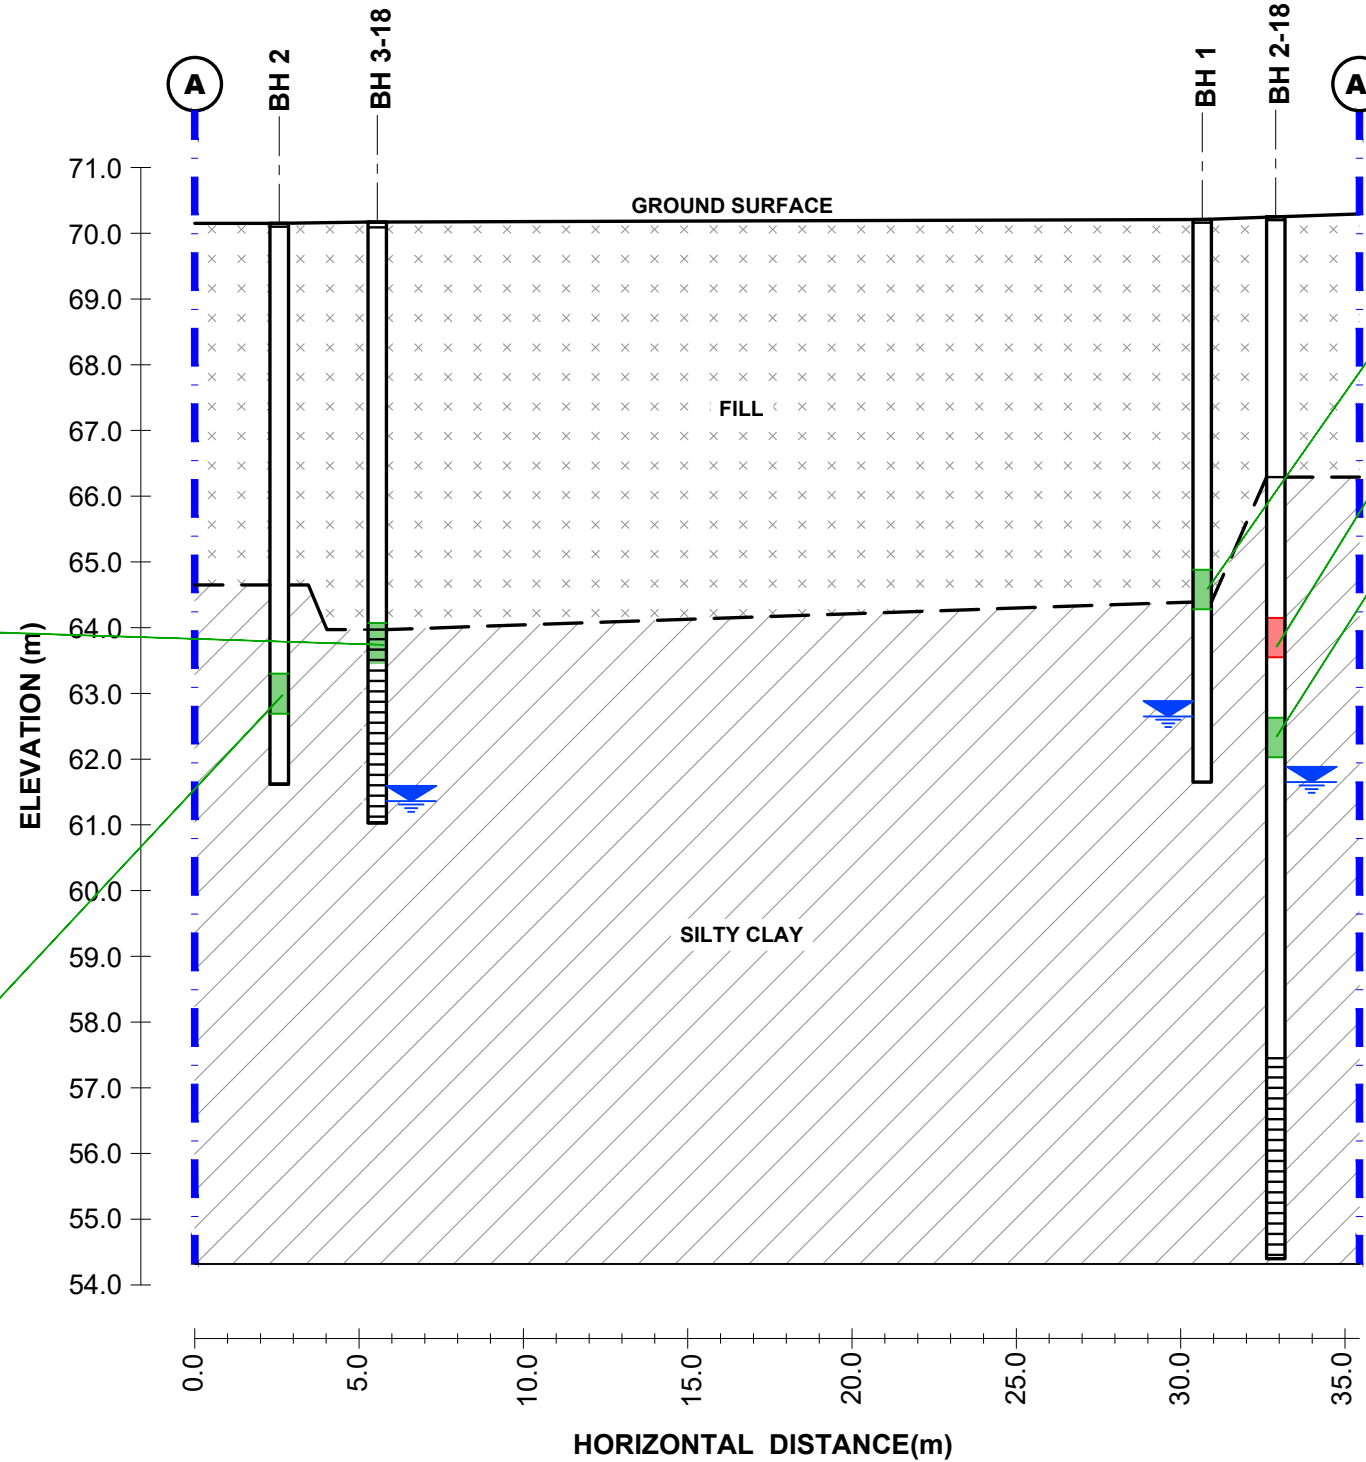
Scale:	AS SHOWN	Date:	07/2021
Drawn by:	YA	Report No.:	PE4365-4
Checked by:	SB	Dwg. No.:	PE4365-5AR
Approved by:	MB	Revision No.:

BH1-SS10 5.33m-5.94m 9-APR-2013
 PHCs comply with the MECP Table 3 Standards

Parameter	Result (µg/g)	Standard (µg/g)
BH2-18-SS9	6.10m-6.71m	26-JULY-2018
PHC F2	949	98
PHC F3	957	300
BH2-18-SS11	7.62m-8.23m	26-JULY-2018
PHCs comply with the MECP Table 3 Standards

CROSS SECTION A-A' - SOIL (PHCs)
