Phase I Environmental Site Assessment

100 Argyle Avenue
Ottawa, Ontario

March 1, 2022

Report: PE4365-3R

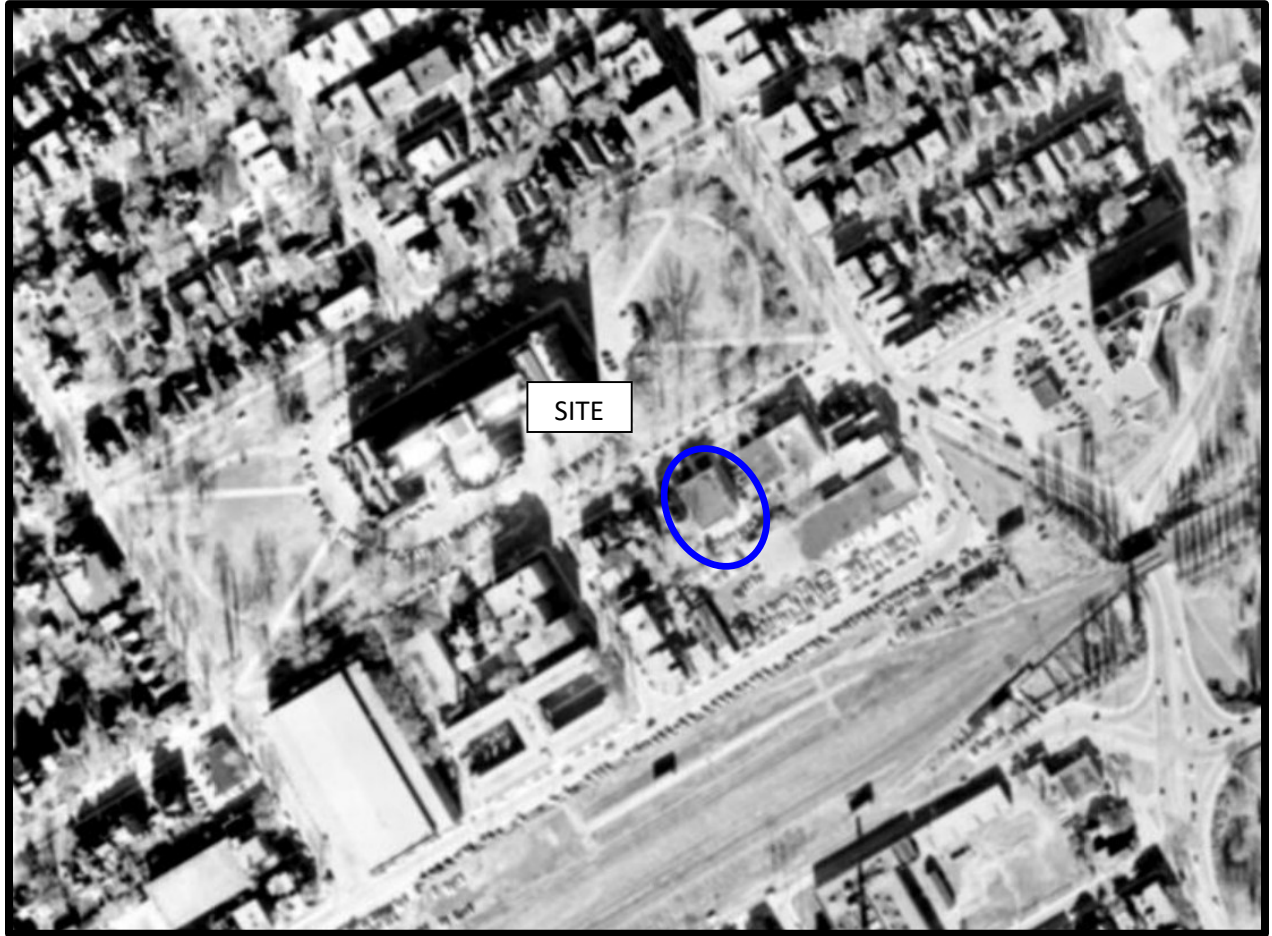
AERIAL PHOTOGRAPH
1958

- 1958 The Phase I – ESA is now occupied by the current building and associated parking areas. The residential dwellings to the east and west of the Phase I – ESA property have been replaced with multi-storey commercial and residential buildings. The property immediately south of the Phase I – ESA property now appears to be occupied by an automotive service garage further east of the Phase I – ESA Property is occupied by a retail fuel outlet.
