Geotechnical Investigation Report

Proposed Enbridge Operations Centre
2571 Lancaster Road, Ottawa ON

File: 1505.00-101

Prepared by:
Malroz Engineering Inc.
308 Wellington St, 2nd Floor
Kingston, ON K7K 7A8

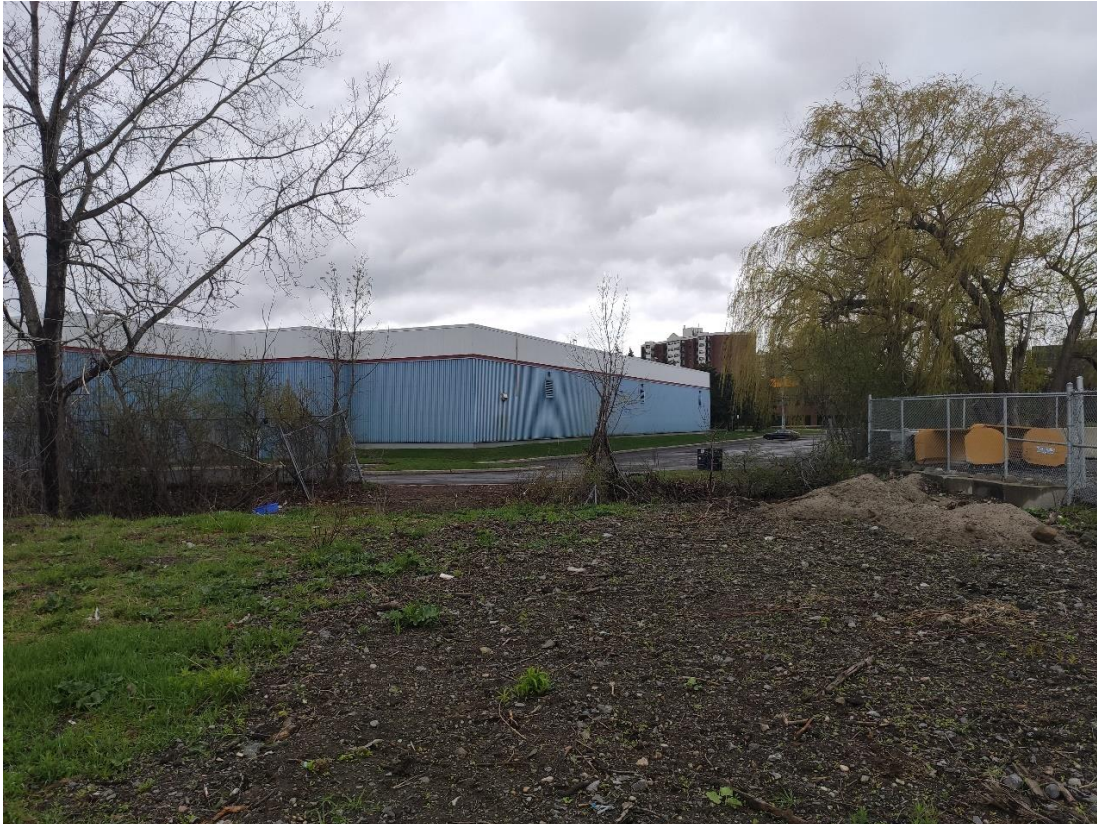
Figure 1 – Site from the former railway easement at north corner, looking south

The Site is presently occupied by the existing Minto arena, occupying most of the footprint of the Site. It is surrounded by paved parking and laneway areas. The former railway easement to the north is presently unoccupied and covered in brush and some tree cover. Some sparse refuse and debris was noted throughout this area at surface.

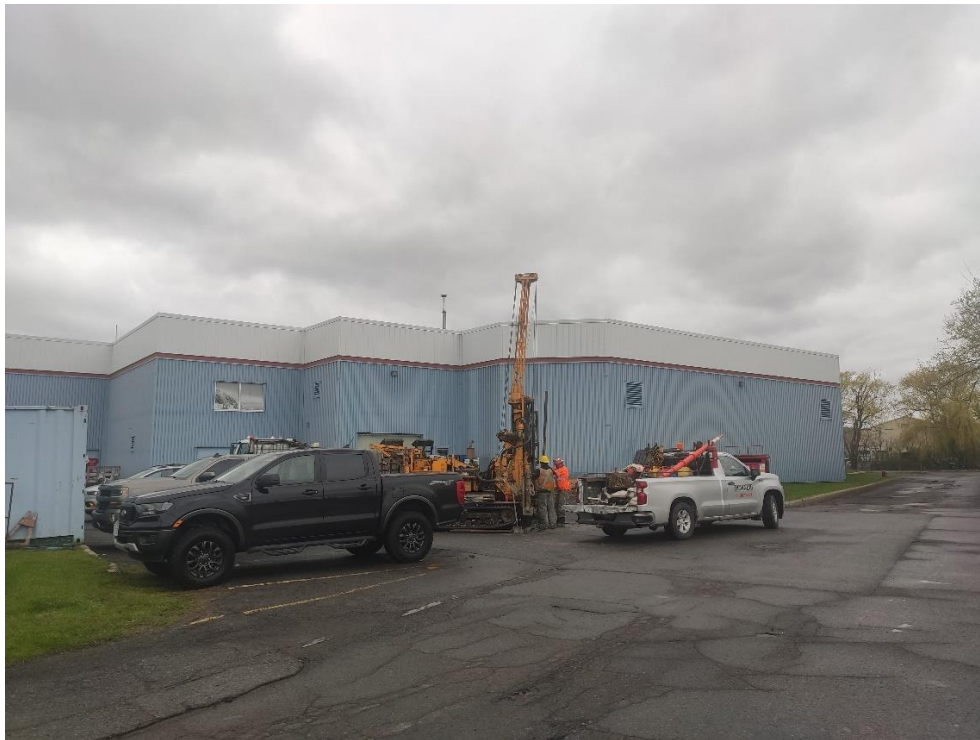
Figure 2 – Drilling with CME-55LC during May 5, 2021 mobilization

Boreholes drilled under the supervision of the Client were advanced using a truck mounted CME-55 drill rig, equipped with solid stem continuous flight augers. Boreholes drilled under the supervision of Malroz were advanced using a CME-55LC drill rig on a rubber tracked carrier, and drilled to practical refusal. Boreholes BH9 and BH11 were further advanced into rock using 'N' sized double tube wireline coring equipment. 50 mm diameter PVC monitoring wells were installed at MW5-21 and MW6-21, by the Client, screened within overburden soils.

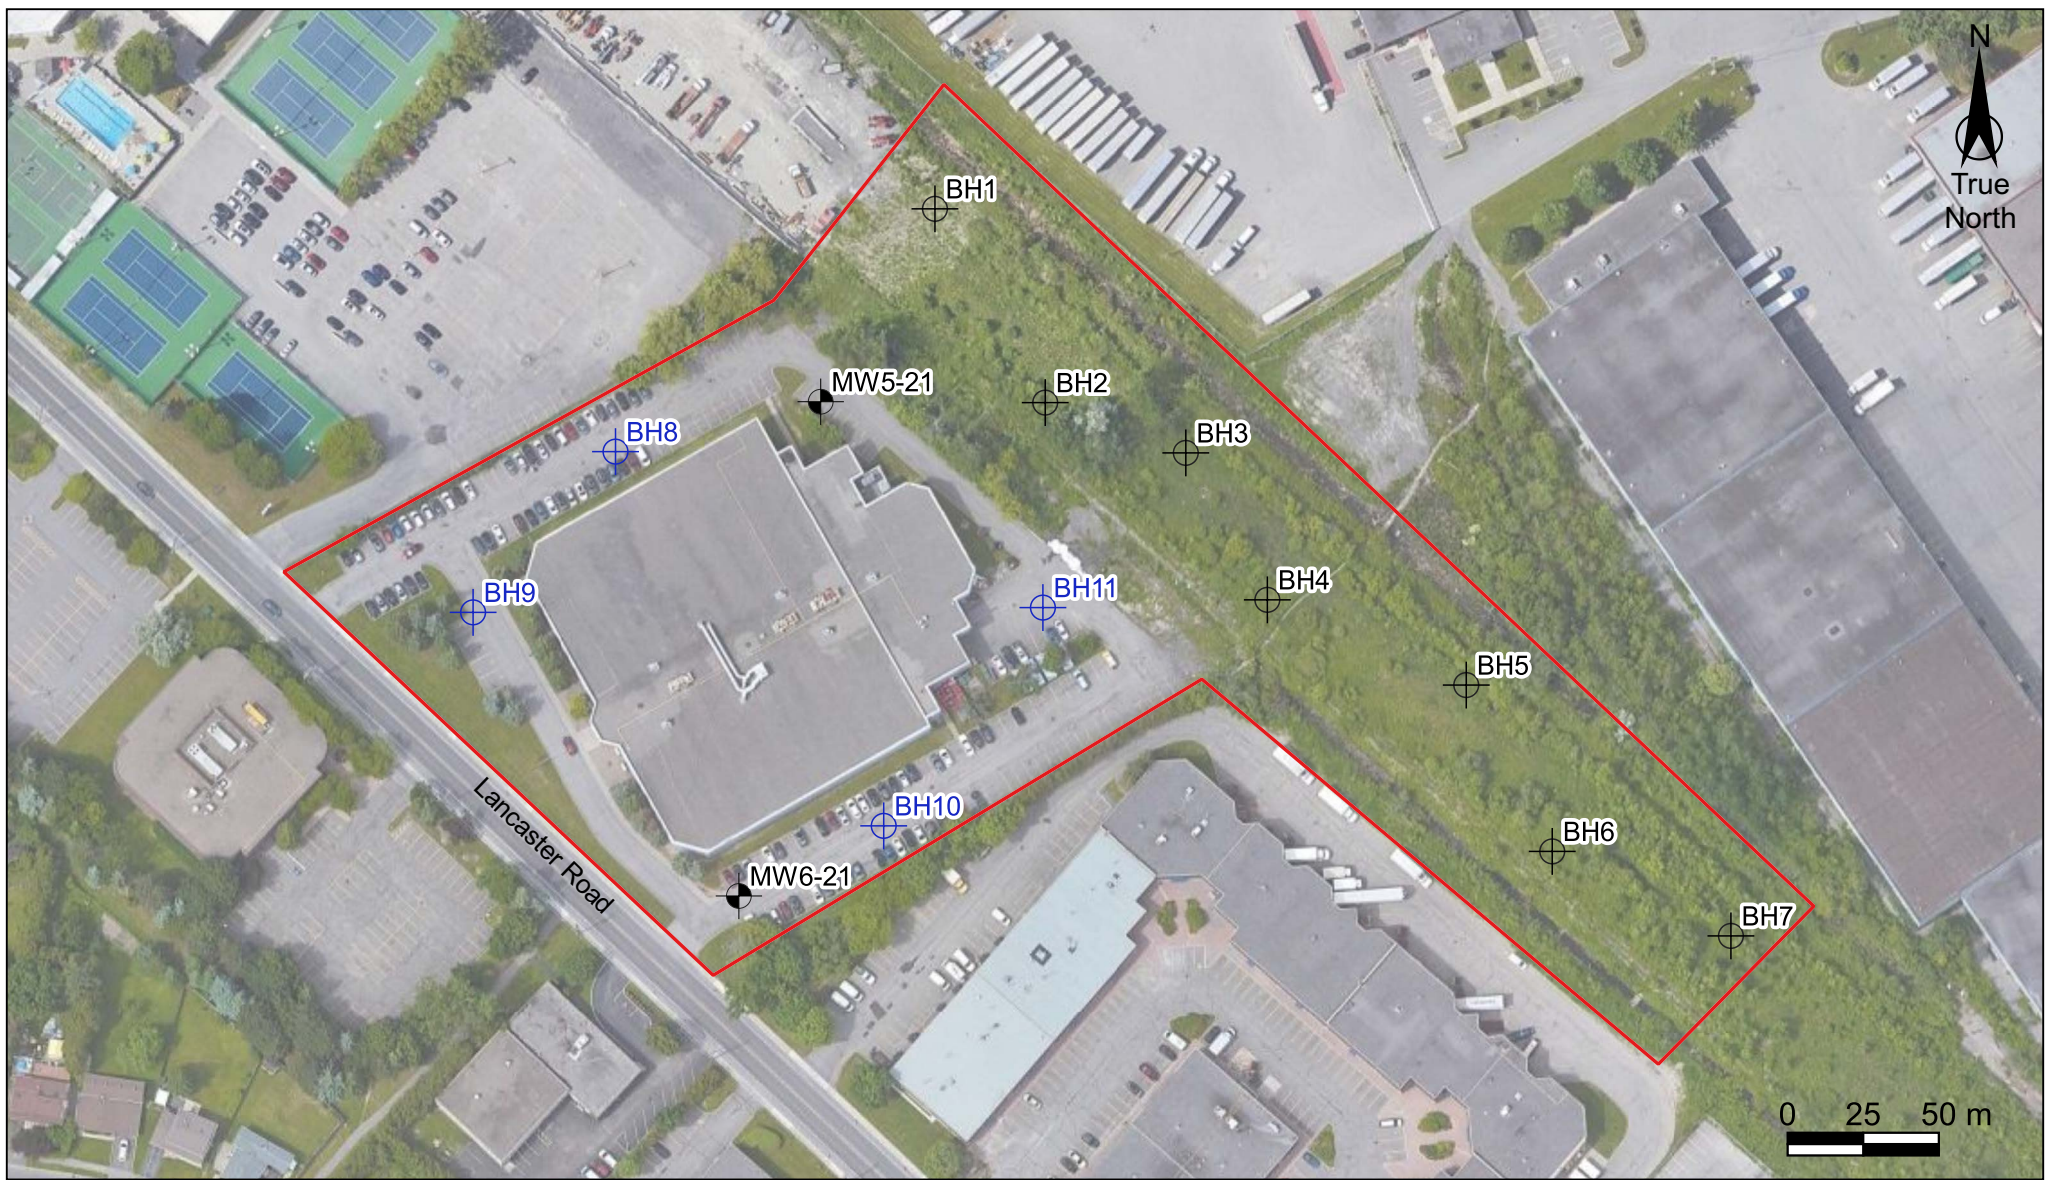
- approximate property boundary
- borehole advanced under the supervision of the Client
- borehole and monitoring well advanced under the supervision of the Client
- borehole advanced under the supervision of Malroz

A total of nine borings, identified as BH1 through BH7, MW5-21 and MW6-21; were advanced on April 6 and 7, 2021, under the supervision of the Client's field staff and drilling subcontractor. Malroz attended a portion of this drilling work and was subsequently provided with boring logs by the Client. Malroz advanced four supplemental borings on May 5, 2021 identified as BH8 through BH11, proximal to the proposed building location in the sketch provided to us by the Client at the time the proposal for this work was developed. Locations were modified based on available access to drilling equipment (e.g. in relation to existing building, laneways etc) and existing buried utilities. A Borehole Location Plan (Figure 1) is presented in Appendix A.

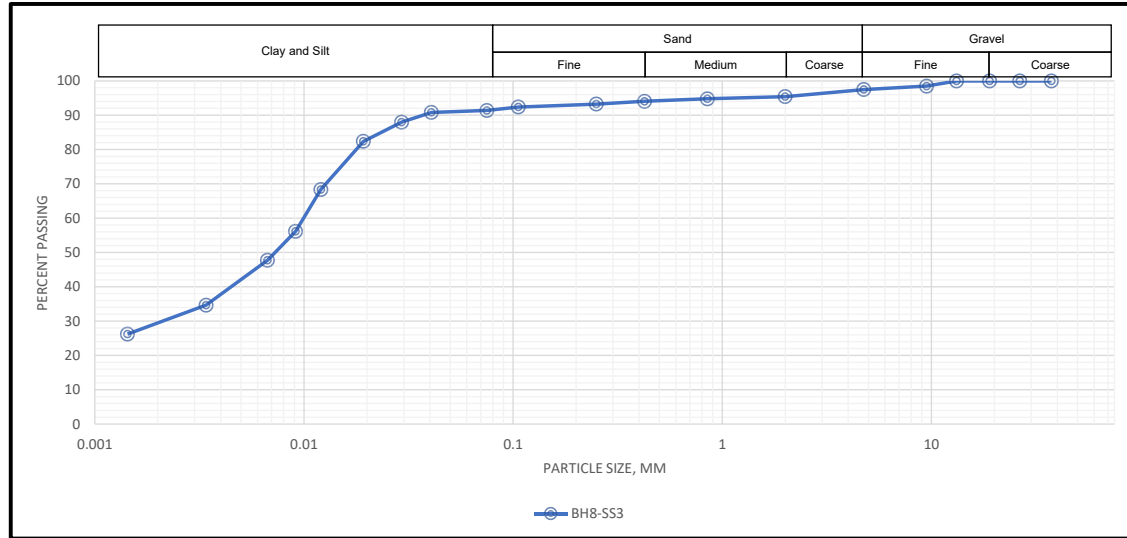
Lab No.: 0164H
 Project No.: 1505
 Client: BluMetric
 Location : 2571 Lancaster Road, Ottawa ON
 Sample: BH8-SS3

Clay (%)	Silt (%)	Sand (%)	Gravel (%)
29	62	7	2
Clayey SILT, trace Sand, trace Gravel

Samples recovered during drilling were transported to Malroz’s geotechnical laboratory in Kingston, Ontario. A total of four samples were submitted for hydrometer grain size analysis (one in addition to the three as per our agreed upon scope of work, as samples were found to be generally non-plastic, and not suitable for Atterberg limits testing).

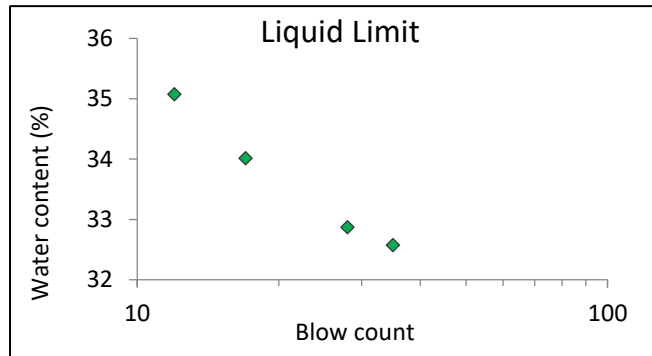
Liquid Limit **33.2%**
 Plastic Limit **19.4%**
 Plasticity Index **13.8%**

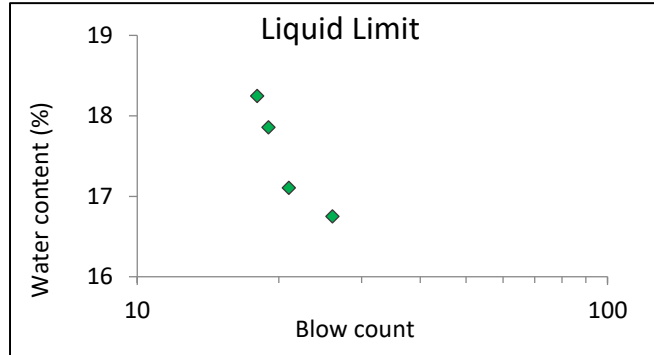
Liquid Limit **17.1%**
 Plastic Limit **11.7%**
 Plasticity Index **5.3%**
