project / projet  
**ENBRIDGE OTTAWA OPERATIONS CENTRE**  
**2571 LANCASTER ROAD**

**TREE CONSERVATION PLAN**

**T1 of 2**

## TREE INVENTORY & PRESERVATION DETAILS

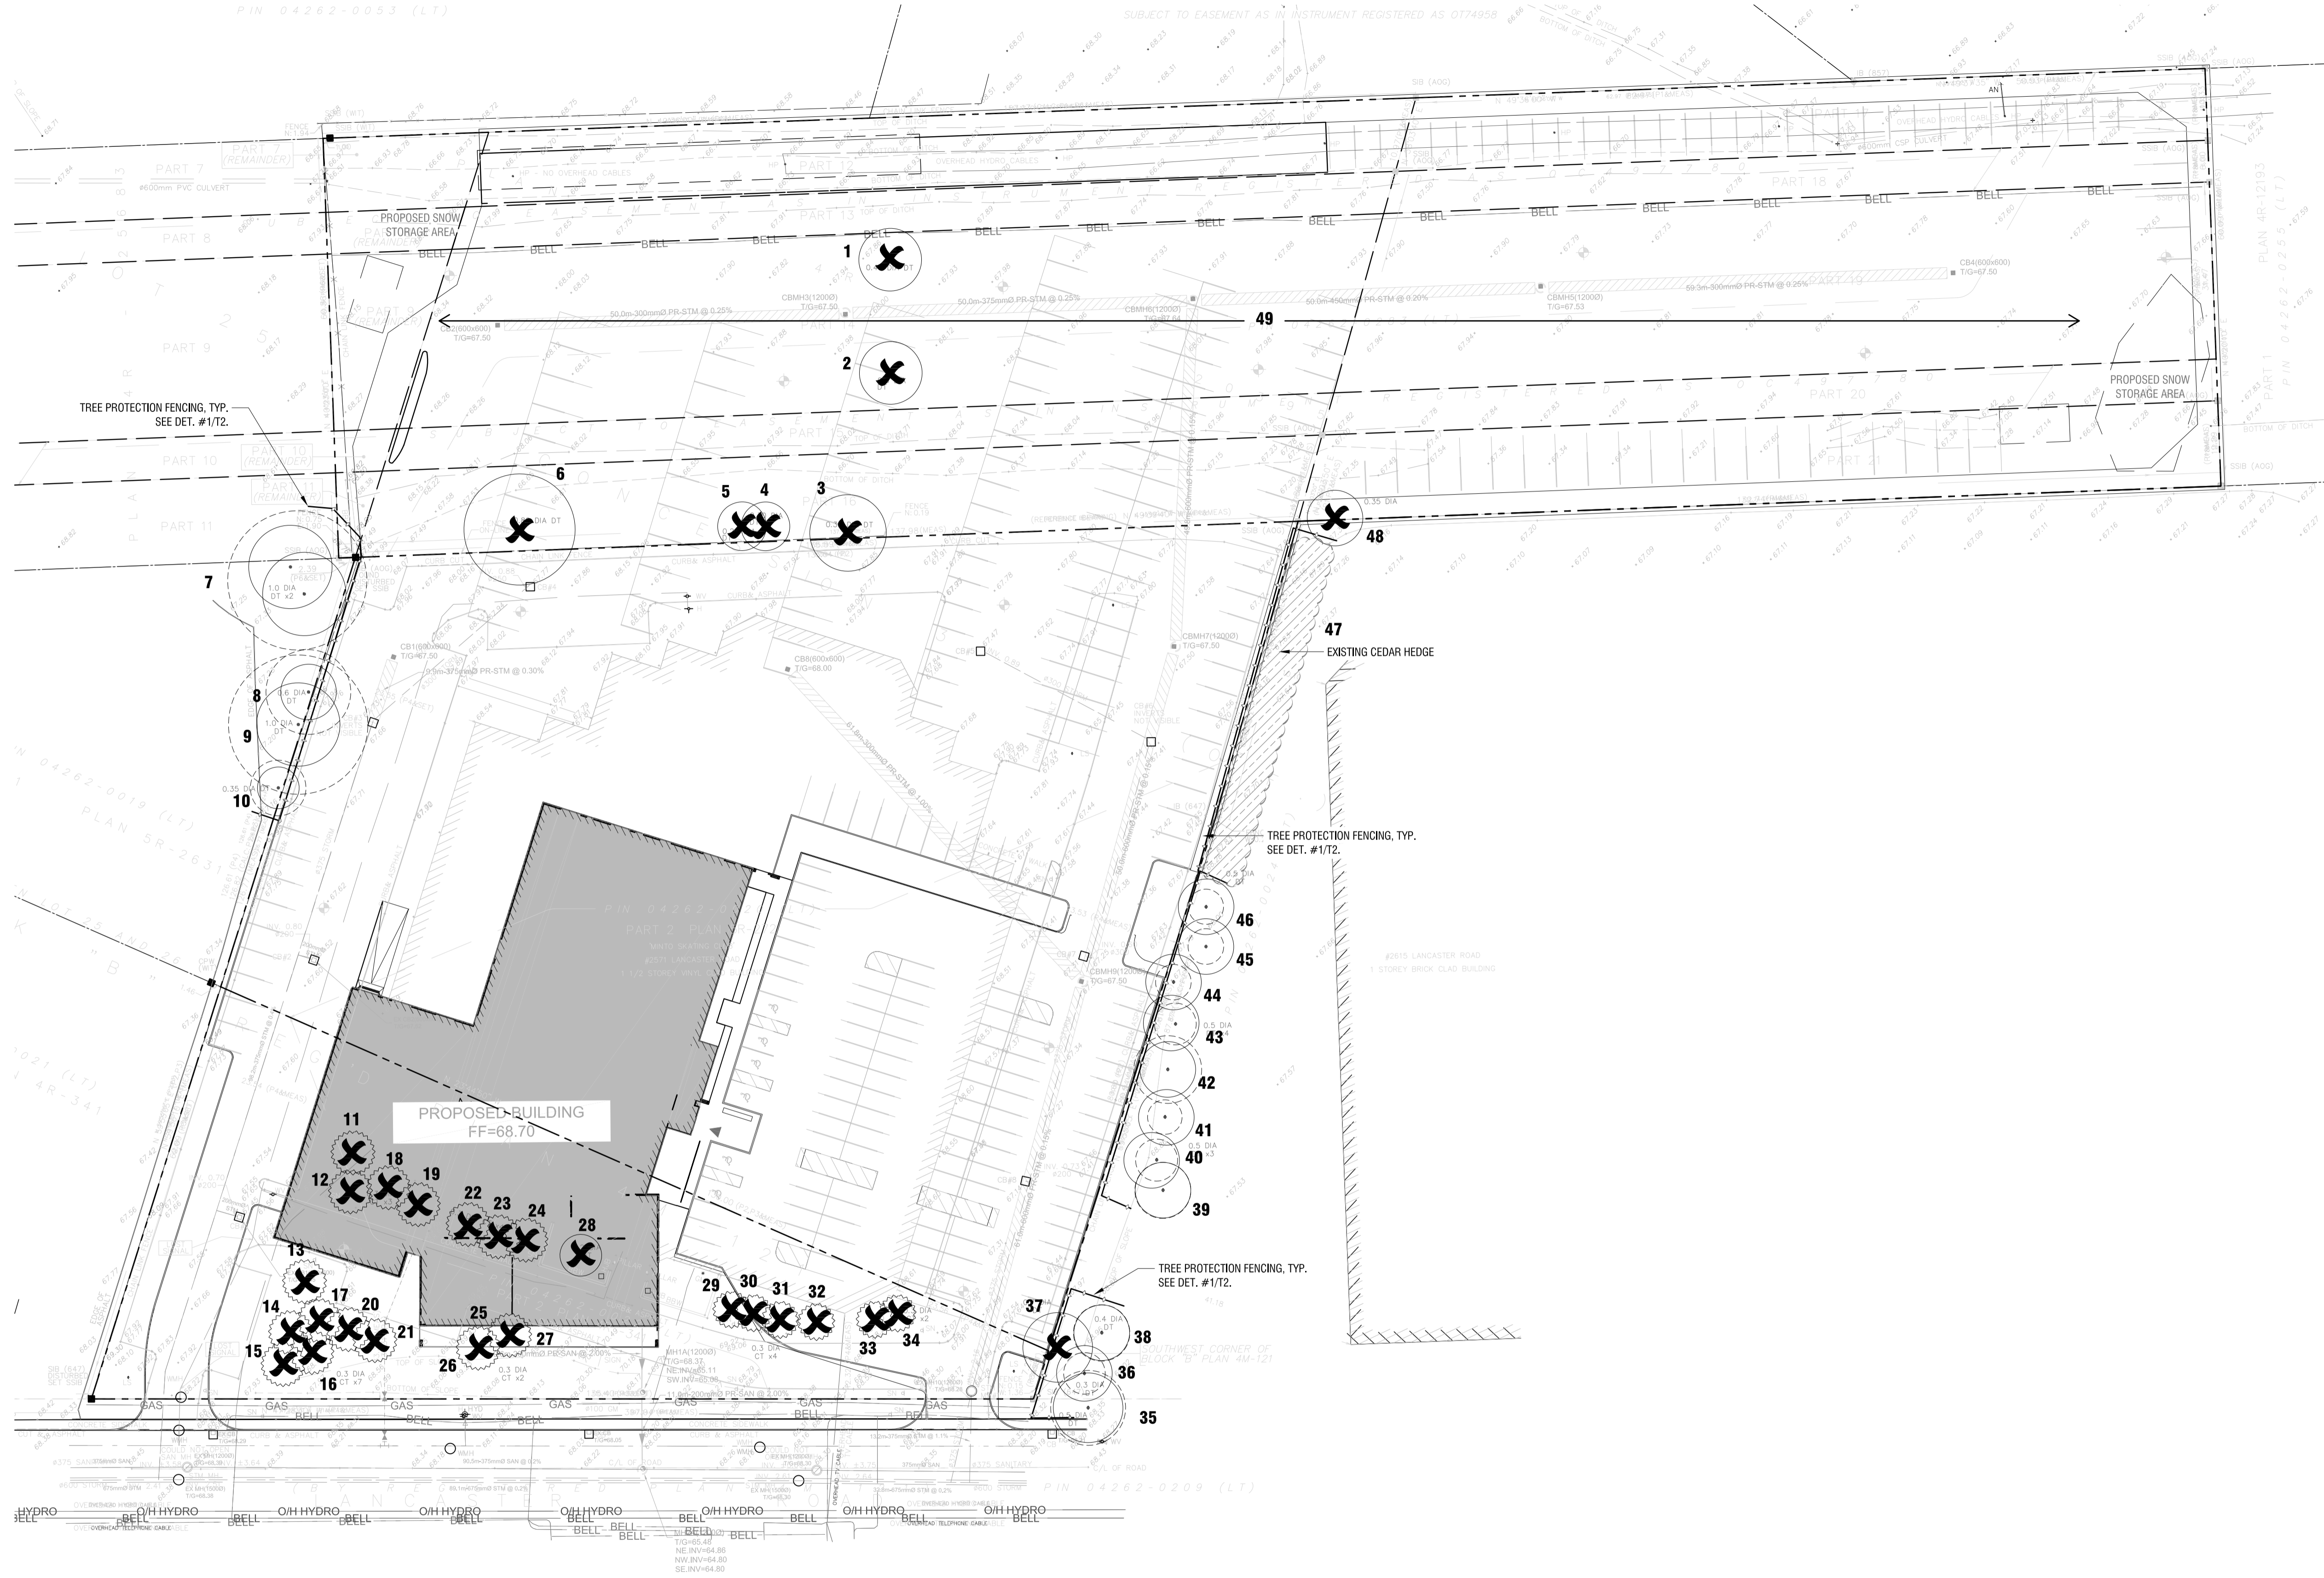
**1** TREE CONSERVATION PLAN  
**T1** 1:500

- EXISTING TREES INFORMATION ON THE ABOVE PLAN DRAWING AND FOLLOWING TREE INVENTORY TABLE IS EXTRACTED FROM AND TO BE READ IN CONJUNCTION WITH "TREE CONSERVATION REPORT FOR 2571 LANCASTER ROAD, OTTAWA" DATED AUGUST 30 2021 PREPARED BY IFS ASSOCIATES.

- ANY WORKS WITHIN CRITICAL ROOT ZONE OF THE RETAINED TREES NEEDS TO BE UNDERTAKEN BY HAND AND/OR LIGHT EQUIPMENT TO THE SATISFACTION OF THE ARBORIST/LANDSCAPE ARCHITECT. SEE ALSO NOTE (5) ON #1/T2 FOR MORE INFORMATION.
