# Proposed Residential Development Phase 1 1500 Merivale Road, Ottawa Transportation Impact Assessment

**Proposed Residential Development – Phase 1  
1500 Merivale Road  
Transportation Impact Assessment**

Novatech File: 121009  
Ref: R-2022-177

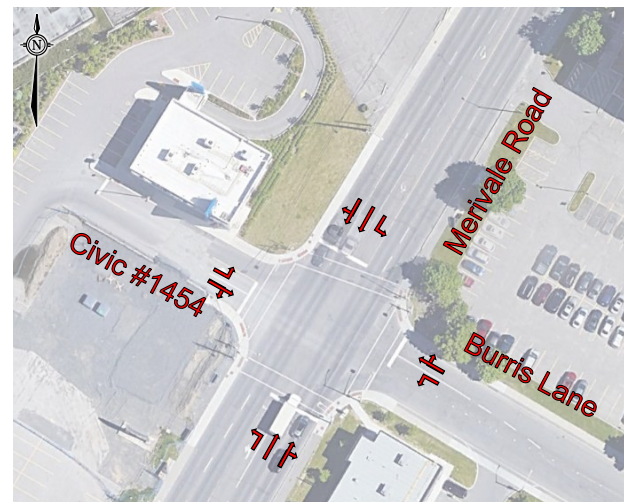
Merivale Road/Burris Lane/Civic #1454

- Signalized four-legged intersection
- Northbound and Southbound Approaches (Merivale Road): one left turn lane, one through lane, and one shared through/right turn lane
- Eastbound/Westbound Approaches (Burris Lane and Civic #1454): one left turn lane and one shared through/right turn lane
- Standard crosswalks are provided on all approaches

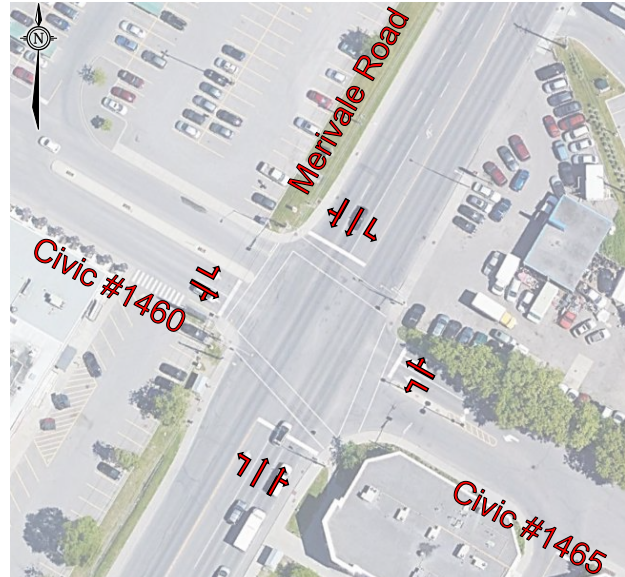
Merivale Road/  
Loblaws Plaza (Civic #1460)/Civic #1465

- Signalized four-legged intersection
- Northbound and Southbound Approaches (Merivale Road): one left turn lane, one through lane, and one shared through/right turn lane
- Eastbound/Westbound Approaches (Civic #1460 and Civic #1465): one left turn lane and one shared through/right turn lane
- Standard crosswalks are provided on all approaches

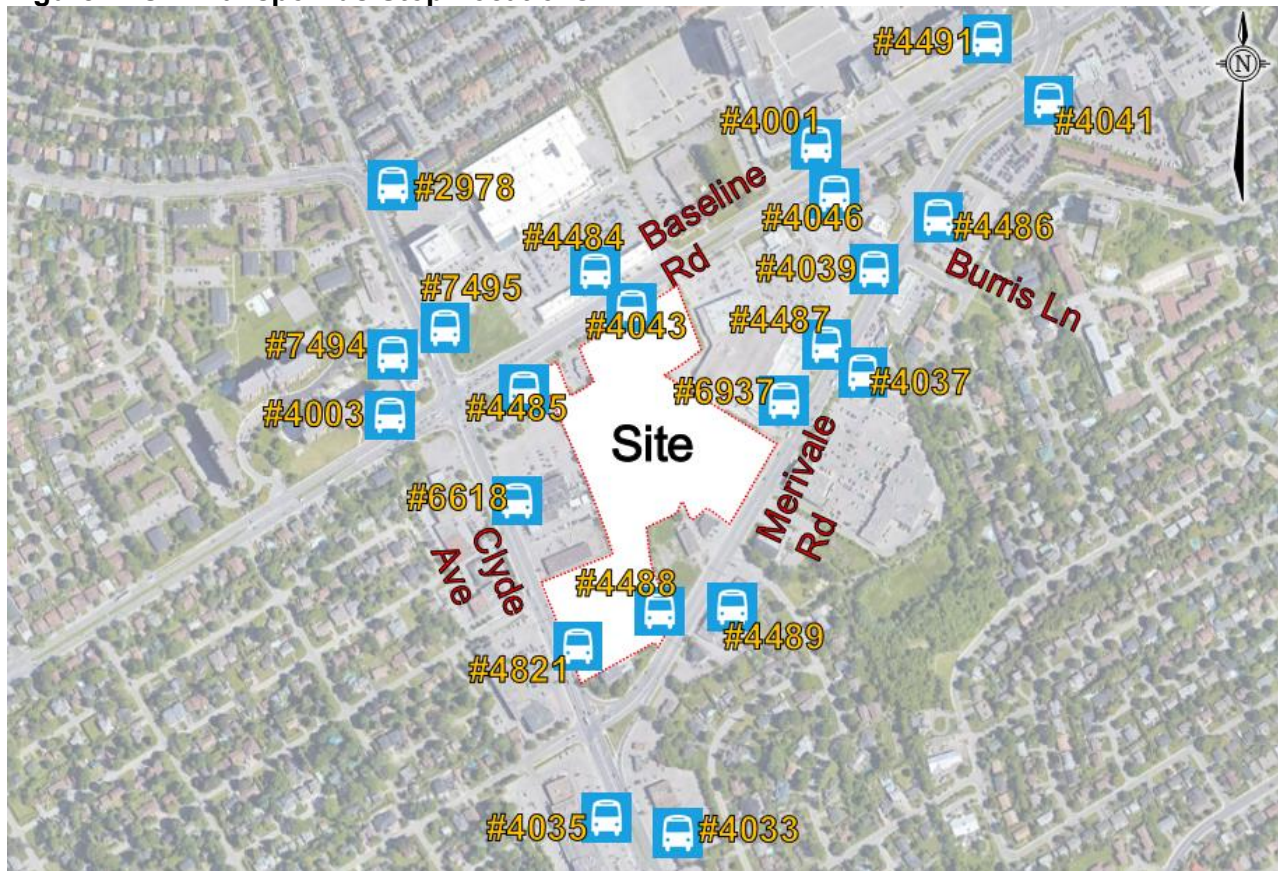
**Figure 2: OC Transpo Bus Stop Locations**

Route #50 travels between Lincoln Fields and Tunney’s Pasture on 30-minute headways, Monday-Saturday.

Route #80 travels between Barrhaven Centre and Tunney’s Pasture on 15-minute headways with all-day service, 7-days per week.
