# New Civic Development Phase 2 Project: Parking Garage and Green Roof

**Environmental Effects Analysis**

**Environmental Impact Statement and Tree Conservation Report Update**

Addendum #1

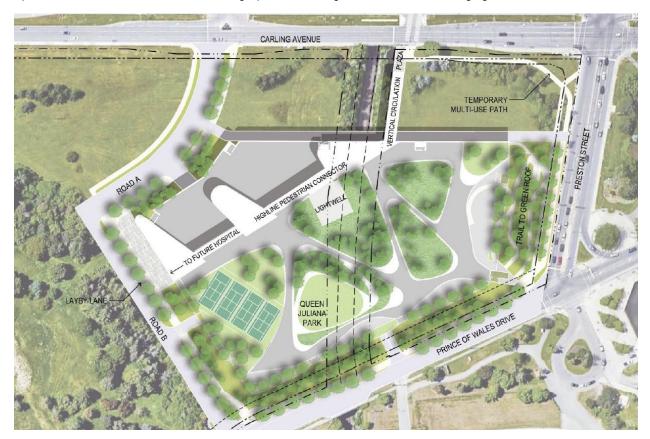
The Parking Garage is 5 levels (1 below grade, 4 above grade) with the active park level above the garage. The parking garage structure, foundation to the roof level, is cast in place and precast concrete. Structures above the roof, the "Highline pedestrian connector", will be mass timber. The garage contains 347 Secured Bicycle Parking Spaces and 2523 Personal Vehicle Parking Spaces including 25 electric vehicle charging stations.

The Parking Garage and Green Roof provides necessary vehicle parking but also acts as a hub for active transportation and public open outdoor space. The structure connects the Hospital building, via a pedestrian bridge, with the Dow's Lake LRT station on the Trillium Line and indoor bicycle storage within the parking garage. The 5-acre park is proposed for the garage's roof and is a combination of a green roof and an active roof that will be available for use by the public and will be accessible from local streets.
