Phase II Environmental Site Assessment

Part of 525 Legget Drive and
Part of 359 Terry Fox Drive
City of Ottawa, Ontario

KRP Properties

Report: PE5413-2

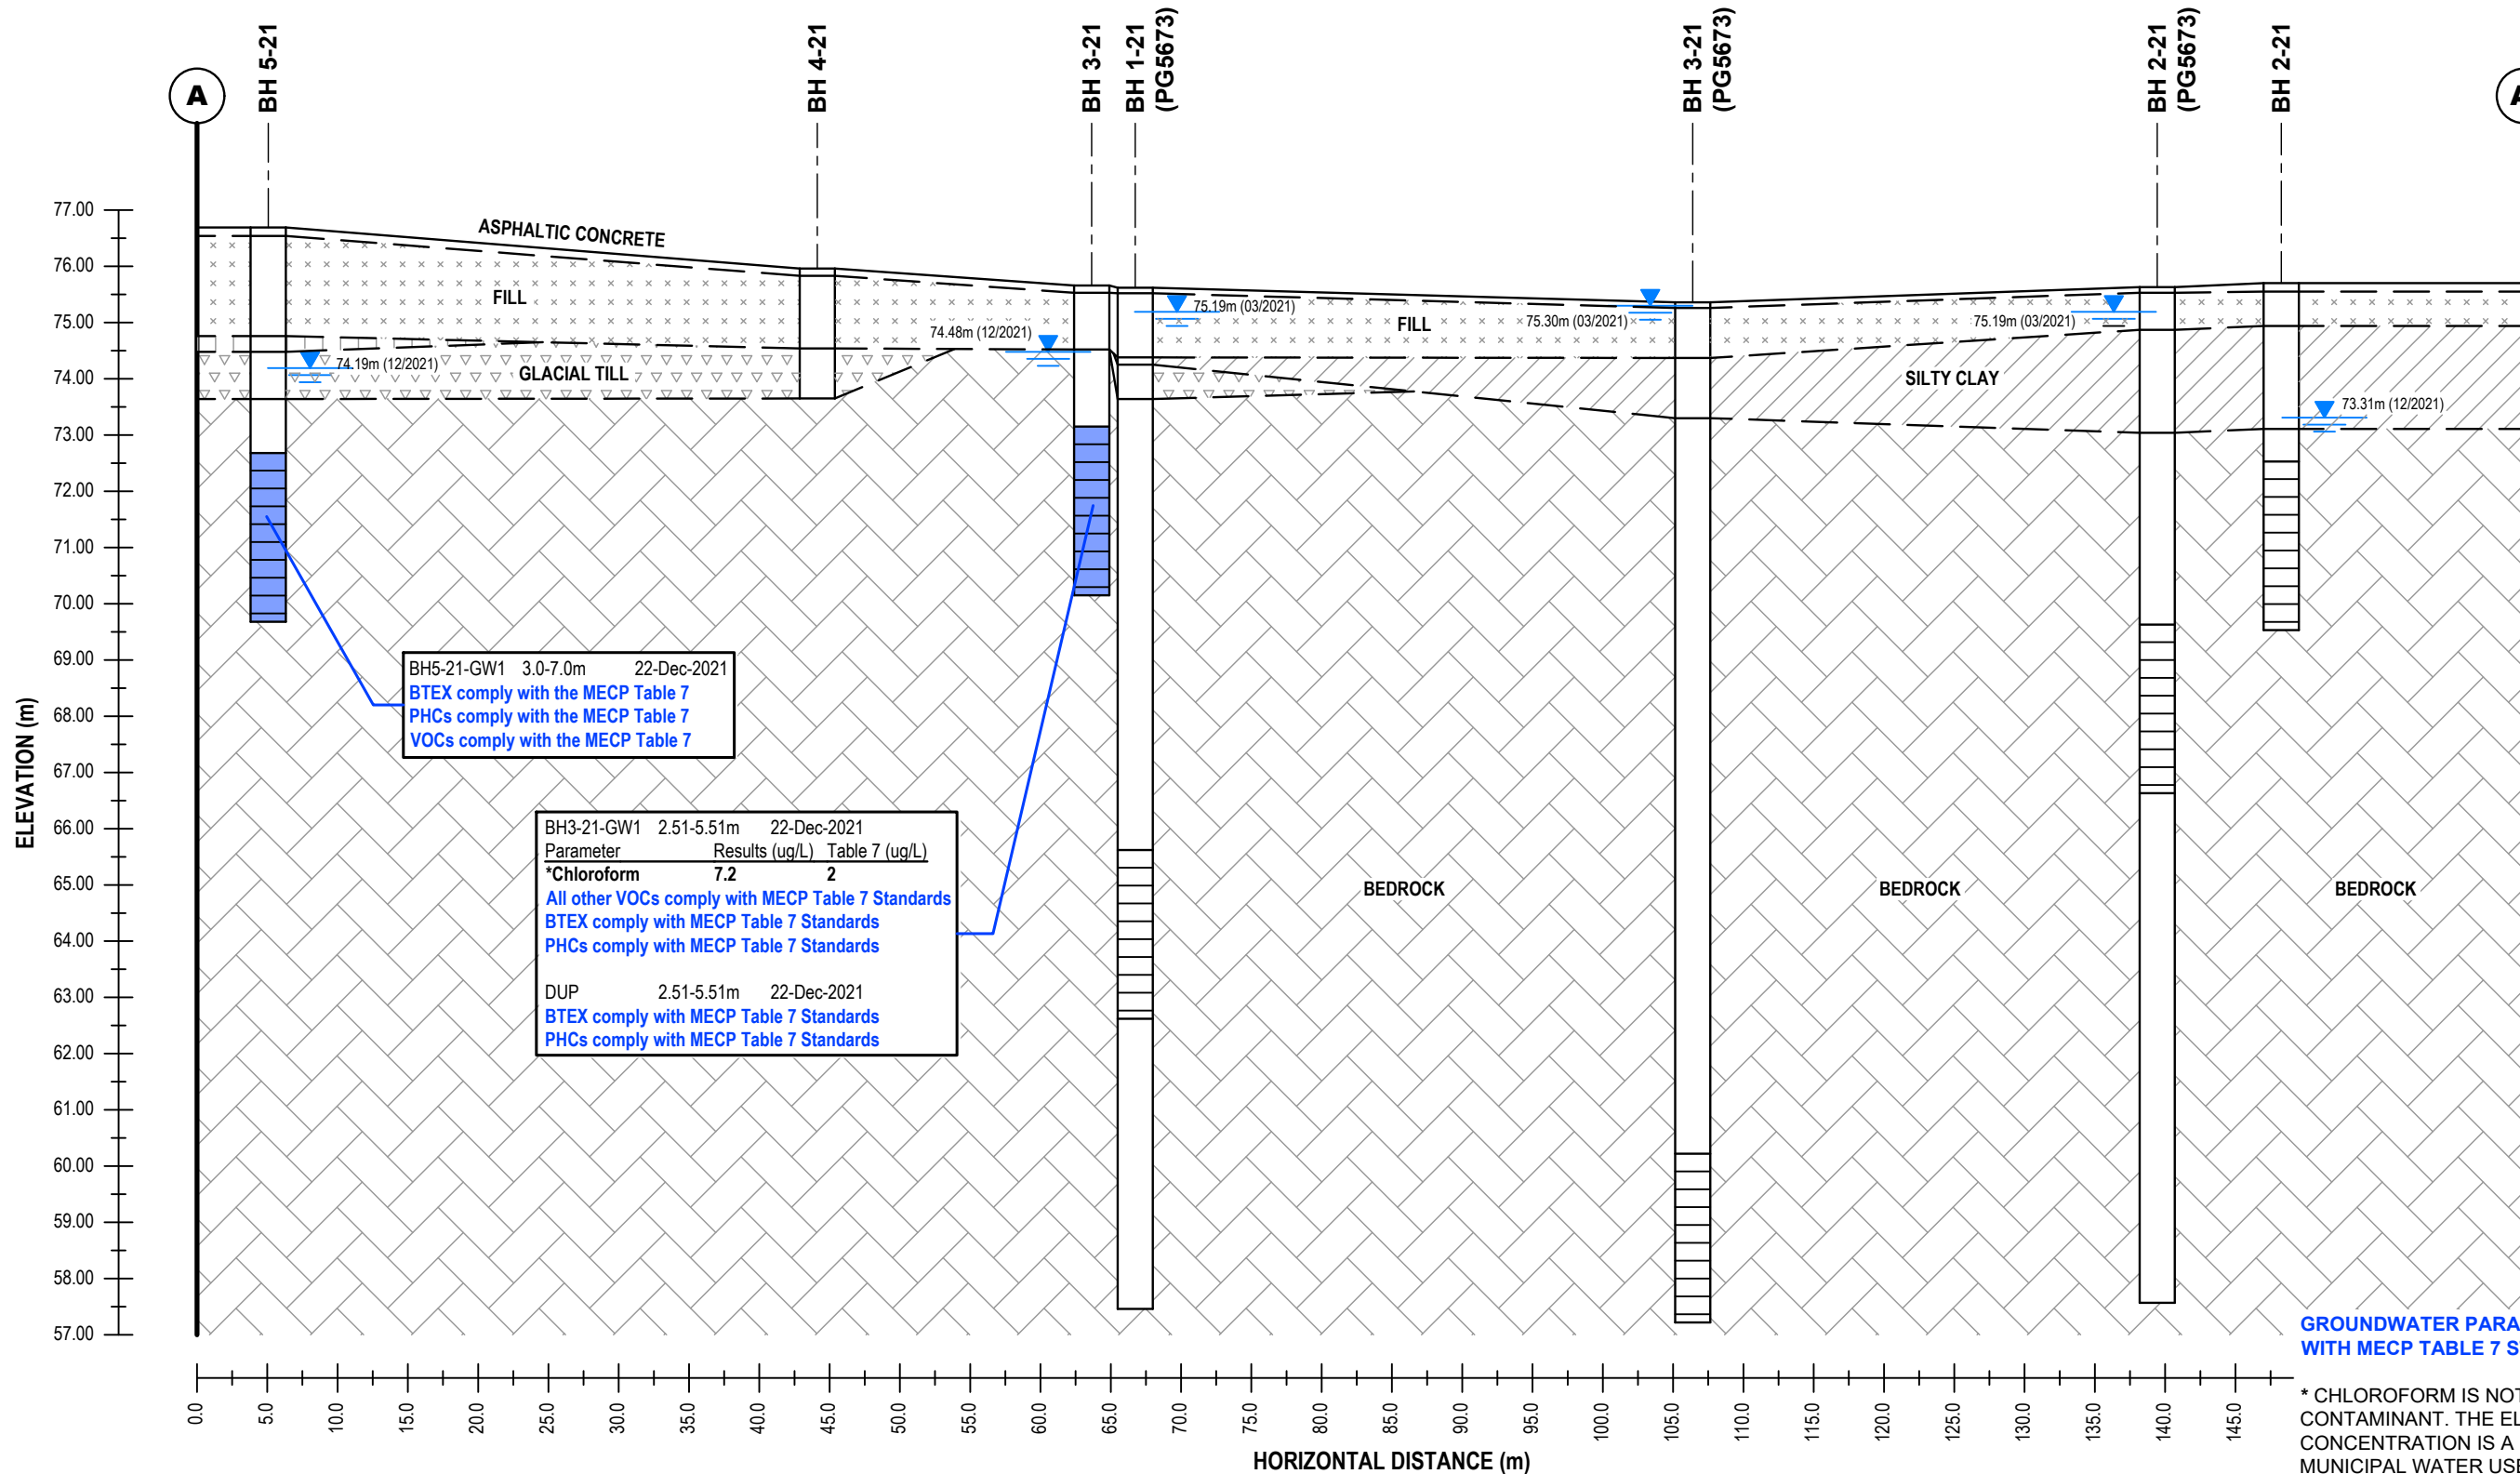
Title: **CROSS-SECTION A-A' - GROUNDWATER**

GROUNDWATER PARAMETERS COMPLY WITH MECP TABLE 7 STANDARDS

* CHLOROFORM IS NOT CONSIDERED A CONTAMINANT. THE ELEVATED CONCENTRATION IS A RESULT OF THE MUNICIPAL WATER USED FOR ROCK CORING AND AS SUCH, THE CONCENTRATION IS EXPECTED TO DISSIPATE OVER TIME.

Drawing PE5413-5A – Cross-section A – A' – Groundwater

The chloroform concentration in excess of the standards is not considered a contaminant as the elevated concentration was due to the use of municipal water during bedrock coring and is expected that this concentration will dissipate over time.

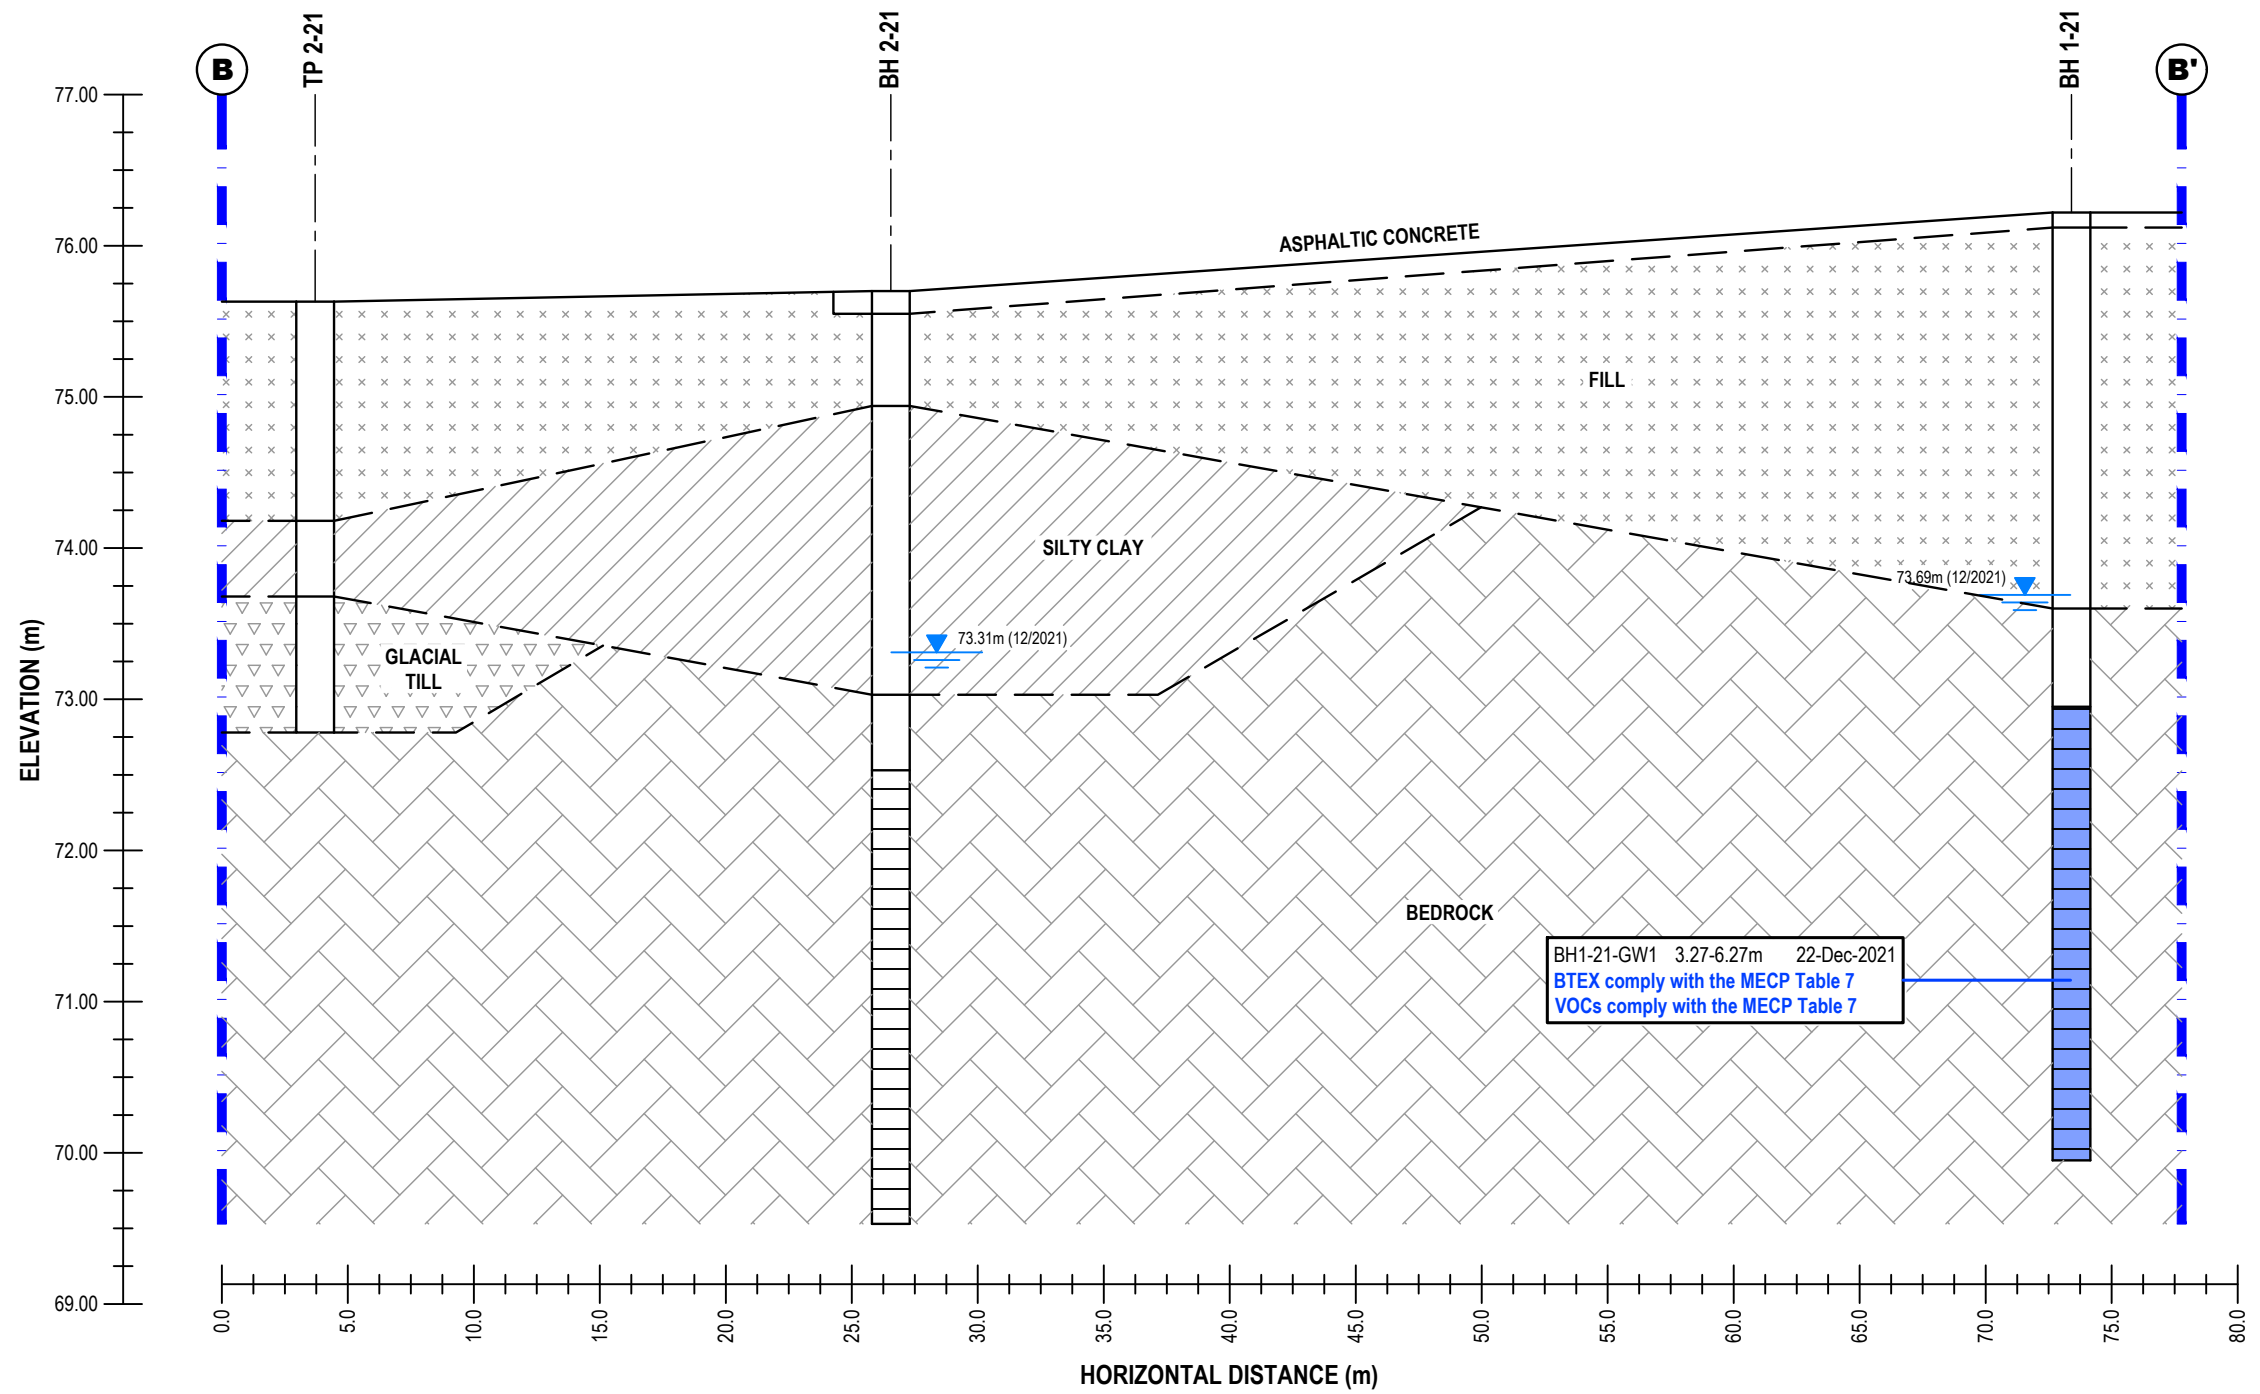
GROUNDWATER PARAMETERS COMPLY WITH MECP TABLE 7 STANDARDS

Drawing PE5413-5B – Cross-section B – B' – Groundwater
