**Phase One Environmental Site Assessment**

**2584-2600 Bank Street**

**Ottawa, Ontario**

**DST File No.: TS-S0-32782**  
**DST Consulting Engineers Inc.**

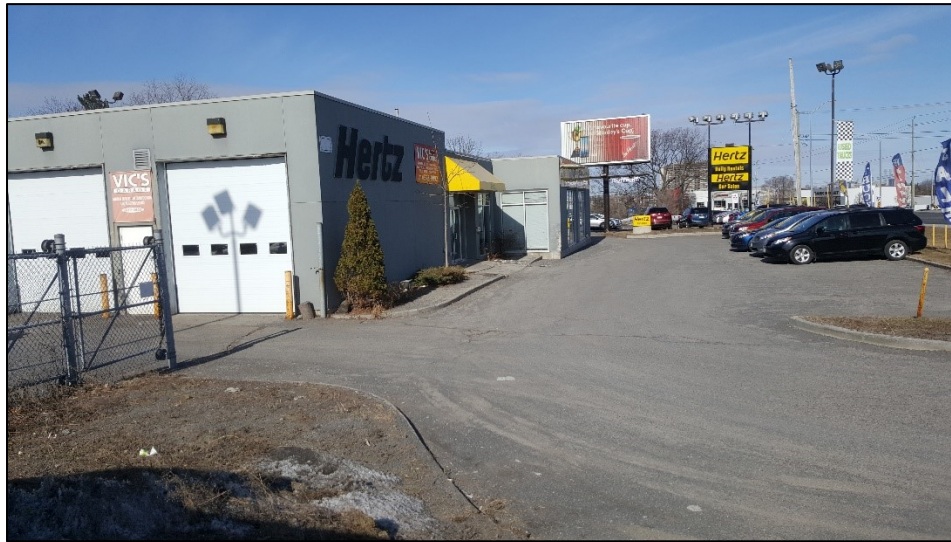
**Photograph 1: View of northeast corner of the Site building, facing north (April 9, 2018)**

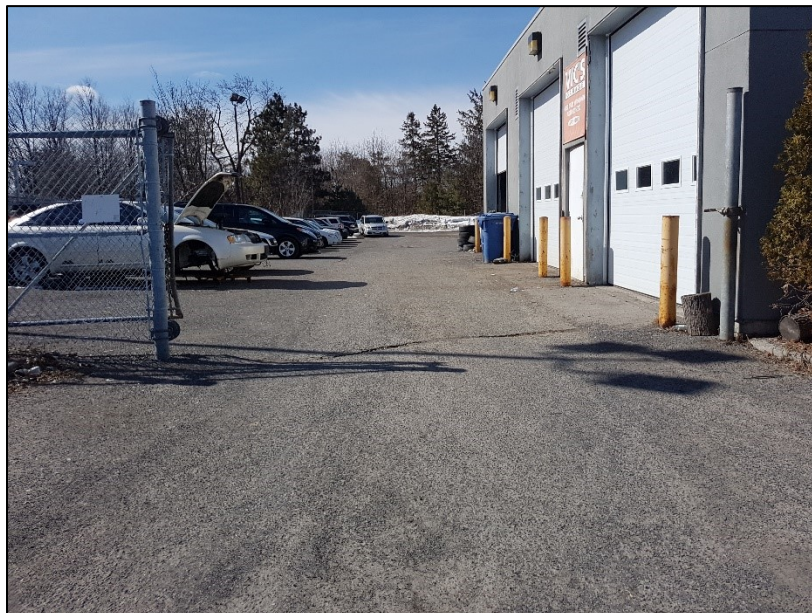
**Photograph 2: View of eastern elevation of Site building (2600 Bank), looking south (April 9, 2018)**

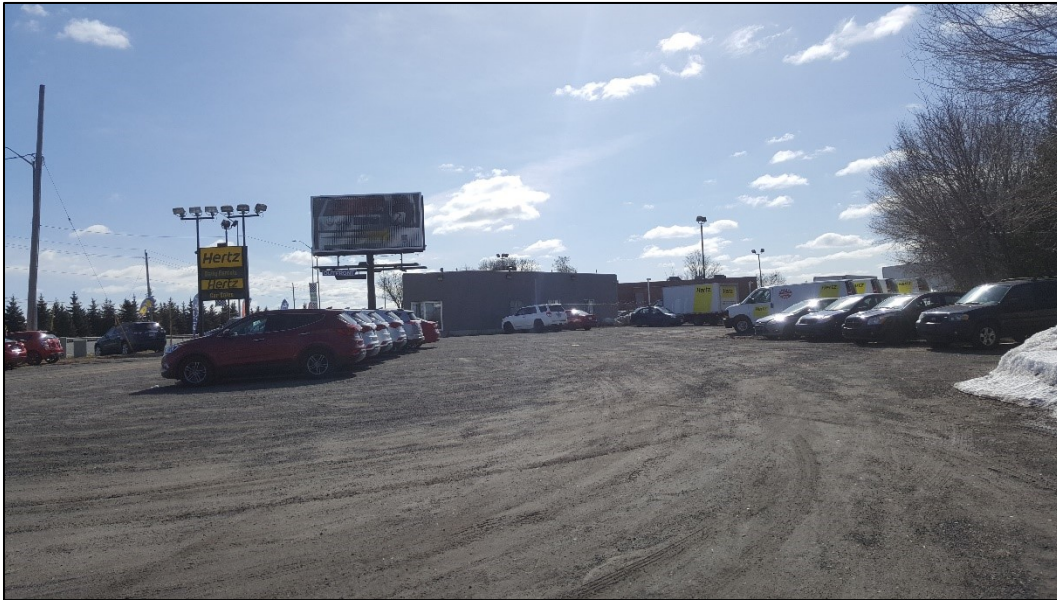
**Photograph 3: View of western elevation of Site building (2600 Bank) and the side gravel parking area, looking east (April 9, 2018)**

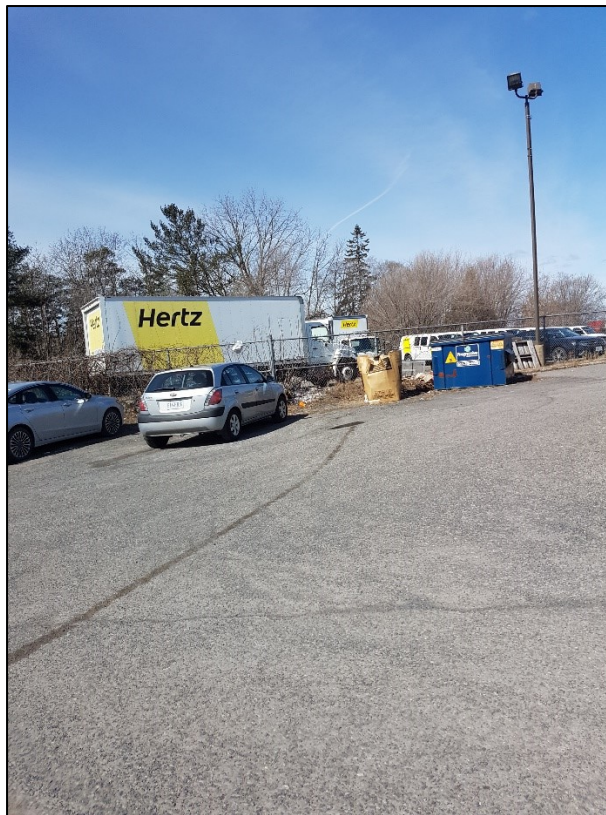
**Photograph 4: View of the southern parking lot area at 2600 Bank, former UST and pump island area. Looking west (April 9, 2018)**

According to DST's records review the Site Building had previously been registered as having a UST. The UST was listed as having a capacity of approximately 15,000 L. The Site Representative estimated that the UST was removed in 2000. However, it should be noted that based on a review of the available aerial photographs for the Site, the concrete pad and area where the UST was reportedly situated was observed to be present up until at least 2007. During the Site reconnaissance, the area where the concrete pad was previously situated was inspected. No concrete pad or other infrastructure associated with the 15,000 L UST was observed, however; it should be noted that two access ports were observed approximately 2.5 m south of the Site building (adjacent to the west side of the wash bay). There is a high potential that these access ports may be associated with a different UST, since they over 8 m north of the 15,000 L UST location.

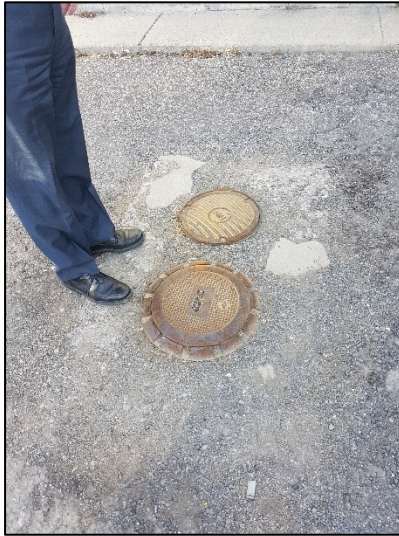
**Photograph 5: View of unidentified access ports observed adjacent to the south elevation of 2600 Bank Street (Site) (April 9, 2018)**

Mr. Brian Findlater, indicated that they do not have any reference to another tank being present at the Site, therefore the purpose of the observed access ports on the south side of the Building remains unknown.

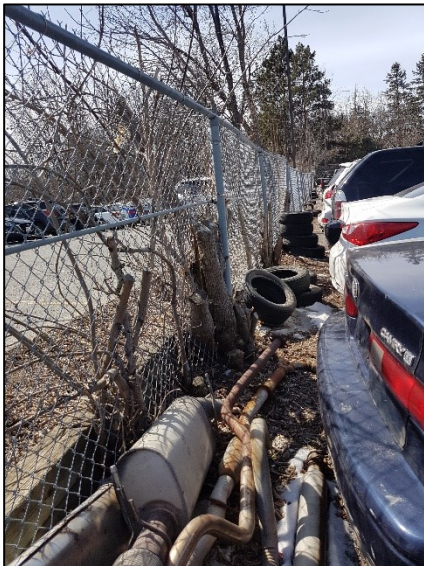
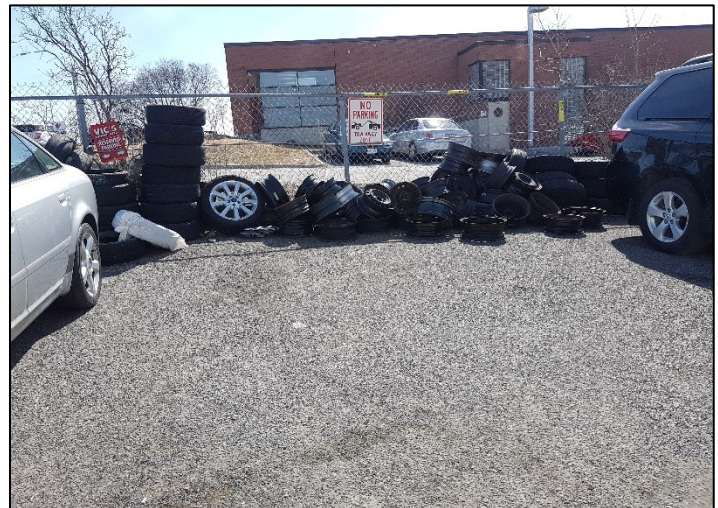
**Photograph 6 and 7: View of the debris stored on the eastern portion of the Site (2600 Bank Street), debris associated with Vic's Automotive. (April 9, 2018)**

No fill material was observed at 2584 or 2600 Bank Street, however there is a potential that fill material was brought to the Site as part of the construction of the Site Building. Piles of tires and other automotive parts piles (steel rims, mufflers, fenders, bumpers, etc) were observed outside in the fenced in area of 2600 Bank Street. Some piles of building debris (concrete, stone, bricks) was observed in the forested area of 2626 Bank Street. Garbage and random debris was observed to be scattered throughout 2626 Bank Street.

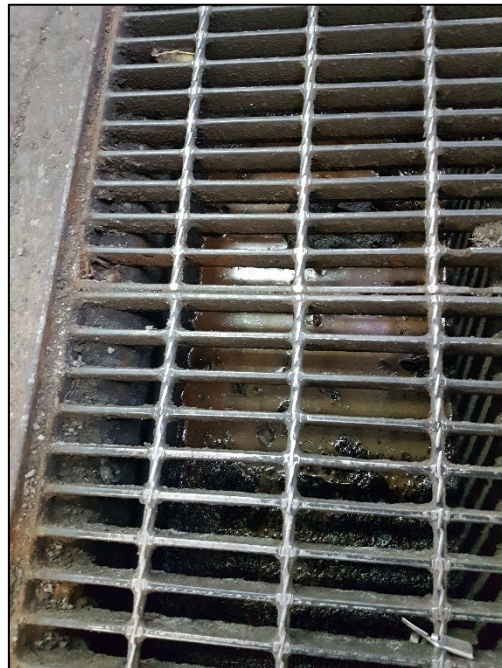
**Photograph 10 and 11: View of the waste oil storage container (left) and the oil water separator trench (April 9, 2018)**

- Inspection of the onsite oil/water separator and interceptor;
- Removal of all refuse and discarded automotive parts from the Site;
- Ensure that the proper housekeeping practices are maintained in the automotive repair tenant unit and that all liquids are contained; and,
- A mould inspection should be completed at the Site due to the ongoing water infiltration issues.

A trench reportedly associated with an oil/water separator was observed within the Vic's Automotive tenant unit. The tenant and Site Representative could not provide any information on the location of the actual oil/water separator. DST inspected the tenant unit; however, the unit was very disorganized and had equipment, parts and machinery covering all available floor space. When asked when the system is cleaned out, it was reported that the system is cleaned out and inspected on a yearly basis. The current landowner provided records indicating that Drain- All had been to the Site in February 2017 and they pumped out the troughs and interceptor and one large pit. Another visit was noted in March 2017, where two large catch basins were pumped out. It should be noted that no documentation was provided indicating that an inspection of the system has been completed. A floor drain was observed in the onsite bathroom. No sumps pump or pits were observed during the Site reconnaissance.

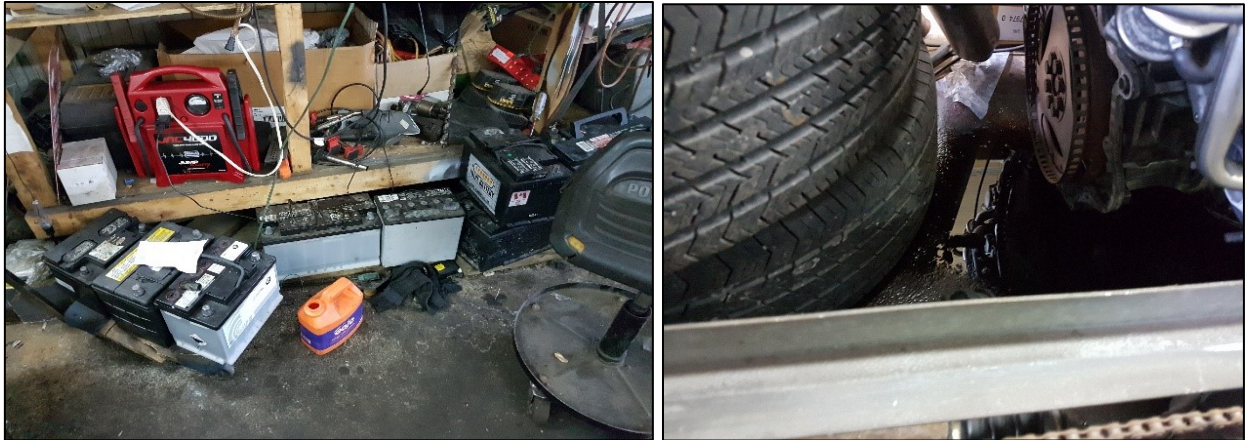
**Photograph 12 and 13: View of the battery storage (left), note pooling liquid underneath the motor in the Vic's Automotive unit (April 9, 2018).**

The floor surface of the mechanical bays was observed to have extensive staining throughout. In addition, pooling liquid on a flat metal plate was observed underneath an engine block that was being stored in the center of the garage. Water staining was observed on the acoustic ceiling tiles throughout the Hertz office space. Reportedly the water staining is a result of ongoing roof sealant issues. The Site Representative indicated that many attempts have been made to fix the leaks, however they have proven to be unsuccessful. Reportedly the leaks have been happening since the addition was added in 2000. No visible mould was observed; however it should be noted that an intrusive investigation into the wall cavities or ceilings was not a part of the scope of this Phase One ESA.

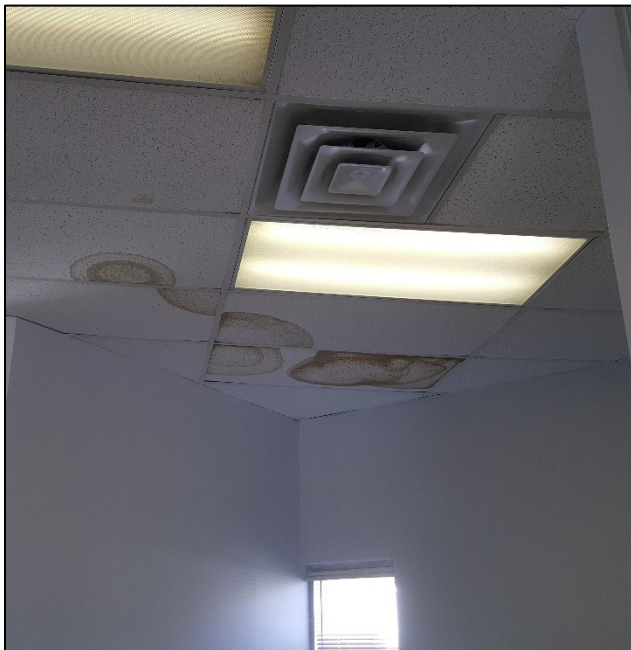
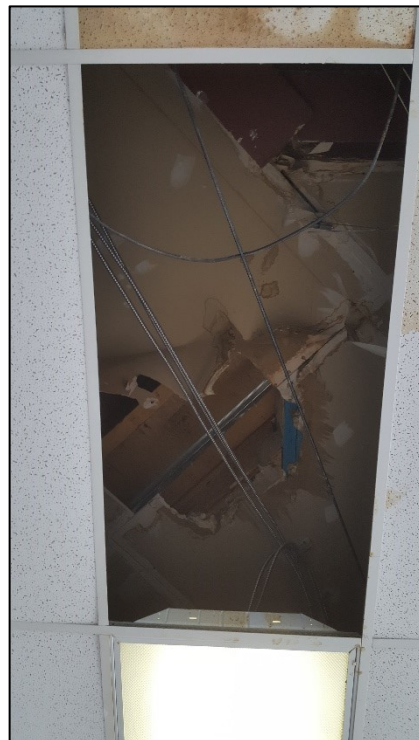
**Photograph 14 and 15: View of water damage observed in the Hertz tenant unit. Water infiltration due to roof sealant issues.**

Water staining was observed on the acoustic ceiling tiles throughout the Hertz office space. Reportedly the water staining is a result of ongoing roof sealant issues. The Site Representative indicated that many attempts have been made to fix the leaks, however they have proven to be unsuccessful. Reportedly the leaks have been happening since the addition was added in 2000. No visual evidence of mould was present in the readily accessible areas of the building.

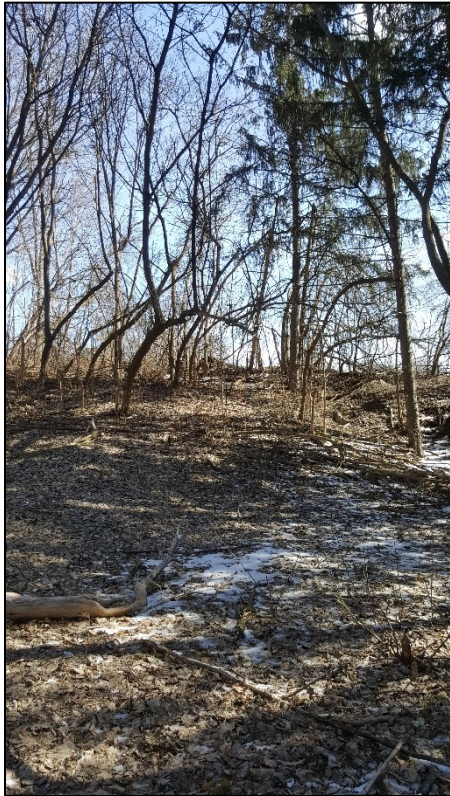
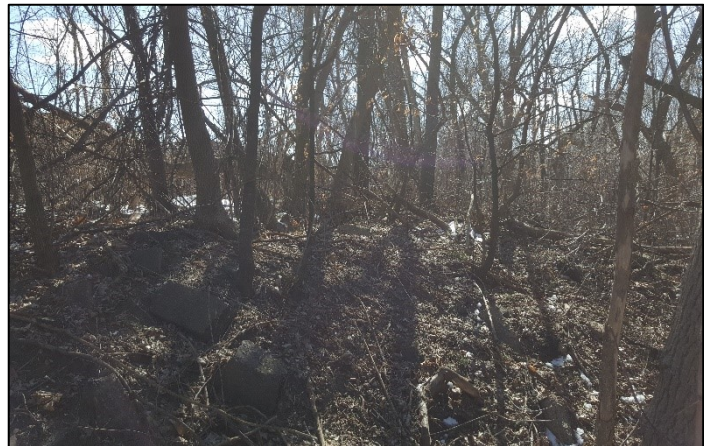
**Photograph 16 and 17: View of the south end of 2584 Bank Street and north portion of the 2626 Bank Street, looking east, on (April 9, 2018).**

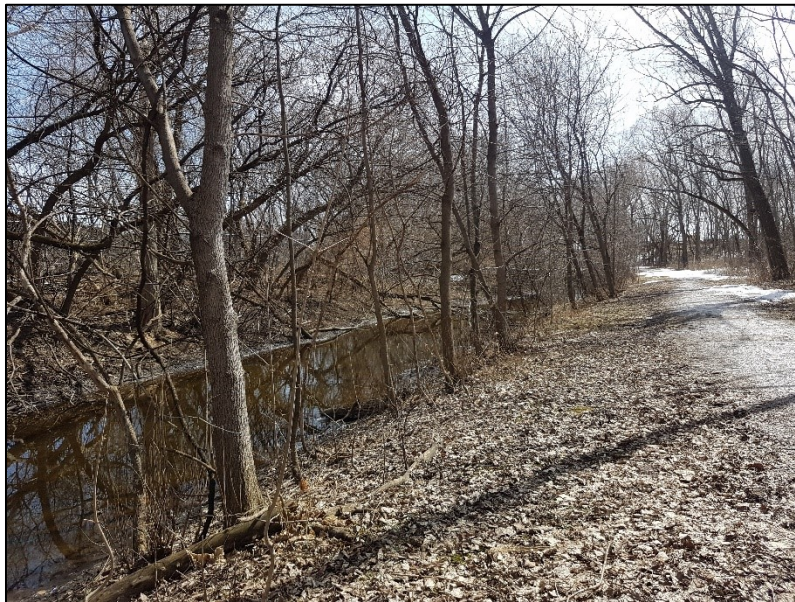
**Photograph 18: View of southern portion of 2626 Bank Street, this portion of the Site contains Sawmill Creek. Looking north east, on April 9, 2018.**

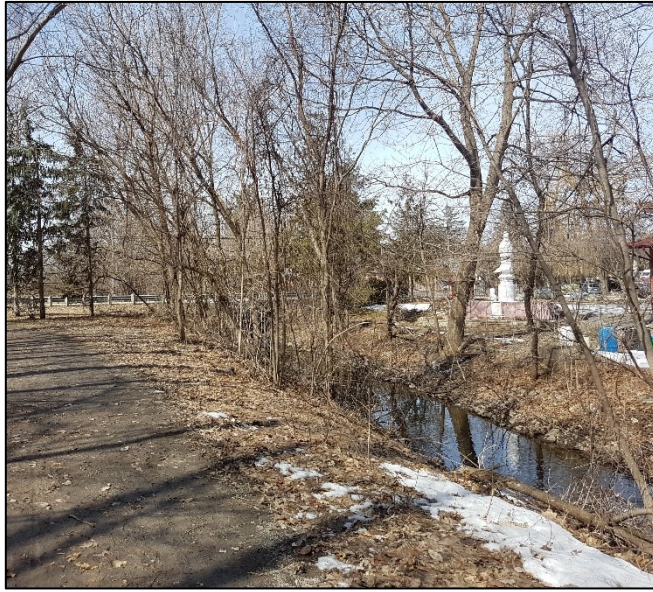
**Photograph 19: View of the east end 2626 Bank Street portion of the Site, Note Sawmill Creek in the on April 9, 2018.**

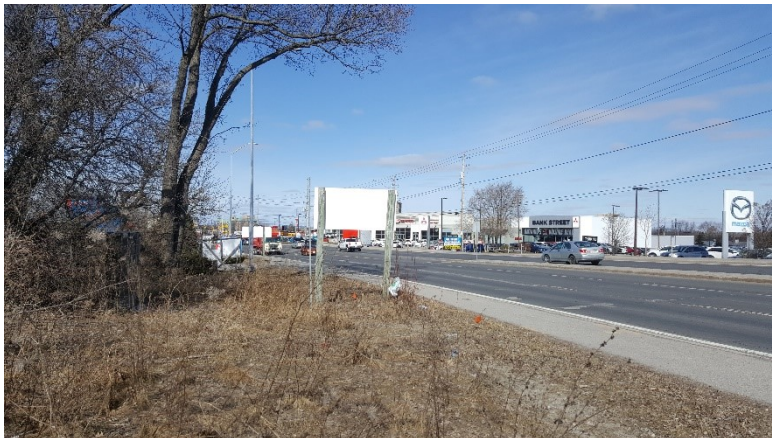
**Photograph 20: View of the north adjacent properties (car dealerships) (April 9, 2018).**

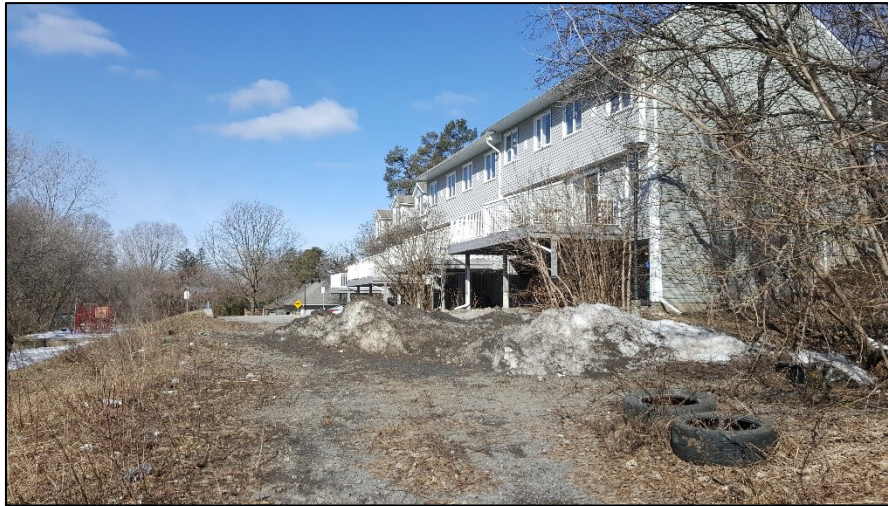
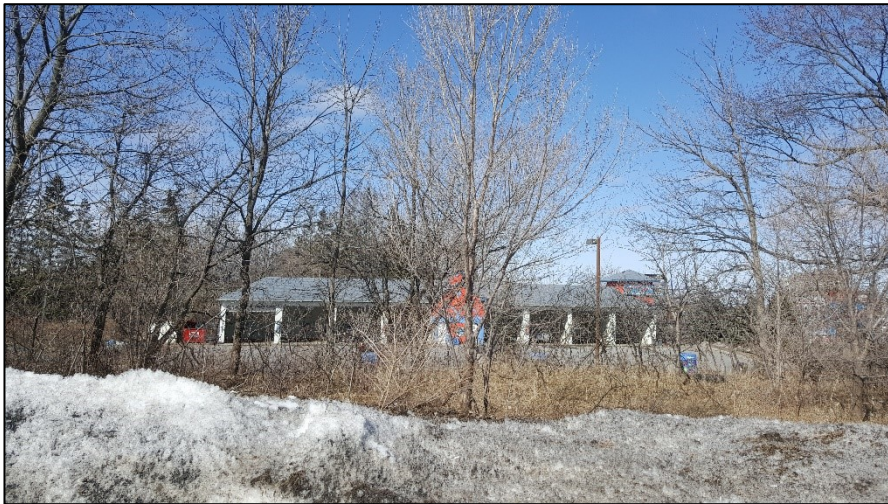
**Photograph 22 and 23: View of the west adjacent properties, (2801 Mesenges) and (2560 Bank Street) on April 9, 2018.**

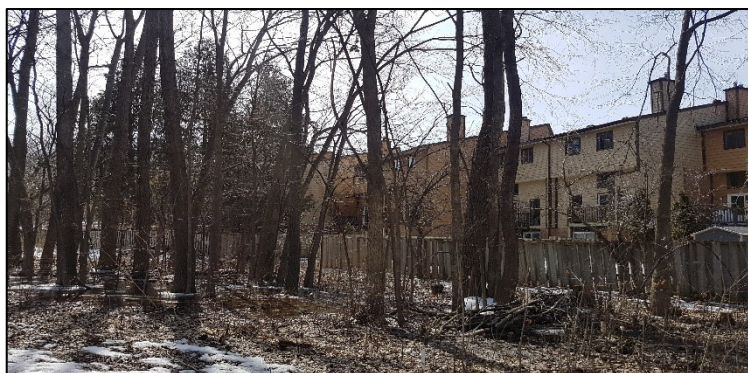
**Photograph 24: View of the residential properties to the south of 2626 Bank Street (southern portion) on April 9, 2018.**
