Phase II Environmental Site Assessment

330 McLeod Street
Ottawa, Ontario

Smart Living Properties

Report: PE4548-2

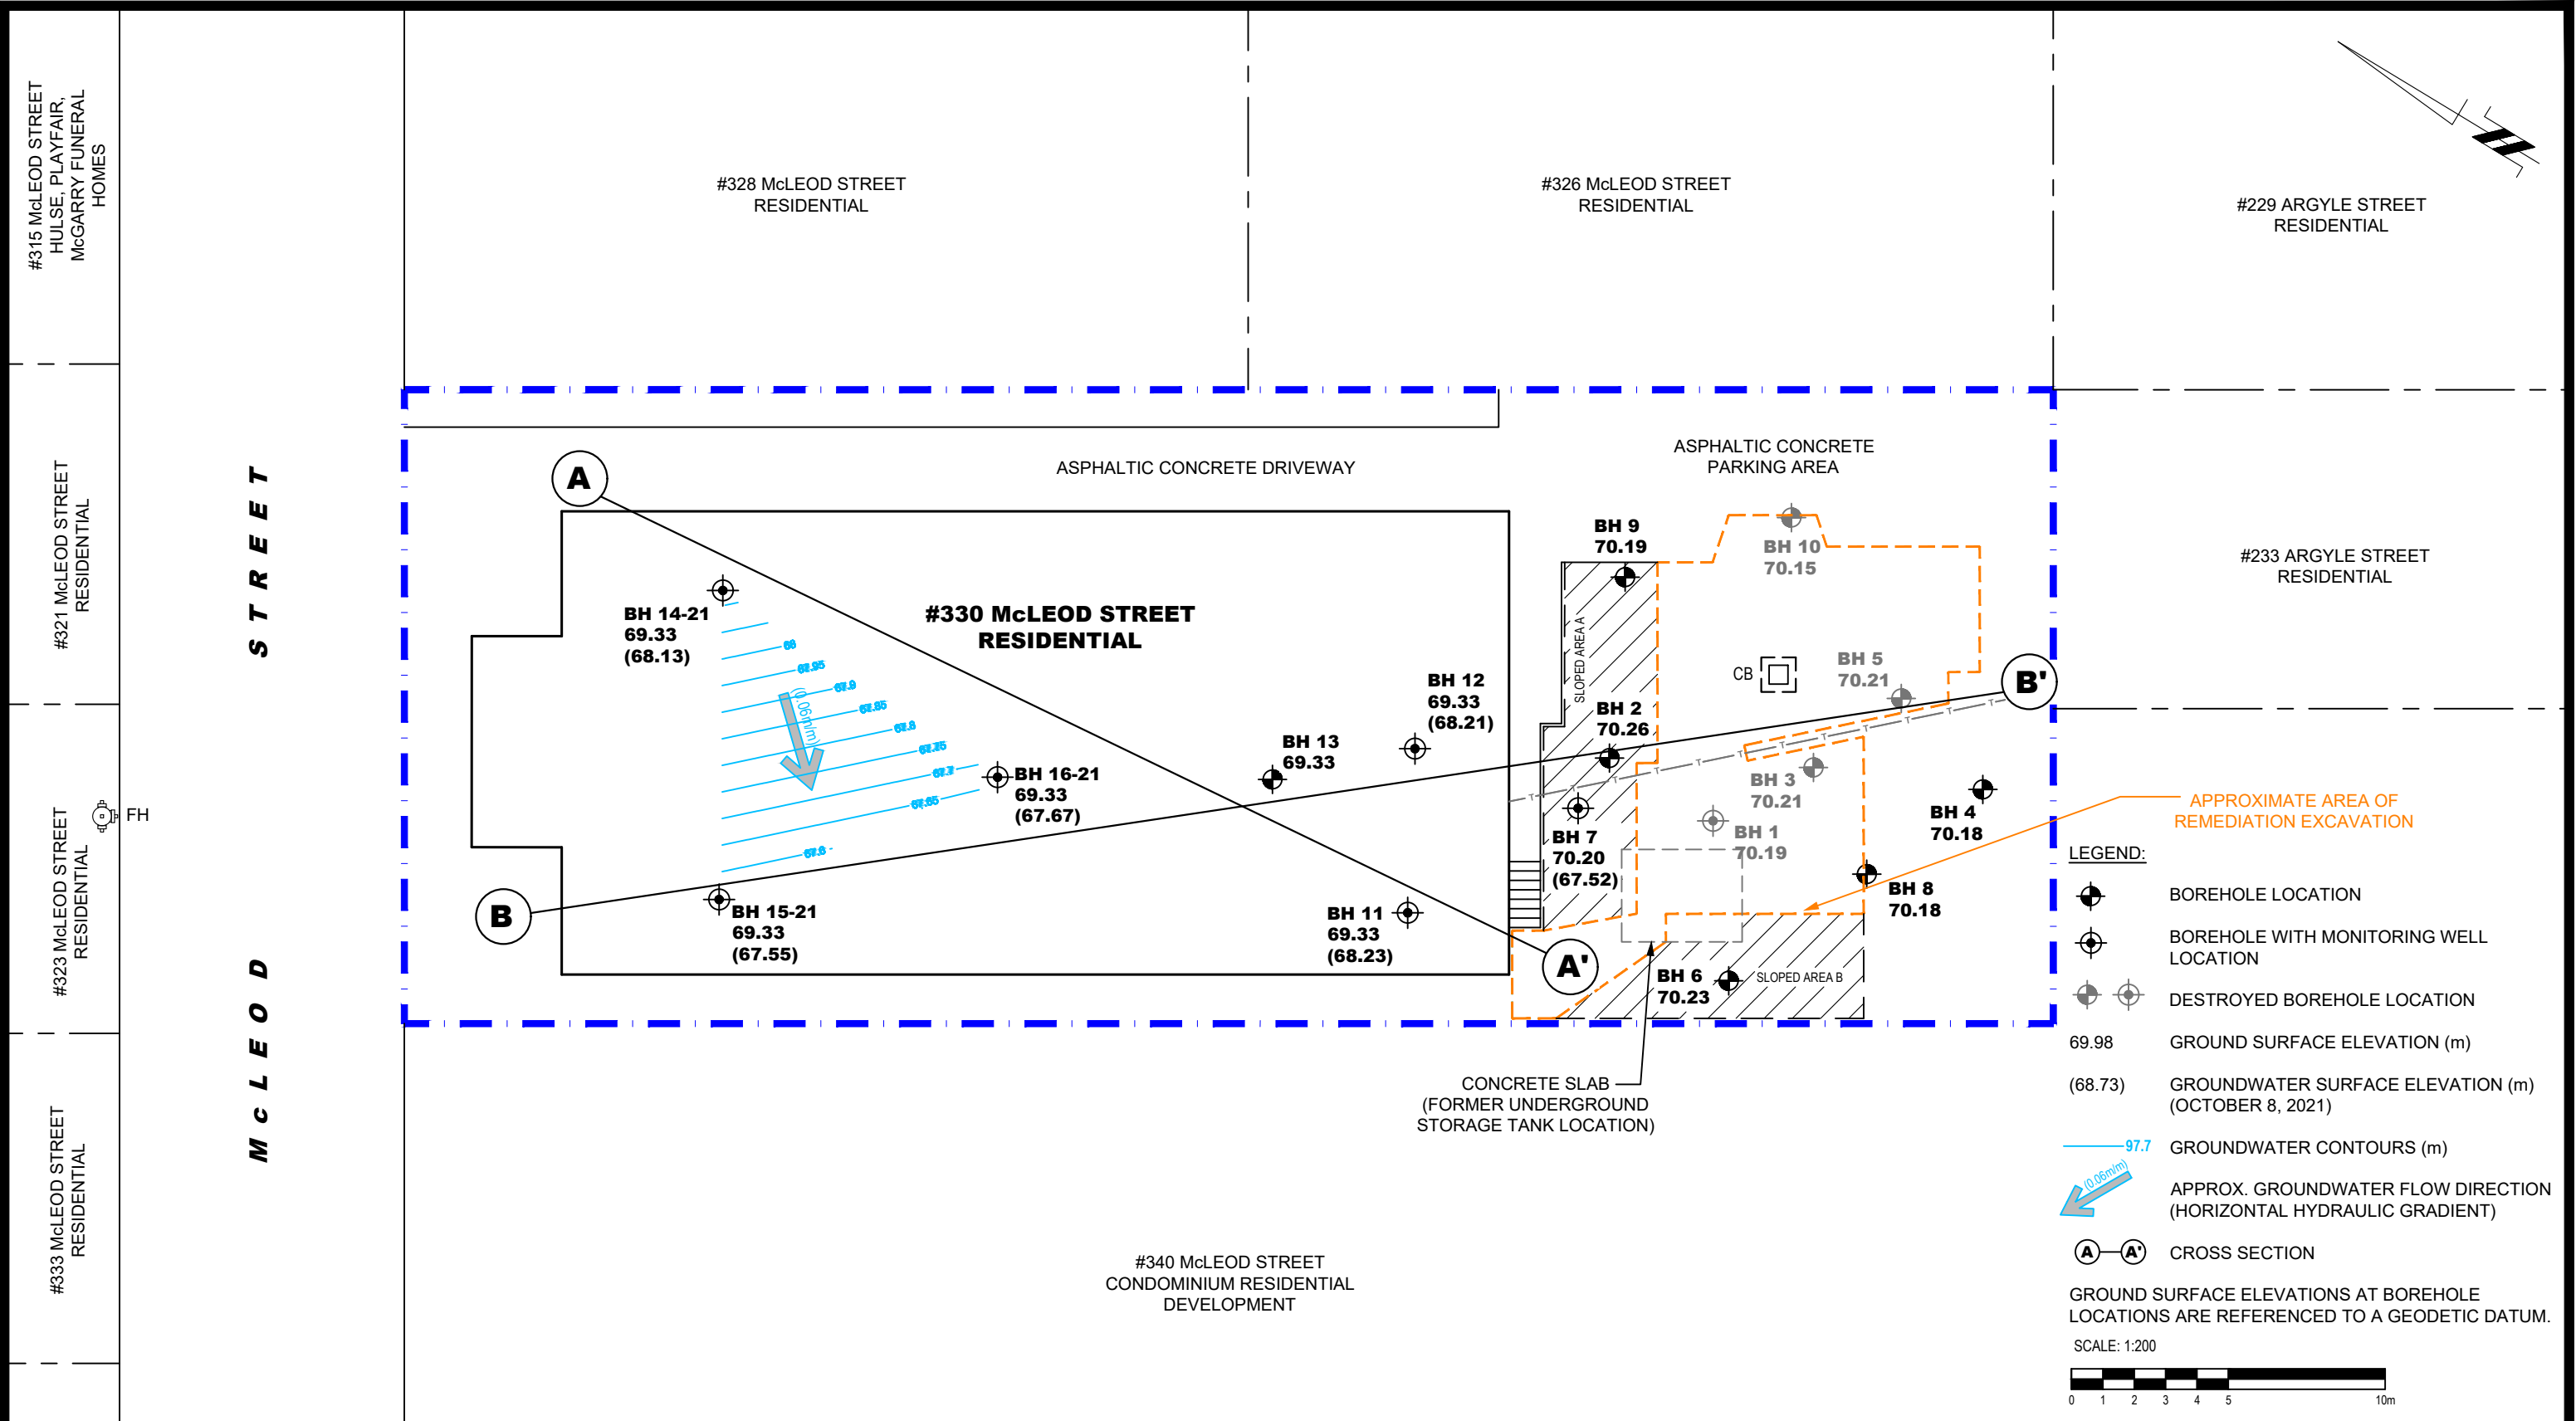
Title: **TEST HOLE LOCATION PLAN**

The field programs consisted of drilling a total of 16 boreholes, seven of which were instrumented with groundwater monitoring wells. The boreholes were drilled to a maximum depth of 6.10 m below the existing grade.
