Phase One Environmental Site Assessment

**2254, 2262, 2270 Braeside Avenue and
2345 Alta Vista, Ottawa, Ontario**

October 22, 2021

GHD

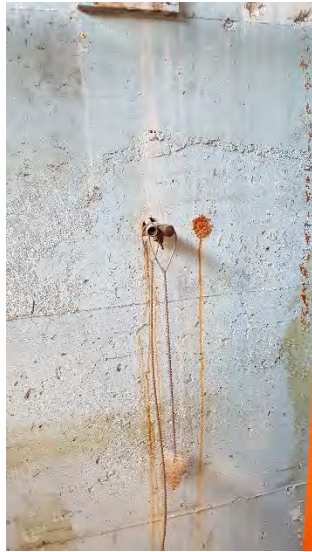
GHD observed the presence of what appeared to be former vent and fill lines, which had been disconnected, on the interior side of an exterior wall within the basement mechanical room of the Church building. Holes in the foundation wall and suspected former mounting locations were observed in approximately the same location on the exterior of the same wall. According to Site personnel, an oil-fired boiler and associated interior heating oil AST were removed in the 1970s when the church heating system was converted to natural gas. The historical storage and use of fuel oil at the Site was identified as a PCA (#28 – Gasoline and Associated Products Storage in Fixed Tanks) in accordance with O. Reg. 153/04. As such, the area of the former petroleum fill pipes and AST in the central portion of the Site (mechanical room of the church) was identified as **APEC #1** in this report.

Photo 9 - View of former/disconnected suspected vent and fill pipes on the interior of the mechanical room of the Church building. The piping is suspected to have been associated with a historical interior aboveground storage tank.

Following the completion of the Phase One ESA for the Site, it is GHD's recommendation that the impacted soil material identified at 2345 Alta Vista Drive (APEC #1) be removed, confirmatory soil sampling of excavation surfaces be collected to confirm removal of all impacted material, and that groundwater samples be collected to determine the presence/absence of potential petroleum impact to the shallow groundwater aquifer. Additional Phase Two Environmental Site Assessment activities at 2254, 2262, and 2270 Braeside Avenue are not required at this time.

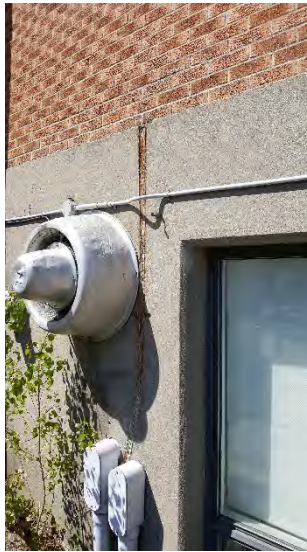
Photo 10 - View of former location of suspected exterior vent and fill pipes on the east Side of the Church building.

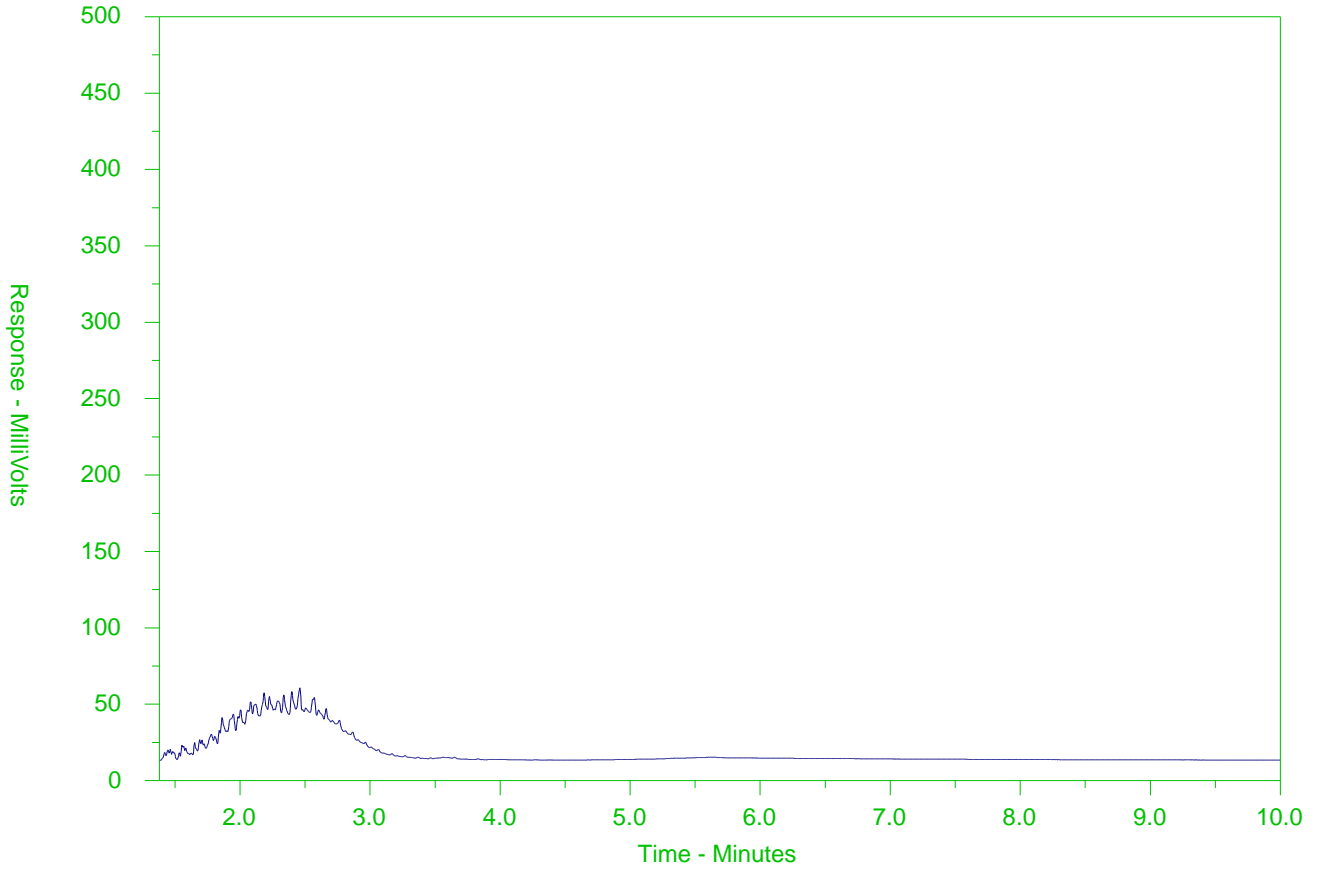
ALS Sample ID: L2651897-2
 Client Sample ID: S-12560245-101521-DA-002

← F2 →		← F3 →		← F4 →	
nC10	nC16	nC34	nC50		
174°C	287°C	481°C	575°C		
346°F	549°F	898°F	1067°F		
Gasoline →			← Motor Oils/Lube Oils/Grease		
← Diesel/Jet Fuels →

The CCME F2-F4 Hydrocarbon Distribution Report (HDR) is intended to assist you in characterizing hydrocarbon products that may be present in your sample.

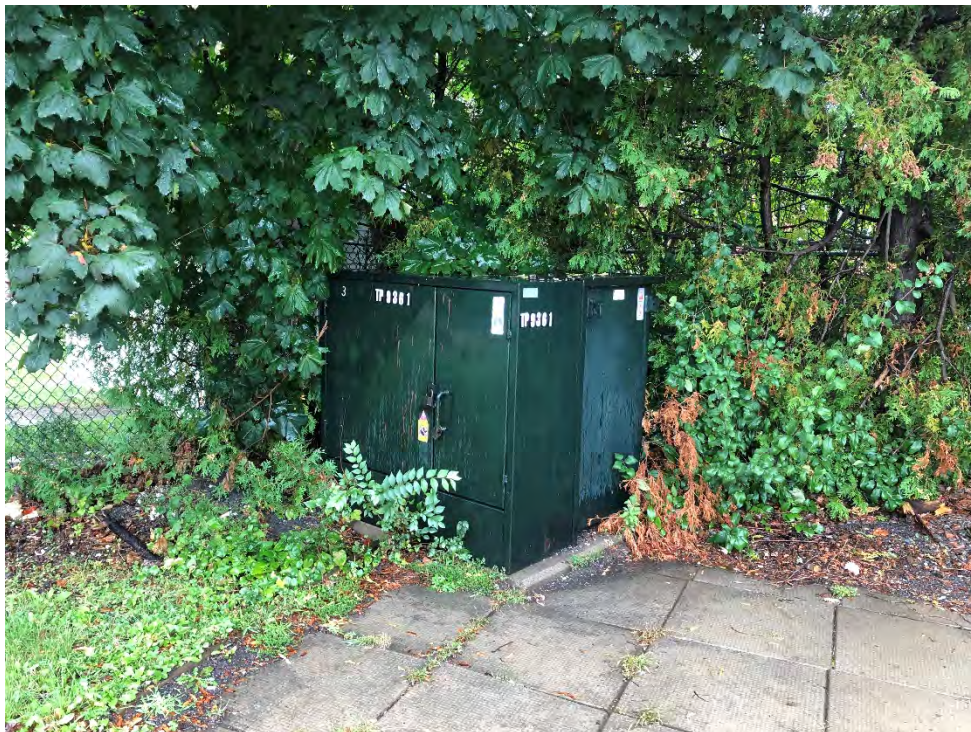
Site personnel reported that no PCB-containing equipment is currently being used, stored, or handled at the Site. At the time of the Site inspection, GHD did not observe any potential PCB-containing equipment at the Site with the exception of a pad-mounted transformer north of the asphalt parking area in the central portion of the Site and fluorescent light ballasts located throughout the church. The pad-mounted transformer appeared to be in good condition and no evidence of leaks was observed by GHD at the time of the Site inspection.

Photo 8 Photo showing the pad-mounted transformer in the central portion of the Site

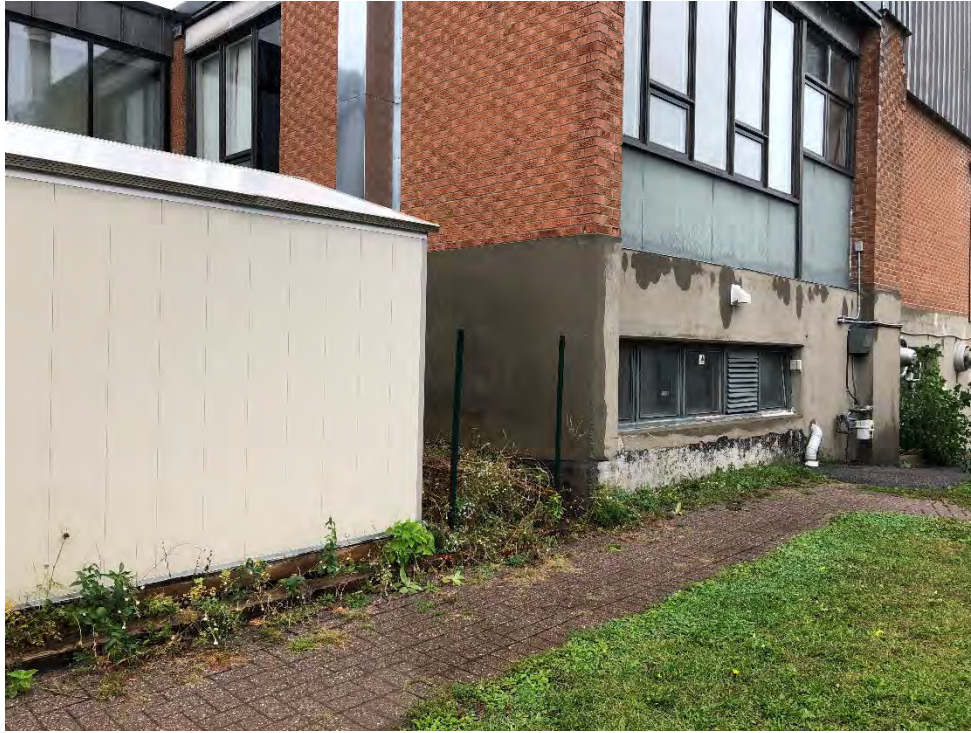
Photo 9 Photo showing the location of the location of the historic fuel oil tank fill pipes on the east side of the church

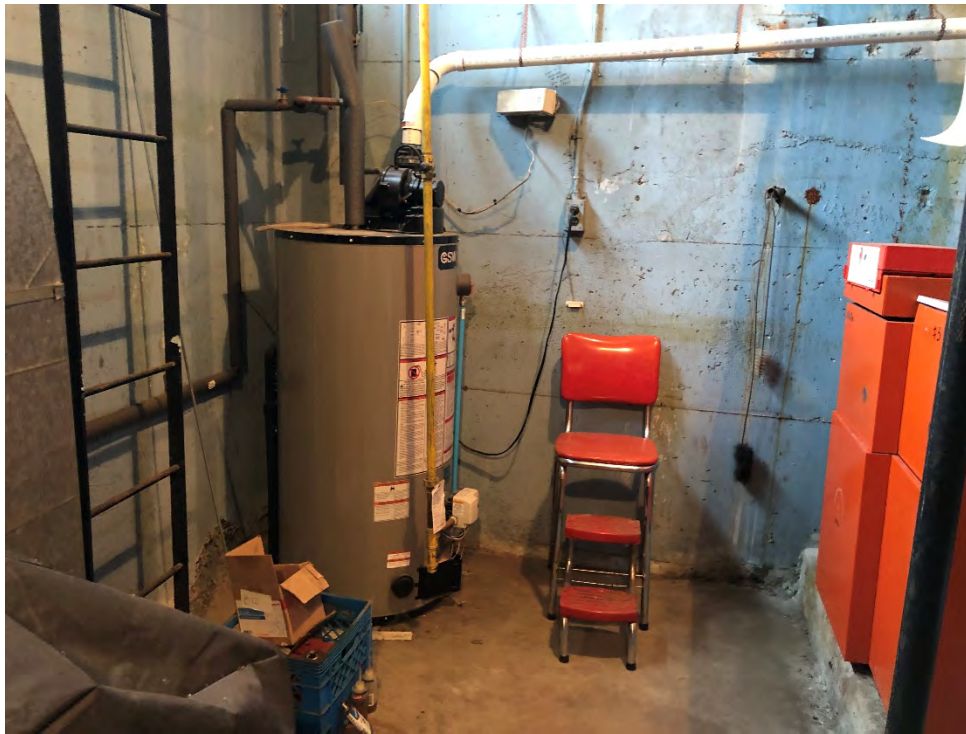
The Site buildings were equipped with natural gas fired boilers or furnaces at the time of the Site Visit. According to Site personnel, the current natural gas fired boiler within the basement of the Church building replaced a former heating oil fired boiler, which was not present at the time of the Site visit. As noted in section 6.2.2. above, historic storage of fuel oil in the central portion of the Site (mechanical room of the church) was identified as **APEC #1** in this report.

Photo 11 View of the historic fuel oil AST location and former fill pipes on the church mechanical room

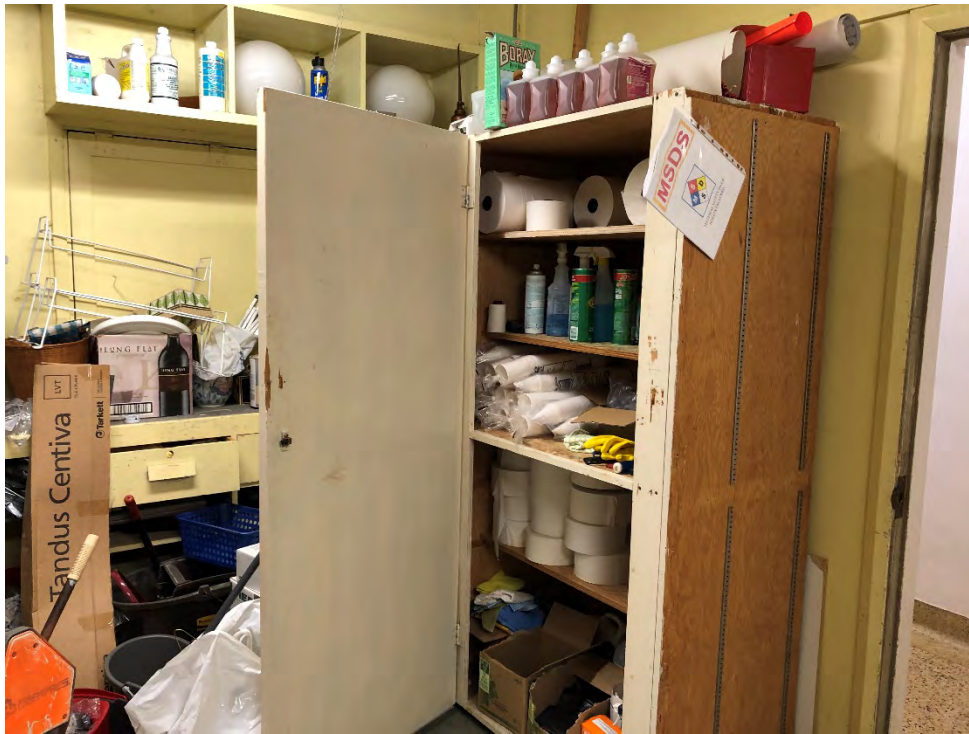
Photo 15 Photo showing the chemical storage cabinet in the janitor's room in the church

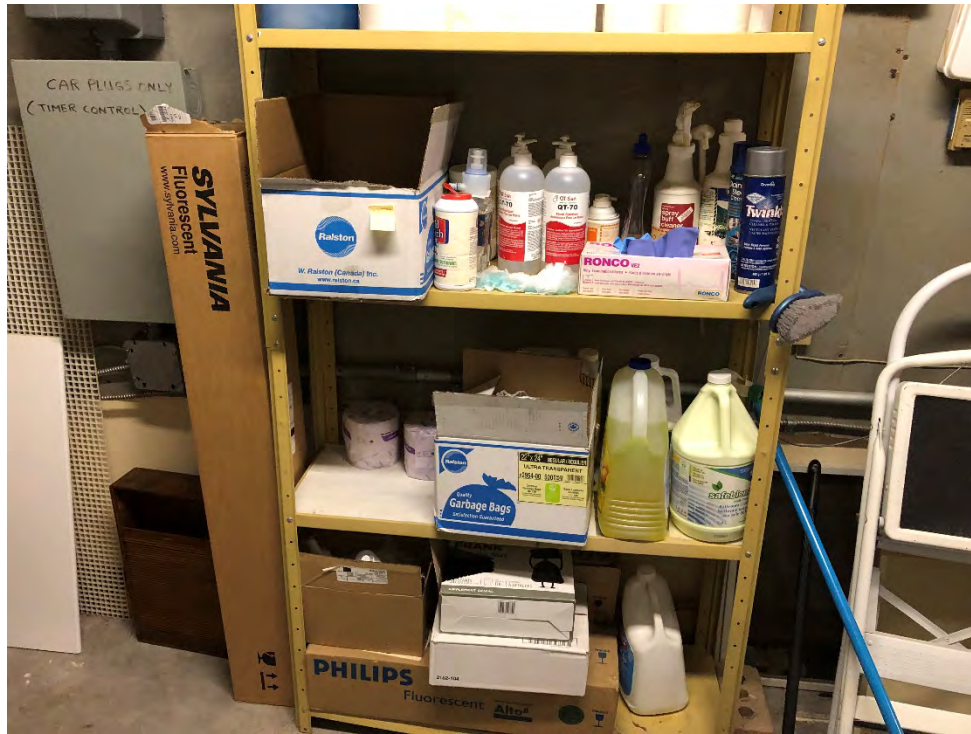
Photo 21 Photo showing the cleaning chemicals stored in the electrical room of Ellwood House Seniors' Residence
